**RE: Soil Infiltration Testing- Arun District Council**

I write following the completion of additional soil infiltration investigation undertaken on the 27<sup>th</sup> and 28<sup>th</sup> February 2014 at four locations within the residential area of Wick, Littlehampton. The works have been carried out to assist with assessment of the soil soakage potential for each location in respect to the proposed planning applications for the area.

Project:  
 WICK ESTATE, LITTLEHAMPTON

Drawing:  
 TEST LOCATION PLAN

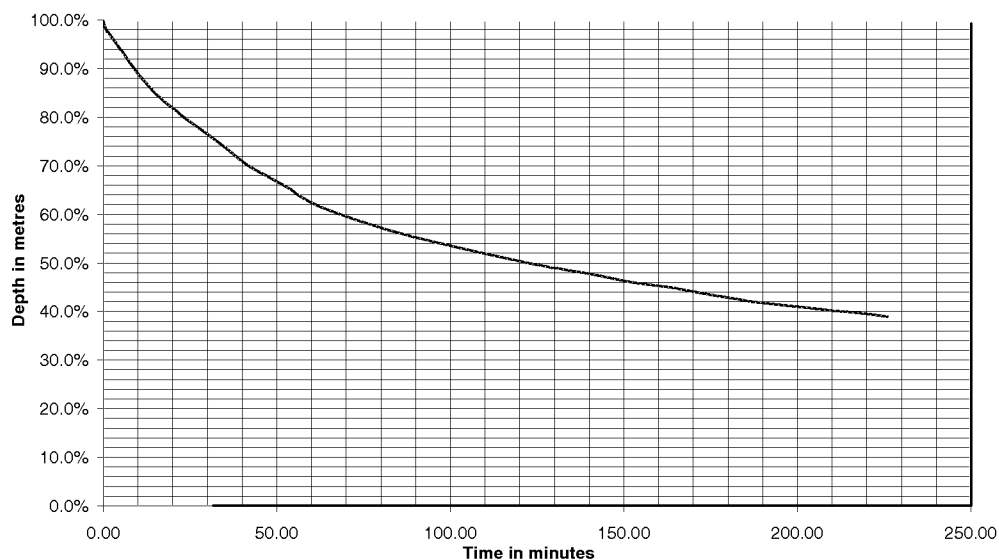
Permeability Graph TP4b Test 2

However, within the Greenfields and Land west of Greensfields sites, again further to the west, further slower infiltrations were observed at 1.20m depth. At these sites it was not possible for the water to fall below the 25% fill depth (within the BRE guidance) in TP3B and TP4B within the time available and as such only fall levels to between 39% and 44% were recorded.

WARNING DOES NOT FALL TO 25% OF START DEPTH-Refer to graph sheet for calculation

Infiltration Rate

from75%-25%

not valid

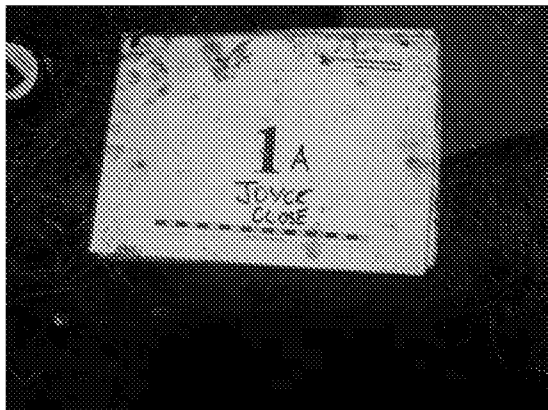
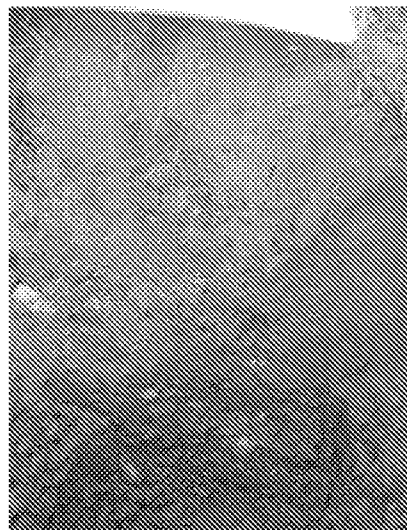
- A. TP1A Joyce Close
- B. TP1A Joyce Close
- C. TP1B Joyce Close
- D. TP1B Joyce Close

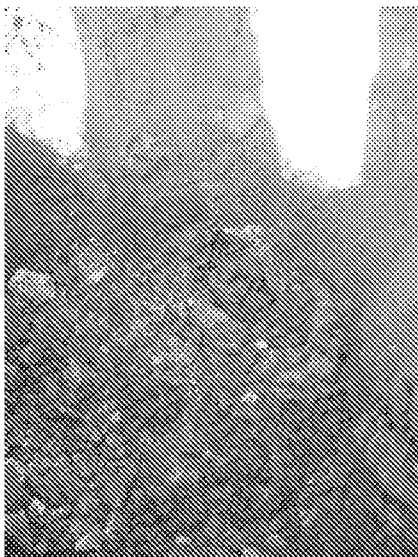
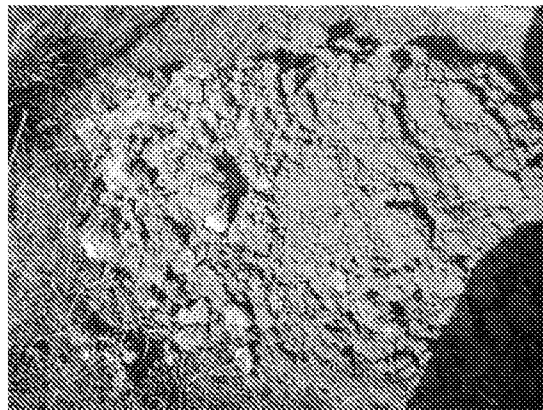
- E. TP2A West of Joyce Close
- F. TP2A West of Joyce Close
- G. TP1B West of Joyce Close
- H. TP1B West of Joyce Close
