**HAMPTON QUAY, LITTLEHAMPTON,  
WEST SUSSEX, BN17 5RA**

**DESIGNER'S RESPONSE TO ROAD  
SAFETY AUDIT STAGE 1**

**Report No.:** 18-270-04C

## **Road Safety Audit Stage 1**

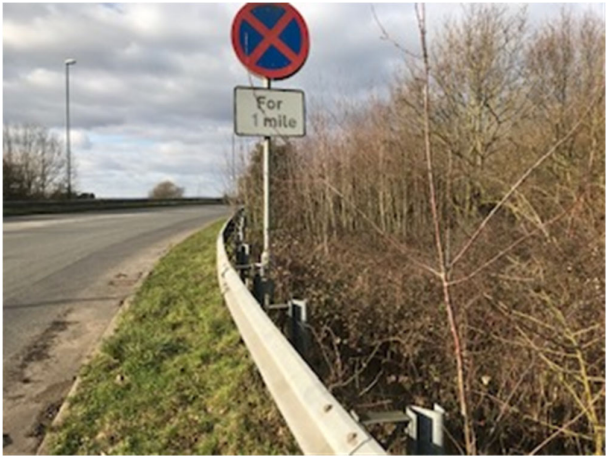
| Audit Item No. | Audit Team Observation | Audit Team Recommendation | Odyssey Designer's Response | Client Comment |
|---|---|---|---|---|
| | <p>due to vegetation – see figure 2 overleaf. Stopping Sight Distances (SSDs) were supplied for assessment and were shown at 120m to the stop line and signal aspects commensurate with 44mph speeds in DMRB. However, this does not take into account the rear of any queue that could have developed due to the crossings being in operation where approach speeds away from the roundabout could be higher. Restricted visibility could lead to rear end shunt collisions.</p> <p>Figure 2: Restricted visibility to signals or queues on the northern approach to the roundabout.</p> | | <p>The queue length has been calculated from junction sensitivity testing (presented in report reference 18-270-05B for the forecast year 2038) which shows a maximum queue length of 15 vehicles on the A259 southbound from the give way line. The forecast flow equates to one vehicle every three seconds so with 12 seconds of red and amber for the crossing only a further four vehicles would be added to the back of the existing queue. From this a queue length of up to 133m has been allowed (at 7m per vehicle).</p> | |

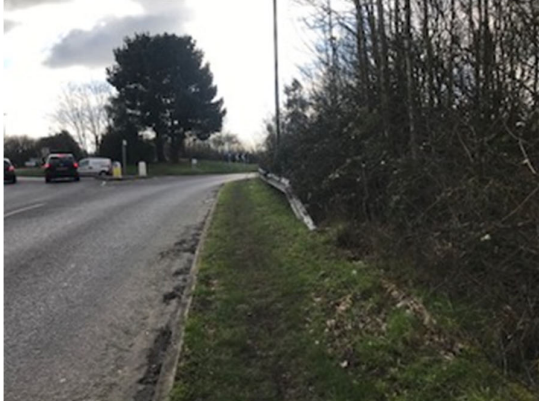
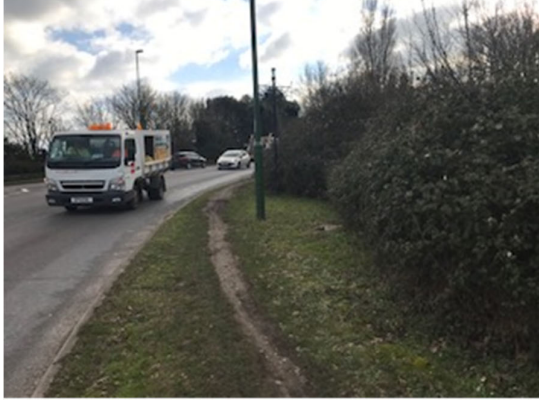
| Audit Item No. | Audit Team Observation | Audit Team Recommendation | Odyssey Designer's Response | Client Comment |
|---|---|---|---|---|
| | <p>A national speed limit applies, and a shared use route that is restricted in width may lead to cyclists being struck by passing vehicles or collisions with street furniture.</p> <p>Figures 3 and 4: VRS close to carriageway and lamp columns in the proposed cycleway/footway.</p> | | | |

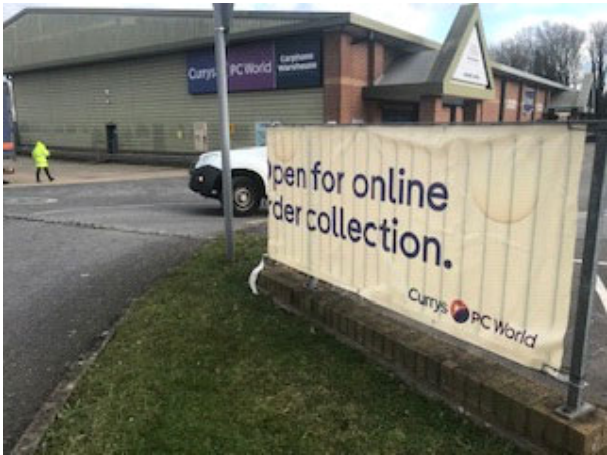
| Audit Item No. | Audit Team Observation | Audit Team Recommendation | Odyssey Designer's Response | Client Comment |
|---|---|---|---|---|
| | <p>footway, where a crossing point is proposed, see figure 5 below. Concern arises that restricted intervisibility could lead to a potential increased risk of vehicle to pedestrian / cyclist collisions.</p> <p>Figure 5: Currys / PC Works banners restricts intervisibility between traffic and pedestrians / cyclists.</p> | | | |

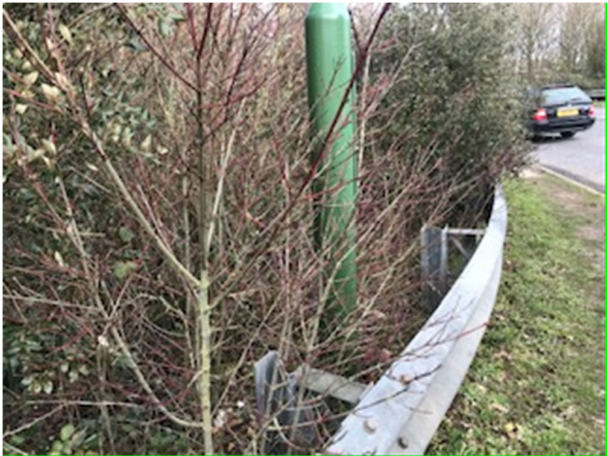
| Audit Item No. | Audit Team Observation | Audit Team Recommendation | Odyssey Designer's Response | Client Comment |
|---|---|---|---|---|
| | <p>restraint system (VRS). It was noted that several of the lamp columns were in close proximity to the VRS, see figure 6 below, which may adversely Impact the safe operation of the VRS. In the event of a loss of control collision, any vehicle striking the barrier will, by design, be contained by the restraint system and led along it. In this case such a vehicle could be led to one of the street light columns that may be within the working width of the barrier, which it will impact potentially increasing injury to the occupants.</p> <p>Figure 6: lamp column in the working width of the VRS.</p> | | <p>The results from this assessment will determine whether there are any changes required and these will be discussed with WSCC.</p> | |

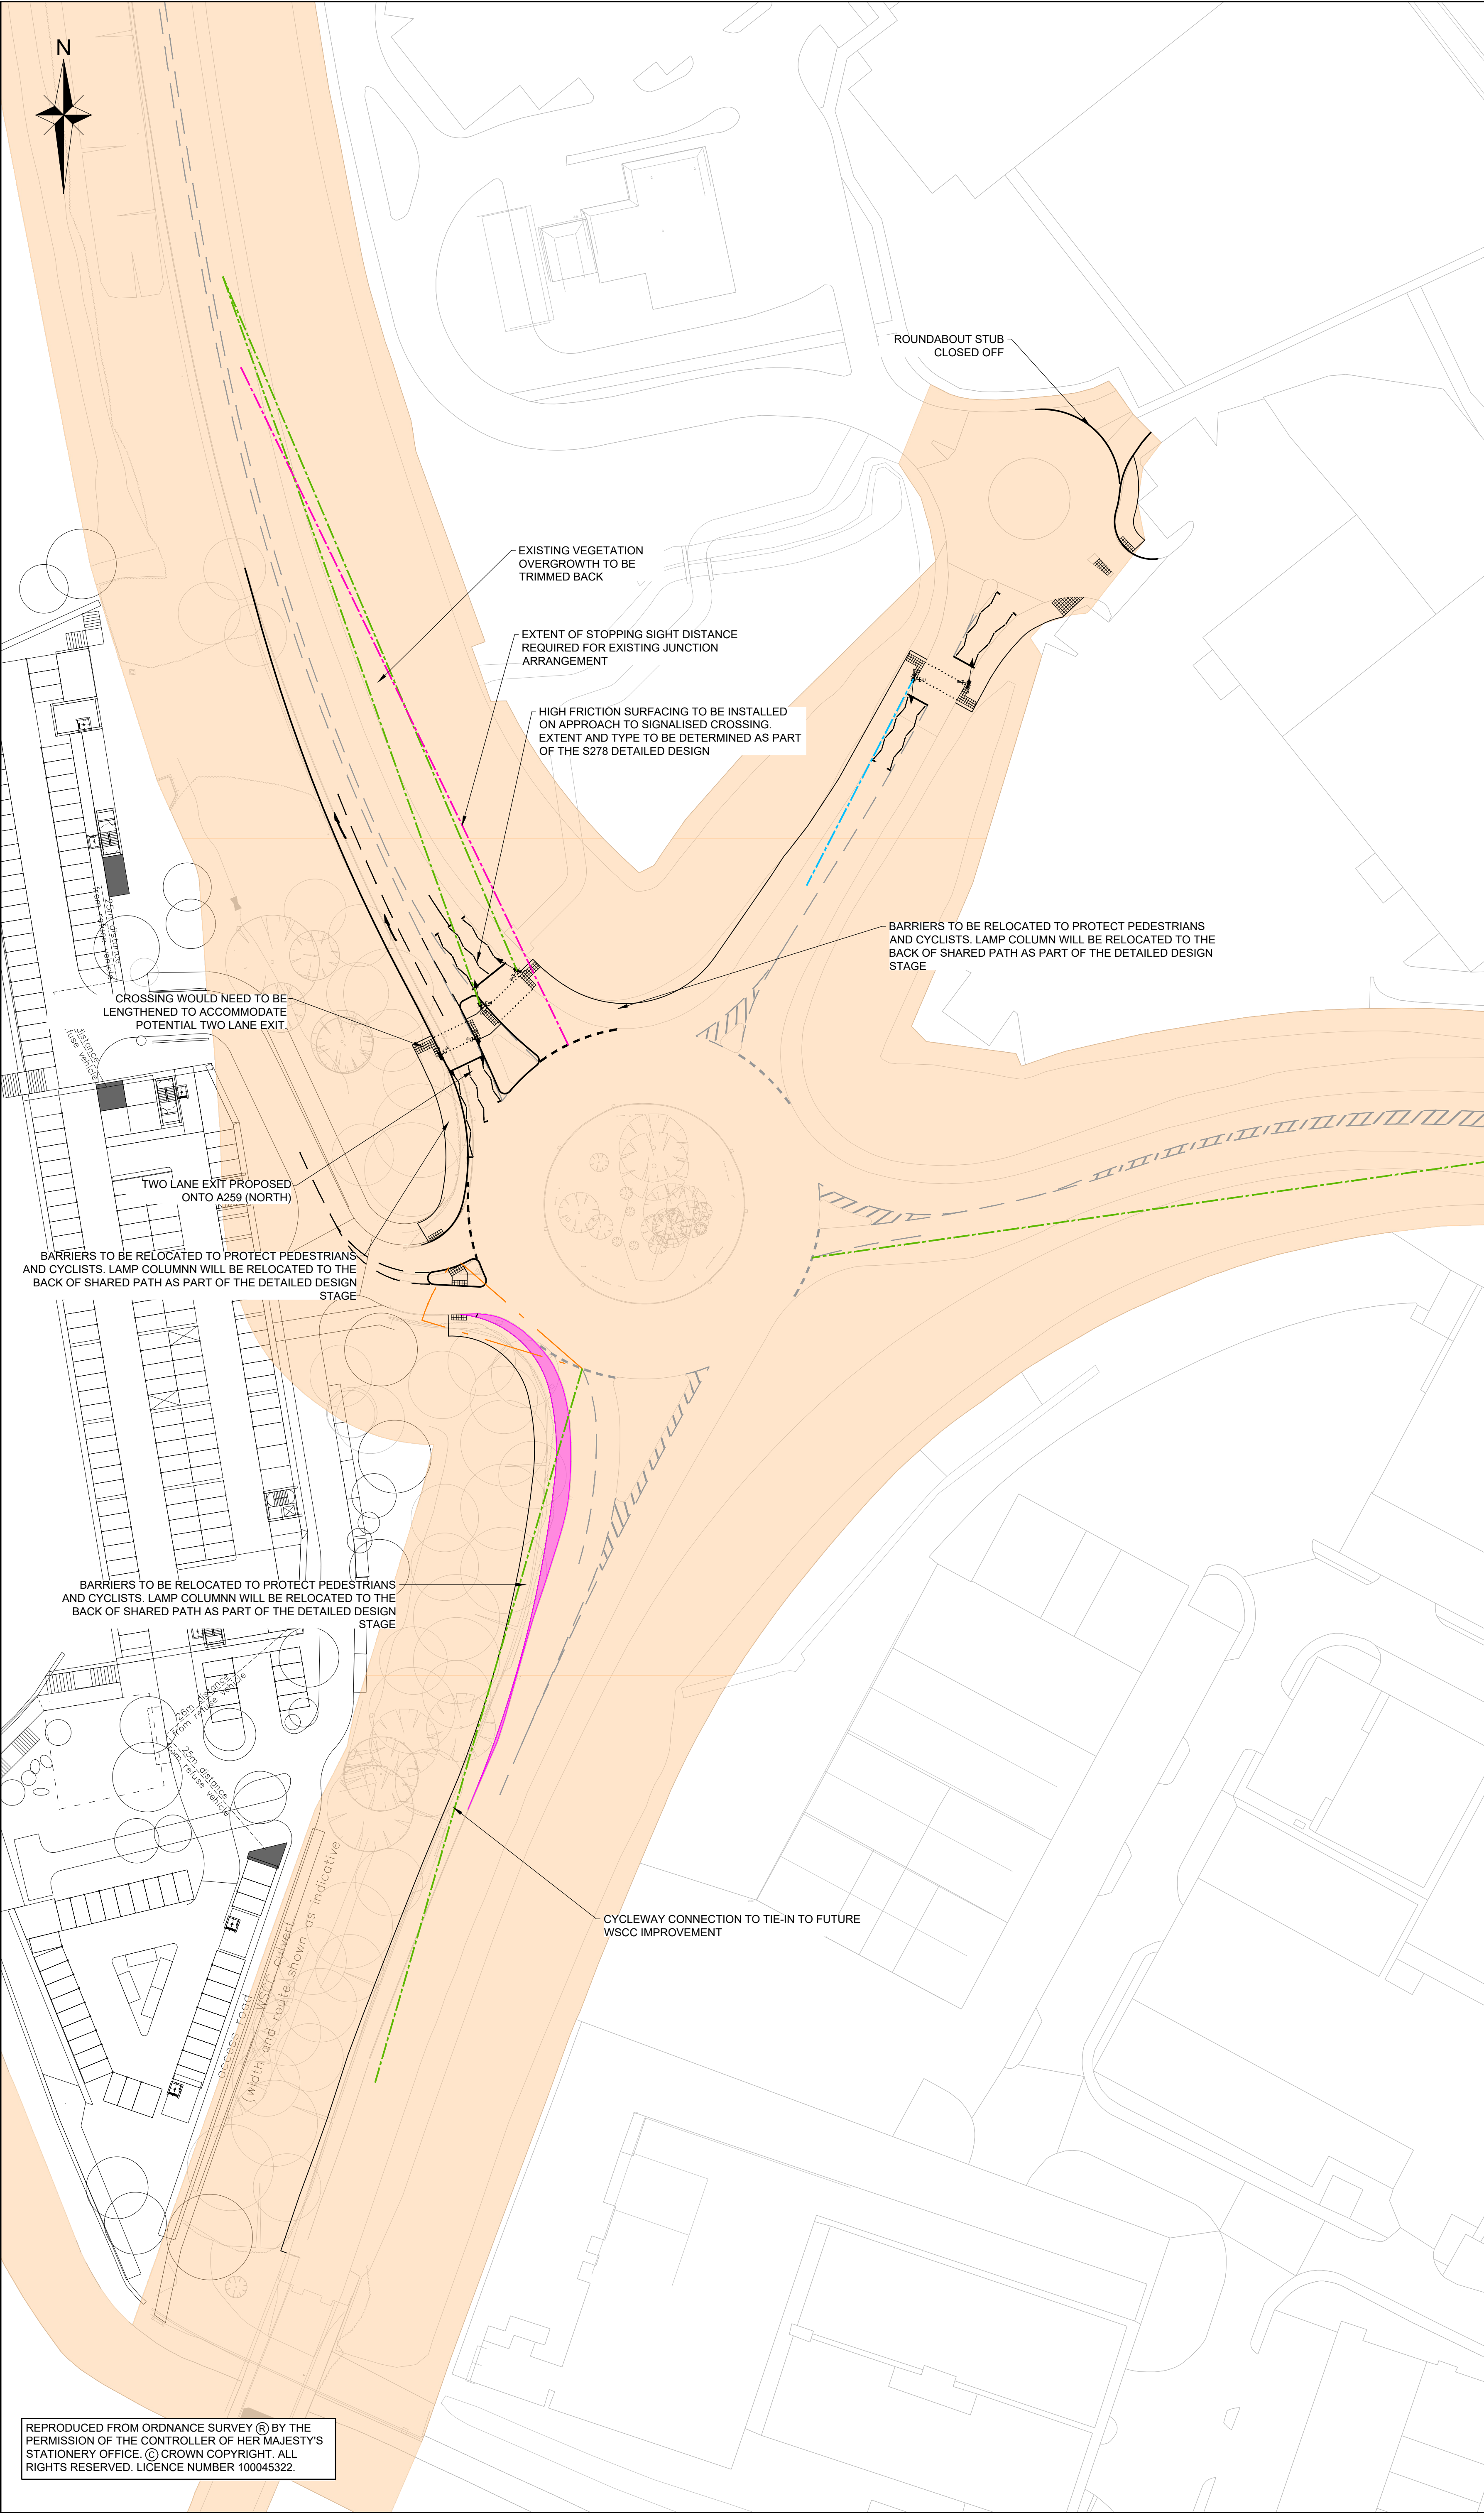
PROPOSED OFFSITE IMPROVEMENTS &  
ALLOWANCE FOR FUTURE IMPROVEMENTS

VISIBILITY TO PEDESTRIAN CROSSING  
(DRAWN IN ACCORDANCE WITH FIGURE 3.53 OF CD116)

120m STOPPING SIGHT DISTANCE (UPTO 44mph DMRB)

37m STOPPING SIGHT DISTANCE (28mph MfS)

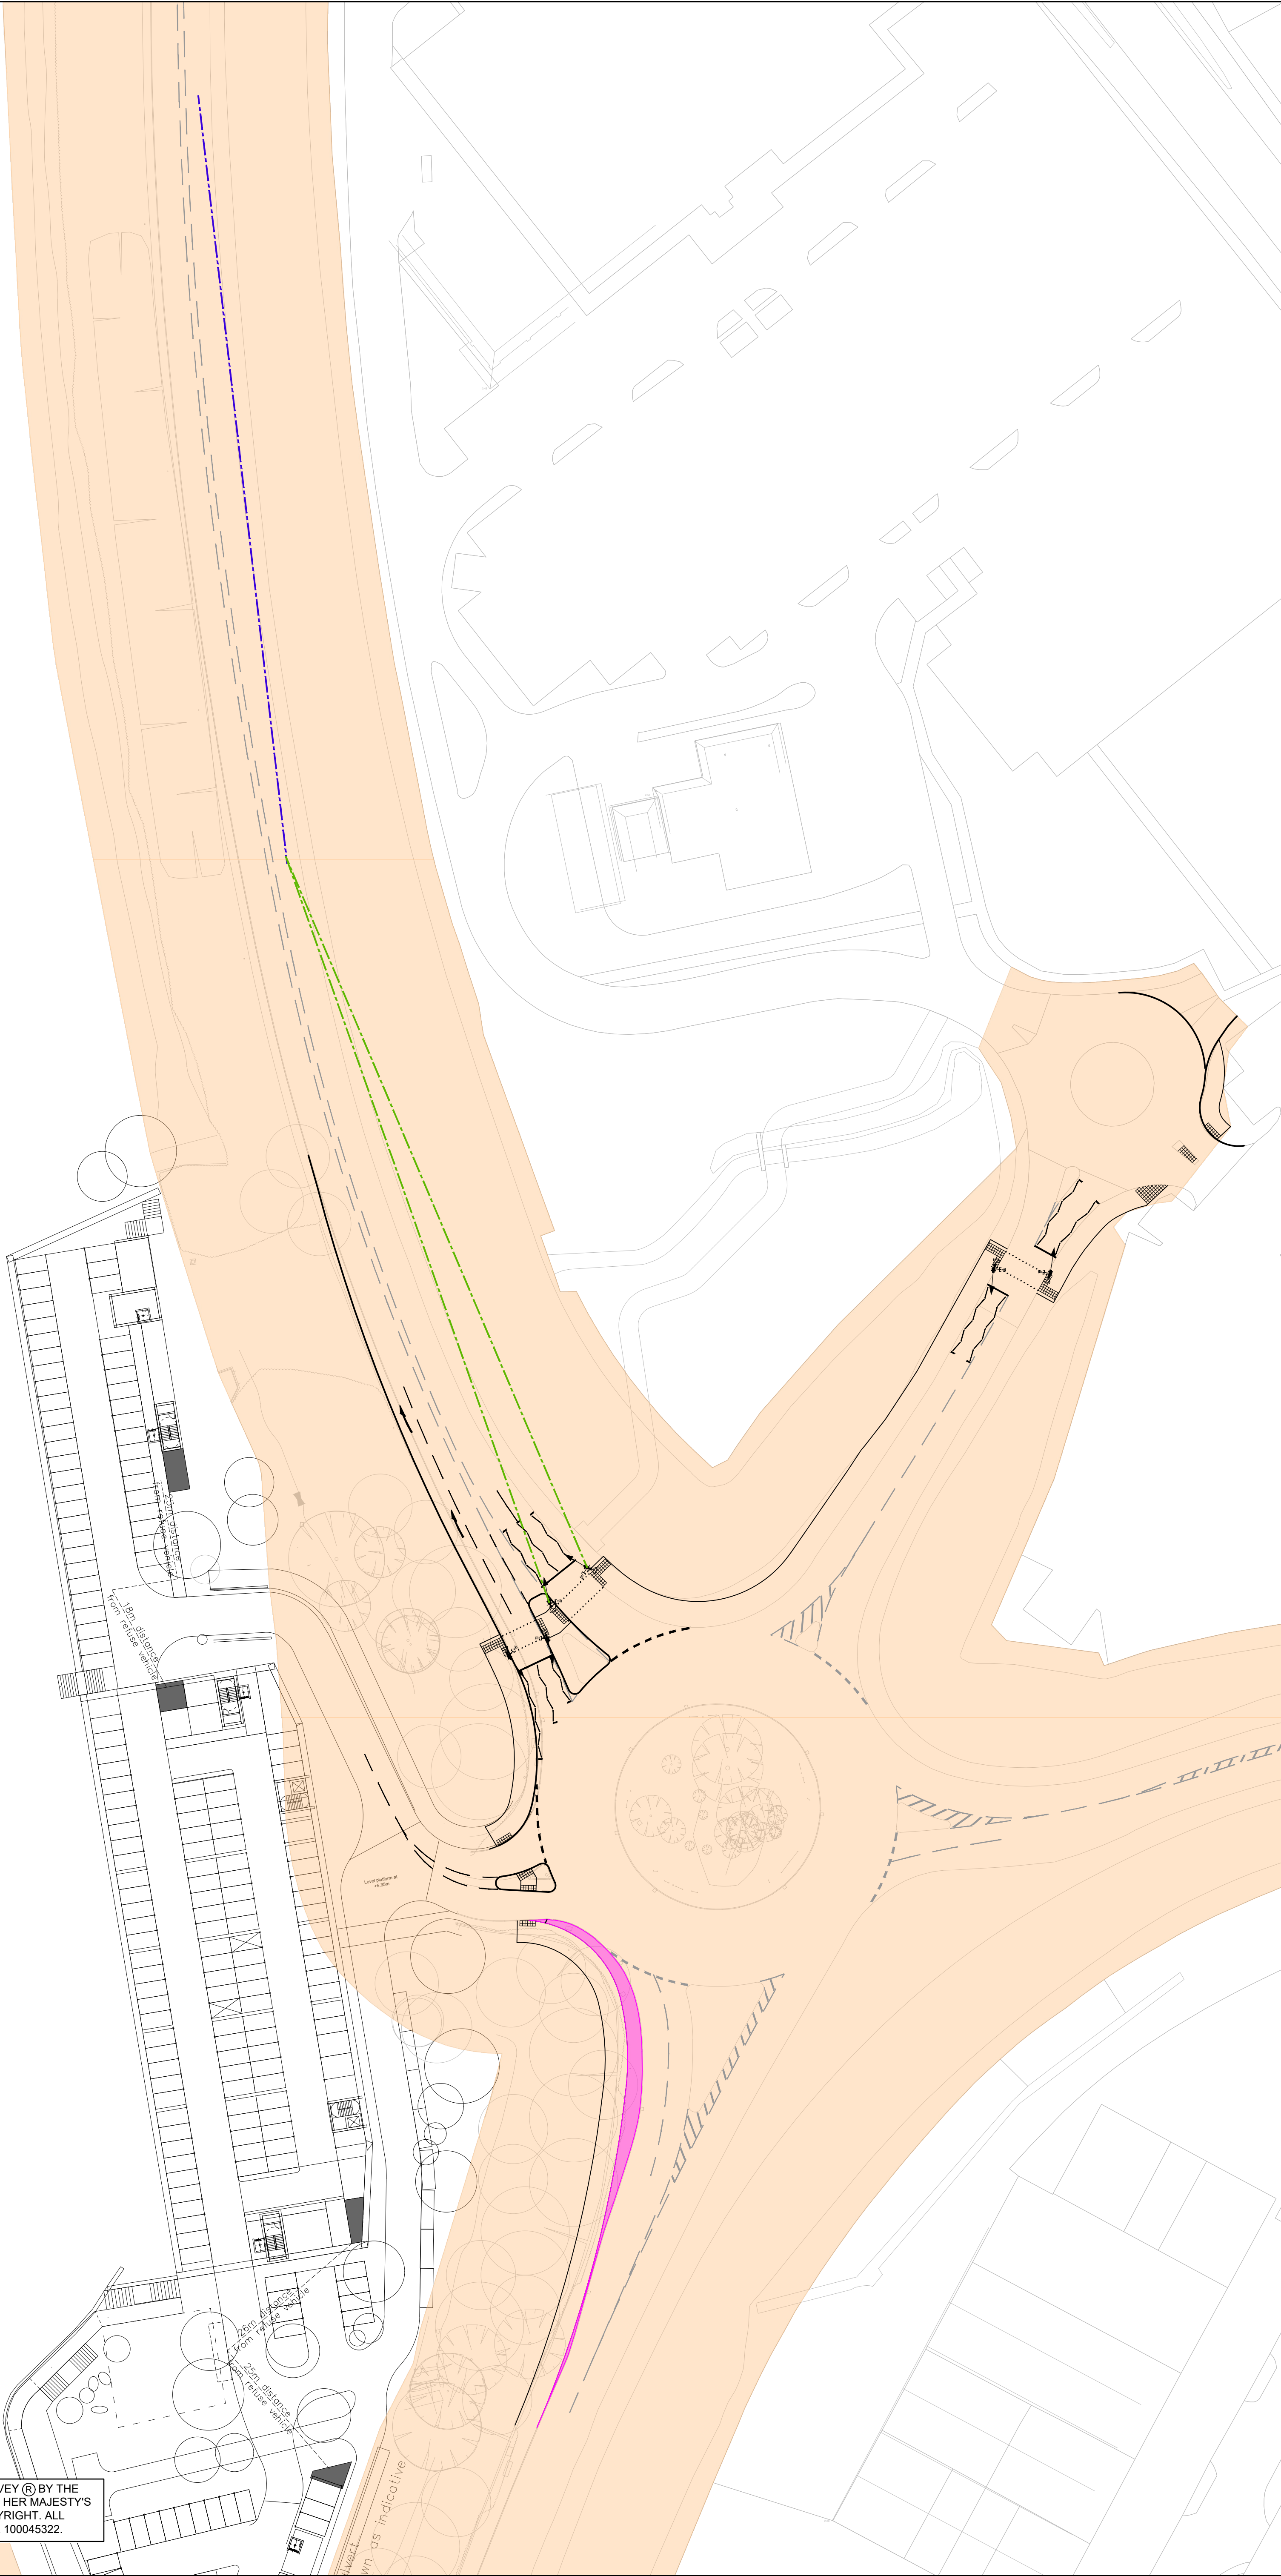
- NOTES
- KEY
- POTENTIAL WIDER A259 IMPROVEMENTS
  - HIGHWAY BOUNDARY
  - 120m STOPPING SIGHT DISTANCE TO THE BACK OF PREDICTED FORECAST YEAR 2038, PM PEAK QUEUE
  - 120m STOPPING SIGHT DISTANCE (UPTO 44mph DMRB)

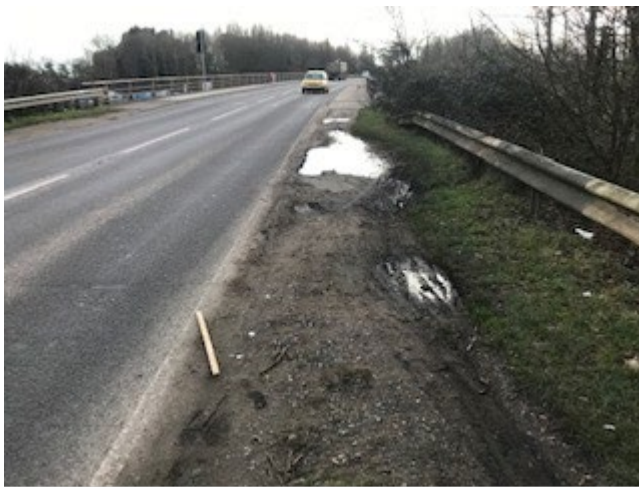
Figure 1: Unmade verge area.

No construction details for the proposed footway / cycleway link were provided for assessment. Surfacing with an insufficient Polished Stone Value (PSV) could lead to overshoot at junctions or cyclist loss of control collisions in the event of sudden braking manoeuvres.

Further, the cycleway proposed does not link to the existing network near the bridge over the Arun – see figure 1 below, where the verge is unmade and has no kerb face.

It is recommended that the PSV of the footway / cycleway link surface material should be a minimum of 55PSV, further that the cycleway / footway should connect to existing facilities.

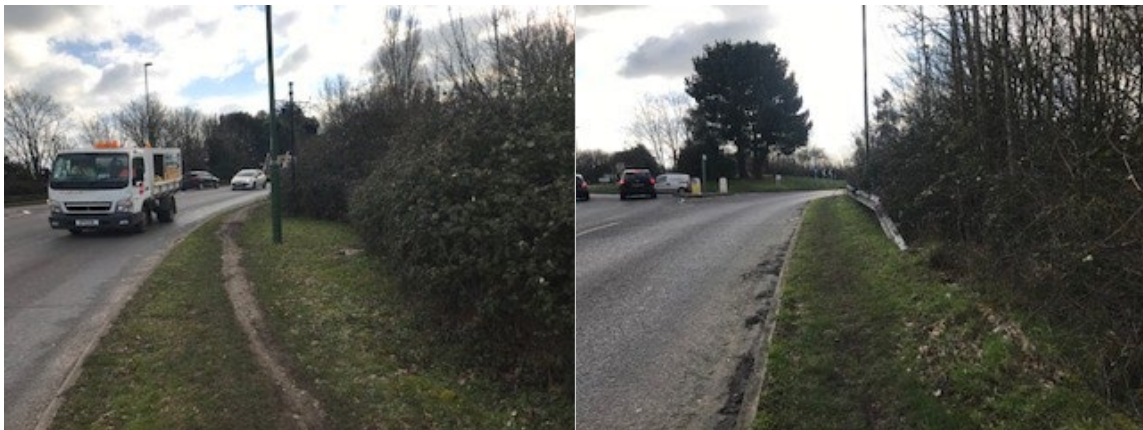
Figures 3 and 4: VRS close to carriageway and lamp columns in the proposed cycleway/footway.

Shared use footway / cycleways are proposed; however, surrounding the roundabout is an existing vehicle restraint system (VRS), see figures 3 and 4 below. The width of the proposed shared use footway / cycleway has not been specified; however, the VRS is in several location 2.0m from the edge of the carriageway. Further, lamp columns and street furniture are in the route and are not shown as being relocated.

A national speed limit applies, and a shared use route that is restricted in width may lead to cyclists being struck by passing vehicles or collisions with street furniture.

It is recommended that the VRS should be repositioned to allow for suitable shared use route and buffer, additionally that signs and lamp columns should be repositioned.

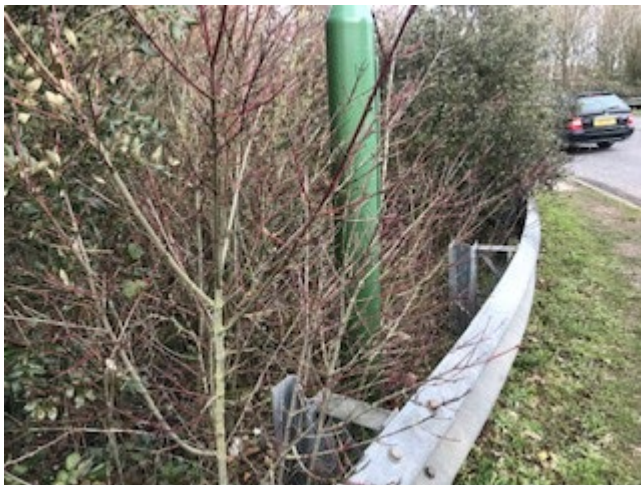
Figure 6: lamp column in the working width of the VRS.

Shared use footway / cycleways are proposed; however, surrounding the roundabout is an existing vehicle restraint system (VRS). It was noted that several of the lamp columns were in close proximity to the VRS, see figure 6 below, which may adversely impact the safe operation of the VRS. In the event of a loss of control collision, any vehicle striking the barrier will, by design, be contained by the restraint system and led along it. In this case such a vehicle could be led to one of the street light columns that may be within the working width of the barrier, which it will impact potentially increasing injury to the occupants.

It is recommended that a check should be undertaken to ensure that the lamp columns are not within the working width of the restraint system.
