**DESIGNER'S RESPONSE TO ROAD  
SAFETY AUDIT STAGE 1**

**Project:** Hampton Quay, Littlehampton, West Sussex, BN17 5RA

**Report No.:** 18-270-04D

**Date:** May 2021

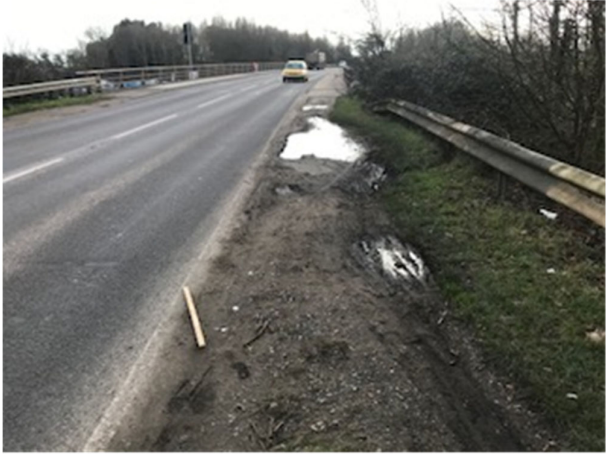
| Audit Item No. | Audit Team Observation | Audit Team Recommendation | Odyssey Designer's Response | Client Comment |
|---|---|---|---|---|
| | <p>Further, the cycleway proposed does not link to the existing network near the bridge over the Arun – see figure 1 below, where the verge is unmade and has no kerb face.</p> <p>Figure 1: Unmade verge area.</p> | | <p>s106 works and allowing for future WSCC improvement.</p> <p><b>Auditors Response:</b> Noted and accepted.</p> | |

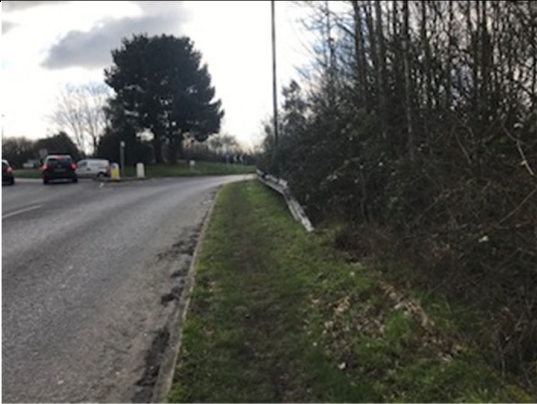
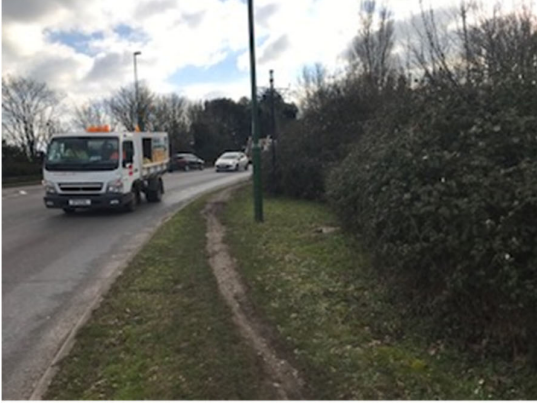
| Audit Item No. | Audit Team Observation | Audit Team Recommendation | Odyssey Designer's Response | Client Comment |
|---|---|---|---|---|
| | <br> <p data-bbox="281 1247 903 1299">Figures 3 and 4: VRS close to carriageway and lamp columns in the proposed cycleway/footway.</p> | | | |

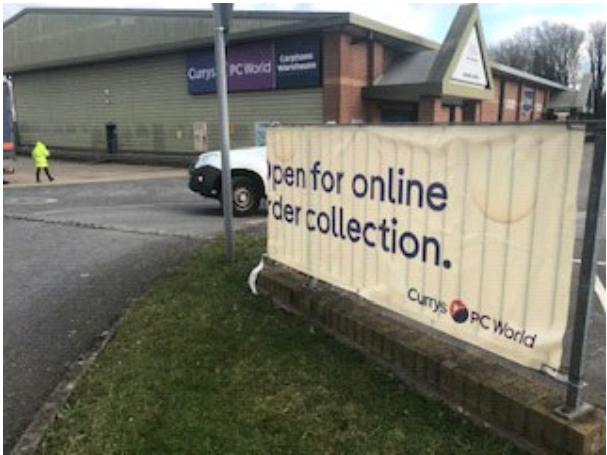
| Audit Item No. | Audit Team Observation | Audit Team Recommendation | Odyssey Designer's Response | Client Comment |
|---|---|---|---|---|
| | <p>footway, where a crossing point is proposed, see figure 5 below. Concern arises that restricted intervisibility could lead to a potential increased risk of vehicle to pedestrian / cyclist collisions.</p> <p>Figure 5: Currys / PC Works banners restricts intervisibility between traffic and pedestrians / cyclists.</p> | | | |

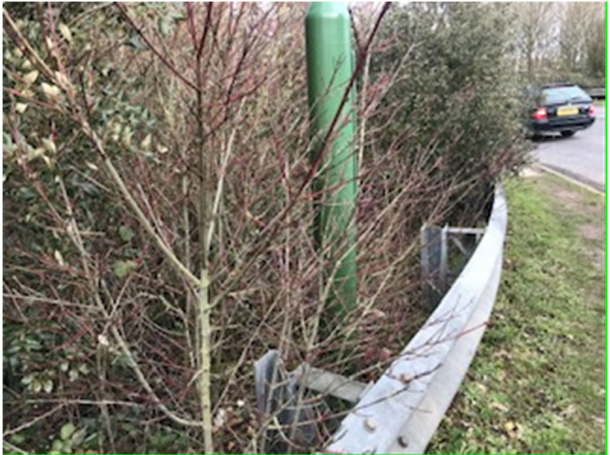
| Audit Item No. | Audit Team Observation | Audit Team Recommendation | Odyssey Designer's Response | Client Comment |
|---|---|---|---|---|
| | <p>restraint system (VRS). It was noted that several of the lamp columns were in close proximity to the VRS, see figure 6 below, which may adversely Impact the safe operation of the VRS. In the event of a loss of control collision, any vehicle striking the barrier will, by design, be contained by the restraint system and led along it. In this case such a vehicle could be led to one of the street light columns that may be within the working width of the barrier, which it will impact potentially increasing injury to the occupants.</p> <p>Figure 6: lamp column in the working width of the VRS.</p> | | <p>The results from this assessment will determine whether there are any changes required and these will be discussed with WSCC.</p> <p><b>Auditors Response:</b> Noted and accepted.</p> | |

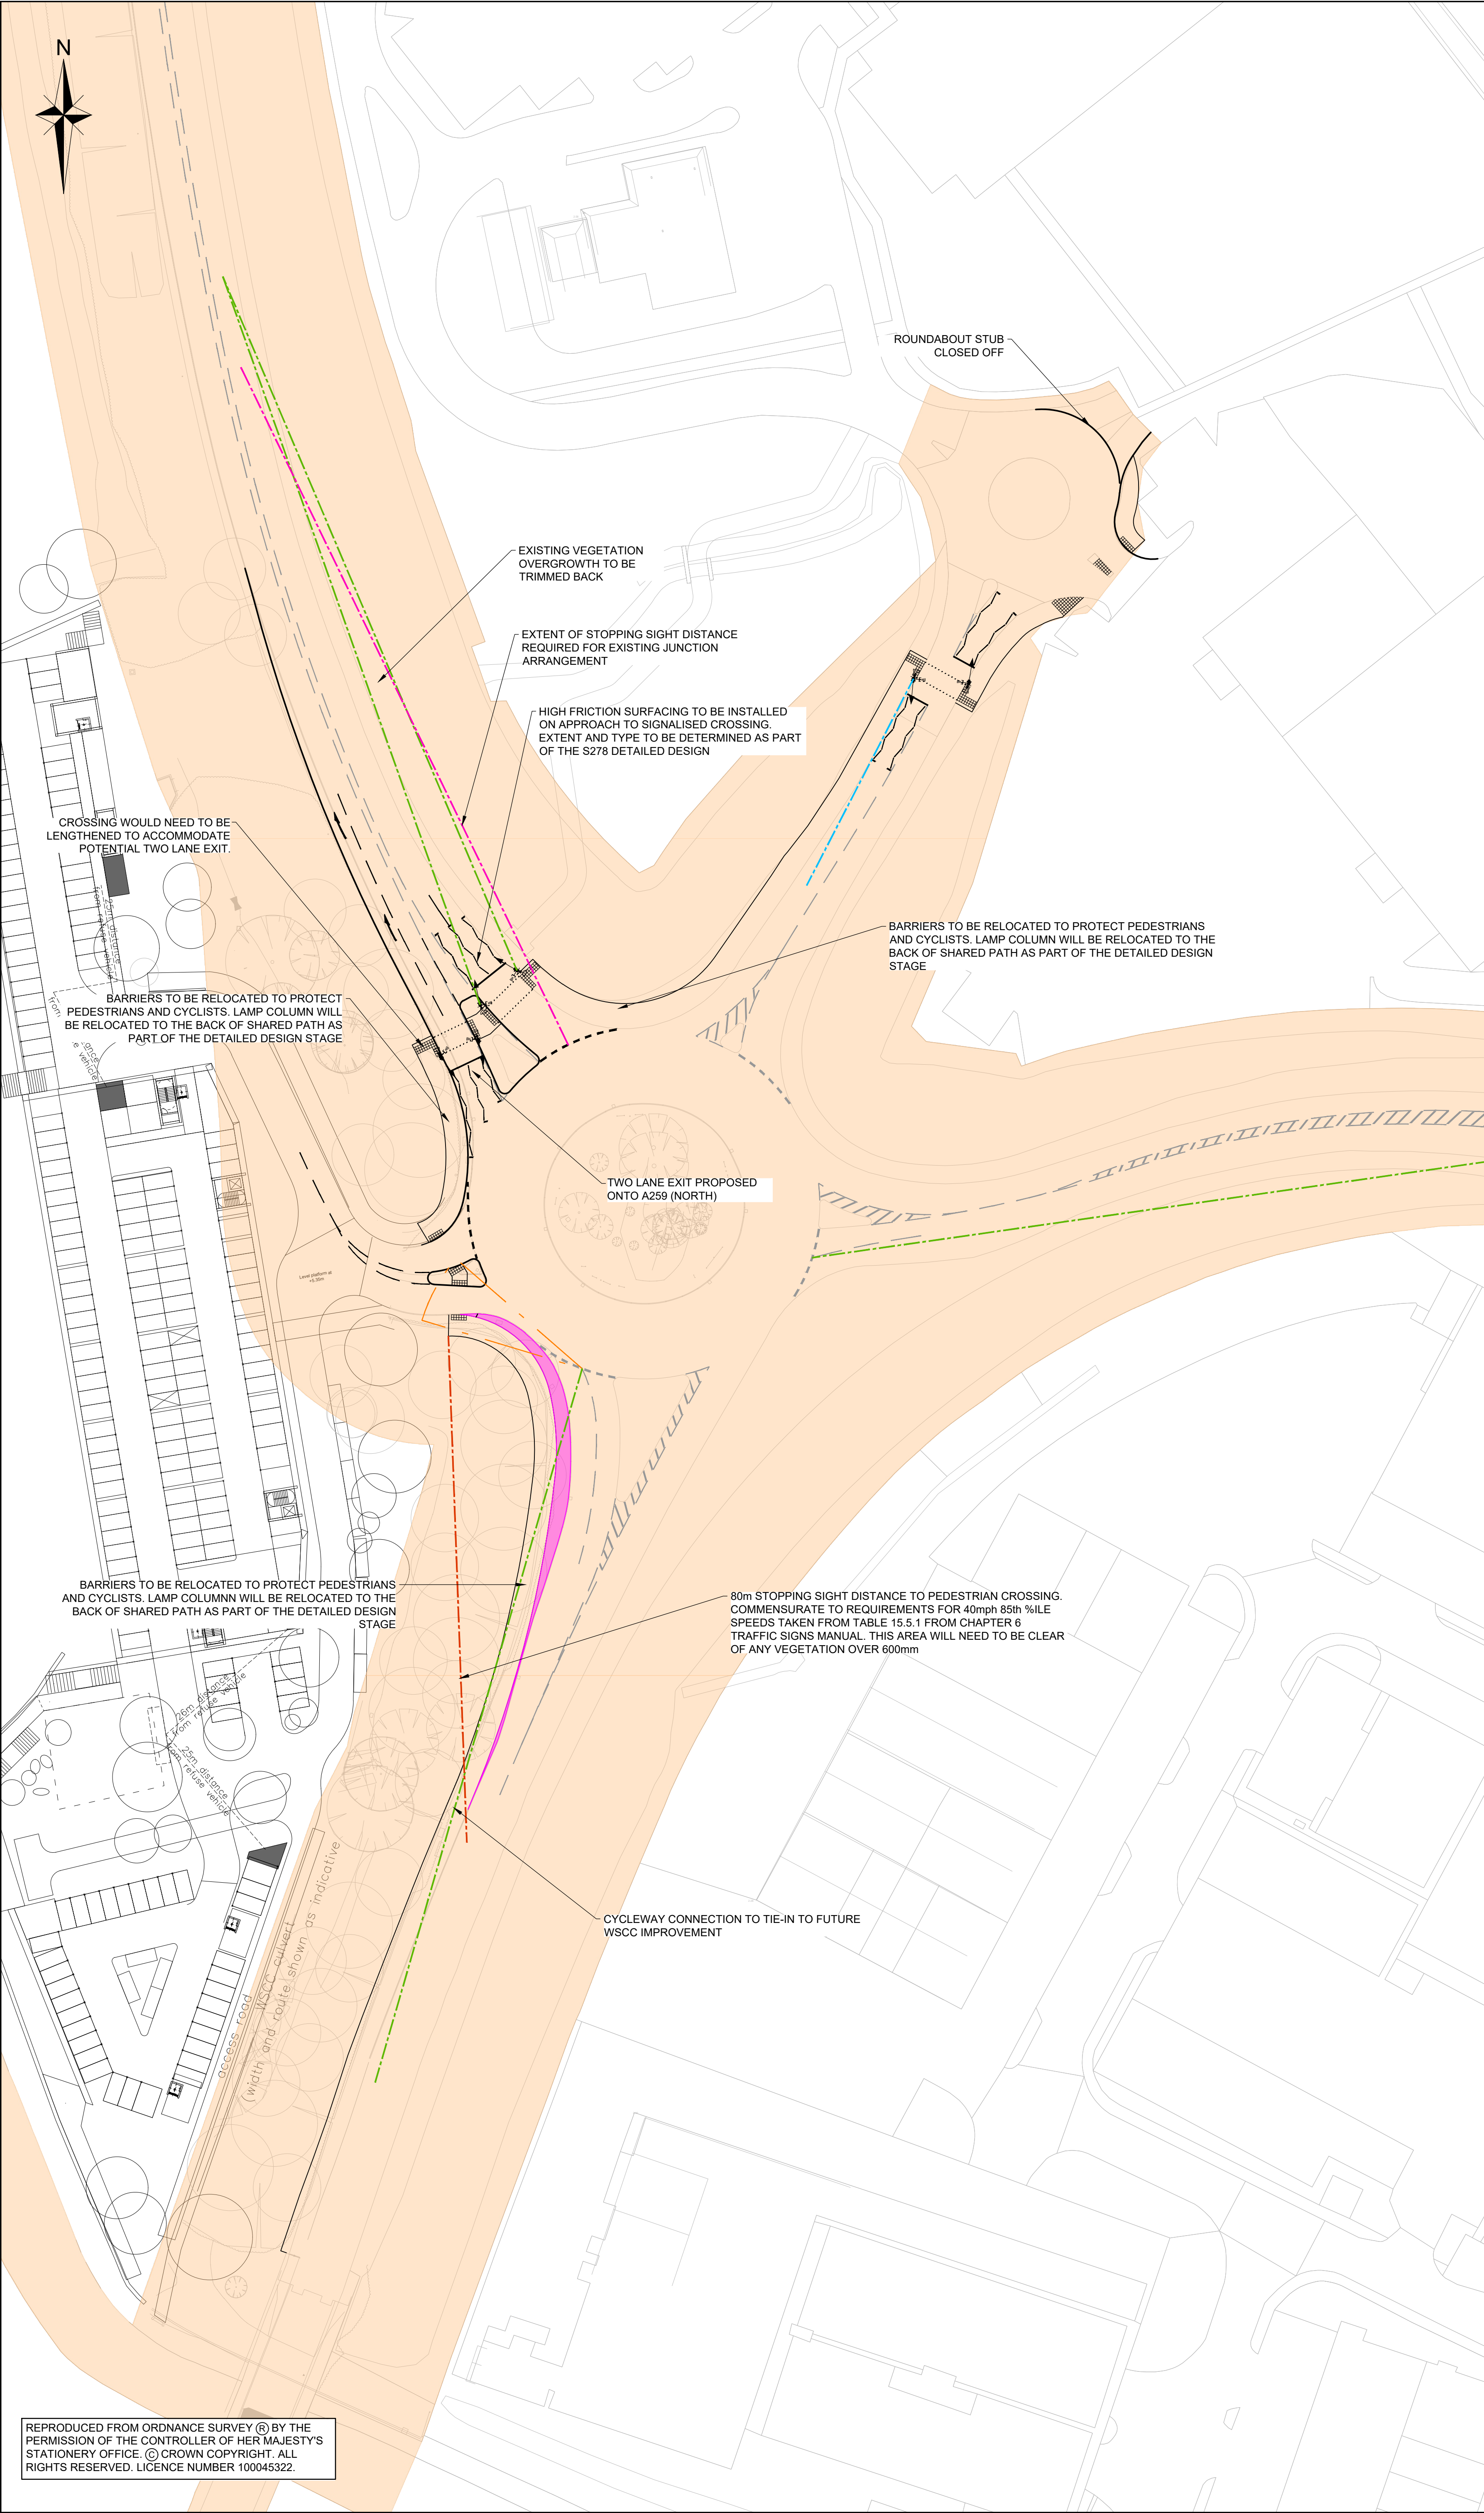
PROPOSED OFFSITE IMPROVEMENTS &  
ALLOWANCE FOR FUTURE IMPROVEMENTS

POTENTIAL WIDER A259 IMPROVEMENTS

VISIBILITY TO PEDESTRIAN CROSSING  
(DRAWN IN ACCORDANCE WITH FIGURE 3.53 OF CD116)

120m STOPPING SIGHT DISTANCE (UPTO 44mph DMRB)

37m STOPPING SIGHT DISTANCE (28mph MfS)

| Audit Item No. | Audit Team Observation | Audit Team Recommendation | Odyssey Designer's Response | Client Comment |
|---|---|---|---|---|
| 3.1.6 | <p><b>PROBLEM</b></p> <p><b>Location:</b> Proposed footway / cycleway link.</p> <p><b>Summary:</b> Insufficient construction details could lead to overshoot at junctions or cyclist loss of control collisions.</p> <p>No construction details for the proposed footway / cycleway link were provided for assessment. Surfacing with an insufficient Polished Stone Value (PSV) could lead to overshoot at junctions or cyclist loss of control collisions in the event of sudden braking manoeuvres.</p> | It is recommended that the PSV of the footway / cycleway link surface material should be a minimum of 55PSV, further that the cycleway / footway should connect to existing facilities. | <p>Suitable surfacing details will be determined and agreed as part of the Detailed Design stage. These details will then be submitted as part of the Stage 2 Road Safety Audit.</p> <p>The connection to the footway on the bridge / footway and cycleway over the bridge is indicated on Drawing 18-270-010F, thus upgrading the Kingley Gate</p> | |

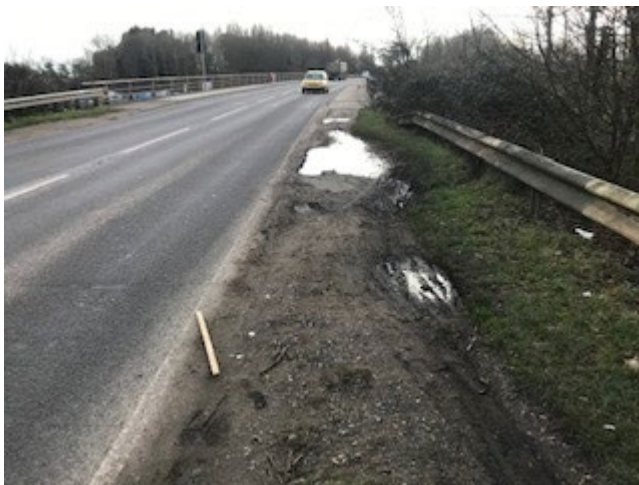
Figure 1: Unmade verge area.

No construction details for the proposed footway / cycleway link were provided for assessment. Surfacing with an insufficient Polished Stone Value (PSV) could lead to overshoot at junctions or cyclist loss of control collisions in the event of sudden braking manoeuvres.

Further, the cycleway proposed does not link to the existing network near the bridge over the Arun – see figure 1 below, where the verge is unmade and has no kerb face.

It is recommended that the PSV of the footway / cycleway link surface material should be a minimum of 55PSV, further that the cycleway / footway should connect to existing facilities.

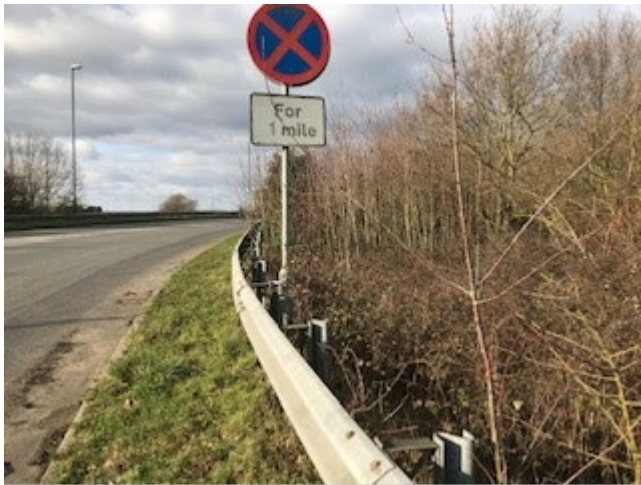
Figure 2: Restricted visibility to signals or queues on the southern approach to the roundabout.

The A259 southern approach is curved and visibility splays pass over the adjacent verge that is restricted due to vegetation – see figure 2 overleaf. Stopping Sight Distances (SSDs) were supplied for assessment and were shown at 120m to the stop line and signal aspects commensurate with 44mph speeds in DMRB. However, this does not take into account the rear of any queue that could have developed due to the crossings being in operation where

approach speeds away from the roundabout could be higher. Restricted visibility could lead to rear end shunt collisions.

It is recommended that SSDs, visibility to signal aspects and the rear of any queue should be free from obstruction and commensurate with vehicle speeds, where it is observed that the A259 straightens away from the roundabout.

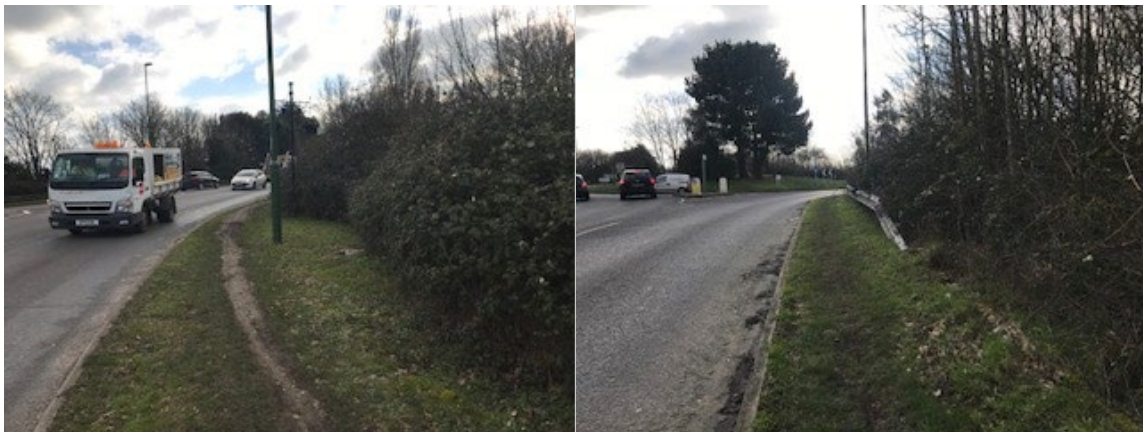
Figures 3 and 4: VRS close to carriageway and lamp columns in the proposed cycleway/footway.

Shared use footway / cycleways are proposed; however, surrounding the roundabout is an existing vehicle restraint system (VRS), see figures 3 and 4 below. The width of the proposed shared use footway / cycleway has not been specified; however, the VRS is in several location 2.0m from the edge of the carriageway. Further, lamp columns and street furniture are in the route and are not shown as being relocated.

A national speed limit applies, and a shared use route that is restricted in width may lead to cyclists being struck by passing vehicles or collisions with street furniture.

It is recommended that the VRS should be repositioned to allow for suitable shared use route and buffer, additionally that signs and lamp columns should be repositioned.

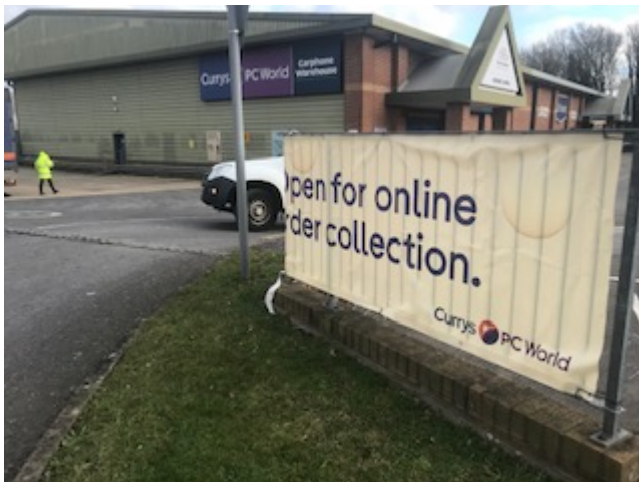
Figure 5: Currys / PC Works banners restricts intervisibility between traffic and pedestrians / cyclists.

Whilst on site, the Audit Team observed an advertising banner for Currys / PC World at the access leading to Currys / PC World at the roundabout at the northern end of Broad Piece. However, the location of the banner would likely impact upon the intervisibility between pedestrians / cyclists waiting on the southern shared use footway, where a crossing point is proposed, see figure 5 below. Concern arises that restricted intervisibility could lead to a potential increased risk of vehicle to pedestrian / cyclist collisions.

It is recommended that the banner should either be removed or relocated outside of the intervisibility splay.

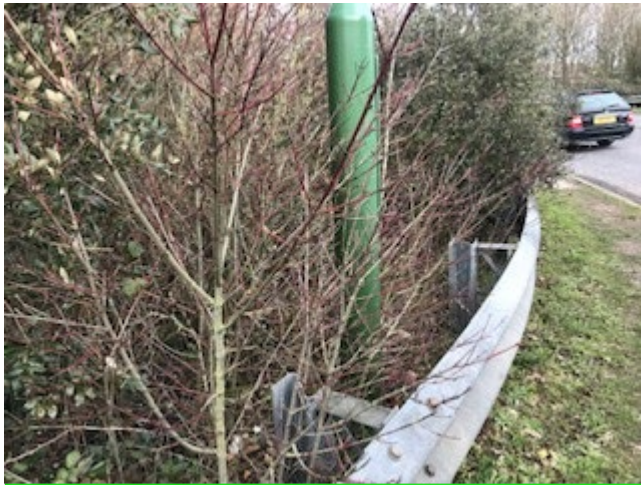
Figure 6: lamp column in the working width of the VRS.

Shared use footway / cycleways are proposed; however, surrounding the roundabout is an existing vehicle restraint system (VRS). It was noted that several of the lamp columns were in close proximity to the VRS, see figure 6 below, which may adversely impact the safe operation of the VRS. In the event of a loss of control collision, any vehicle striking the barrier will, by design, be contained by the restraint system and led along it. In this case such a vehicle could be led to one of the street light columns that may be within the working width of the barrier, which it will impact potentially increasing injury to the occupants.

It is recommended that a check should be undertaken to ensure that the lamp columns are not within the working width of the restraint system.
