Geotechnical Site Investigation Report

Project Name: Land adjacent to Toddington Lane,
Littlehampton

Client: Worthing Homes

Project ID: J14912

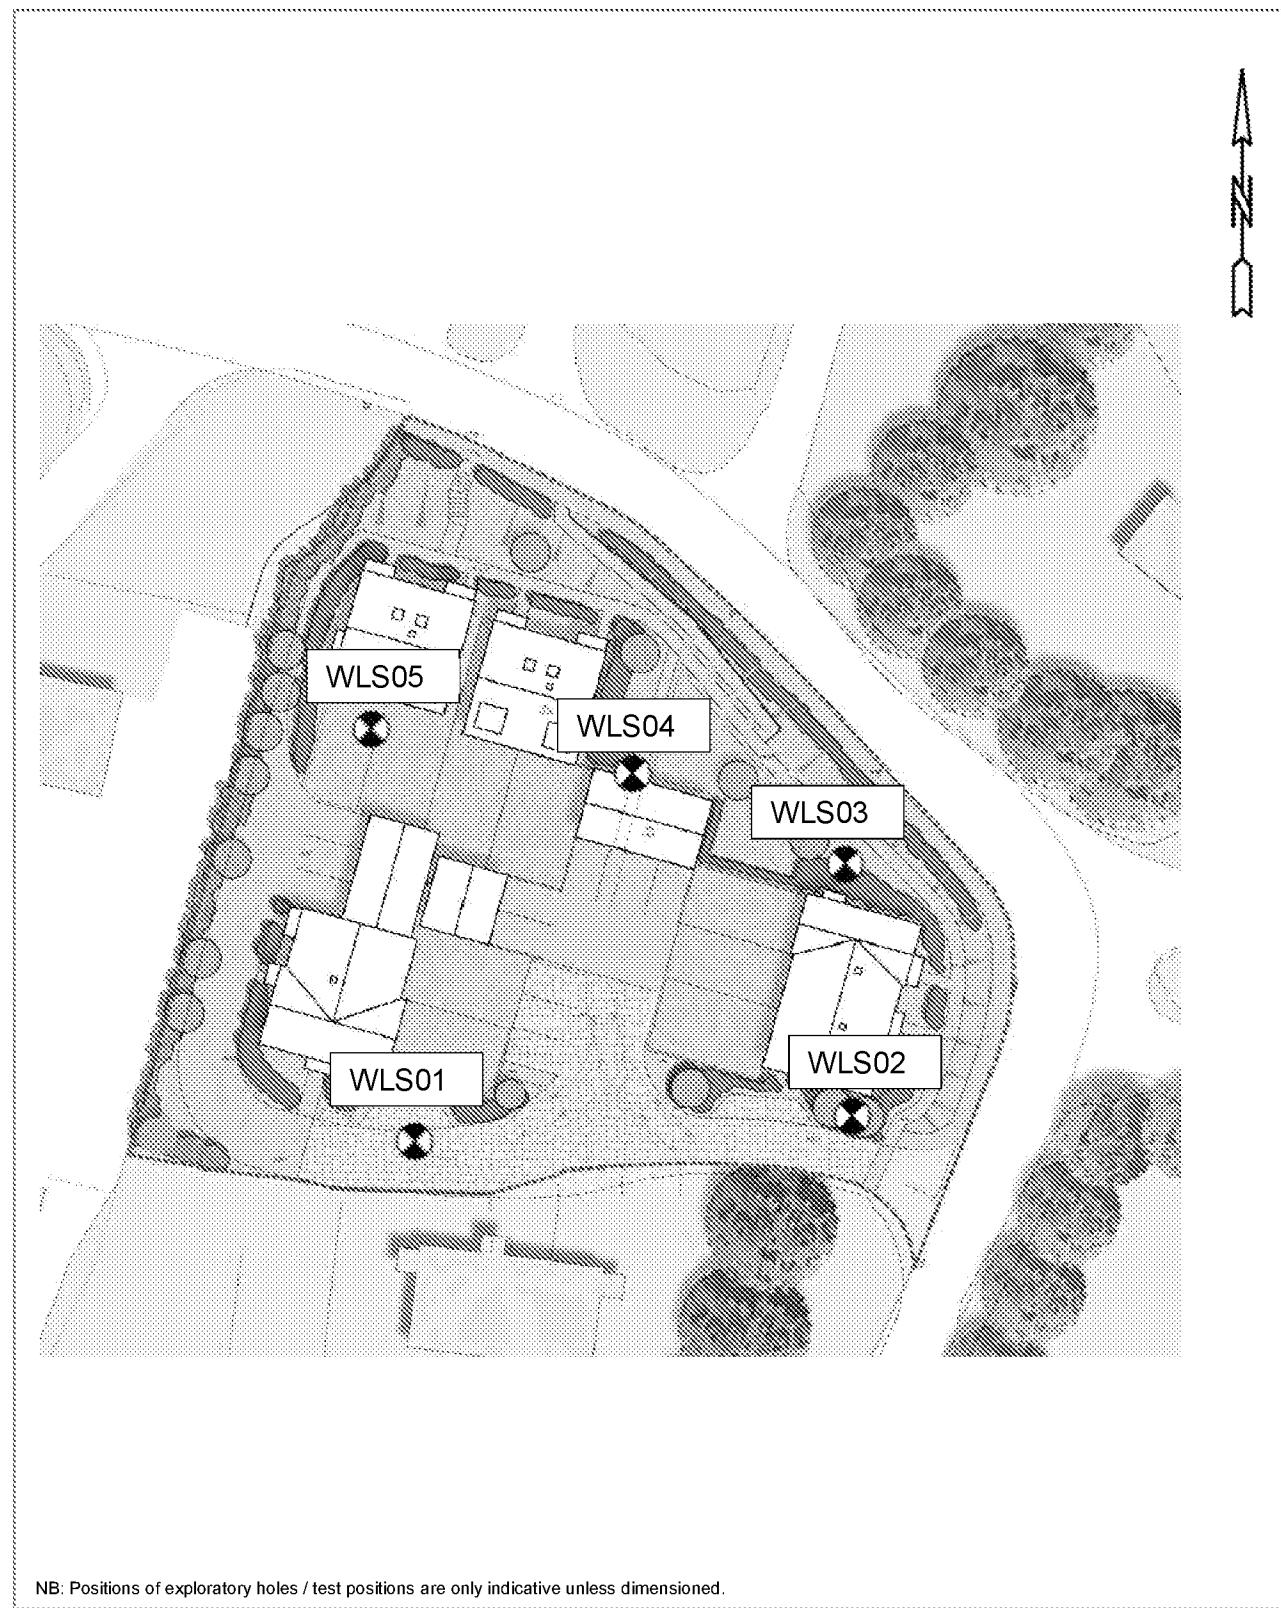
NB: Positions of exploratory holes / test positions are only indicative unless dimensioned.

Site:	Land off Toddington Lane, Littlehampton	Project ID	J14912
Figure 2	Site Investigation Layout Plan	Date:	19.10.21

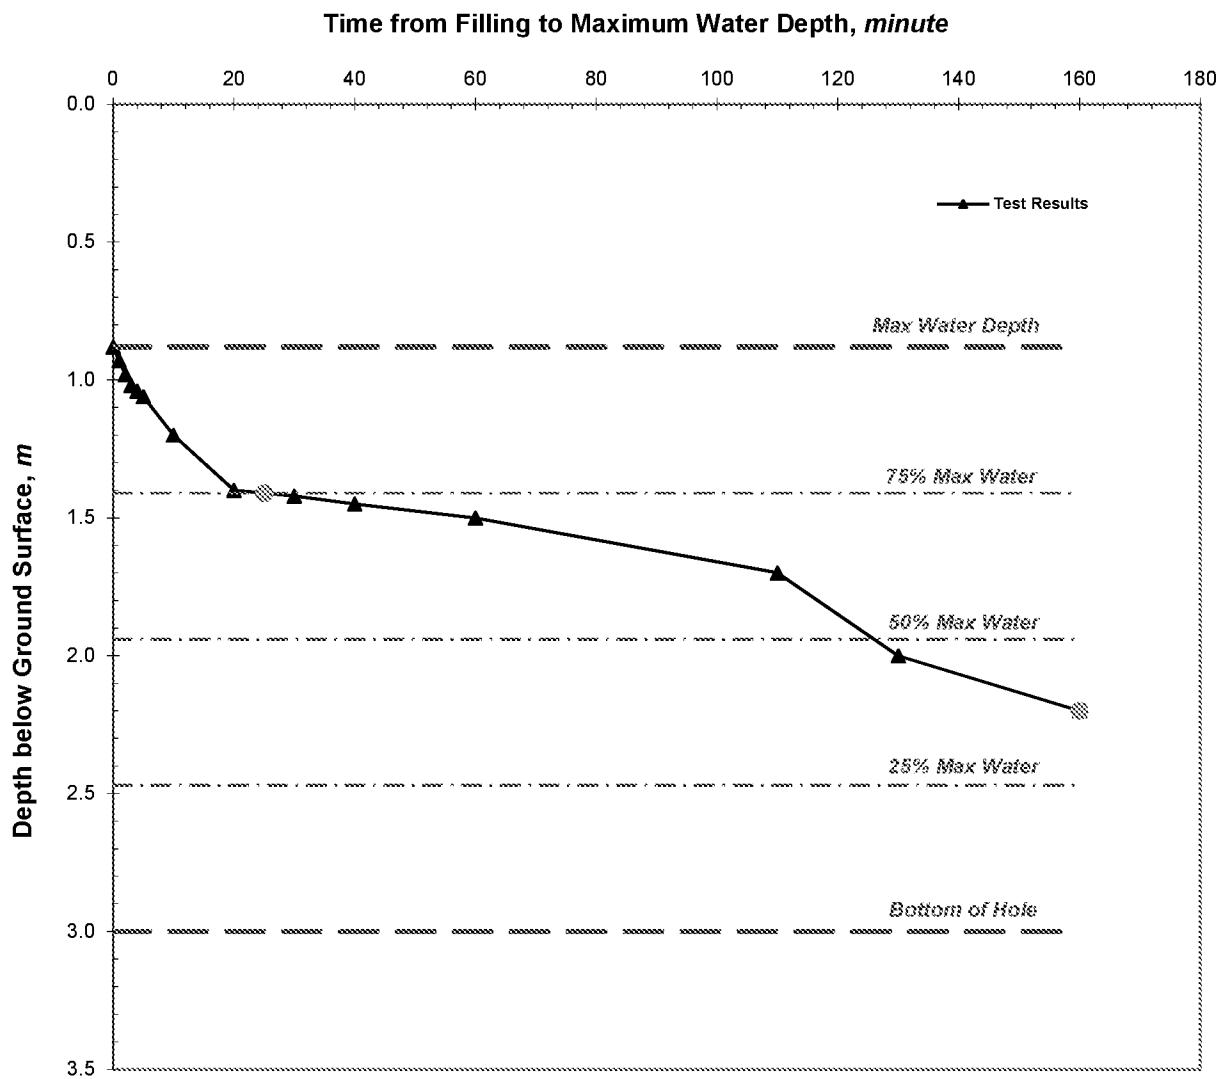
Test Hole No: WLS01
Test No: Test No 1 (Initial)

Preliminary Falling-Head Soakage Test

Diameter of Borehole, m	0.100	Depth to Water at Start of Test, m	0.880
Depth to End of Borehole Casing, m		Max Water Dropdown during Test, m	1.320
Depth to Borehole Base, m	3.000	Total Soakage Test Time, min	160.0
Depth to Top of Permeable Soils, m		Mean Internal Discharge Area, m ²	0.383
Depth to Groundwater Surface, m		Discharge Rate, litre/min	0.046
Depth to Top of Granular Fill, m		Soakage Rate, litre/m ² /min	0.120
Voids Assumed within Borehole, %	100%	BRE Soil Infiltration Rate, m/sec	2.00E-06

Test Site	Test Depth	Design Infiltration Rate	Notes
WLS01	3.0	0.120	2.0×10^{-6}
WLS02	3.0	0.527	8.8×10^{-6} 3 fillings carried out
WLS03	5.0	0.034	5.7×10^{-7}

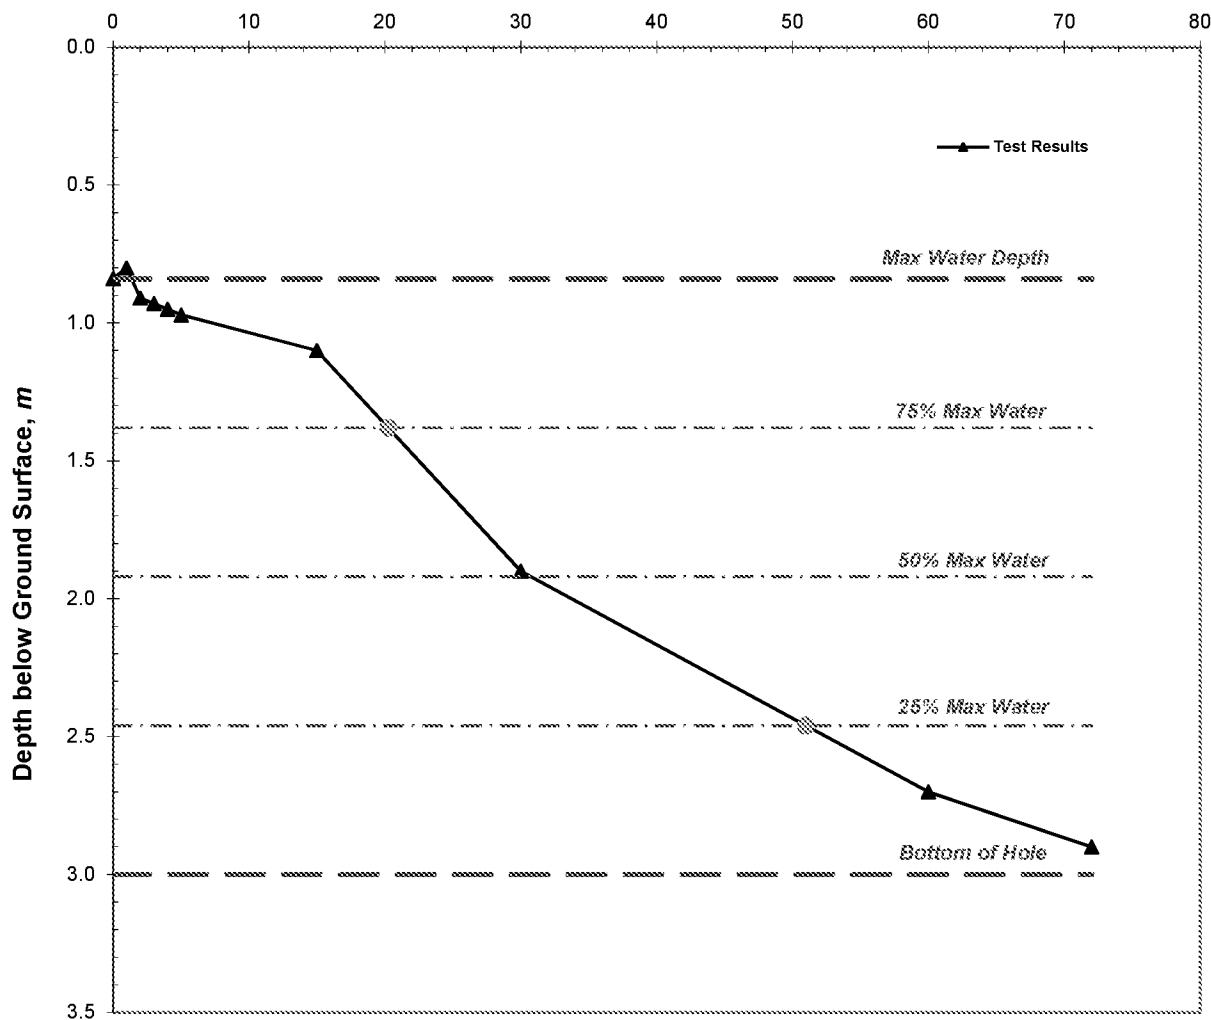
Test Hole No: WLS02
Test No: Test No 1 (Initial)

Diameter of Borehole, m	0.100	Depth to Water at Start of Test, m	0.840
Depth to End of Borehole Casing, m		Max Water Dropdown during Test, m	2.060
Depth to Borehole Base, m	3.000	Total Soakage Test Time, min	72.0
Depth to Top of Permeable Soils, m		Mean Internal Discharge Area, m ²	0.347
Depth to Groundwater Surface, m		Discharge Rate, litre/min	0.276
Depth to Top of Granular Fill, m		Soakage Rate, litre/m ² /min	0.795
Voids Assumed within Borehole, %	100%	BRE Soil Infiltration Rate, m/sec	1.32E-05

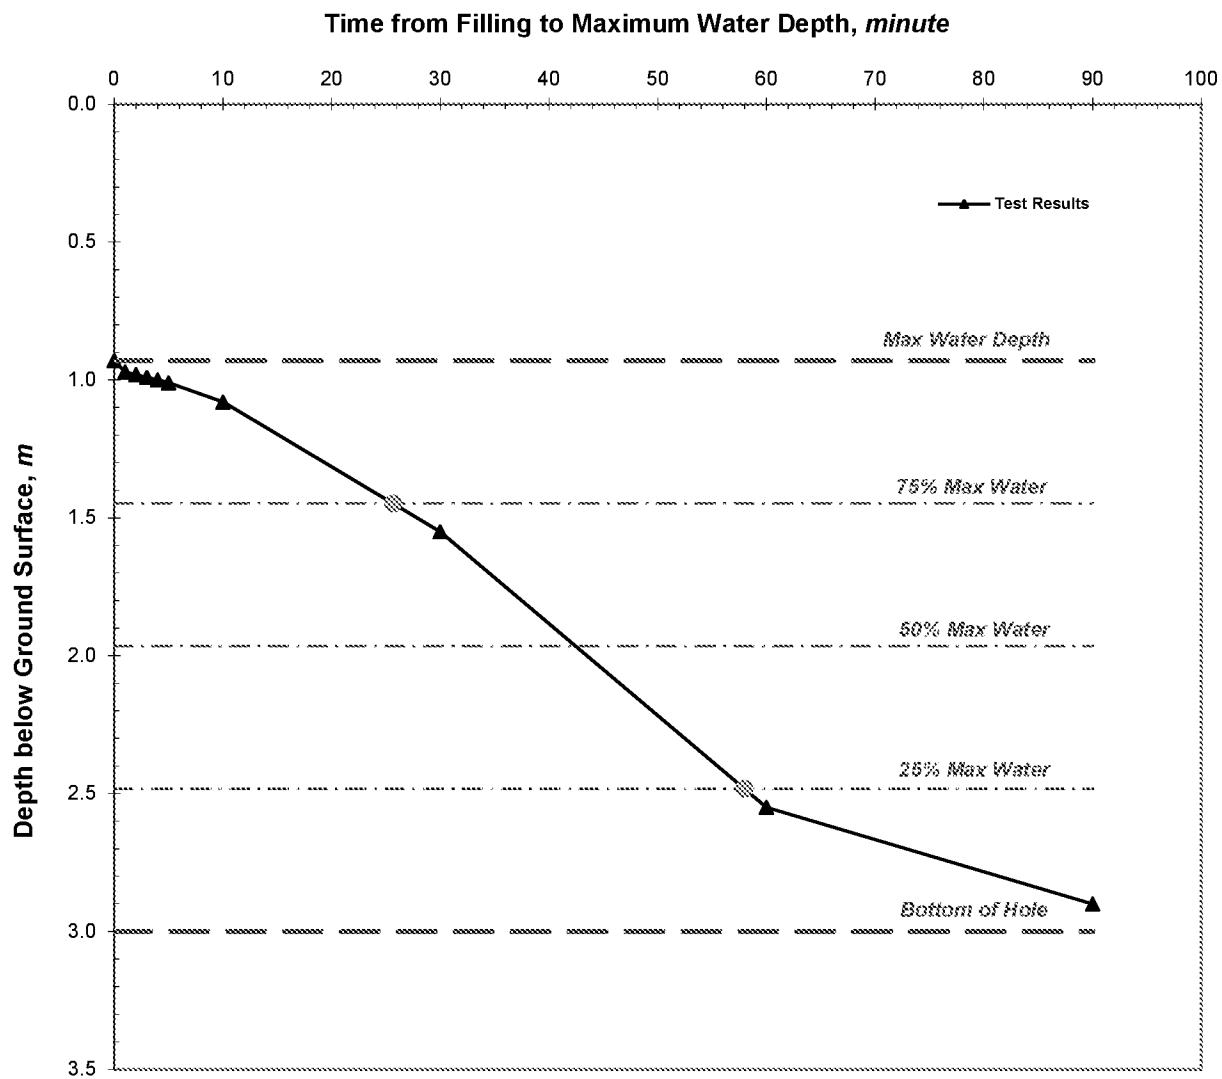
Test Hole No: WLS02
Test No: Test No 2 (Repeated)

Preliminary Falling-Head Soakage Test

Diameter of Borehole, m	0.100	Depth to Water at Start of Test, m	0.930
Depth to End of Borehole Casing, m		Max Water Dropdown during Test, m	1.970
Depth to Borehole Base, m	3.000	Total Soakage Test Time, min	90.0
Depth to Top of Permeable Soils, m		Mean Internal Discharge Area, m ²	0.333
Depth to Groundwater Surface, m		Discharge Rate, litre/min	0.251
Depth to Top of Granular Fill, m		Soakage Rate, litre/m ² /min	0.755
Voids Assumed within Borehole, %	100%	BRE Soil Infiltration Rate, m/sec	1.26E-05

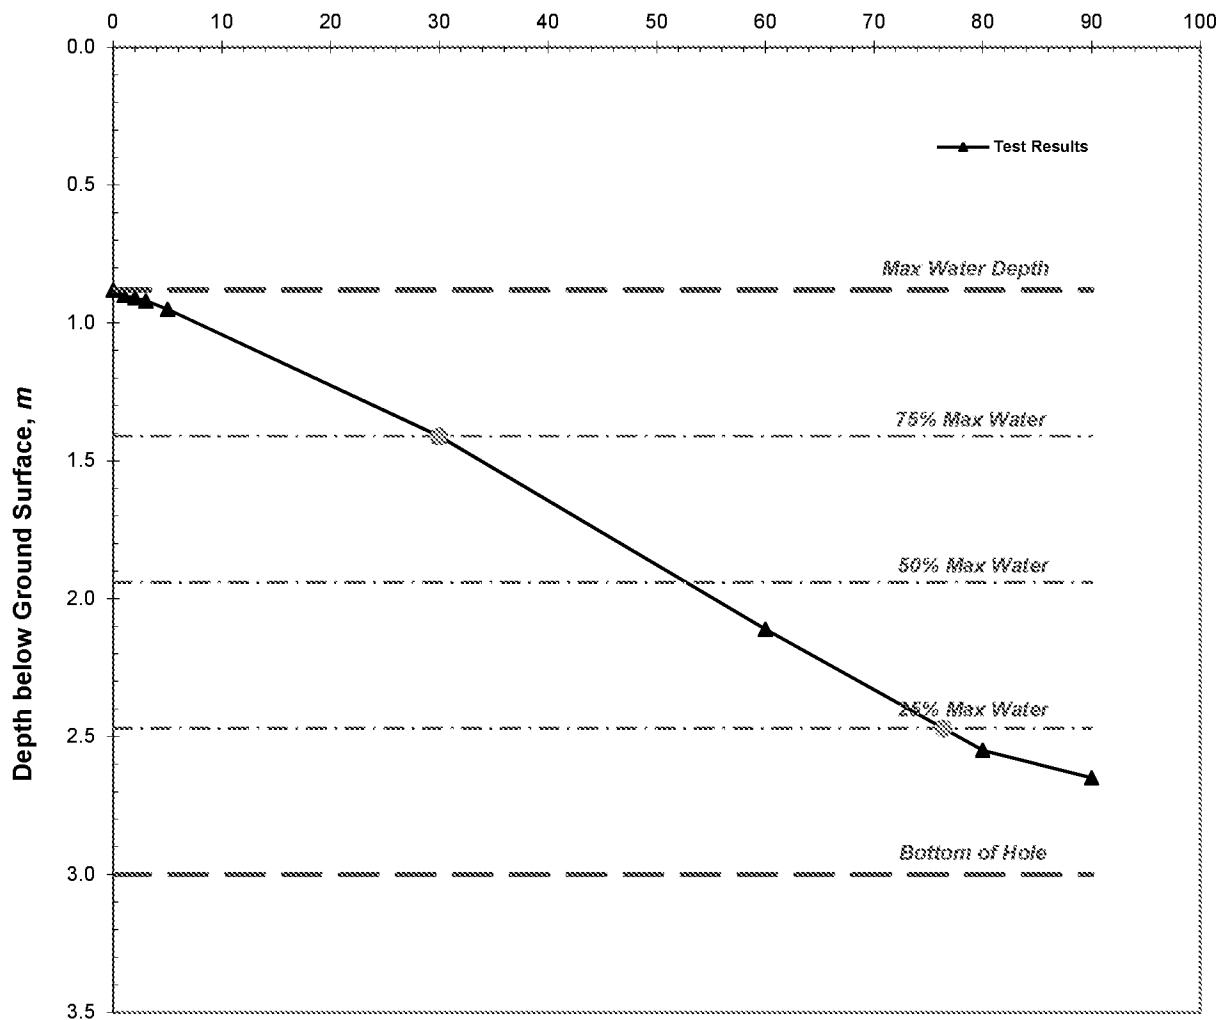
Test Hole No: WLS02
Test No: Test No 3 (Repeated)

Diameter of Borehole, m	0.100	Depth to Water at Start of Test, m	0.880
Depth to End of Borehole Casing, m		Max Water Dropdown during Test, m	1.770
Depth to Borehole Base, m	3.000	Total Soakage Test Time, min	90.0
Depth to Top of Permeable Soils, m		Mean Internal Discharge Area, m ²	0.341
Depth to Groundwater Surface, m		Discharge Rate, litre/min	0.180
Depth to Top of Granular Fill, m		Soakage Rate, litre/m ² /min	0.527
Voids Assumed within Borehole, %	100%	BRE Soil Infiltration Rate, m/sec	8.78E-06

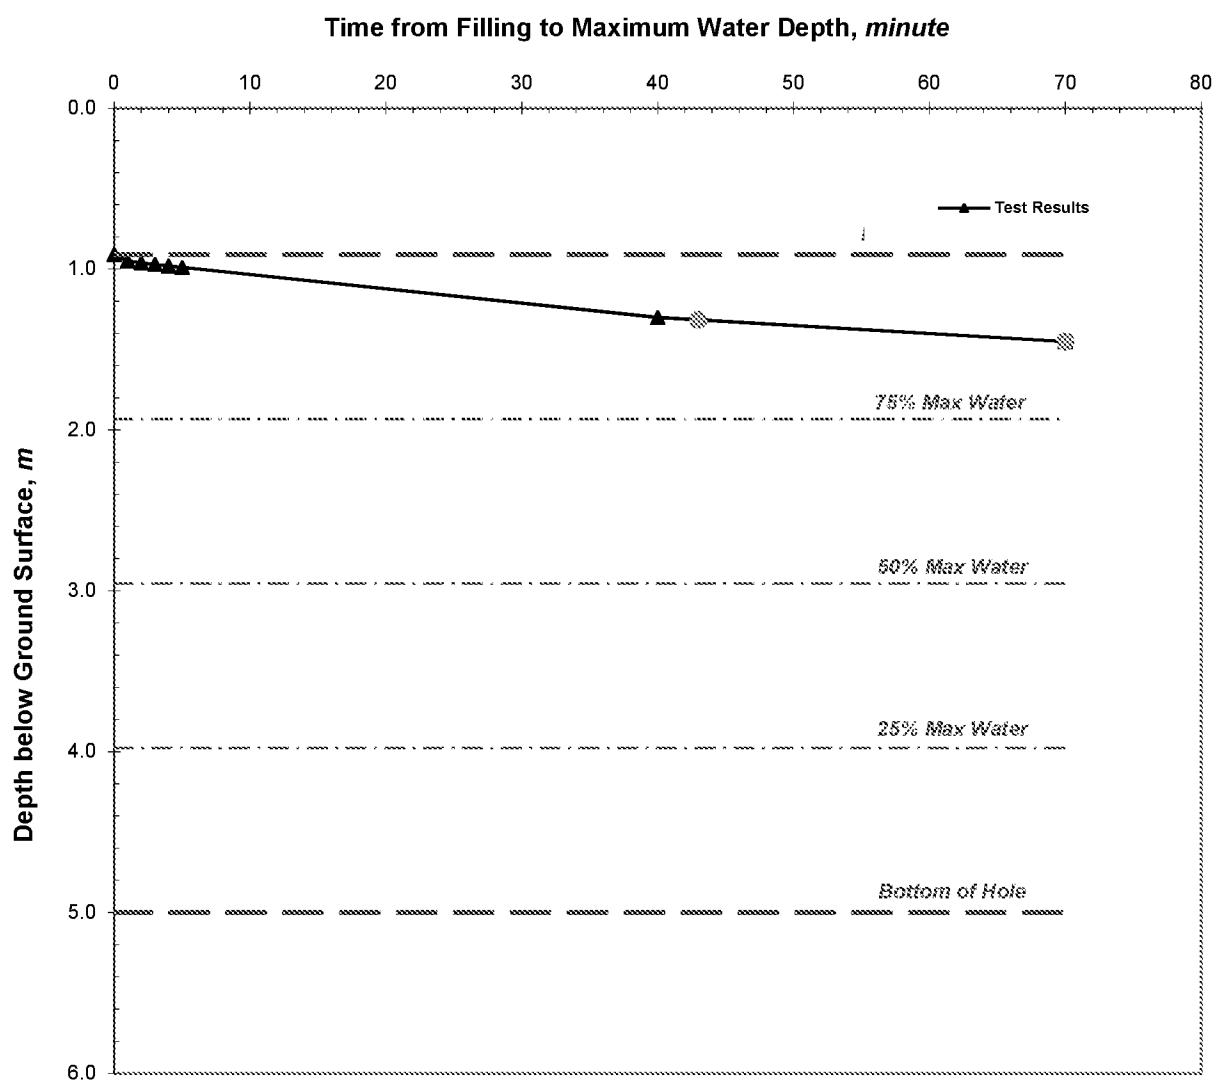
Test Hole No: WLS03
Test No: Test No 1 (Initial)

Preliminary Falling-Head Soakage Test

Diameter of Borehole, m	0.100	Depth to Water at Start of Test, m	0.910
Depth to End of Borehole Casing, m		Max Water Dropdown during Test, m	0.540
Depth to Borehole Base, m	5.000	Total Soakage Test Time, min	70.0
Depth to Top of Permeable Soils, m		Mean Internal Discharge Area, m ²	1.144
Depth to Groundwater Surface, m		Discharge Rate, litre/min	0.039
Depth to Top of Granular Fill, m		Soakage Rate, litre/m ² /min	0.034
Voids Assumed within Borehole, %	100%	BRE Soil Infiltration Rate, m/sec	5.72E-07

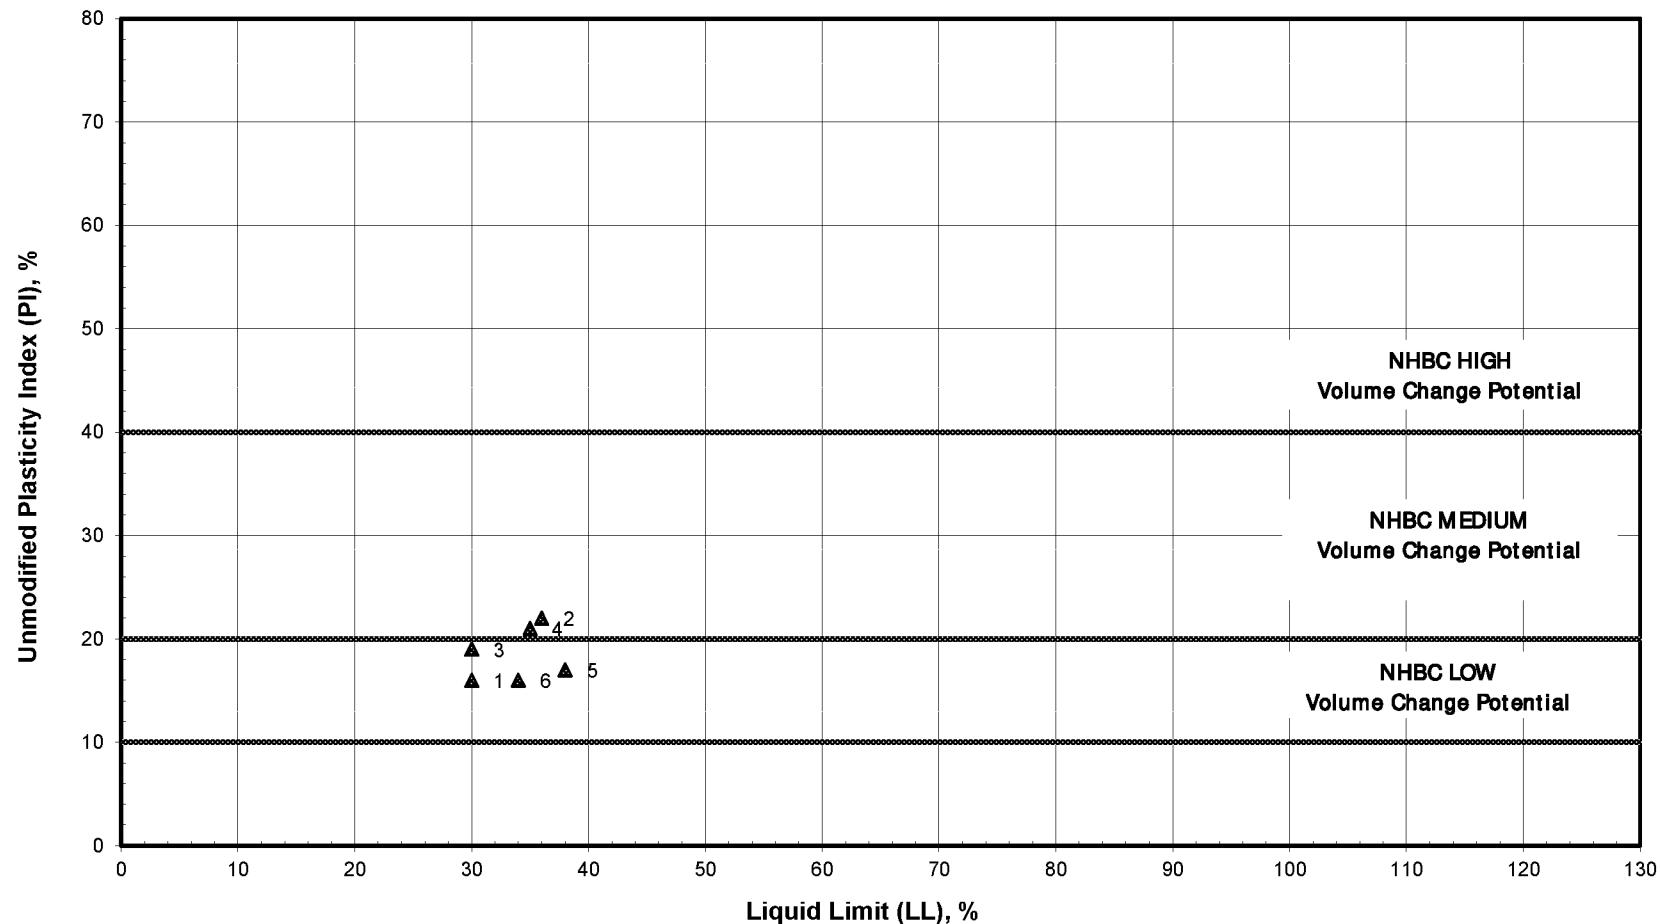
No.	TH No.	Depth
1	WLS01	2.50
2	WLS02	1.60
3	WLS03	1.50
4	WLS03	2.00
5	WLS04	1.00
6	WLS05	1.00

Liquid Limit	Plastic Limit	Unmodified Plasticity Index
Maximum Value	38	Maximum Value
Minimum Value	30	Minimum Value
Average Value	34	Average Value

Plasticity Chart for Atterberg Limit Tests

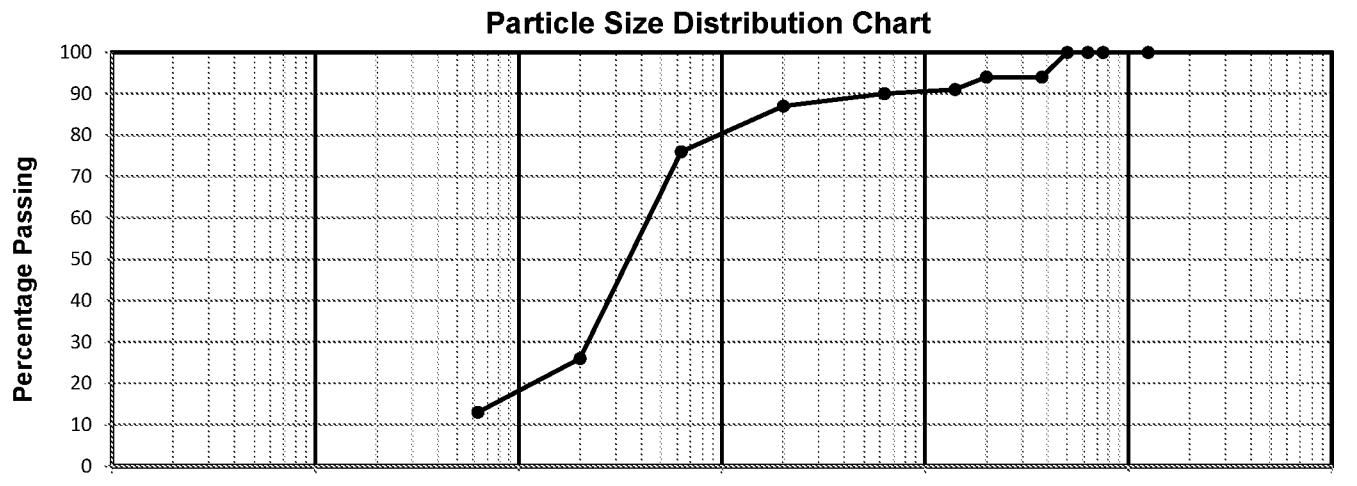
Particle Size	% Passing
125mm	100
75mm	100
63mm	100
50mm	100
37.5mm	94
20mm	94
14mm	91
6.3mm	90
2mm	87
630µm	76
200µm	26
63µm	13

CLAY	Fine	Medium	Coarse	Fine	Medium	Coarse	Fine	Medium	Coarse	COBBLES
	SILT			SAND			GRAVEL			
	13			74			13			0

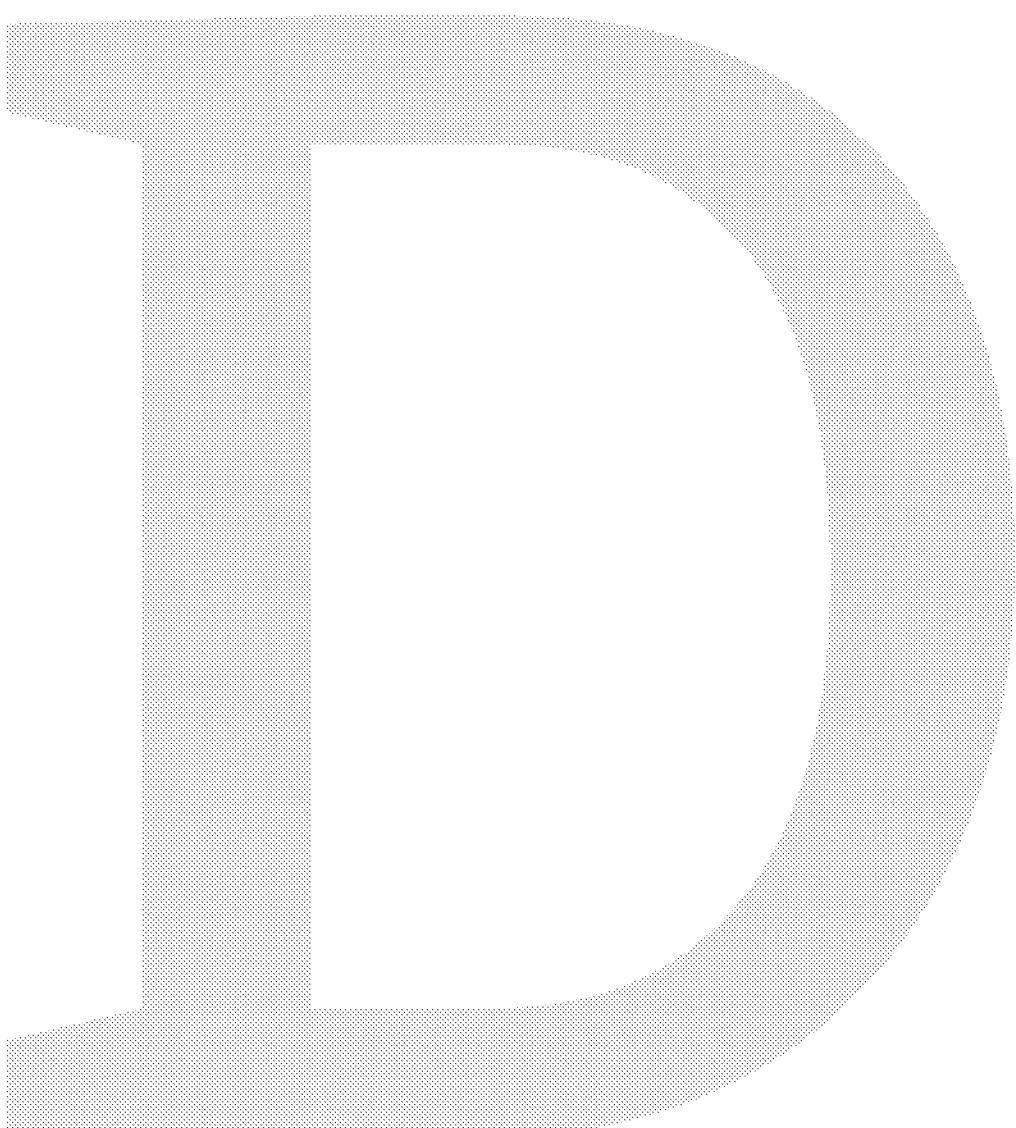
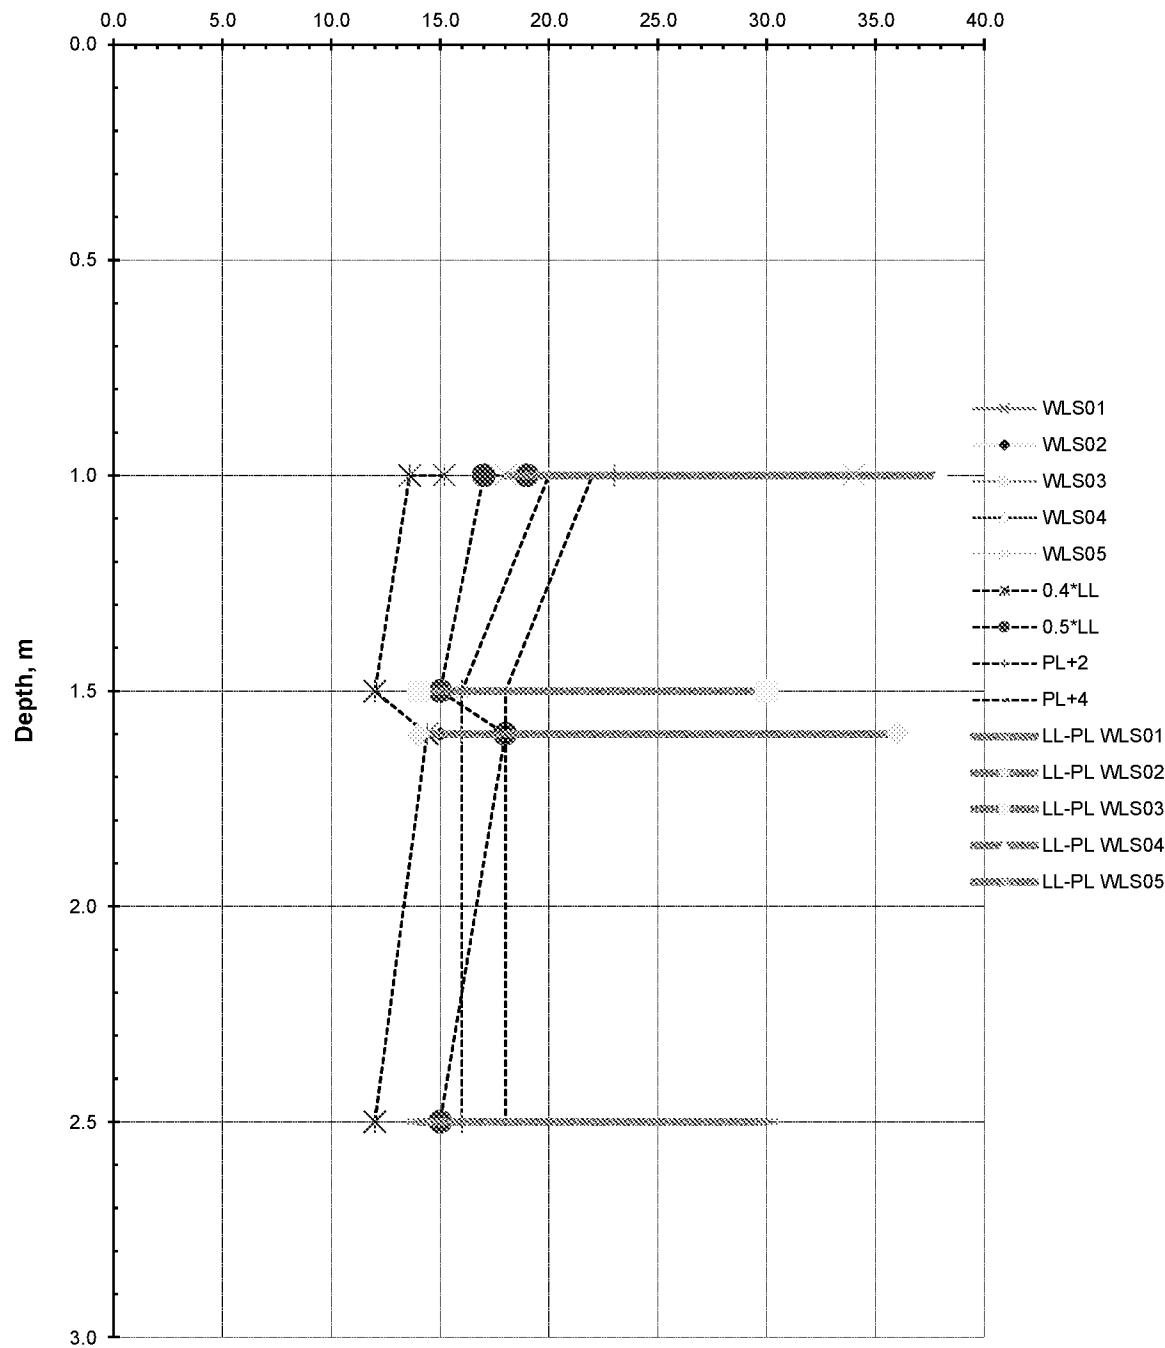
Moisture Content and Atterberg Limit Tests vs Depth

In Accordance with BS 1377 : Part 2 : 1990 : Clause 3

A plot of moisture content and Atterberg Limit tests versus depth is included within Appendix D Figures 3 and 4.
