57 RIVER ROAD, LITTLEHAMPTON, SUSSEX

HERITAGE STATEMENT

July 2021

**PROJECT:** 57 River Road, Littlehampton, Sussex

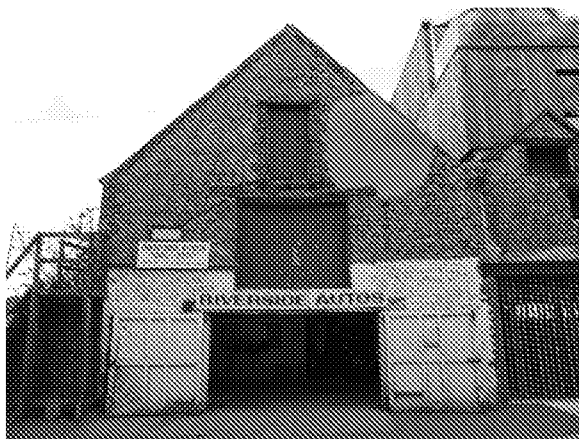
Figure 1: 57 River Road

- 1.3.1 57 River Road is included in Arun District Council's List of Buildings or Structures of Local Character (adopted September 2005). 57 River Road was included on the list because it was considered to meet the following criteria:
- Buildings which are extremely good examples of traditional or established, or unusual type;
  - In special cases, buildings or structures which contribute towards the local townscape or have important historical associations;

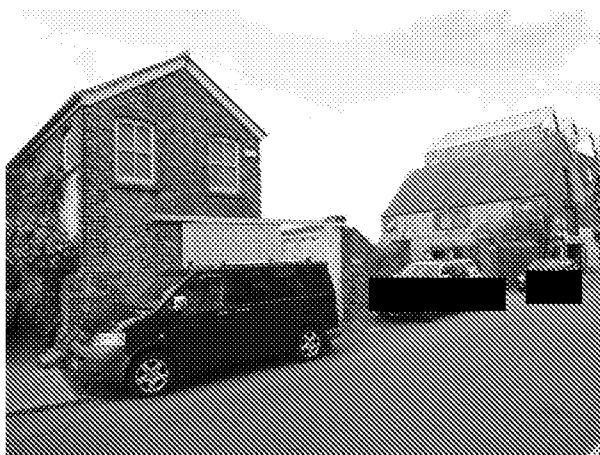
Figure 2: 49 River Road

1.3.4 49 River Road is also included in Arun District Council's List of Buildings or Structures of Local Character. This building is located adjacent to the yard at 57 River Road.

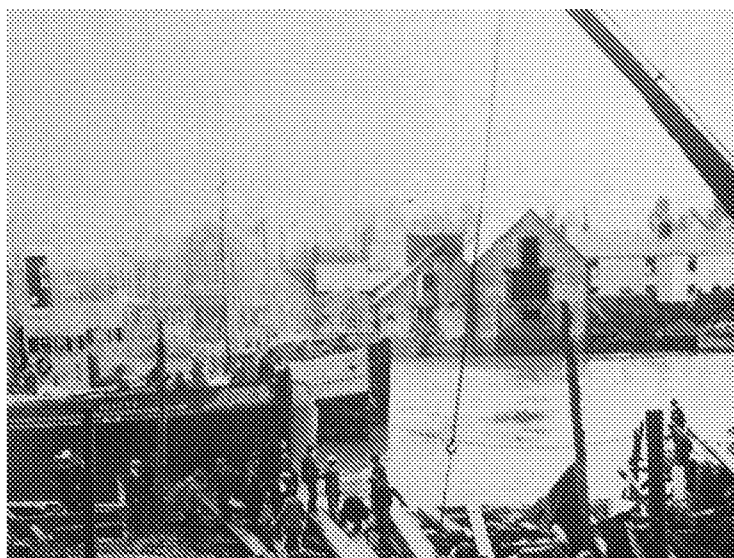
- 3.1.5 A photograph showing the launch of the barge *Wessex* from Harvey's Yard in c. 1915 shows the river frontage elevation of the group of warehouses associated with 57 River Road. This provides details of the original south-west elevation with its large loading bay doors on the first floor and a smaller door in the roof space.

Figure 6: Photograph dating from c. 1915 showing the riverside elevation of 57 River Road

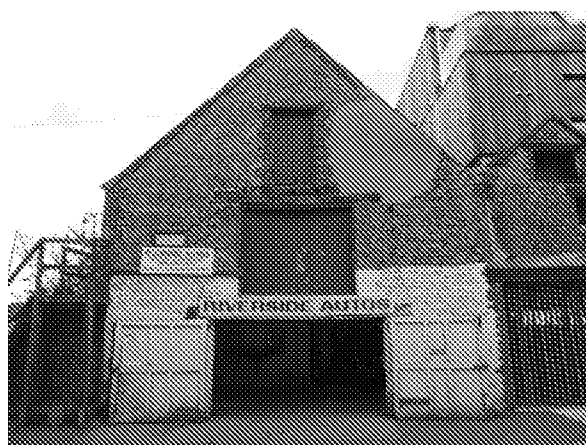
- 3.2.1 57 River Road is of coursed flint cobble construction with brick dressings. The gabled roof is finished with asbestos tiles. The front elevation includes a pair of 20<sup>th</sup> century doors below a timber lintel on the ground floor. There is a door opening with a segmental arched brick head to the left. On the first floor there is a smaller loading bay opening with double doors below a timber lintel. This appears to be of similar size to the loading bay opening on the original south-west elevation. There is a date stone with the name T Isemonger to the left of this opening. There is a single loading bay door to the roof space.

Figure 8: Front elevation of 57 River Road

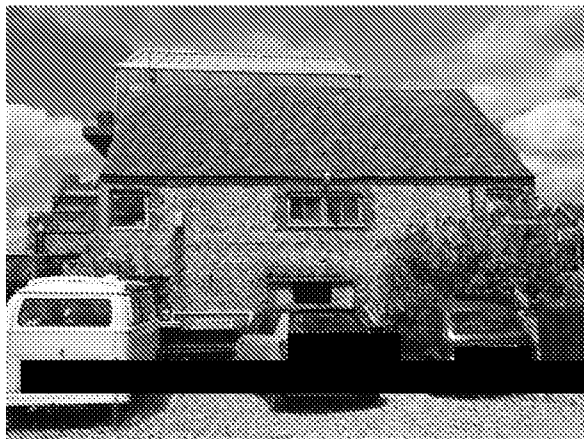
- 3.2.2 The south-east elevation includes a large central window opening on the first floor. This is flanked by a truncated window opening on the LHS and a door opening to the right. The door opening to the right may be a later insertion associated with the construction of steps. Historic mapping suggests that this was a late 19<sup>th</sup> century change. There is a 20<sup>th</sup> century door opening with an I-beam lintel on the LHS of the ground floor.

Figure 9: South-east elevation of 57 River Road

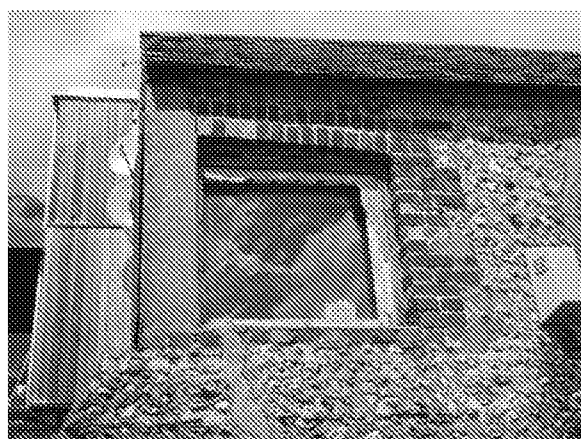
Figure 10: Truncated first floor window

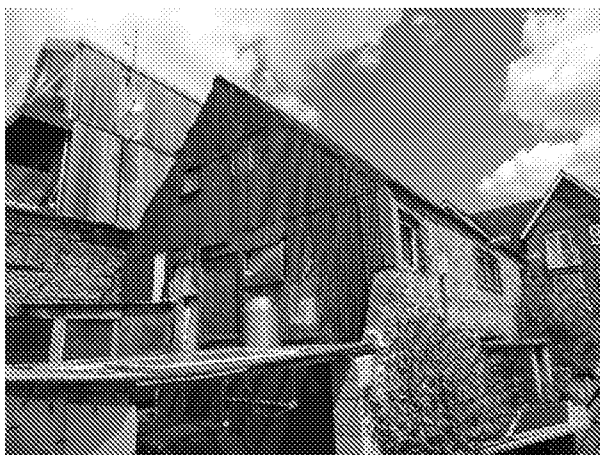
- 3.2.3 The south-west end bay of 57 River Road was demolished in the c. mid-20<sup>th</sup> century. The south-west elevation is clad with corrugated metal sheets. There is a central door opening on the first floor with a plank and batten door. The exposed edges of the demolished section of wall on the RHS have been capped with cement. Part of the flint cobble plinth survives and demonstrates the extent of the original building. The area of the demolished bay is occupied by makeshift wooden structures containing equipment for painting cars and a car port.

Figure 12: South-west elevation of 57 River Road

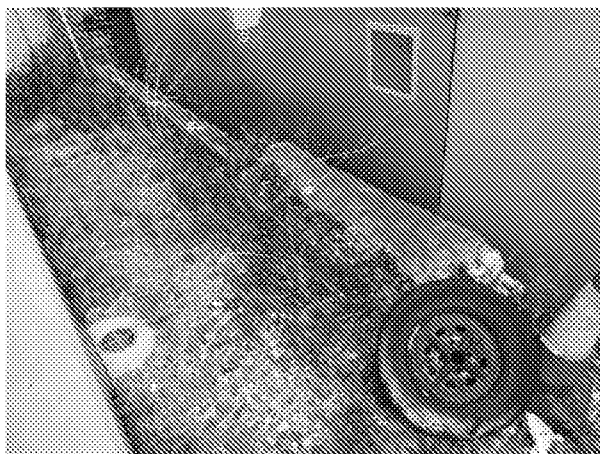
Figure 13: Section of flint plinth showing south-western extent of the original building

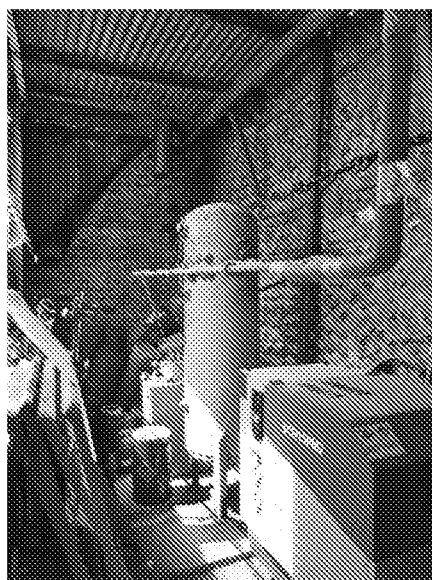
Figure 15: Covered area to the rear (within the footprint of the demolished bay)

- 4.2.1 57 River Road has been historically altered with the demolition of a bay on the River Arun side of the building. The original roof covering has been replaced with modern tiles. None of the original doors or windows survive, although the openings with brick dressings partly survive. The south-west elevation with corrugated metal cladding does not contribute to the character of the building or to views towards the Conservation Area from the opposing bank of the River Arun. The south-east elevation has obviously been truncated, along with one first floor window, and a door with an unsympathetic steel I-beam lintel inserted on the LHS of the ground floor. A modern concrete block structure is located at the centre of the elevation. The front elevation includes 20<sup>th</sup> century double doors, possibly to an enlarged opening and a large mortar repair to the top RHS. The exterior has been much changed, although its original form and function can still be appreciated.

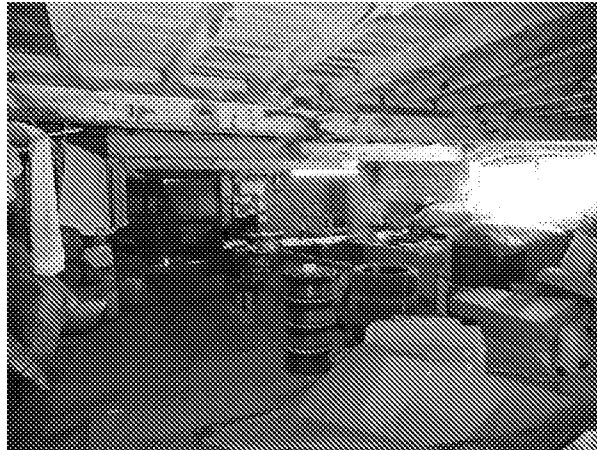
- 3.2.5 The first floor is open and includes five beams which define the surviving six bays. The floor beams are dropped tie beams which rest on brick lined recesses in the longitudinal walls. Some of these beams include evidence for shipping marks. The joists rest on battens nailed to the sides of the beams. These joists are hand sawn rather than machined.

Figure 16: First floor looking towards the front of the building

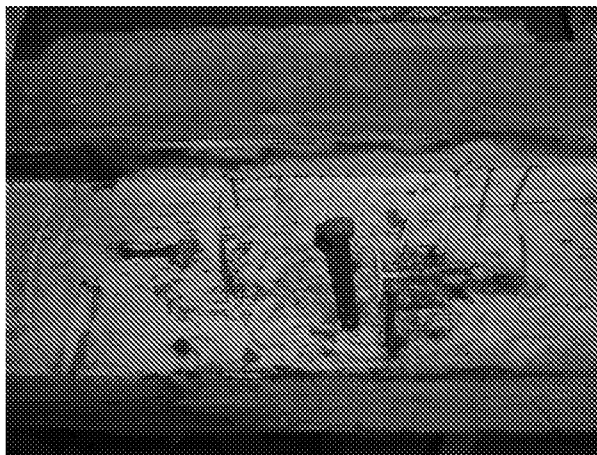
Figure 17: Shipping marks on one of the central transverse beams

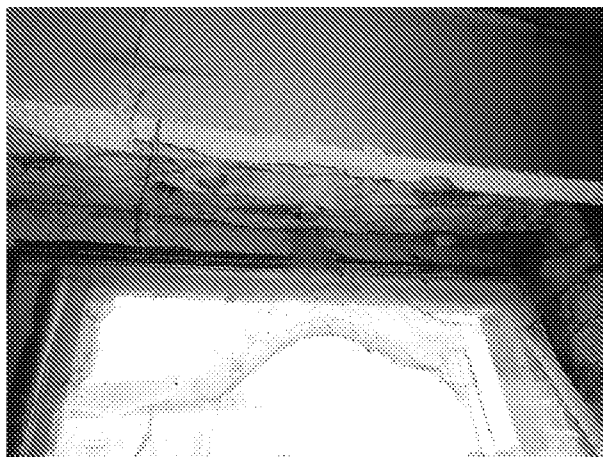
Figure 19: Dowels along the soffit of the lintel on the southern side of the first floor

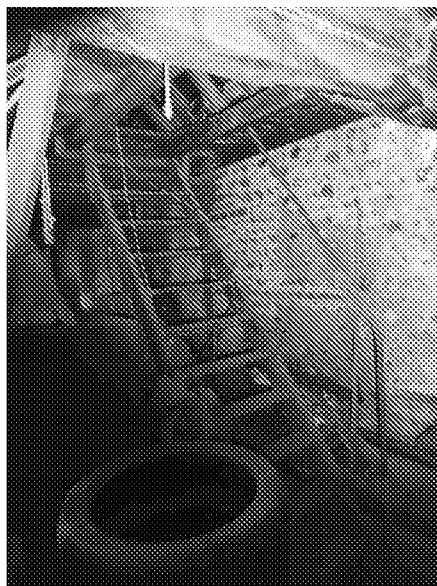
- 3.2.7 Access to the second floor is by timber steps in the south-east bay and through a hatch in the upper floor. The roof structure includes collars which are jointed to the principal rafters with halved lap joints fixed with iron nails. These collars clasp side purlins with splayed scarfs, also fixed with nails, located at the collar positions. The apex of the roof includes a ridge plank. The principal elements of the roof include mill sawn timbers. The softwood rafters are regularly sawn and are probably machine sawn. There are diagonal set rafters in the two end bays to brace the roof longitudinally. It is possible that these were added following the demolition of the south-west bay. The plank and batten door on the south-east elevation includes trapezoidal battens and round end strap hinges and is probably of late 19<sup>th</sup> to early 20<sup>th</sup> century date. There are chalk marks referring to foresails and topsails on the inside leaf of the door.

Figure 21: Steps from the first to second floors

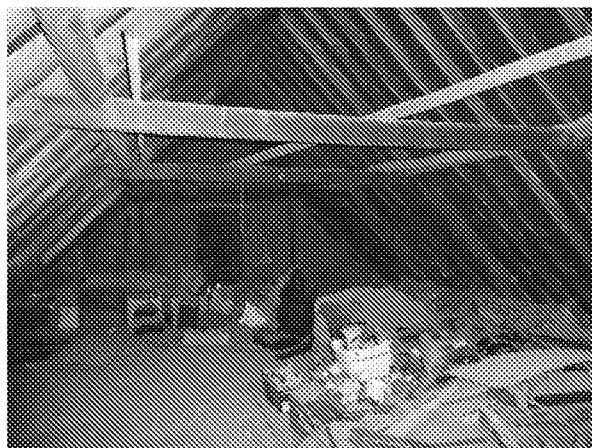
Figure 22: Collared truss roof structure

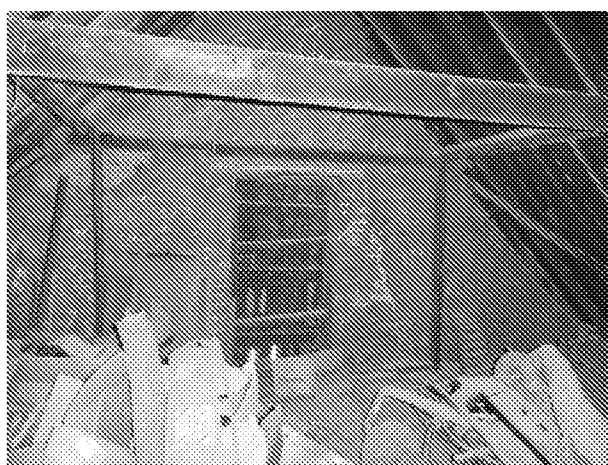
Figure 25: Loading bay door on the north-east side of the second floor (diagonally set rafter to the right of the photo)

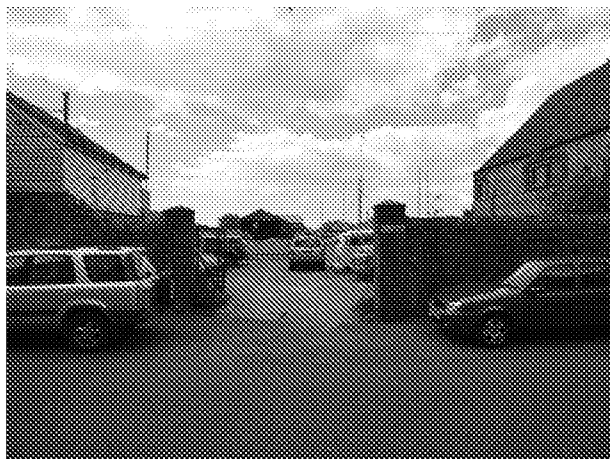
- 3.2.8 The yard on the south-east side of 57 River Road is accessed through a boundary wall of coursed flint cobble construction. This wall is keyed into the brick quoins of 57 River Road to the right and is ramped on the left hand side of the entrance. The wall then returns along the south-east side of the yard and includes a mix of coursed flint cobbles and areas of brickwork. The north-western side of the yard is defined by 57 River Road. The riverside includes a recently constructed section of concrete wall for flood defences. The gate piers are of brick. The brick pier on the RHS appears to be of 20<sup>th</sup> century date. The yard has an informal surface and is used for car parking.

Figure 26: Front boundary wall and entrance to the yard

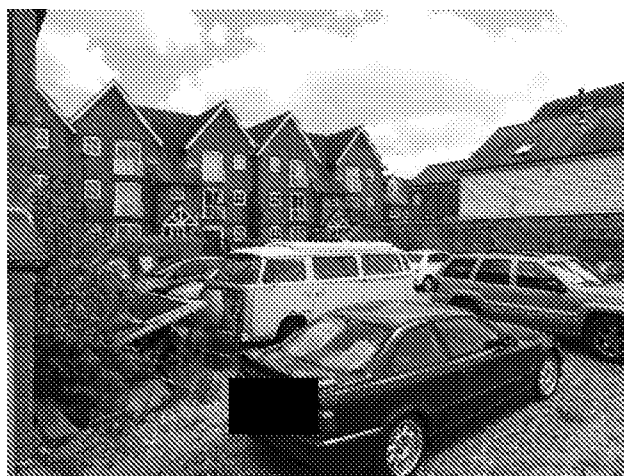
Figure 27: The yard viewed from the riverside wall

- 4.4.2 Development of the yard would involve the loss of an open space associated with wharves along the east bank of the river Arun. A recent flood defence wall (LU/291/17/PL) has limited the visual association of this space with the river and its historical use as a wharf. The timber revetment along the river was replaced as part of these works. The openness of the yard does provide views onto the side elevation of 57 River Road. Otherwise the yard is not a particularly attractive space which is used for car parking. The Conservation Officer's pre-application comments recognised the potential of the proposed scheme to enhance this part of the Conservation Area: *'It is considered that the redevelopment of this site offers the opportunity to improve this part of the conservation area, which is positive'*.

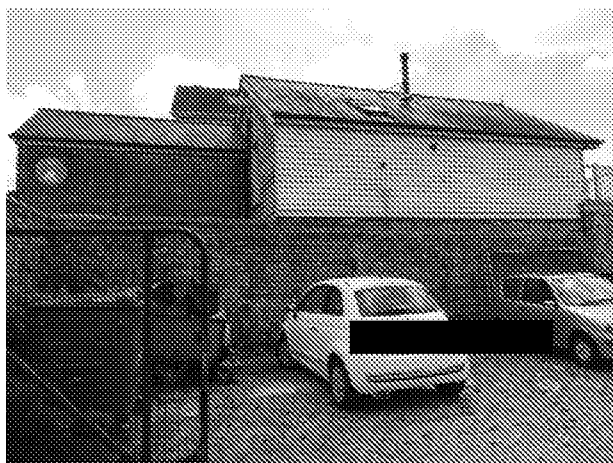
Figure 28: South-east wall of the yard

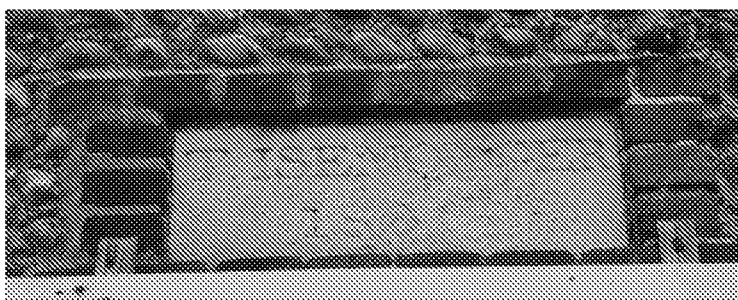
Figure 29: Date stone on the front elevation of 57 River Road

- 4.2.5 Further mitigation that would link to the historic retained façade of 57 River Road could include an information board that provides an understanding of the history of the site and its riverside context. This would raise an awareness of the history of this part of the Conservation Area and would represent a public benefit. This could take the form of a nearby information board about 'Bridging the River Arun'. In addition, materials will be recycled where practicable as part of the proposed scheme.

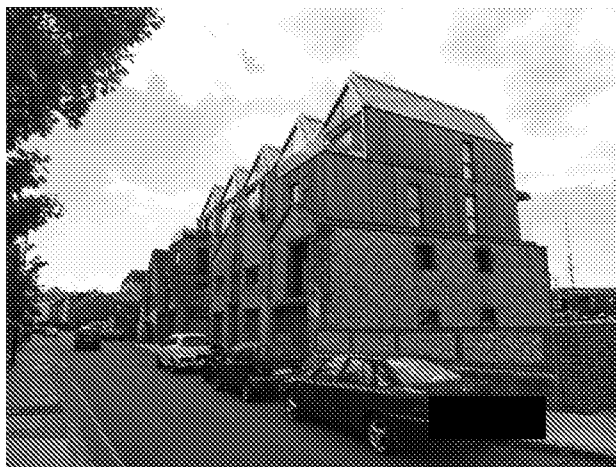
- 4.2.6 The previously approved scheme on the north-western side of 57 River Road involved alterations to Buildings or Structures of Local Character (ref. LU/44/11/). This development involved the demolition of the existing structures whilst retaining the front and side walls. The inserted building is 4-storeys and a northern light style roof. The vertical emphasis, rhythm and palette of materials were all considered to be acceptable in principle. The proposal to retain the River Road façade of the existing buildings was welcomed in the Delegated Report, which stated that:

Figure 30: Adjacent development along River Road

- 4.2.7 The proposed scheme seeks to replicate the approach taken for the above scheme.
- 4.2.8 Of some relevance to the proposed scheme is *Dorothy Bohm v SSCLG* (2017) EWHC 3217 (Admin), which relates to a challenge to an Inspector's decision to grant planning permission for the demolition and rebuilding of a dwelling house in the Hampstead Conservation Area in London.
