### **Baseline Ground Investigation Report**

| <b>Report:</b> | BASELINE GROUND INVESTIGATION REPORT |
| <b>Site:</b> | DAISYFIELDS TOURING PARK, CORNFIELD CLOSE, WICK, LITTLEHAM PTON,<br>WEST SUSSEX, BN17 6LD |

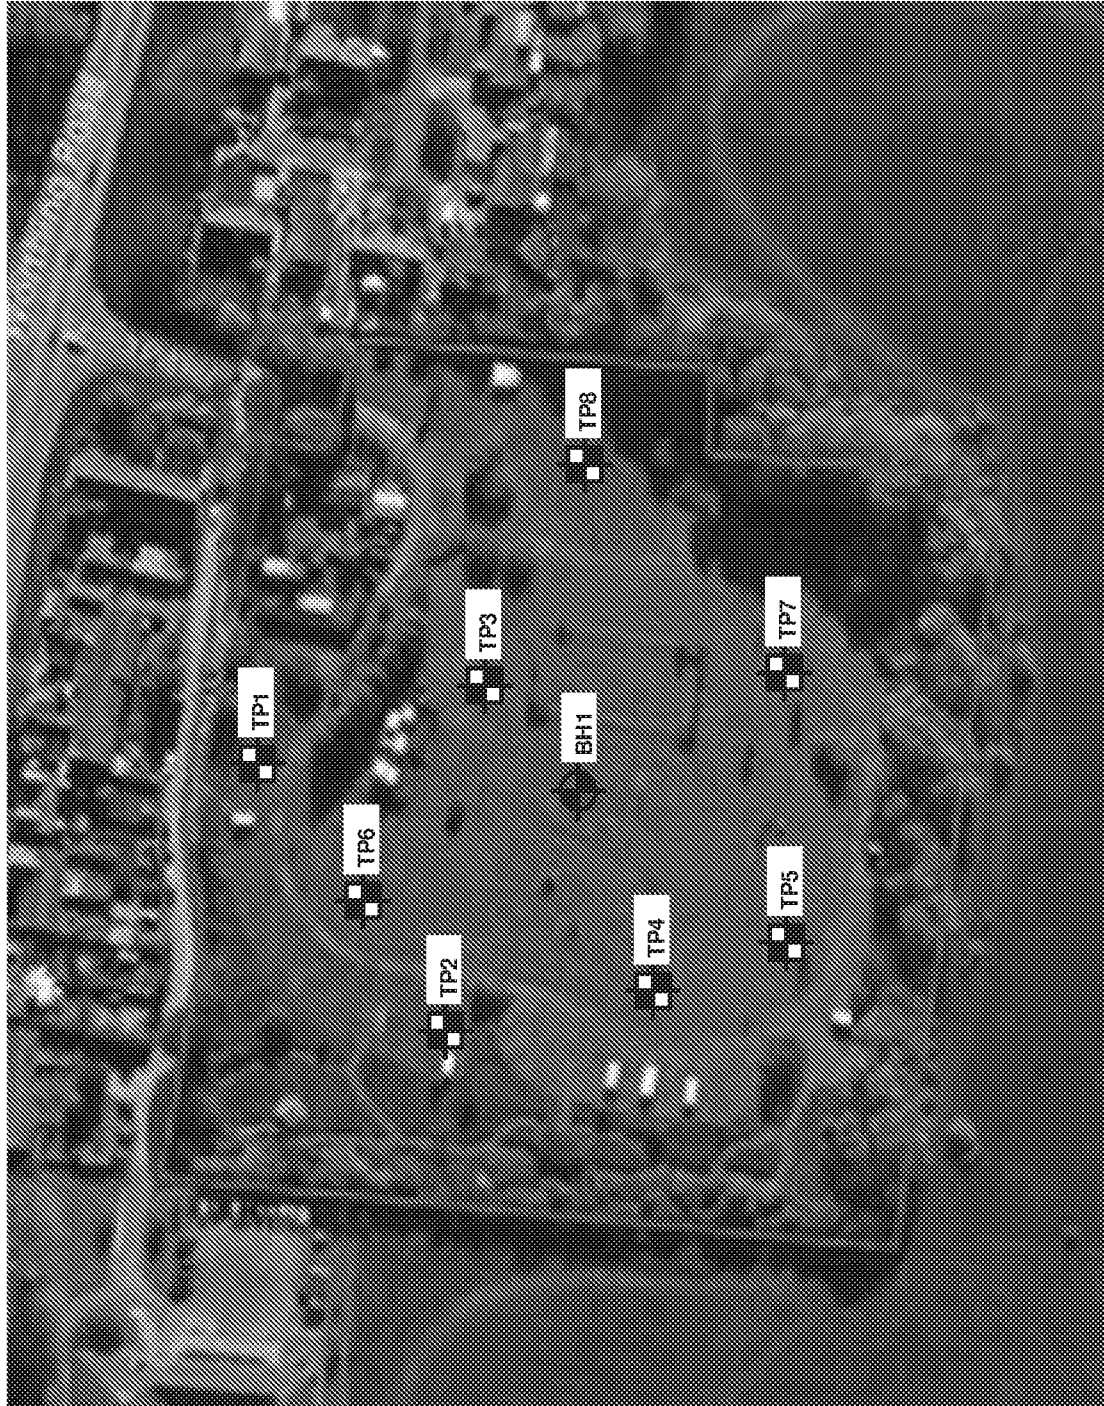
**FIGURE 2**

**Exploratory Hole Location Plan**

| <b>Project:</b> | Cornfield Close, Littlehampton | | | <b>Title</b> | Site Investigation Plan |

For further details of the ground conditions, reference should be made to the exploratory hole logs presented in Appendix B, the geotechnical testing results in Appendix C, geochemical testing results in Appendix D and the ground gas monitoring results in Appendix E.

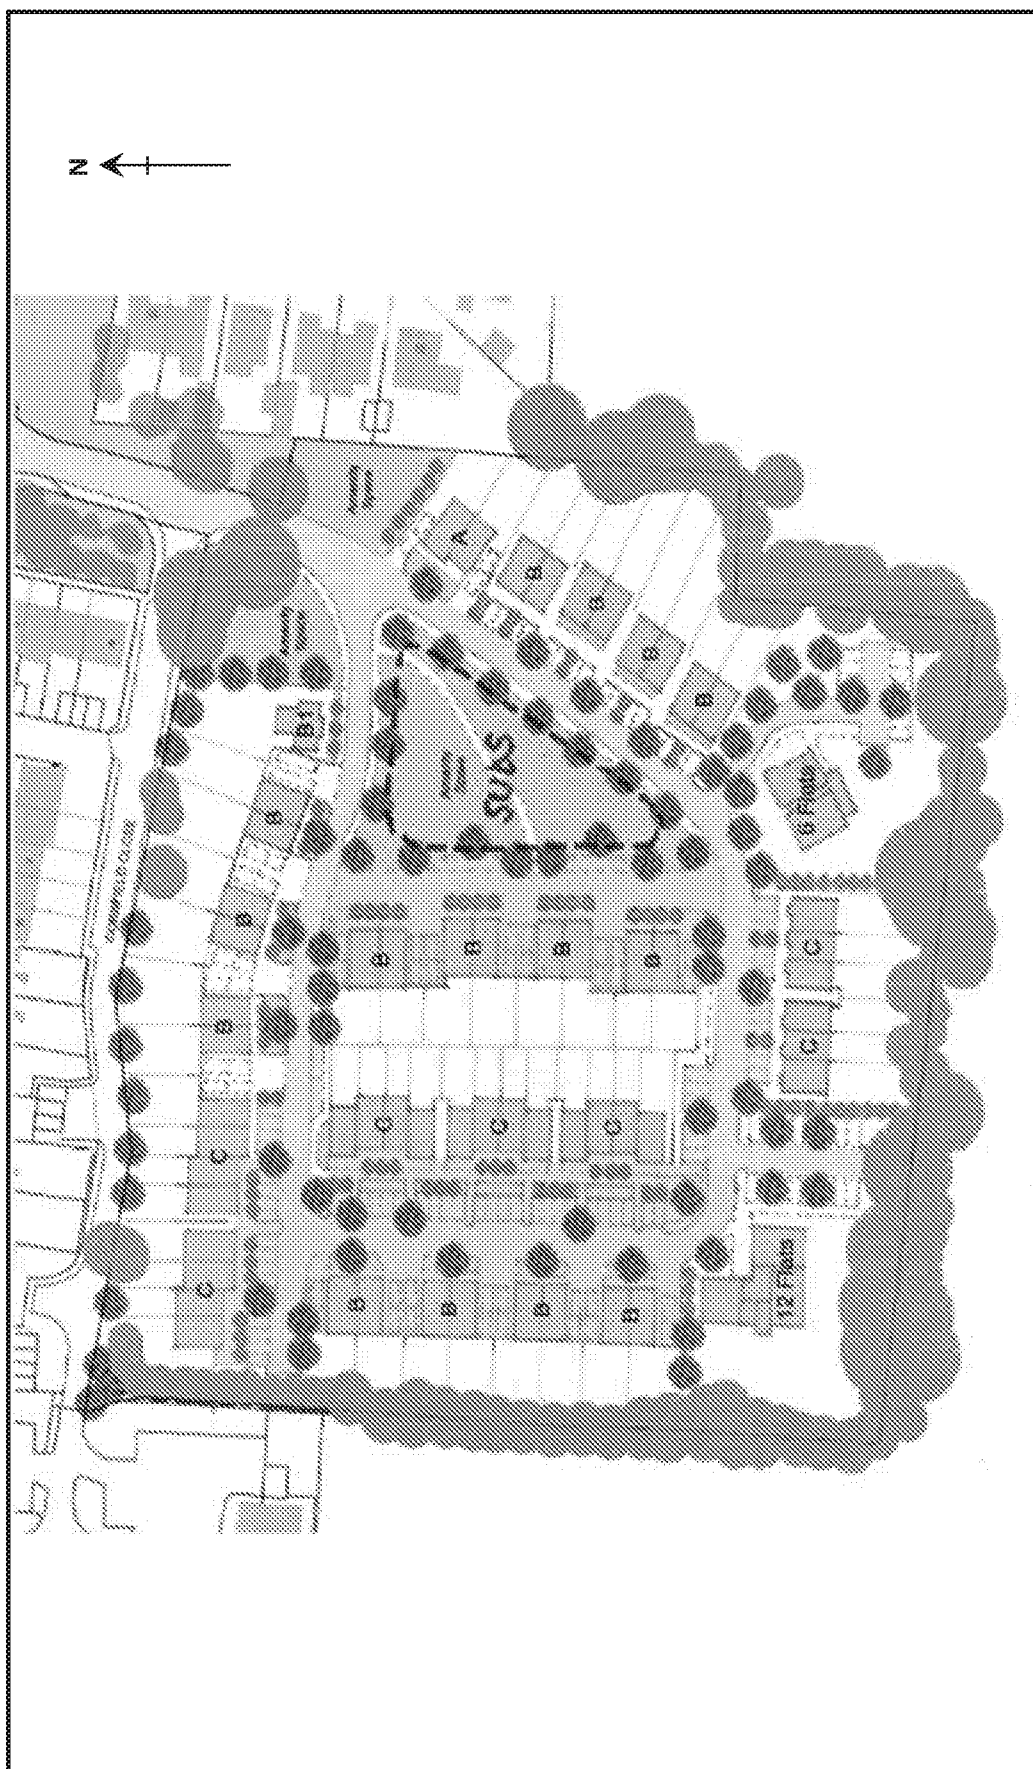
| Project: Cornfield Close, Littlehampton | | Title | | Proposed SUDS Area | |
