**REMEDIATION STRATEGY & VERIFICATION PLAN**

**FORMER DAISYFIELDS CARAVAN PARK**

**CORNFIELD CLOSE, LITTLEHAMPTON**

**THAKEHAM CLIENT LIMITED**

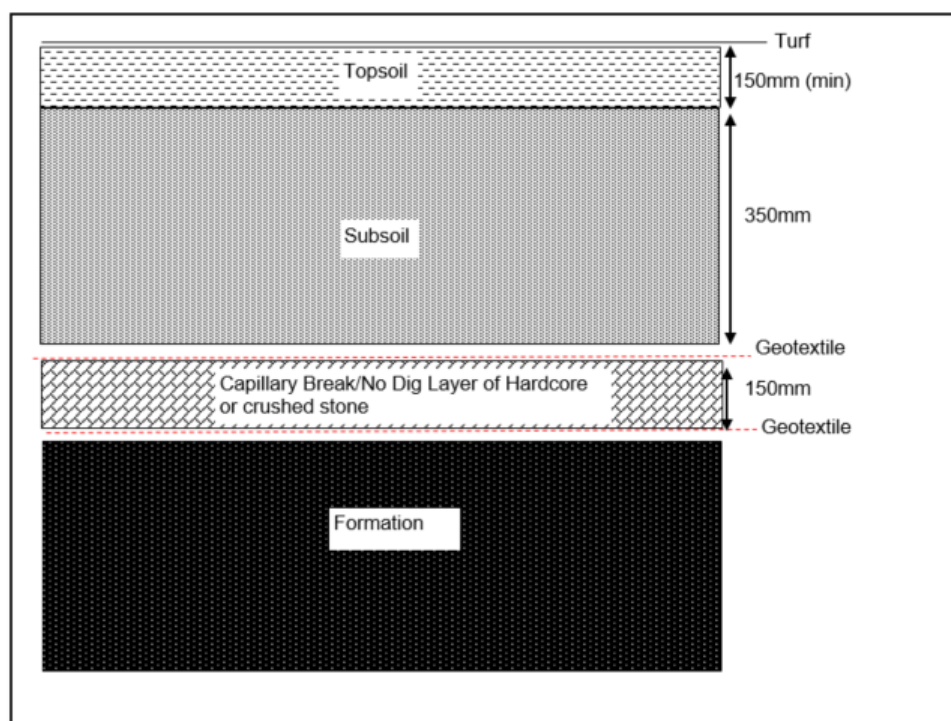
In areas remote from those designated for tree root protection it is recommended that the Made Ground beneath be removed or the site raised to a depth of 650mm and be replaced with chemically and geotechnically suitable material with a high visibility marker geotextile layer such as Terram High-Vis placed at the base between the imported soils and a capillary break layer comprising crushed stone or hardcore of 150mm and underlain by a further layer of Terram. An indicative diagram of the cover system construction is shown below:-

suitable growing media. The cover system shall incorporate a 150mm thick break layer formed of stone or crushed concrete with a geotextile membrane laid above and beneath, and overlain by a layer of geofabric to act as a visible deterrent overlain by a minimum 300mm thickness of subsoil and a minimum of 150mm of Topsoil.

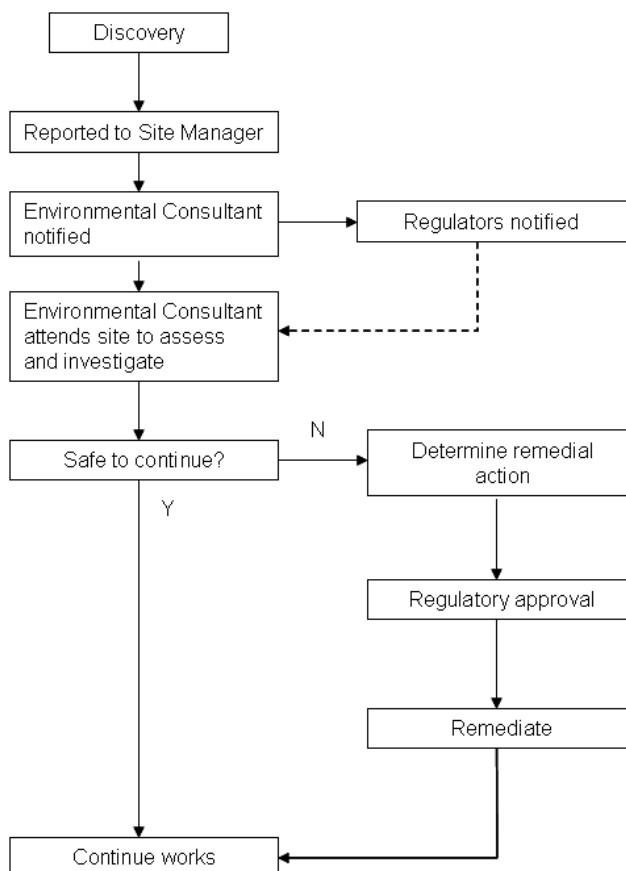
The process is summarised overleaf:
