**REMEDIATION STRATEGY & VERIFICATION PLAN**

**FORMER DAISYFIELDS CARAVAN PARK**

**CORNFIELD CLOSE, LITTLEHAMPTON**

| Reference: | GE17106-RSVP-GE-NOV18 |

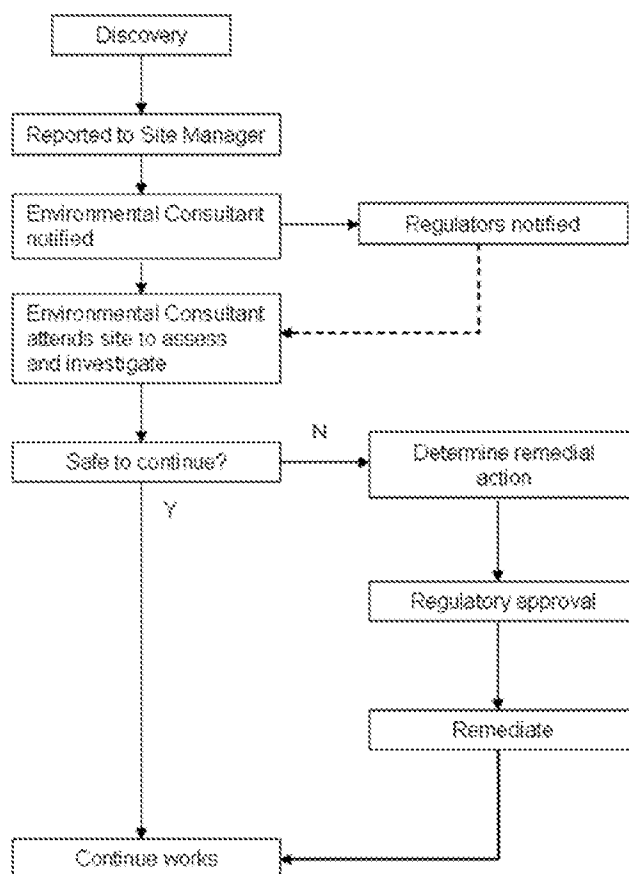
The process is summarised overleaf:
