**REMEDIATION STRATEGY & VERIFICATION PLAN**

**FORMER DAISYFIELDS CARAVAN PARK**

**CORNFIELD CLOSE, LITTLEHAMPTON**

| Reference: | GE17106-RSVP-GE-NOV18 |

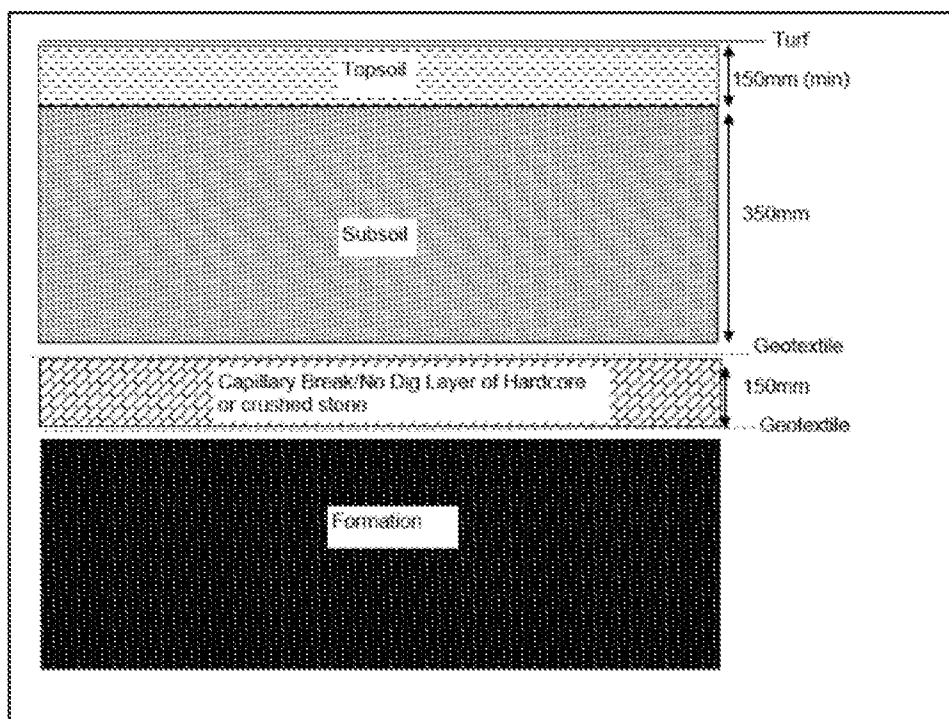
In areas remote from those designated for tree root protection it is recommended that the Made Ground beneath be removed or the site raised to a depth of 650mm and be replaced with chemically and geotechnically suitable material with a high visibility marker geotextile layer such as Terram High-Vis placed at the base between the imported soils and a capillary break layer comprising crushed stone or hardcore of 150mm and underlain by a further layer of Terram. An indicative diagram of the cover system construction is shown below:-

suitable growing media. The cover system shall incorporate a 150mm thick break layer formed of stone or crushed concrete with a geotextile membrane laid above and beneath, and overlain by a layer of geofabric to act as a visible deterrent overlain by a minimum 300mm thickness of subsoil and a minimum of 150mm of Topsoil.

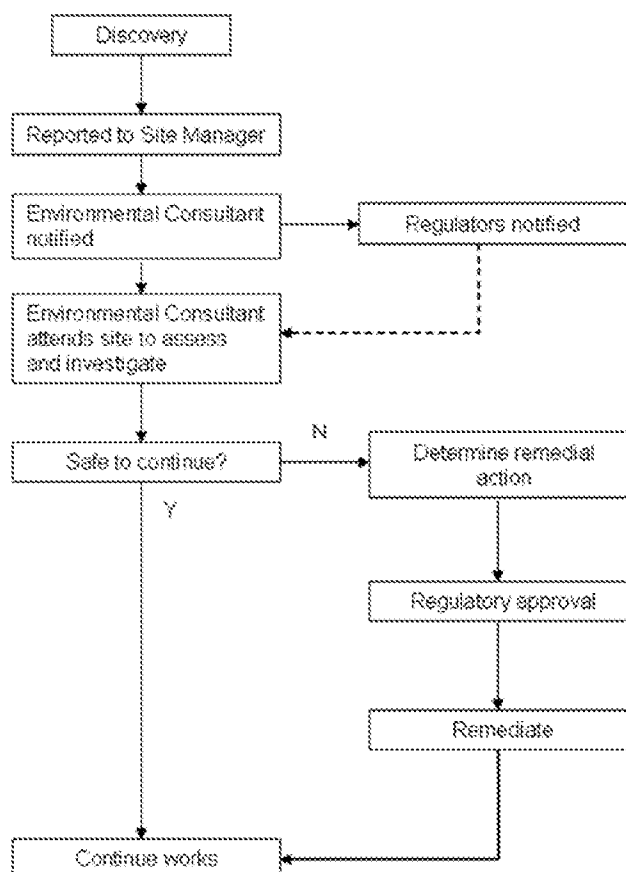
The process is summarised overleaf:

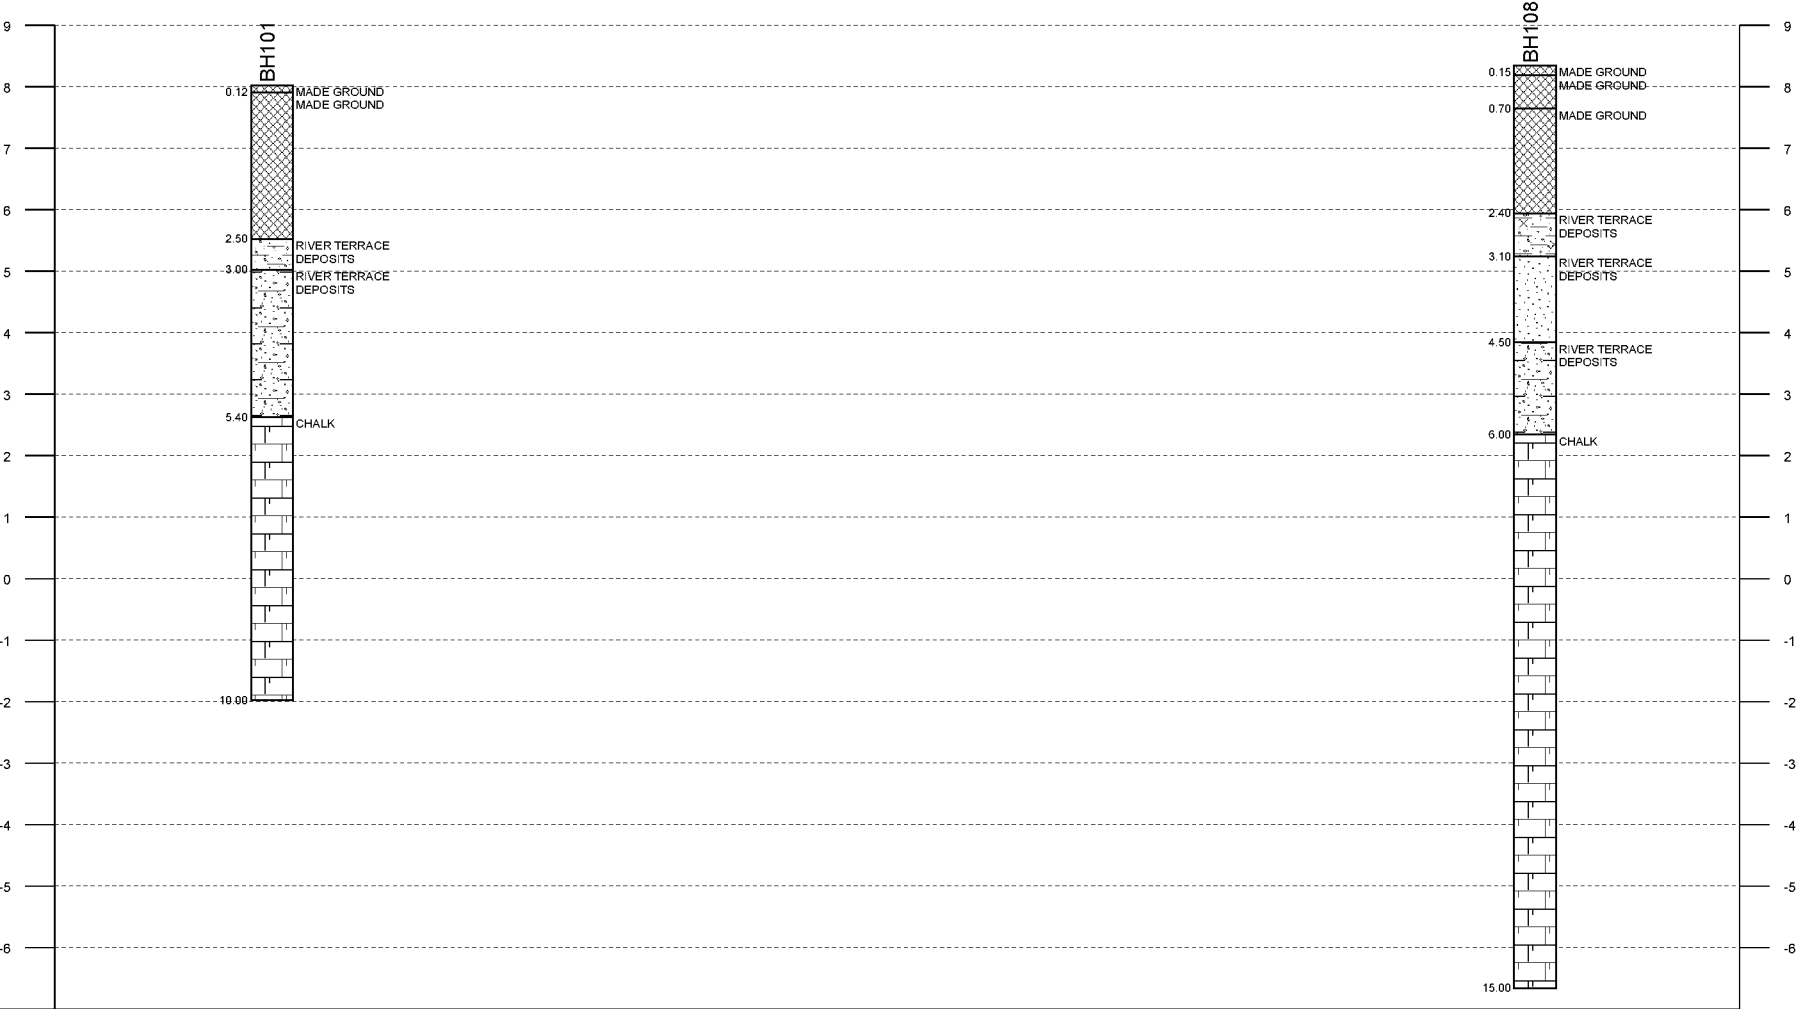
- MADE GROUND
- Silly sandy gravelly CLAY
- Sandy gravelly CLAY
- SAND
- Clayey gravelly SAND
- CHALK

Underlying the River Terrace Deposits, the Lewes Nodular Chalk was encountered within the cable percussion boreholes to depths of between 10.00m and 15.00m bgl (maximum depth of the investigation) and was generally recovered as structureless CHALK composed of sub-angular to rounded gravel. Clasts are weak, medium, high and very high density, off-white within an off-white matrix. For further details of the ground conditions encountered, reference should be made to the information presented in Appendix A, which includes four sections across the site.
