**QUALITATIVE PILING RISK ASSESSMENT**

**SOUTH OF CORNFIELD CLOSE,  
LITTLEHAMPTON, WEST SUSSEX**

**THAKEHAM CLIENT LIMITED**

| <b>Reference:</b> | GE18103-QPRA-JUL19 |

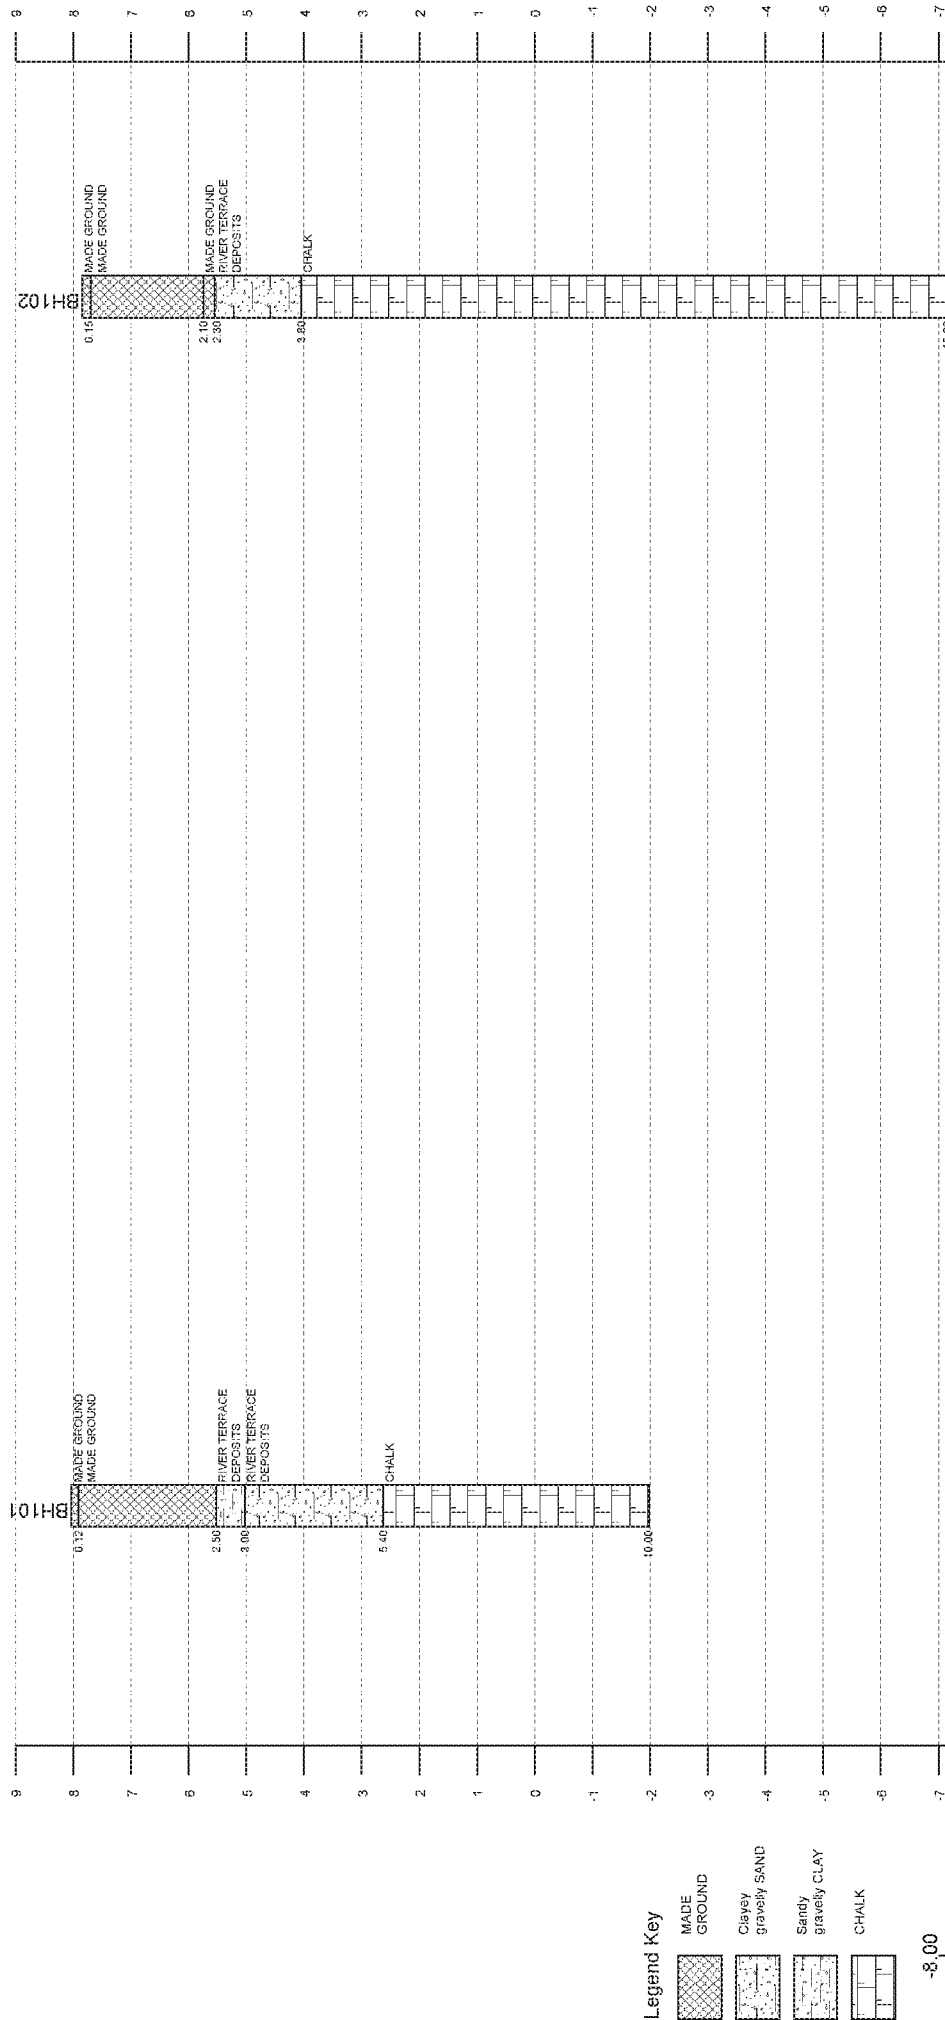
- MADE GROUND
- Clayey gravelly SAND
- Sandy gravelly CLAY
- CHALK

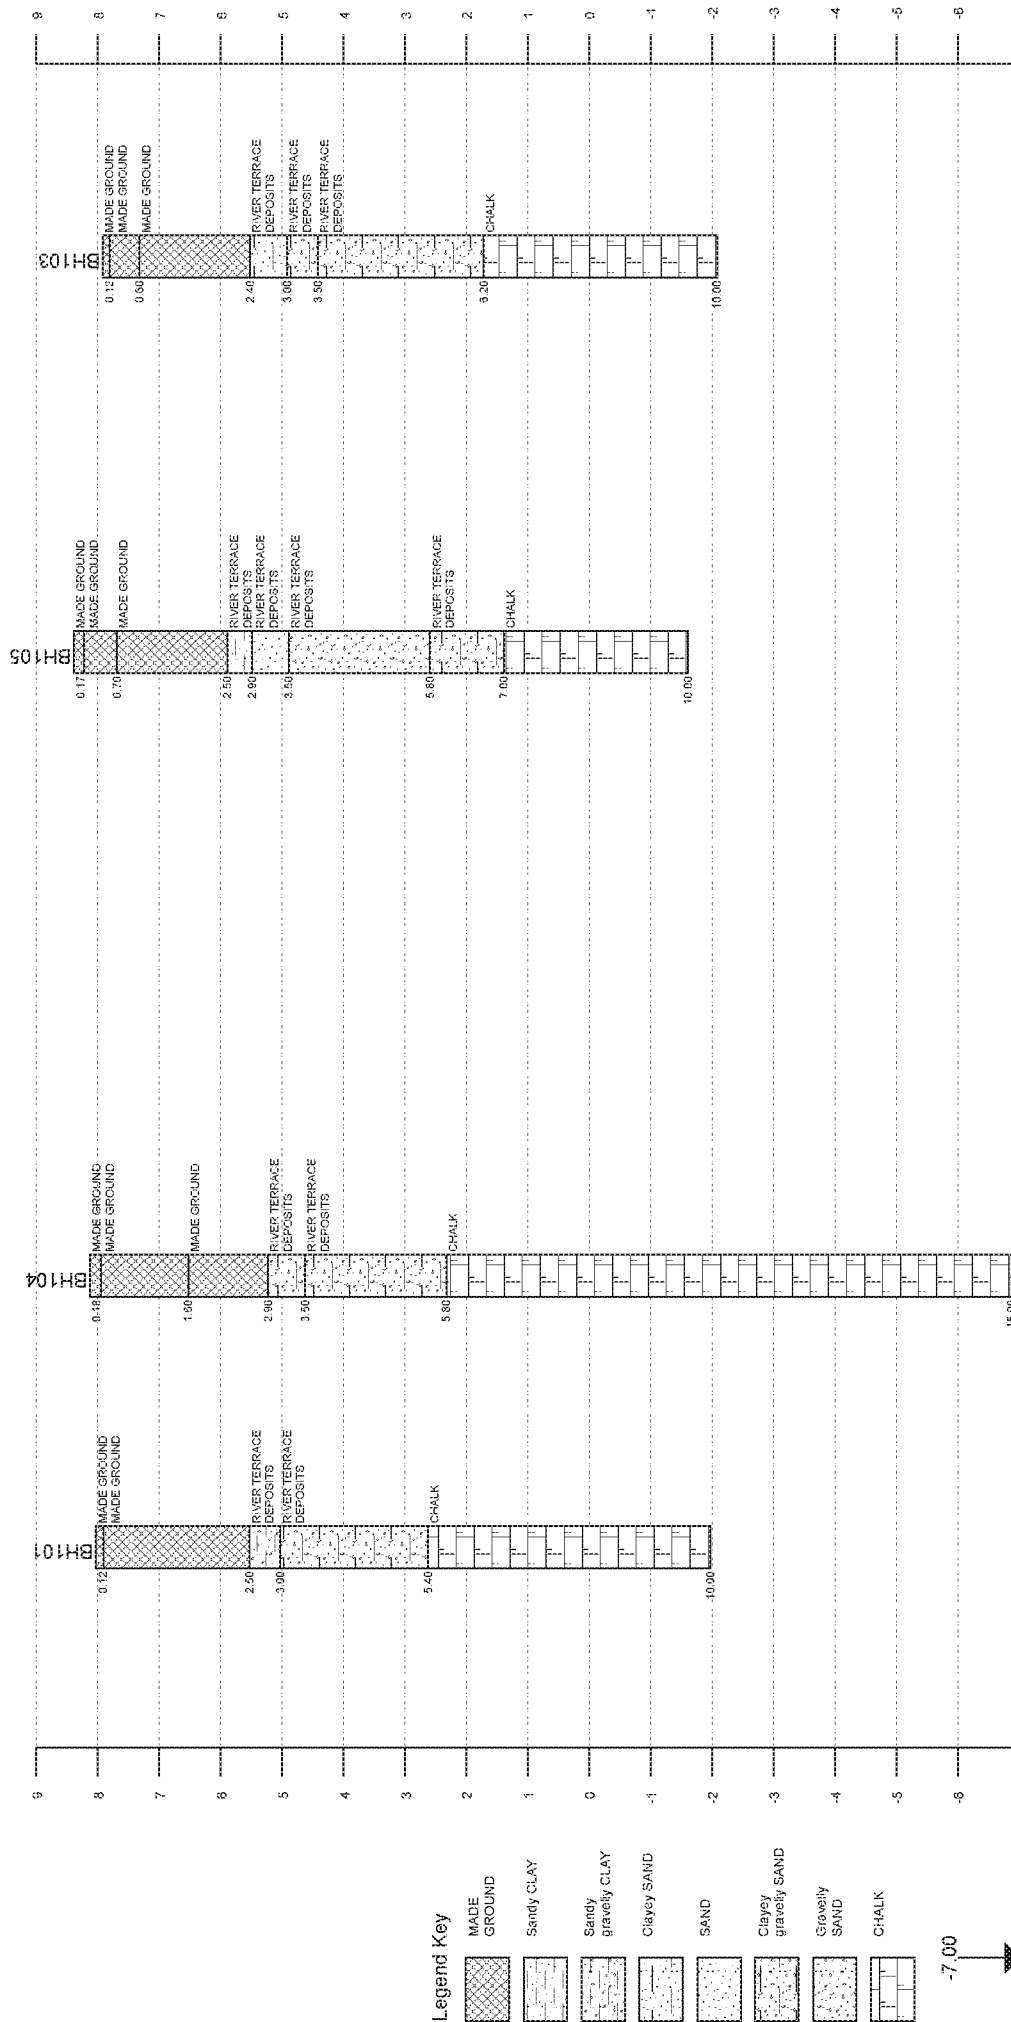
- MADE GROUND
- SANDY CLAY
- SANDY GRAVELLY CLAY
- CLAYEY SAND
- SAND
- CLAYEY GRAVELLY SAND
- GRAVELLY SAND
- CHALK
