**REMEDIATION STRATEGY & VERIFICATION PLAN**

**FORMER DAISYFIELDS CARAVAN PARK**

**CORNFIELD CLOSE, LITTLEHAMPTON**

**THAKEHAM CLIENT LIMITED**

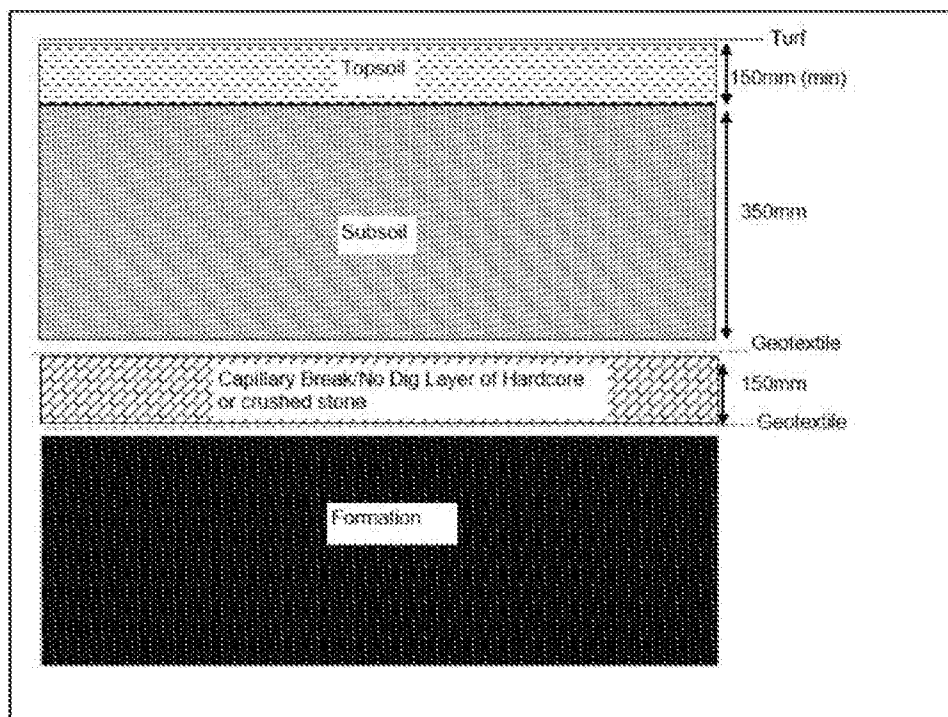
Schematic 1 – Private Gardens

In areas remote from those designated for tree root protection it is recommended that the Made Ground beneath be removed or the site raised to a depth of 650mm and be replaced with chemically and geotechnically suitable material with a high visibility marker geotextile layer such as Terram High-Vis placed at the base between the imported soils and a capillary break layer comprising crushed stone or hardcore of 150mm and underlain by a further layer of Terram. An indicative diagram of the cover system construction for private gardens is shown within Schematic 1 below:

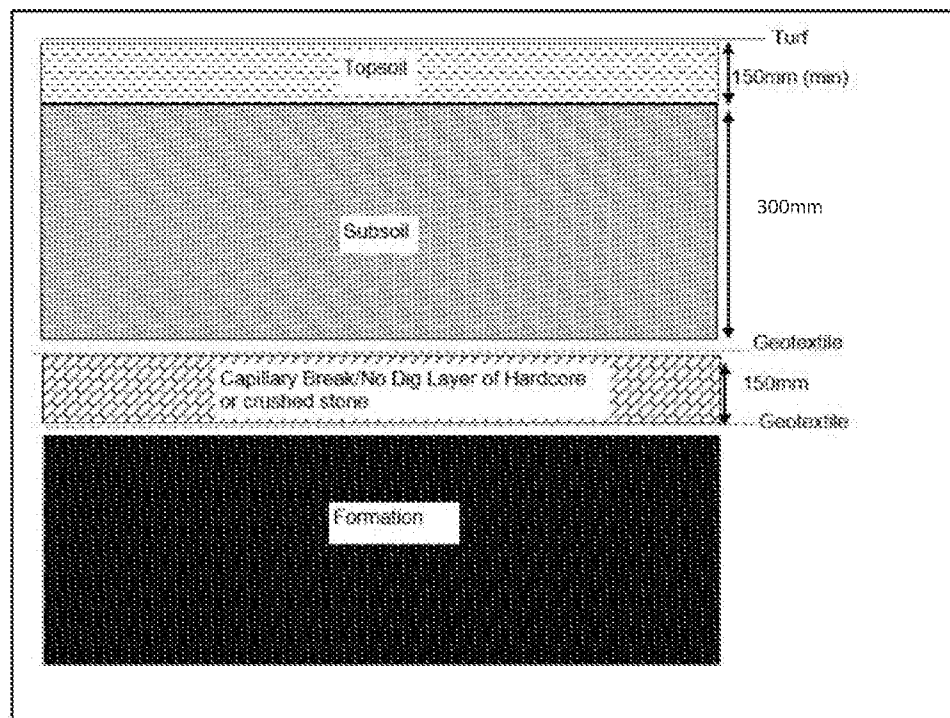
Schematic 2 – Communal Gardens and Public Open Space

An indicative diagram of the cover system construction for communal landscaping and public open space is

shown within Schematic 2 below:

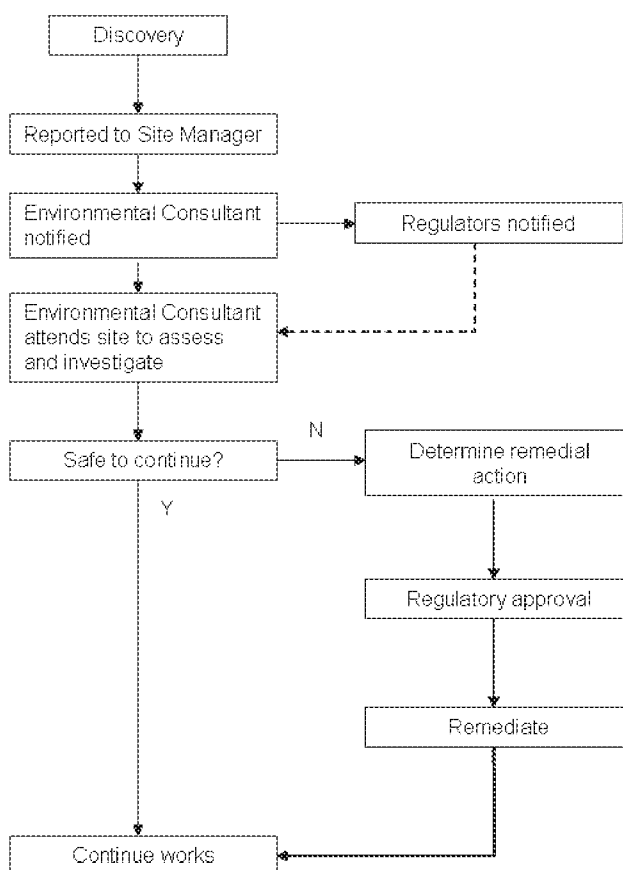
- Any further remediation will be undertaken in accordance with a method statement submitted to the Local Authority for approval. The works shall be supervised by the Environmental Consultant who shall provide a Verification Report for the Local Authorities purposes.

The process is summarised overleaf:

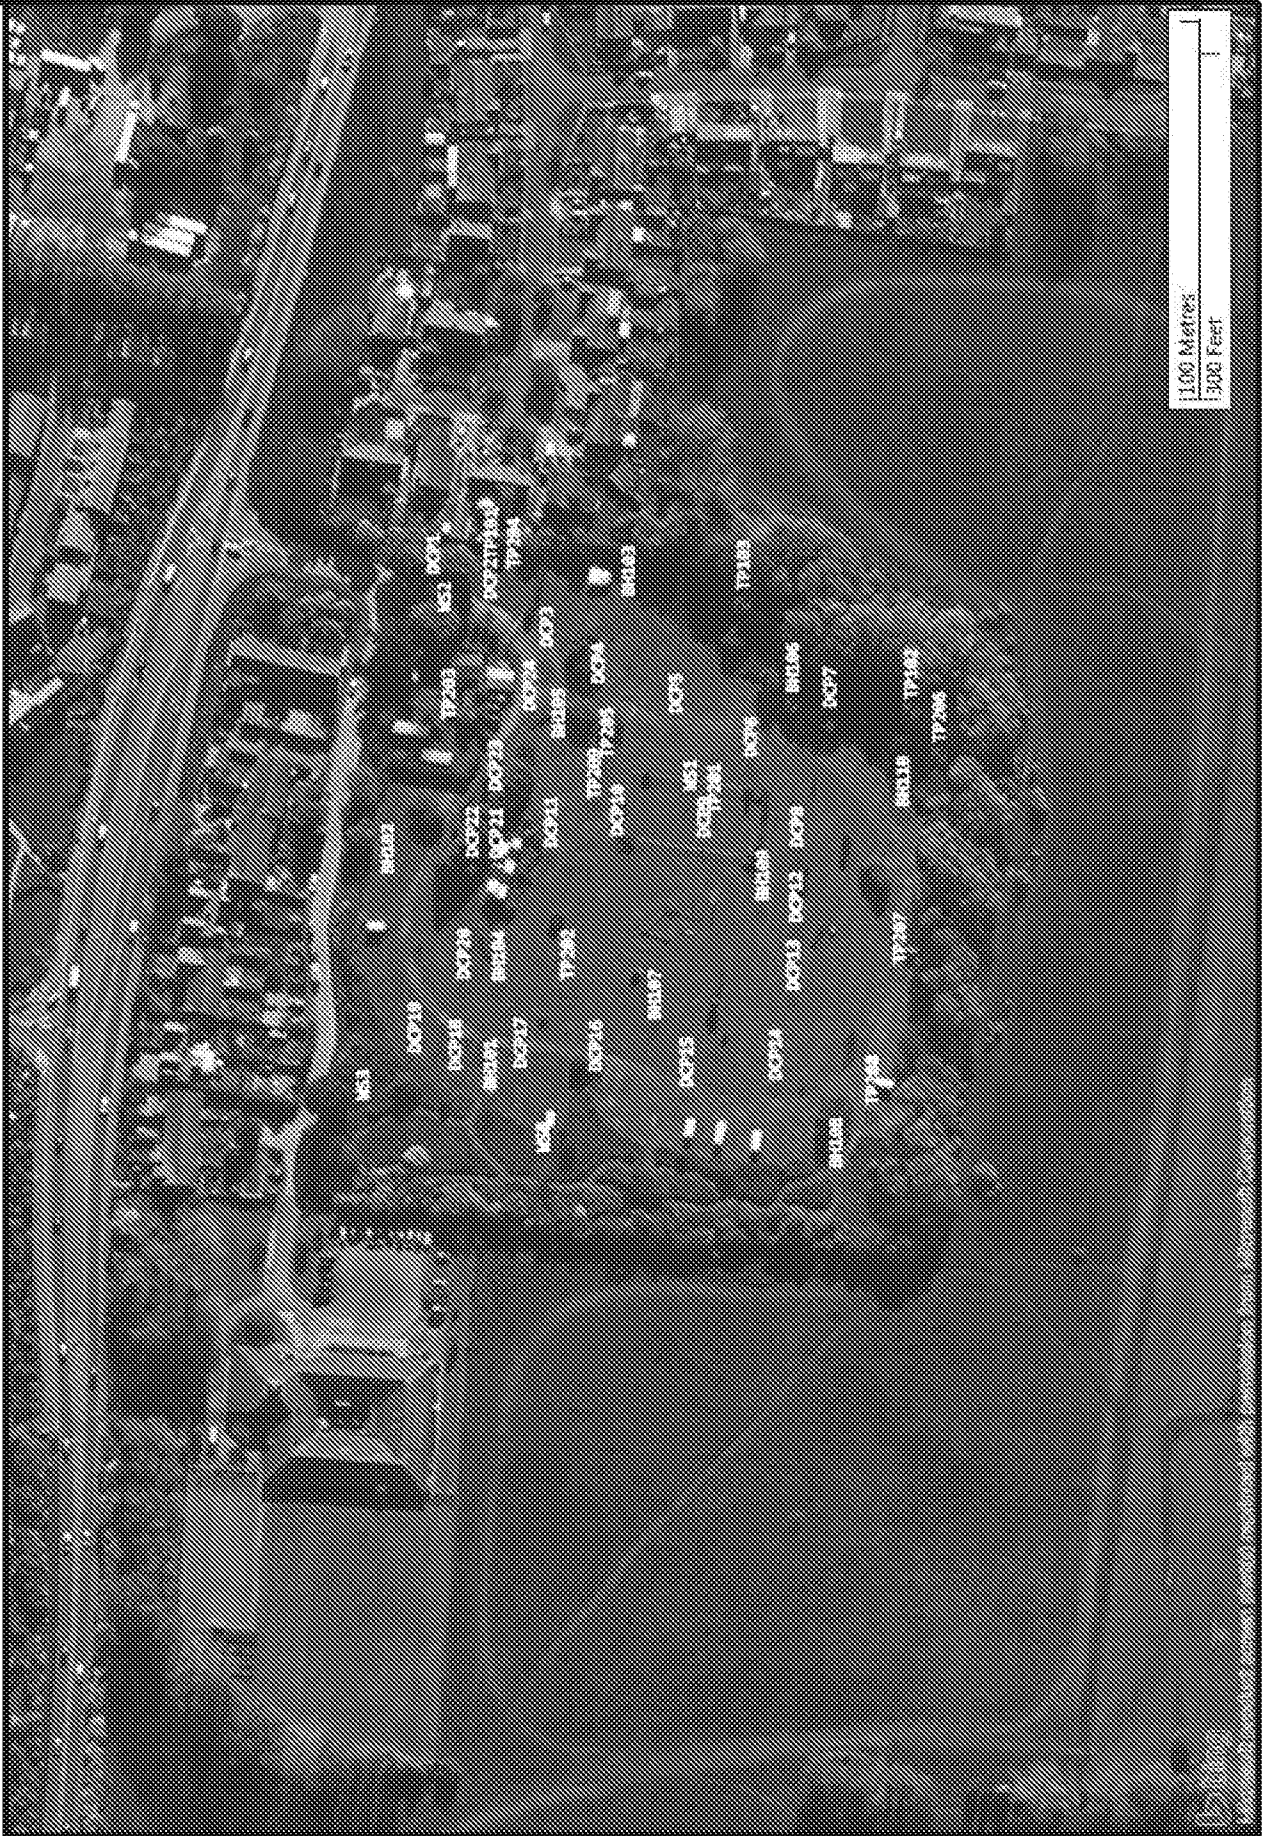
**Title :** Figure 2 - Exploratory Hole Location Plan  
**Scale:** 1:2000  
**Engineer:** Anthony

- Legend Key
- Locations By Type - Empty
  - Locations By Type - CP
  - Locations By Type - TP
  - Locations By Type - WLS
  - Locations By Type - DGP
