# Former Waitrose, Avon Road, Littlehampton, West Sussex

Bat Survey

December 2018

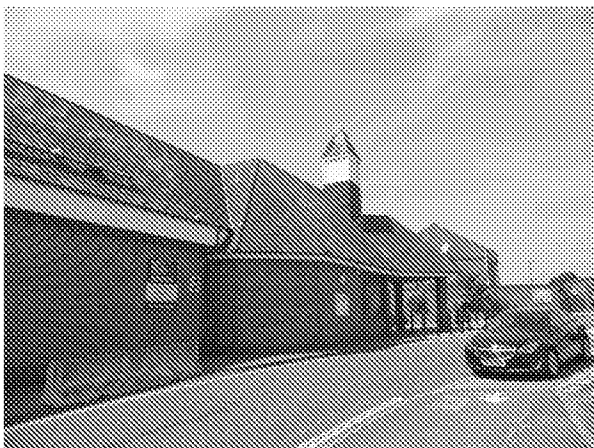
Exterior view north elevation

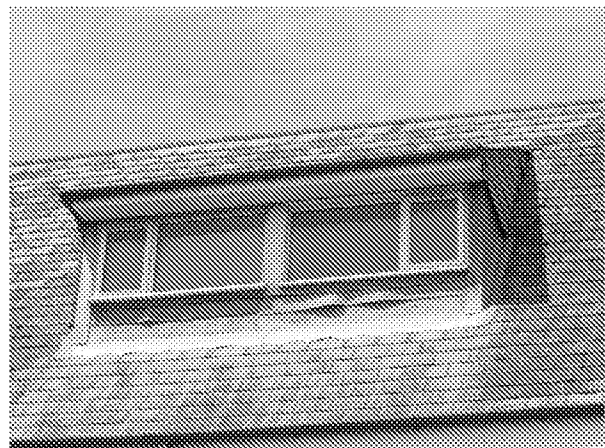
- ❖ Gaps present beneath lead flashing around the windows;
  - ❖ A missing section of fascia board providing an access point into the soffit box at the south-west corner of the building; and

Lifted lead flashing around windows

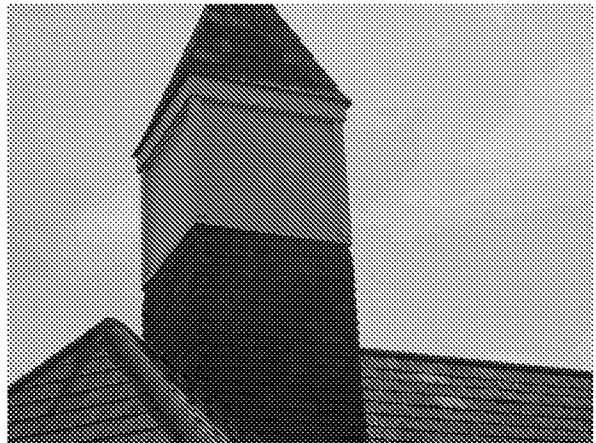
- ❖ Several raised/missing tiles on the hipped roof pitches recorded on the south and western aspects.

Clock tower, western aspect, missing/slipped hanging tiles

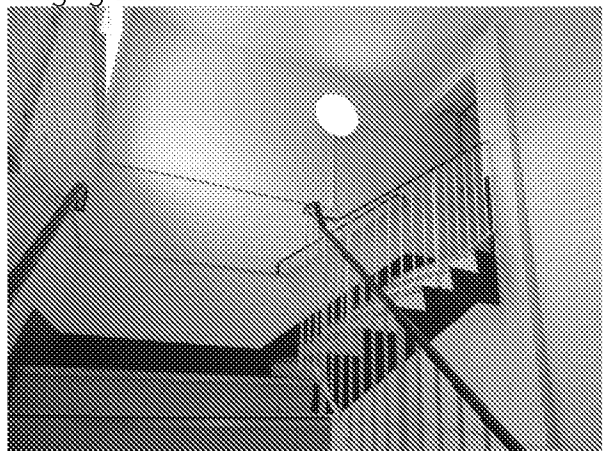
Connecting stairwell

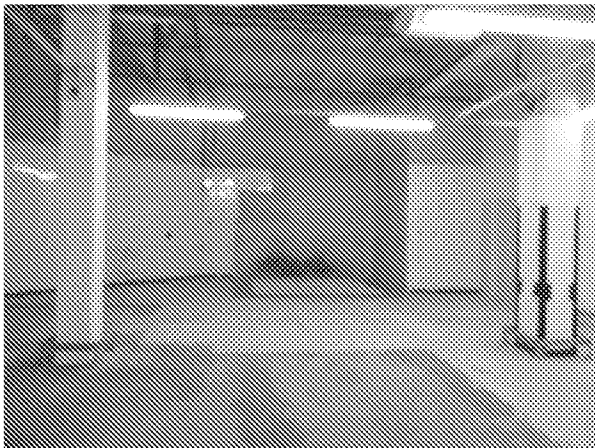
- 4.2.13 The first floor predominantly consisted of a large open main storage room. The room had a corrugated metal ceiling, concrete floor and a mix of tile, plasterboard and brick walls. The construction was sound and provided no potential roosting features for bats. No evidence of roosting bats was found within this room.
- 4.2.14 The remainder of the upper floor was made up of a number of interconnected rooms, including cleaning stores, offices, corridors, and a CCTV room. These areas were located behind closed doors, they had a mixture of concrete and carpeted floors, painted brick walls, and suspended ceilings. No evidence of roosting bats was found within any of these spaces.

Upper floor, main internal storage room

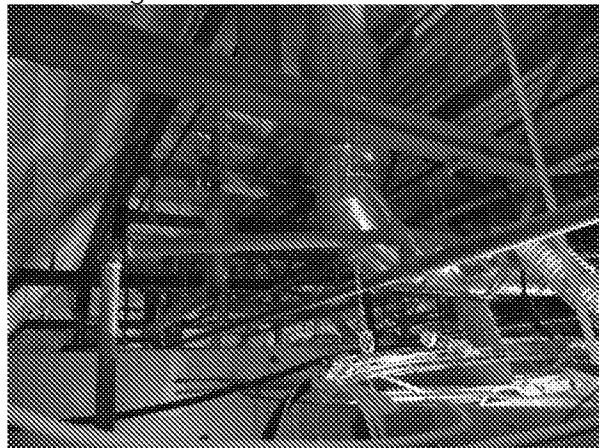
- 4.2.15 Two roof voids were accessed during the assessment. The void within the clock tower was not accessible. Roof void 1 was a large space, covering most of the western section of the building, and was approximately c.2m in height. It was accessed from three locations on the ground floor in the western section of the building via broken/removed tiles in the suspended ceiling. The void had a flat metal corrugated roof. No lining was present and there was considerable pipe work and many steel joists present within the void, making it heavily cluttered and unsuitable for species which prefer internal flight space. There was no observable evidence of bats within this roof void.

Roof void 1, very cluttered

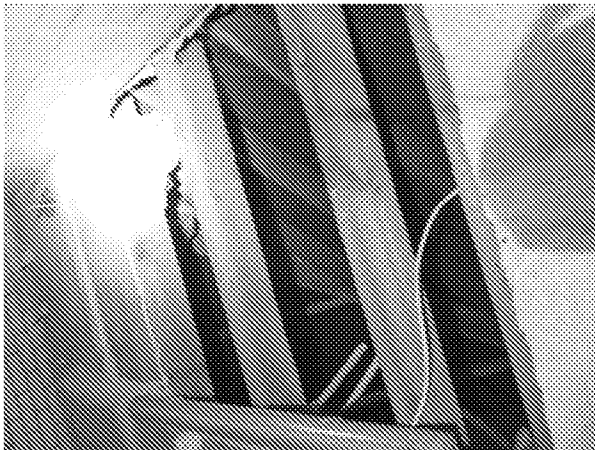
Roof void 2, rough timbers

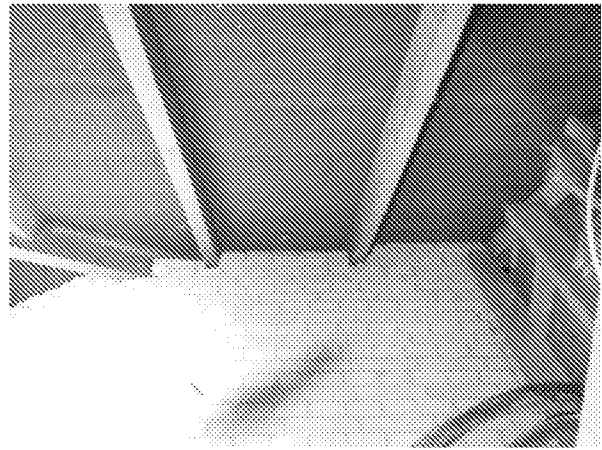
Roof void 2, lining
