## Street Frontage Analysis

## Roof Typology

Opportunities & Constraints

## 3D Site Analysis

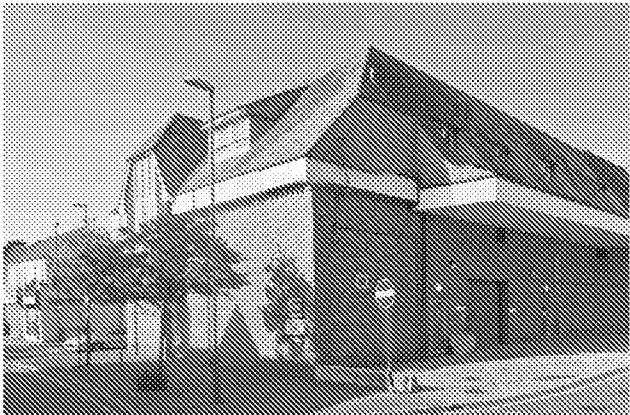
Example of an existing weak street frontage that does not positively respond to the East Street Conservation Area.

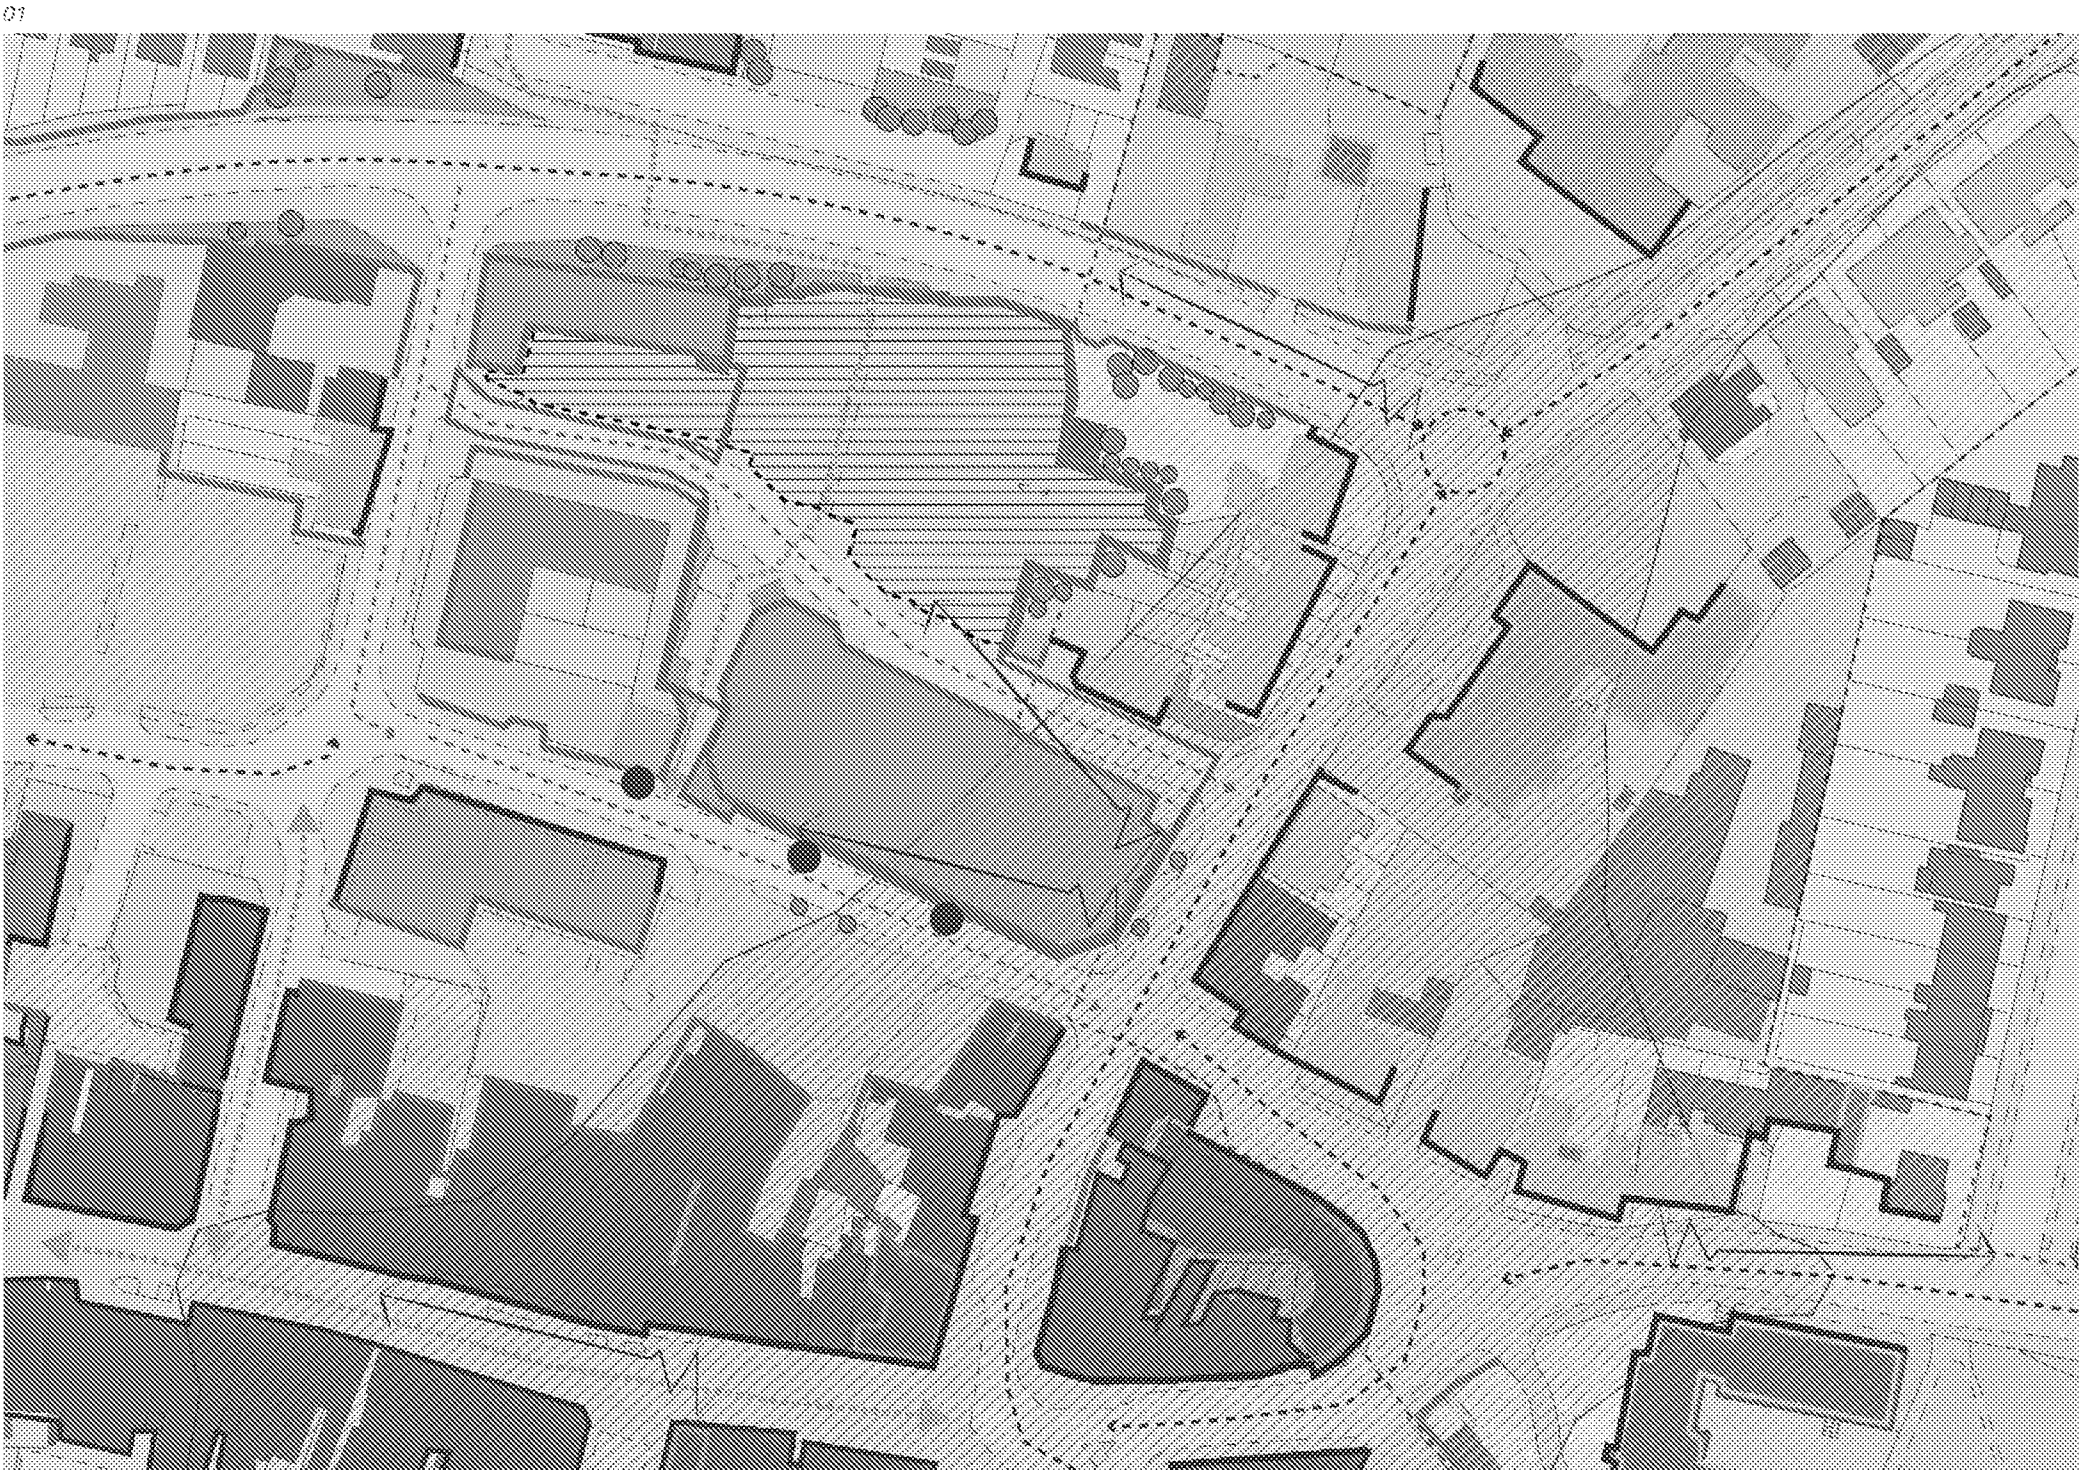
01  
Location Plan. Constraints Diagram.

- Proposal kept below existing building heights
- The South East of the site sits in a Flood Zone 3 area.
- The site has a 1.8m level change.
- Careful consideration of the local context and adjacent properties.
- Noise pollution from the bus stops on Anchor Springs.
- Public footpath to running alongside the West frontage of existing Waitrose and across the car park.

- Replace the disused Waitrose with high quality and thoughtful residential units.
- Provide a quality space to enhance the community.
- To provide a new public realm and improve the existing public footpath.
- Design a rich and engaging landscape which will enhance the local ecology.
- Use local materials to enhance the character of the town centre.
