**CONTRACT NO. E13353/1**

**PRELIMINARY RISK ASSESSMENT REPORT**  
**FOR A PROPOSED UNIT AT RIVERSIDE**  
**INDUSTRIAL ESTATE, LITTLEHAMPTON**

**Prepared by**  
**DTS Raeburn Limited**

# **PRELIMINARY RISK ASSESSMENT REPORT FOR A PROPOSED UNIT AT RIVERSIDE INDUSTRIAL ESTATE, LITTLEHAMPTON**

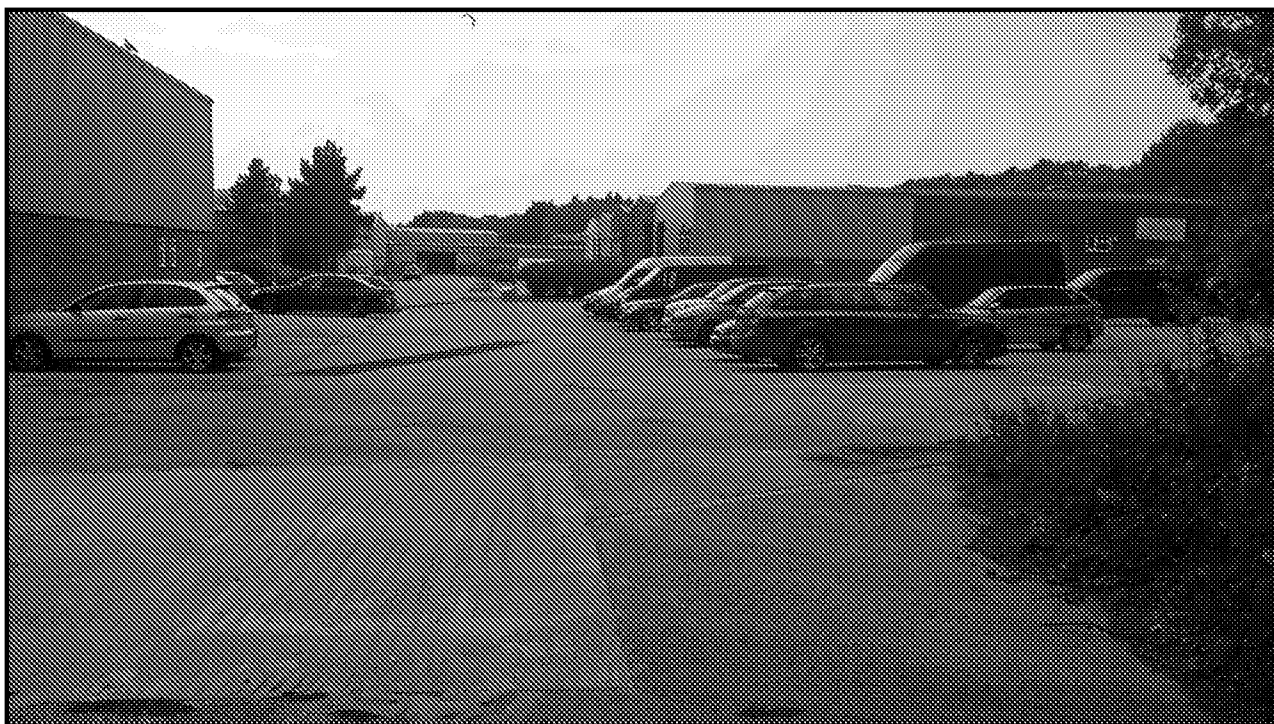
The site is roughly triangular in shape and covers an area of about 0.13 hectares. It is generally flat and largely occupied by a concrete surfaced car park used by the neighbouring industrial units. The surface of the concrete was in poor condition in some areas with evidence of repair work.

Plate 1: View south across car park

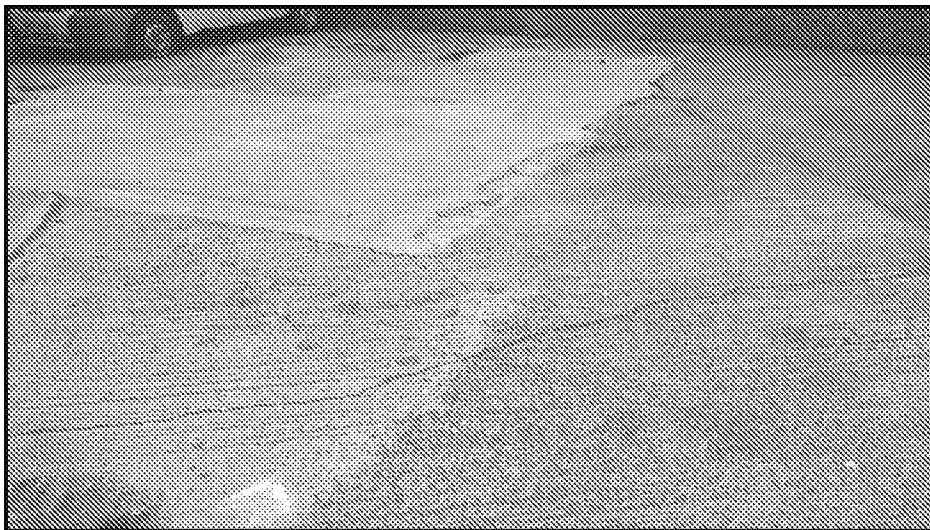
**Plate 4:**  
**Poor condition surface concrete**

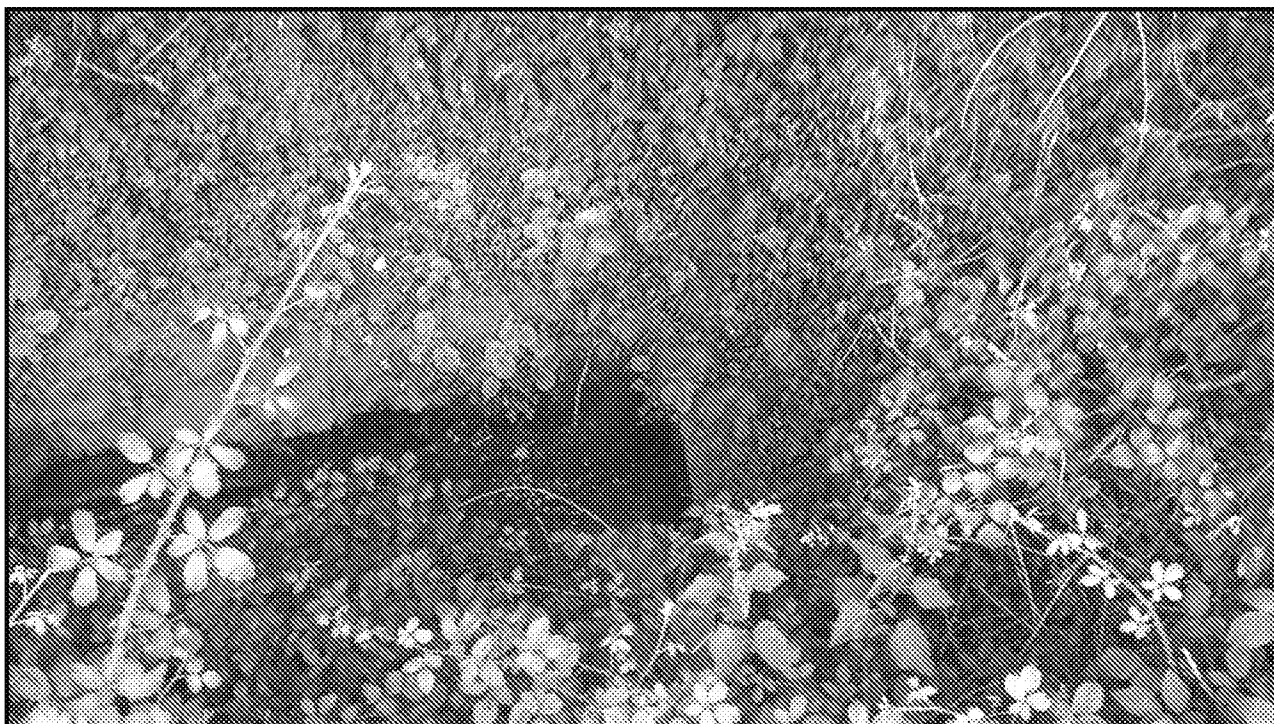
The eastern boundary of the site is formed by an industrial unit approximately 6m in height. The site is bounded to the north-west by an area of landscaping with a drainage ditch about 1m lower than the site (dry during the site walkover in June 2020). Beyond the drainage ditch there is an embankment within the landscaping that rises to Bridge Road, situated about 2-3m above the site level. A number of mature deciduous trees were observed within the landscaping (over 15m in height), and there were a few areas of fly tipping.

The nearest surface water feature to the site is a drainage ditch located adjacent the northwest boundary. This flows into the River Arun about 250m to the south.

**Plate 5: Drainage ditch along north western boundary**
