**CHURCHILL RETIREMENT LIVING LIMITED**

**38 & 40 EAST STREET & 35 FITZALAN ROAD, LITTLEHAMPTON, WEST SUSSEX,  
BN17 6AN**

**GROUND INVESTIGATION REPORT**

March 2017  
Report No. CCL02814.CD22

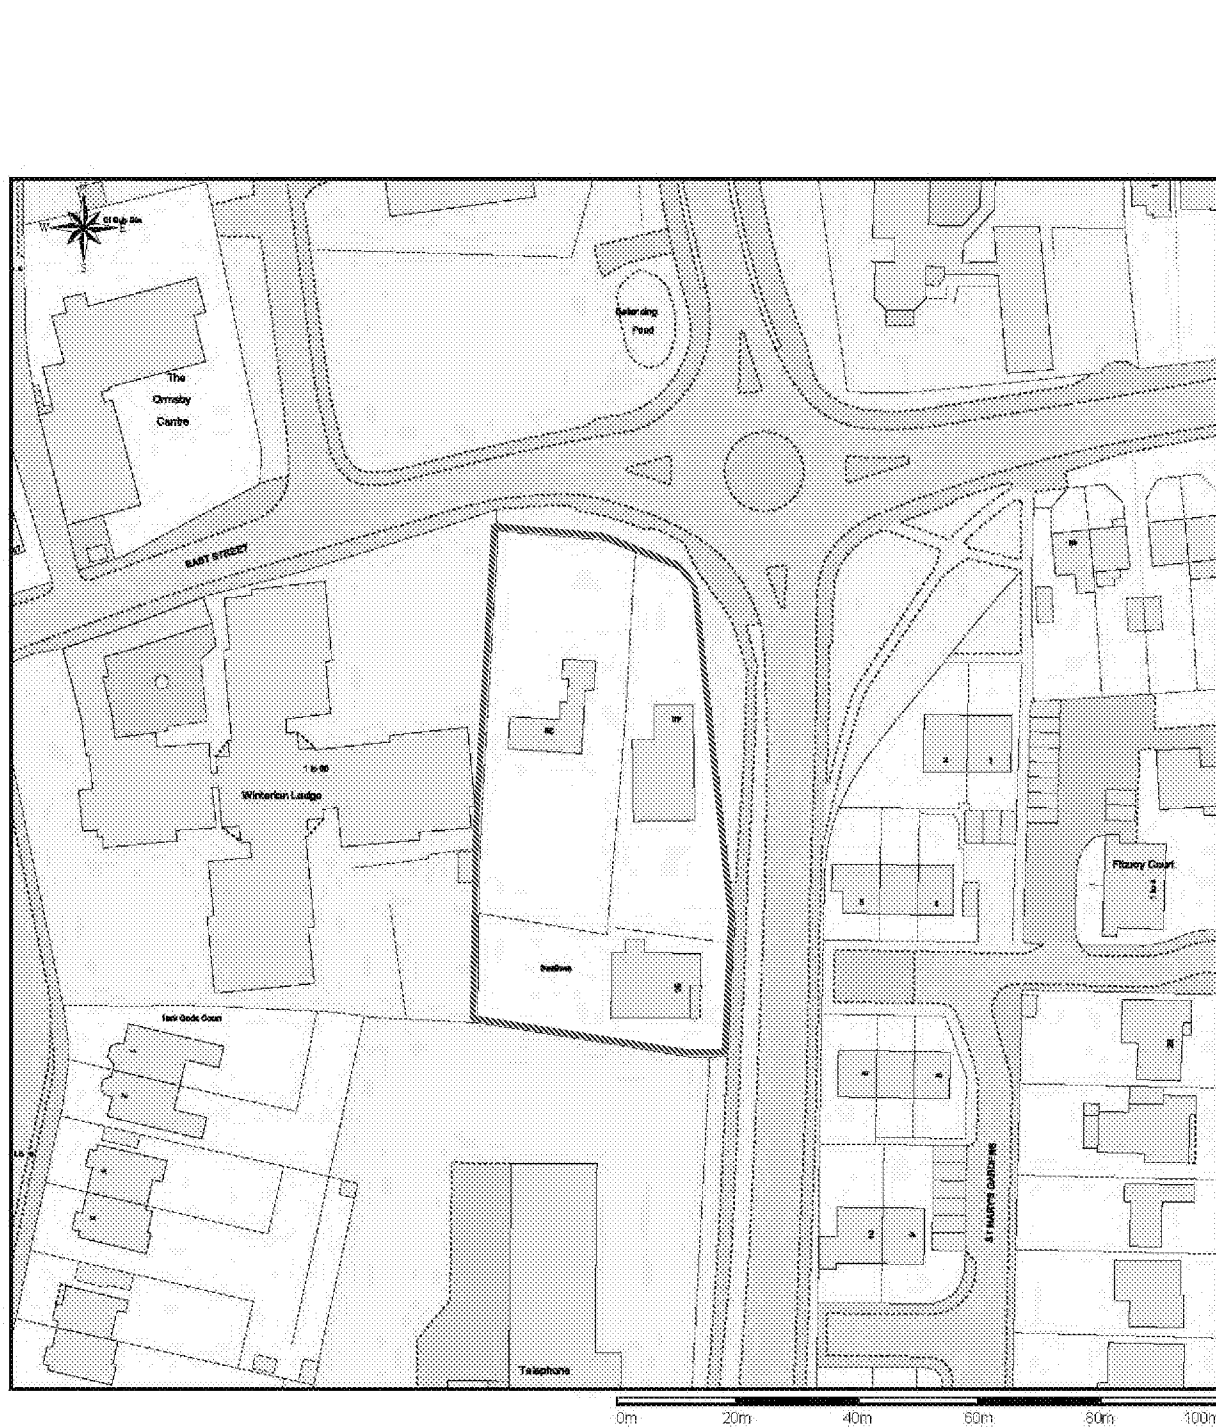
FIGURE 2

**SITE PLAN**

Scale 1:1250

The site is located to the south of East Street and the west of Fitzalan Road, and on the eastern edge of Littlehampton town centre, as shown on Figure 1. The National Grid Reference for the site is TQ 3193 2291. A site plan is provided as Figure 2. The plan indicates that the site is bounded by East Street to the north, Fitzalan Road to the east, a commercial property (possibly associated with a telephone exchange) to the south and an apartment block referred to as Winterton Lodge to the west.

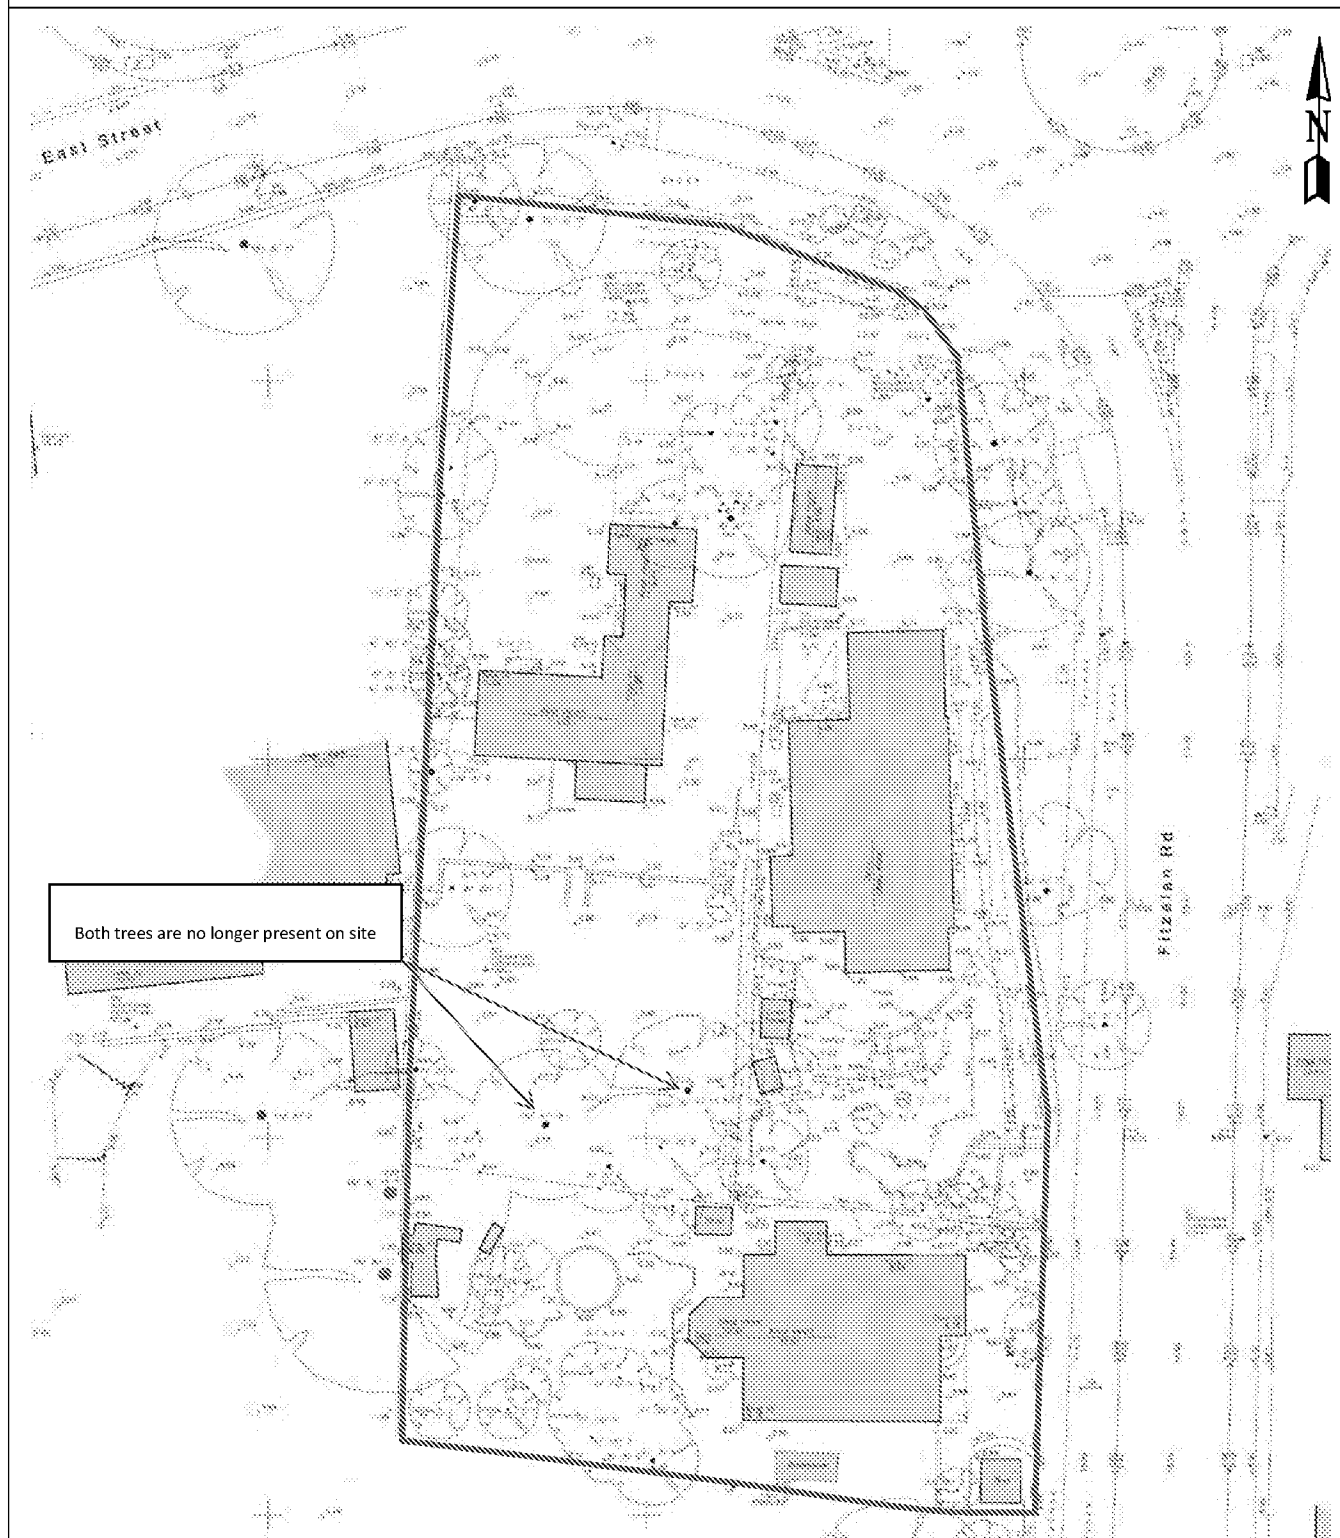
FIGURE 3

**TOPOGRAPHICAL SURVEY PLAN**

Reproduced from the January 2016 1:200 scale Drawing No. SU-01 produced by D&H Surveys

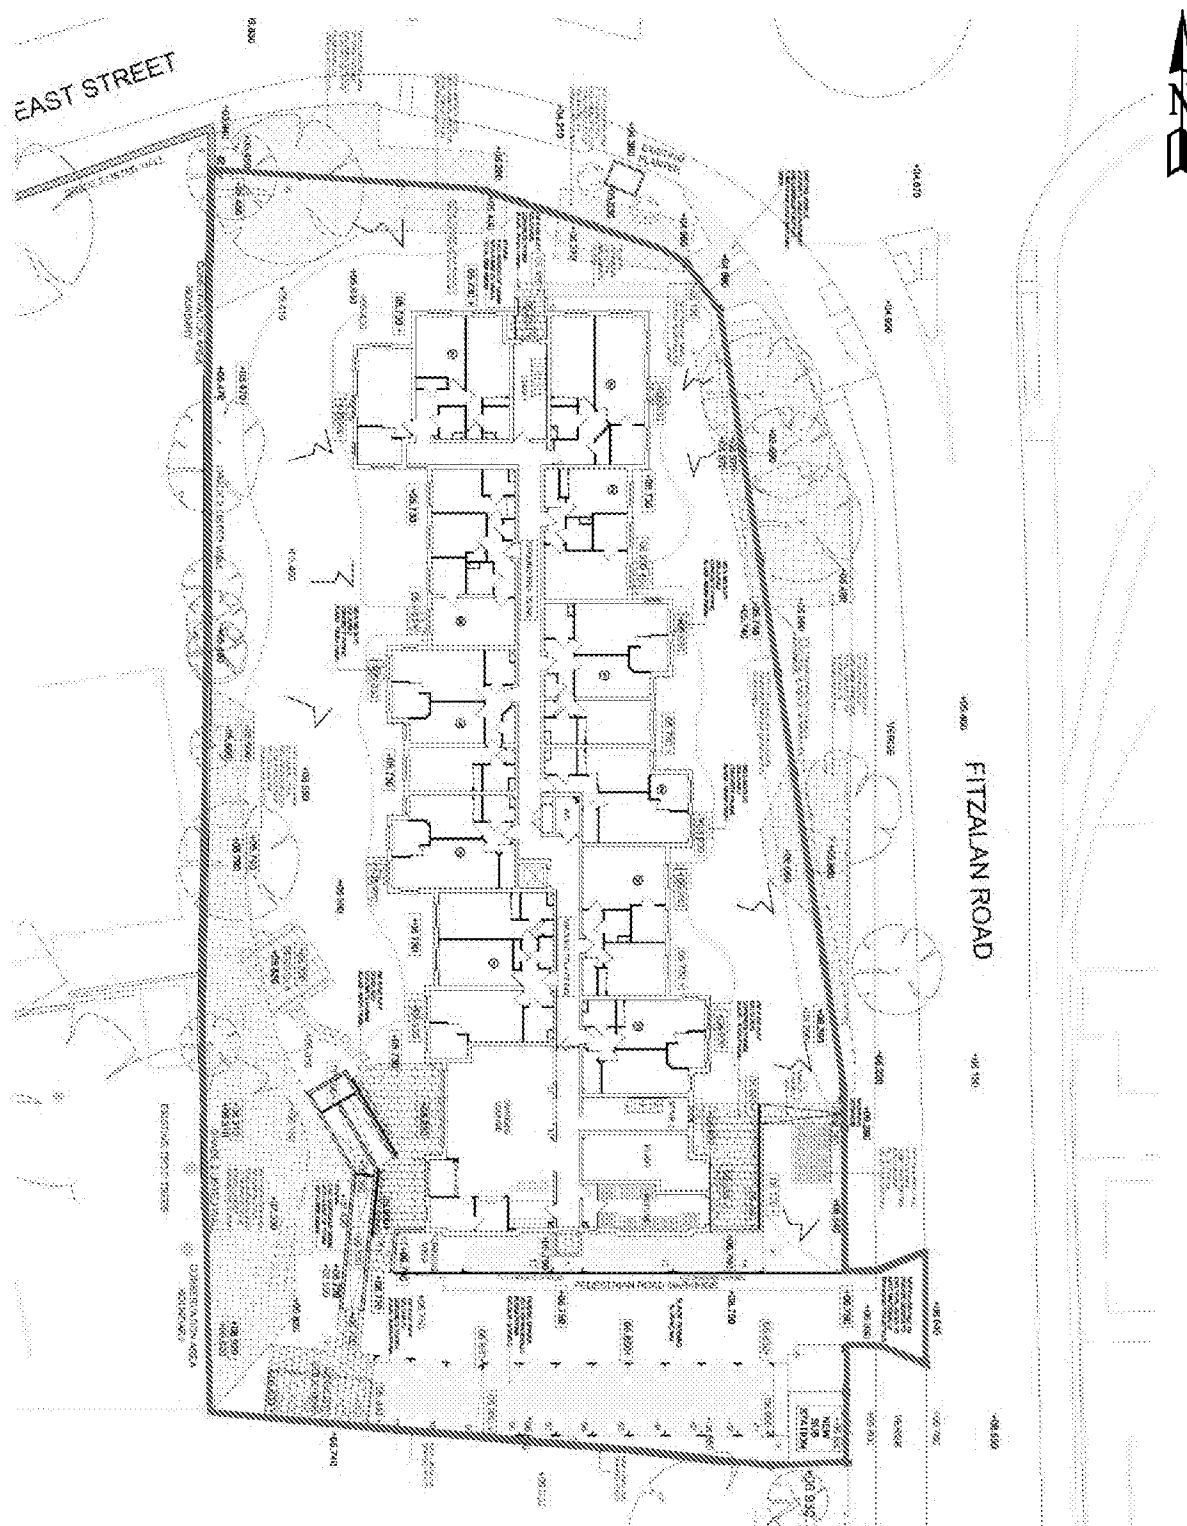
FIGURE 4

**PROPOSED DEVELOPMENT PLAN**

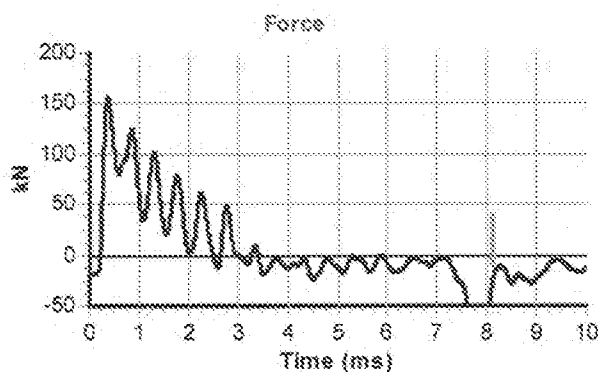
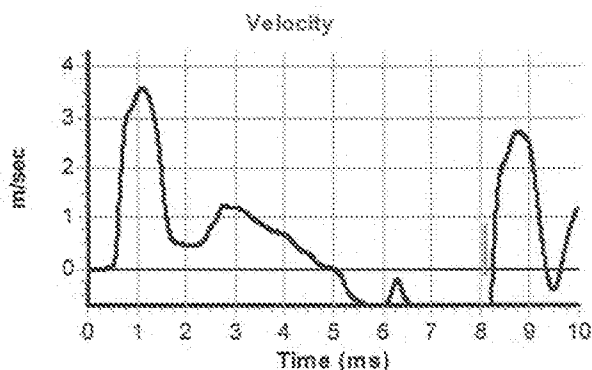
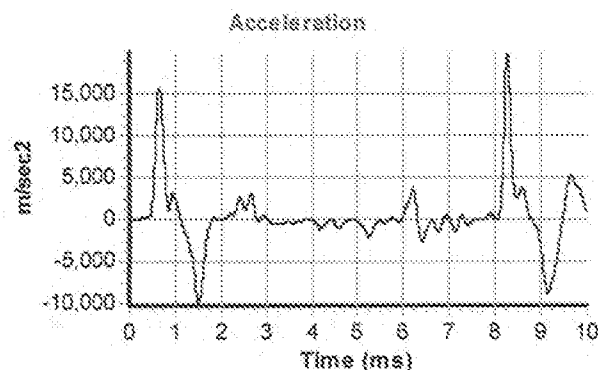
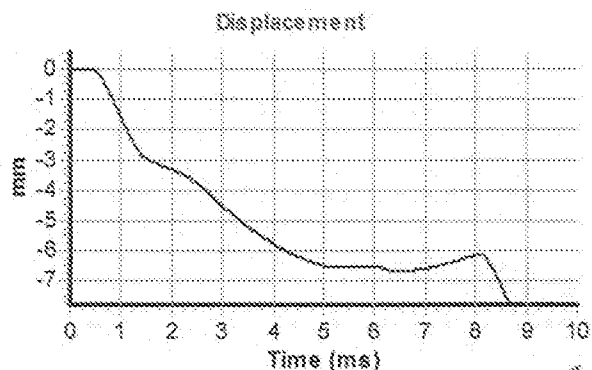
Hammer tested at Dynamic samplings yard.

Area of Rod A ( $\text{mm}^2$ ): 1021  
Theoretical Energy  $E_{\text{theor}}$  (J): 473  
Measured Energy  $E_{\text{meas}}$  (J): 346

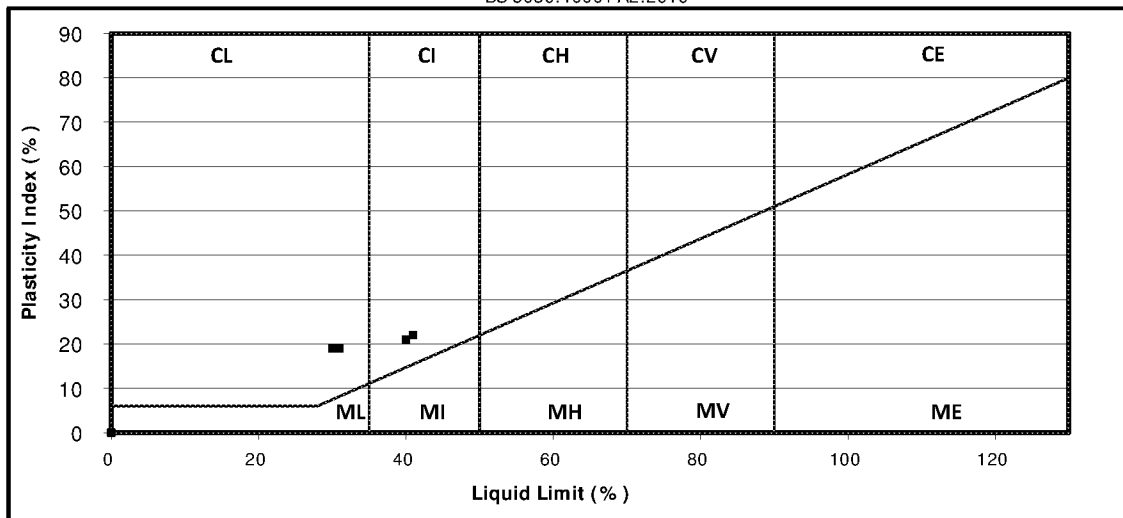
**Symbols:** NP : Non Plastic # : Liquid Limit and Plastic Limit Wet Sieved  
PLASTICITY CHART FOR CASAGRANDE CLASSIFICATION.  
BS 5930:1999+ A2:2010

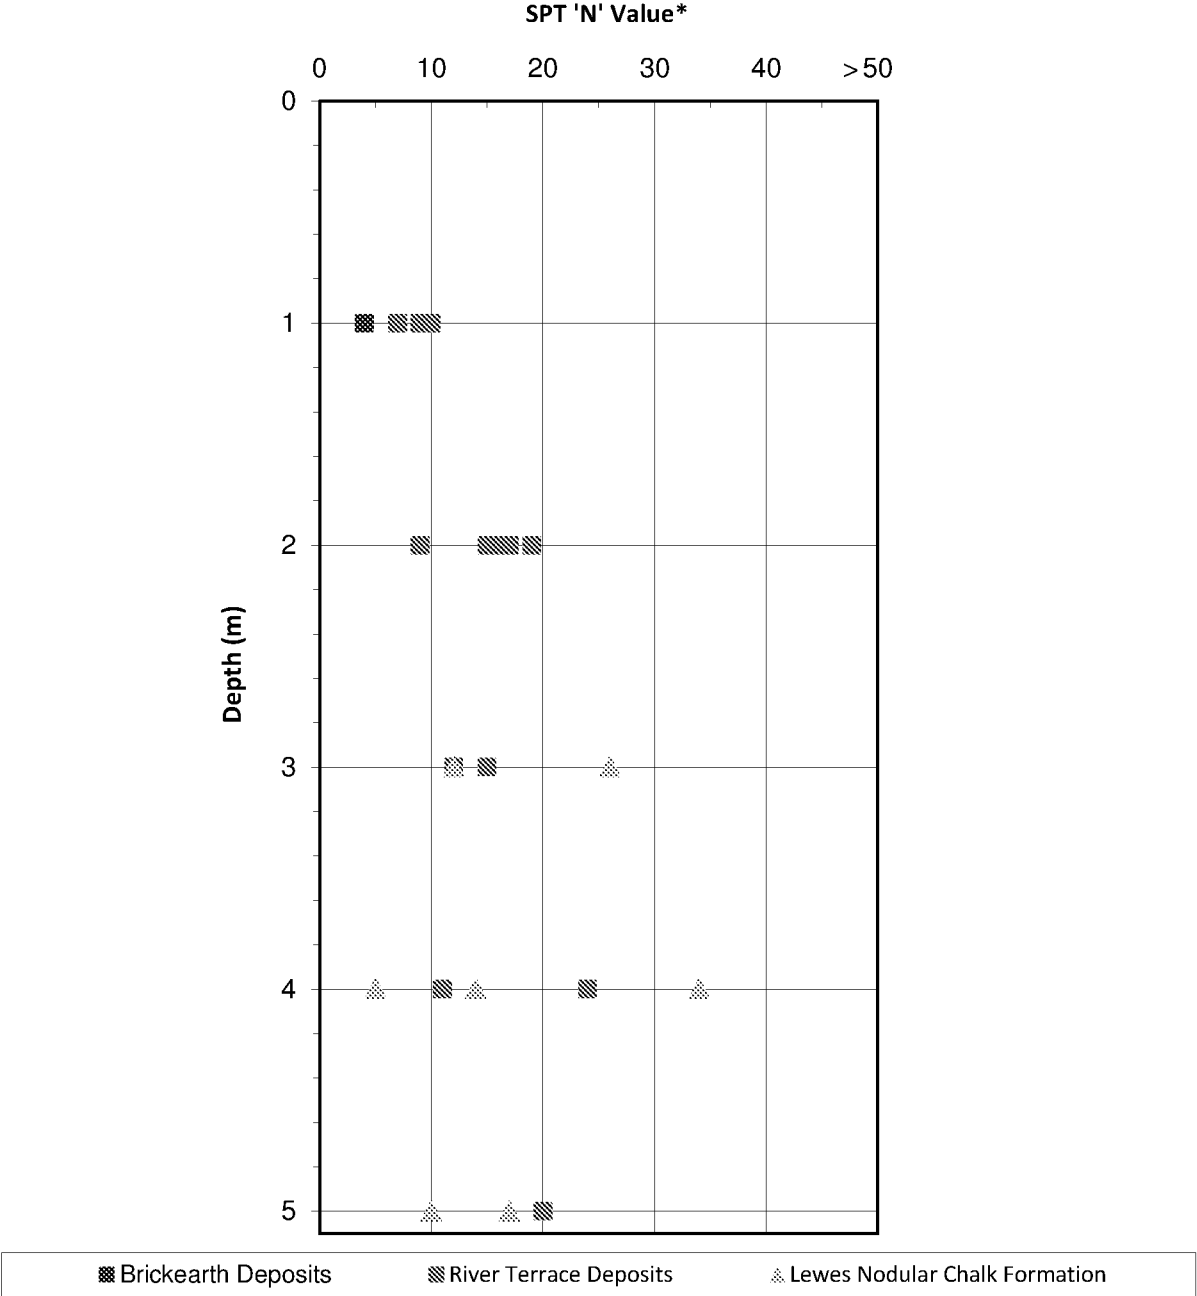
FIGURE I-1

\*SPT 'N' values are uncorrected

SPT 'N' VALUE PROFILE

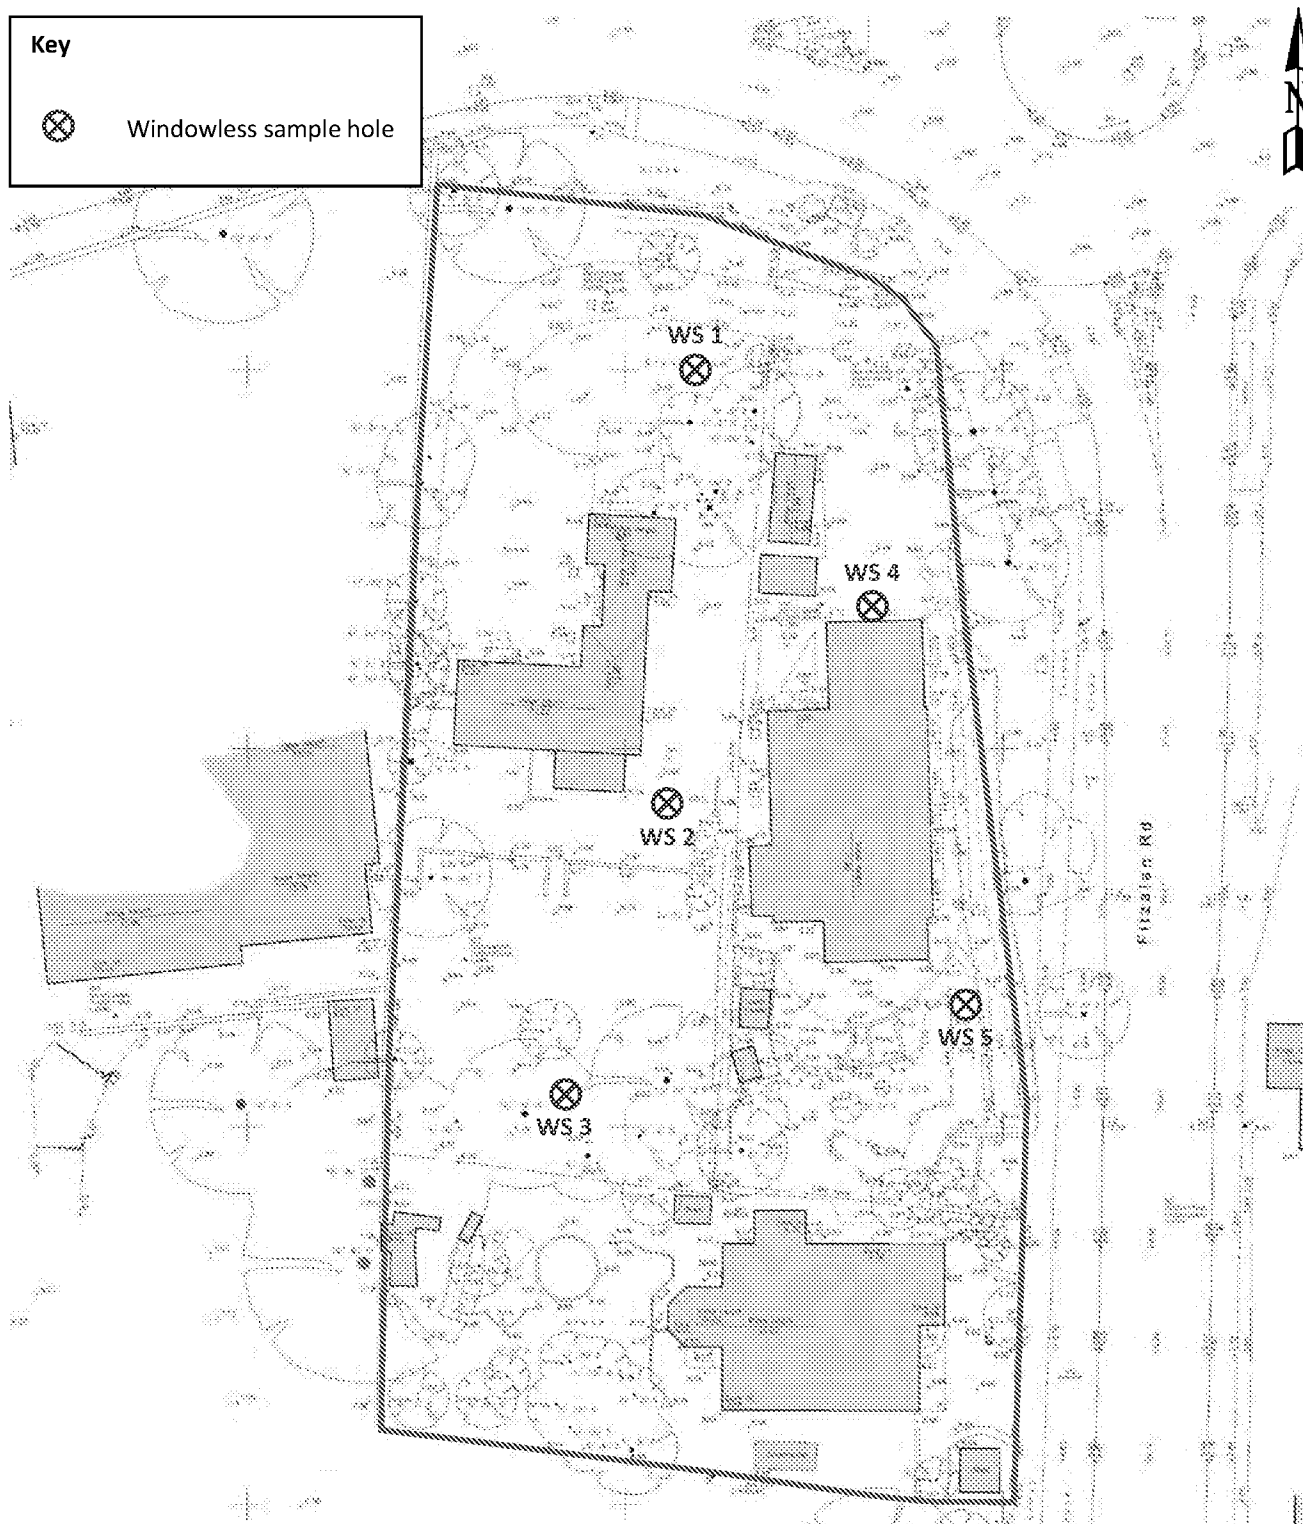
FIGURE I-2

**EXPLORATORY HOLE LOCATION PLAN**

| Exploratory Hole and Technique | Rationale for Hole Location | Depth (m) | Sampling/In Situ Testing and Monitoring |
|---|---|---|---|
| WS1 – WS5 | Exploratory holes located within or close to the proximity of the footprint of the proposed building to provide information on foundations, assess potential contamination to soils and provide information of groundwater levels. | 5.0 m | Representative Made Ground samples recovered for analytical testing<br><br>Samples of potential founding strata recovered for geotechnical testing<br><br>Standard Penetration Tests undertaken at selected depth intervals<br><br>In-situ hand shear vane tests were undertaken to provide undrained shear strength data of fine grained strata |
