Geoenvironmental Report

Waitrose, Littlehampton

SHF.1995.004.GE.R.001.C

Project:	Waitrose Littlehampton
For:	Cummings Group Limited
Status:	Rev C
Date:	August 2024
Author:	Nigel Ramsumair - <i>MGeo (Hons.)</i> , Principal Geo-Environmental Engineer
Review	Reuben Fisher - <i>BSc (Hons.), MSc, FGS</i> , Geo-Environmental Consultant Engineer

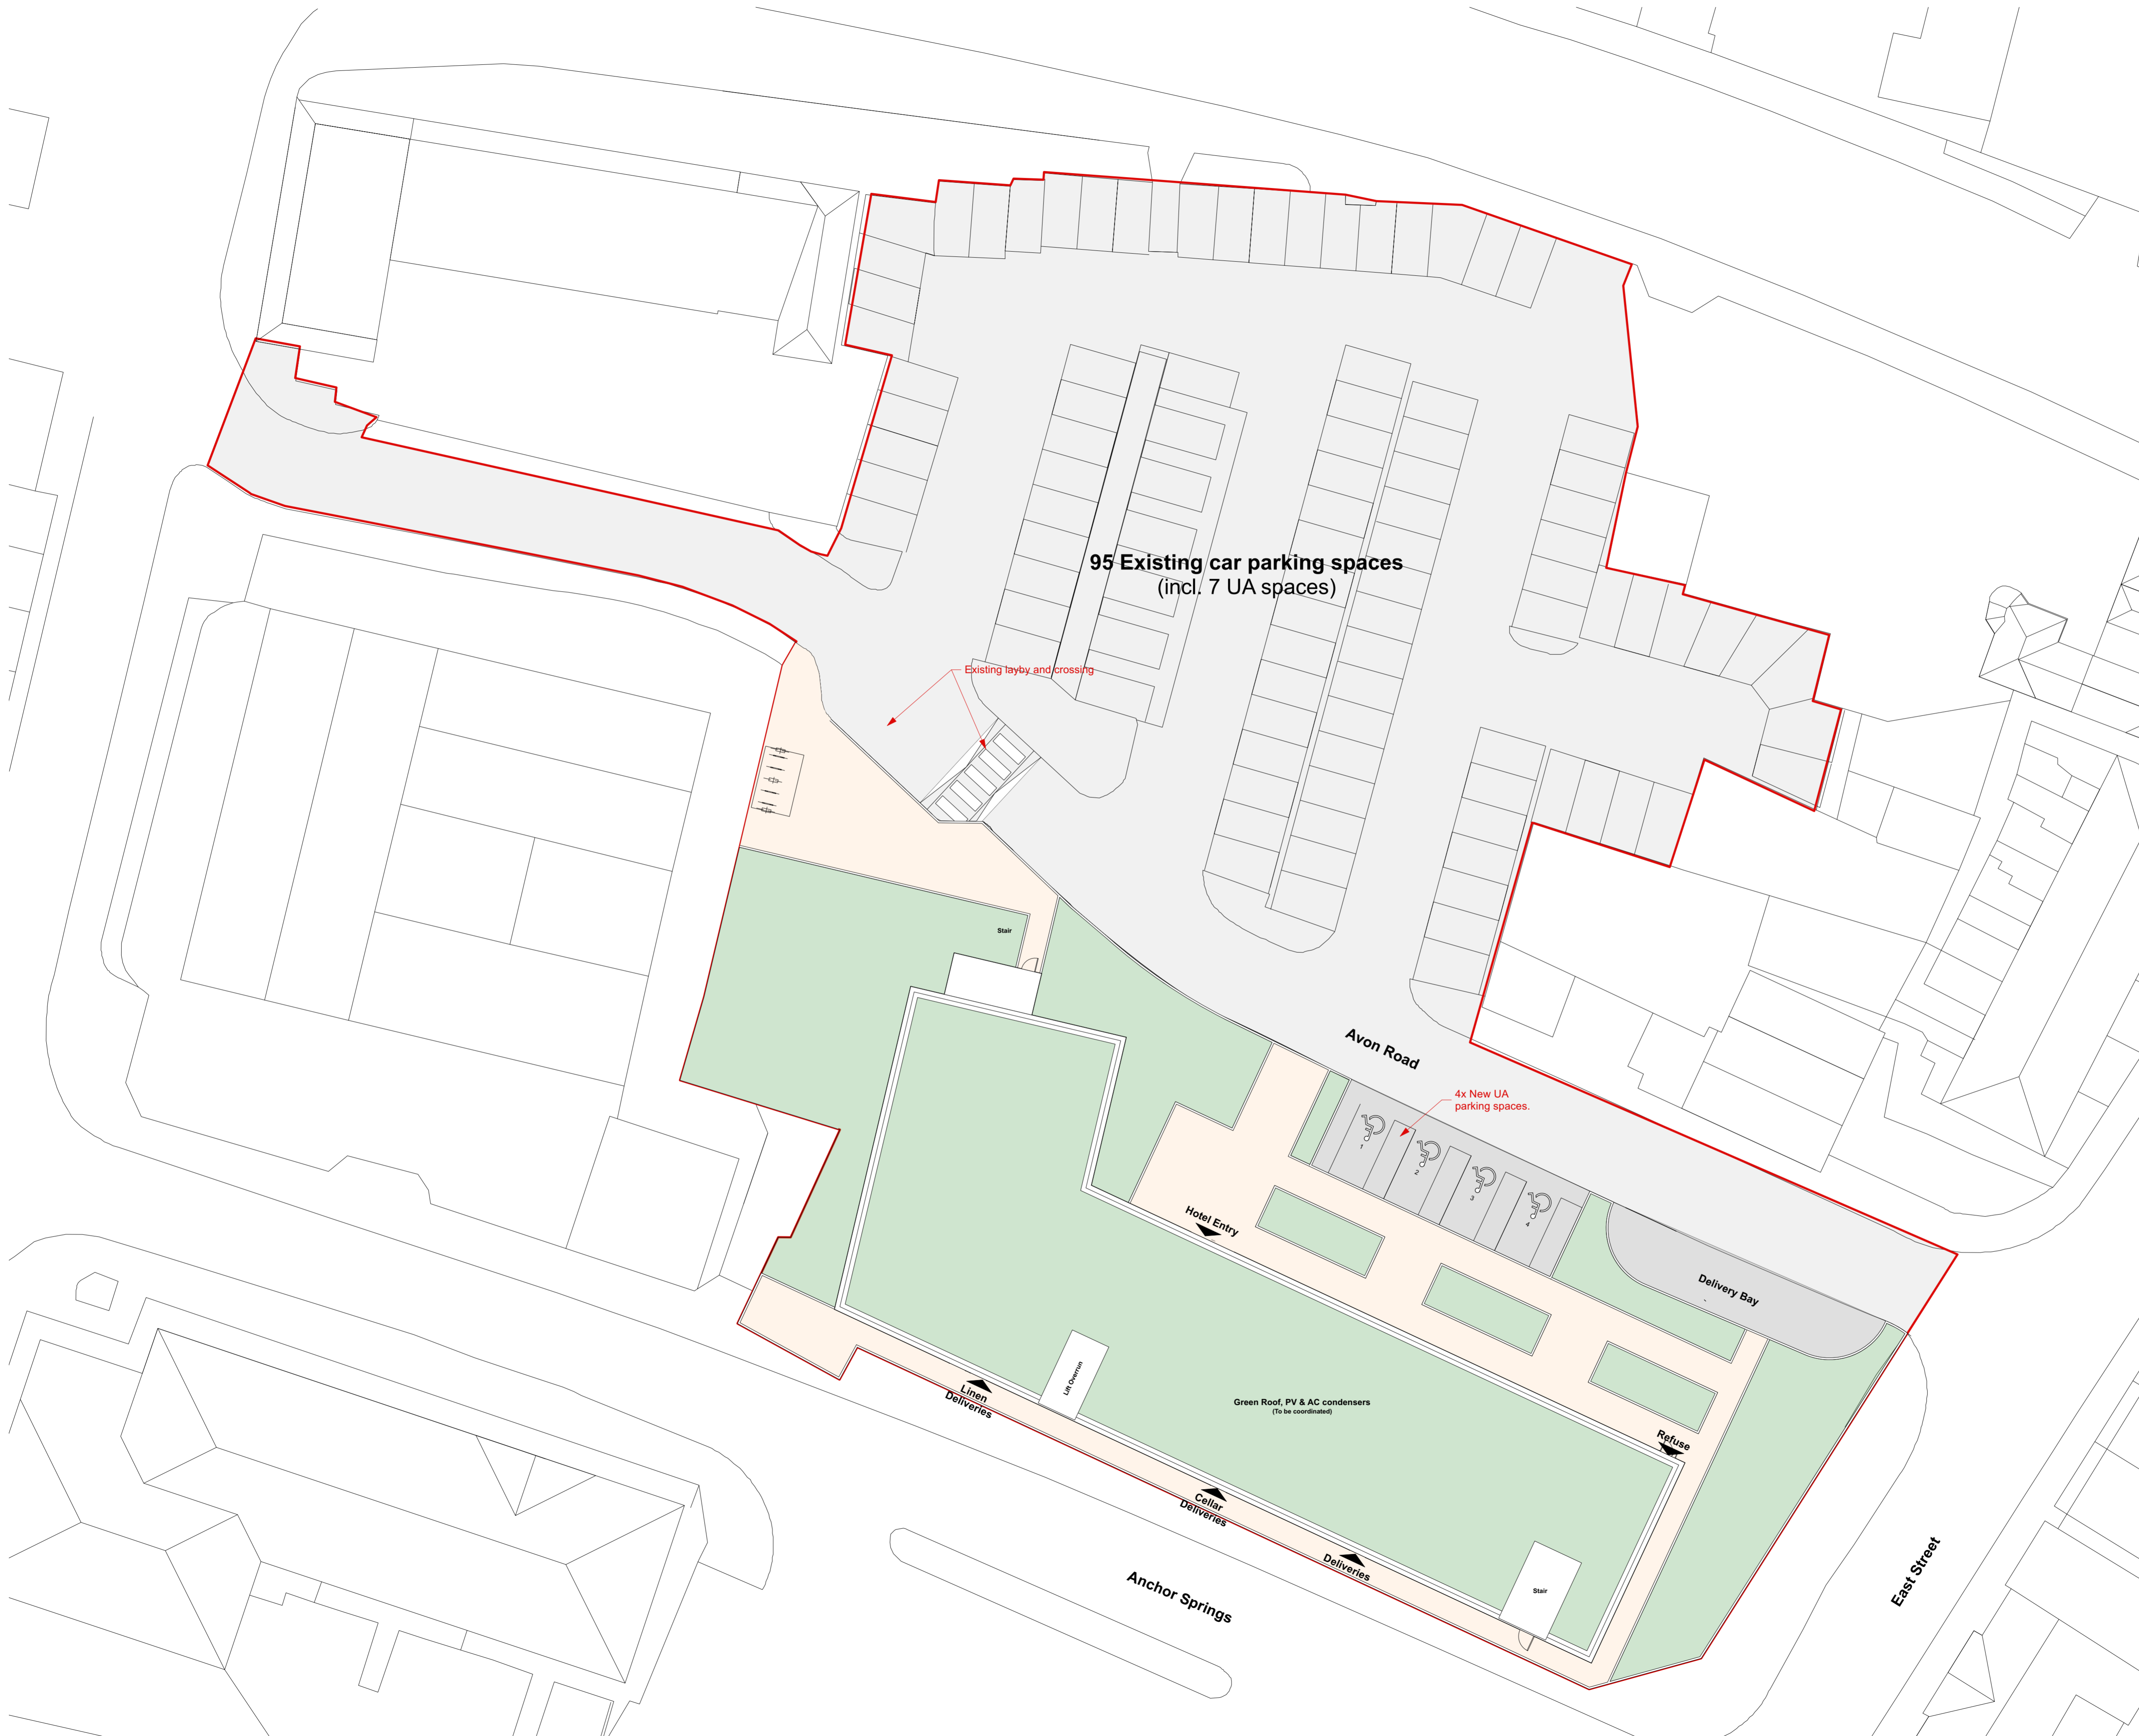
Drawing No. **6122-F2-002** Revision **F**

Site boundary ———
 105 Total Parking spaces

95 Existing car parking spaces
 (incl. 7 UA spaces)

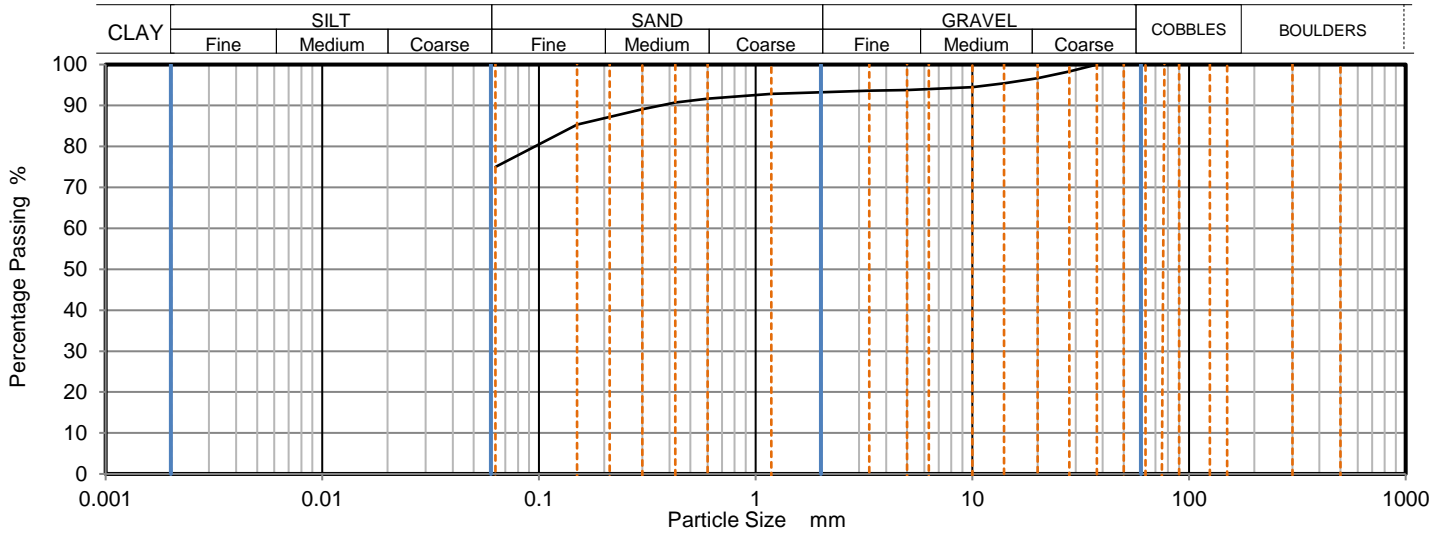
Depth Top [m]: 2.00
Depth Base [m]: Not Given
Sample Type: B

Laboratory Reference: 245965
Hole No.: TP2
Sample Reference: Not Given
Sample Description: Yellowish brown slightly gravelly slightly sandy CLAY
Sample Preparation: Sample was quartered, oven dried at 108.9 °C and broken down by hand.

Sample Proportions	% dry mass
Very coarse	0.00
Gravel	7.00
Sand	18.00
Fines <0.063 mm	75.00
