**Preliminary Ecological Appraisal
and Biodiversity Net Gain Assessment**

**Land at Former Westholme Nursery,
Littlehampton**

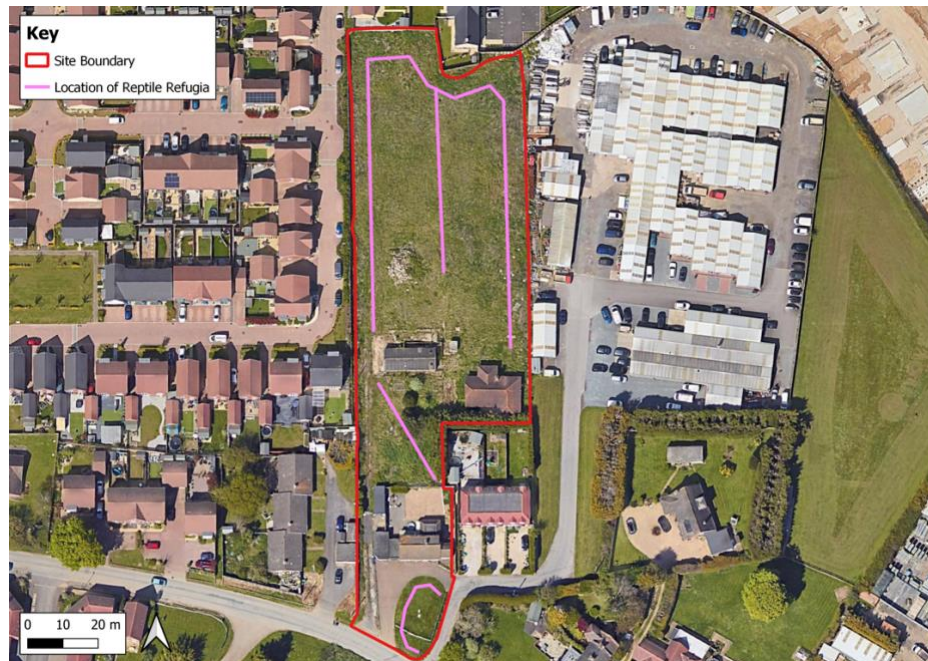
Figure 4: Artificial Refugia Locations

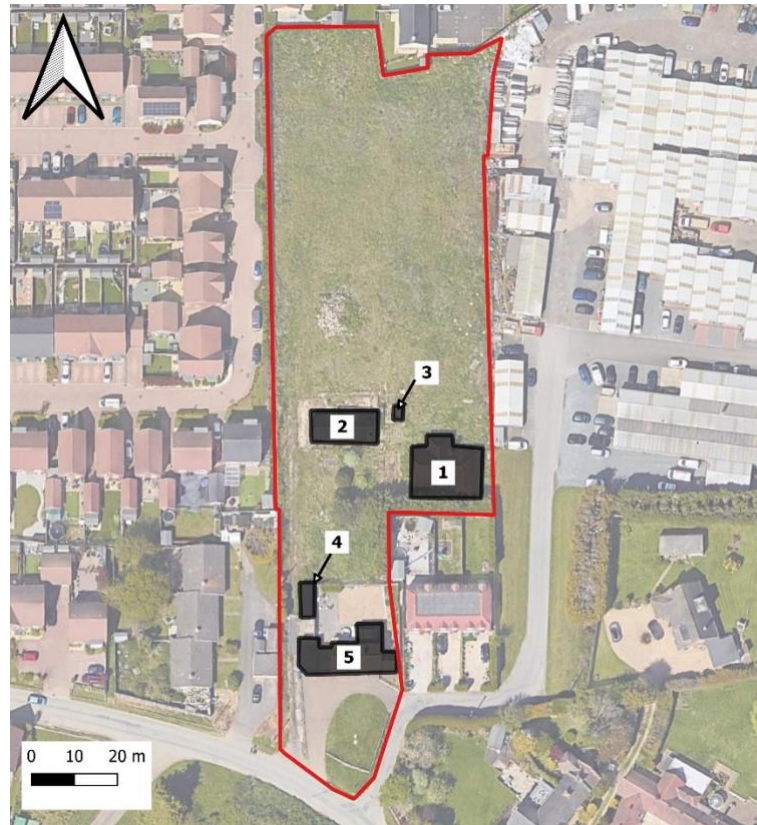
Figure 9: Buildings present within the site.

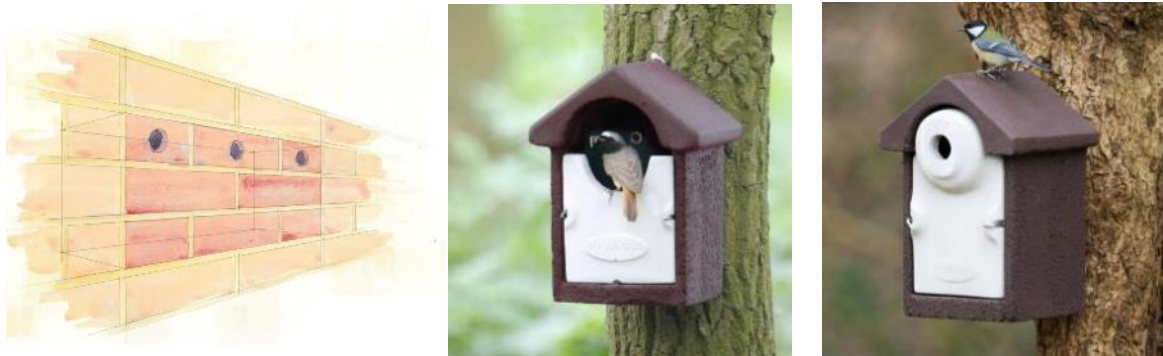
Figure 12: Examples of suitable bird boxes which could be installed on site – NHBS terraced sparrow box with custom brick facing (left), Vivara Pro Barcelona WoodStone Open Nest Box (centre) and Vivara Pro Seville 32mm WoodStone Nest Box (right)

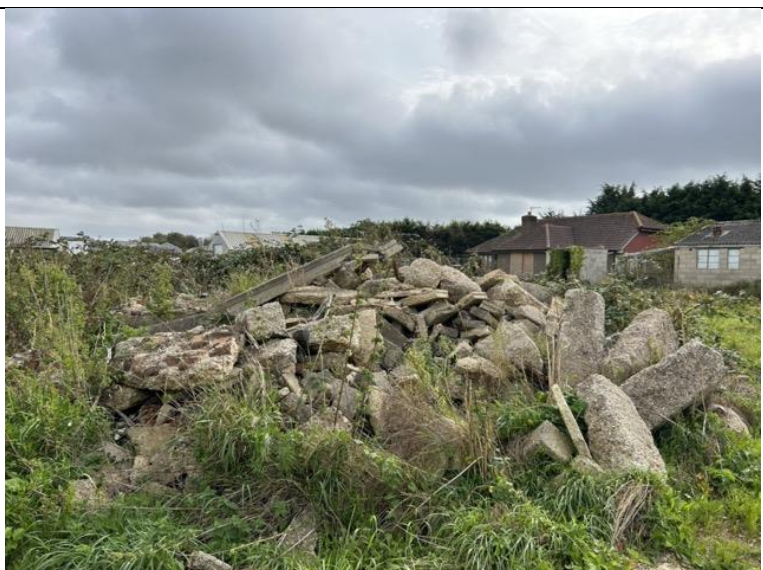
Appendix 4: Species List
