## Bat Emergence Survey EPSL required

Middleton House,  
Yapton Road,  
Middleton-on-Sea  
PO22 6DU

July 2018

Paul Diamond. Director.  
Ecological Surveys Ltd.

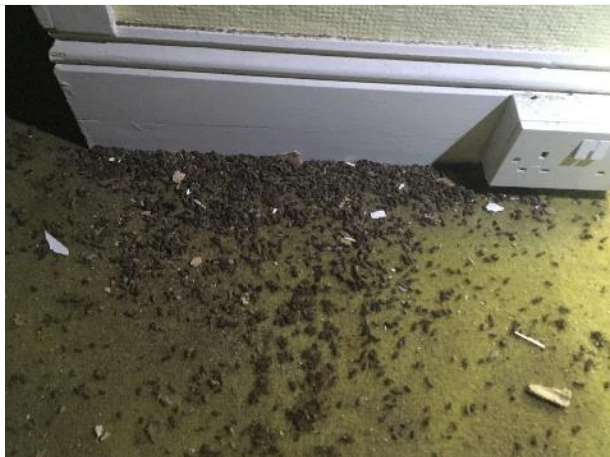
With reference to the initial IEBIBEAS report, the surveyors assessed the main house as having a confirmed bat roost, with 5 serotine bat droppings found in the main house and ingress points being noted along soffits. An outhouse was also identified as having low potential to support roosting bats, with warped weatherboarding on the eastern aspect of the structure. Further Bat Emergence Surveys were therefore recommended. The Bat Emergence Surveys found the main house to be a low value roost for serotine, brown long-eared, and common pipistrelle bats.

Serotine bat droppings present in the main house.

- Evidence indicates that the roosts present are maternity roosts for common pipistrelle and serotine bats. This is suggested by the number of common pipistrelles seen to emerge and the large number of serotine droppings present.

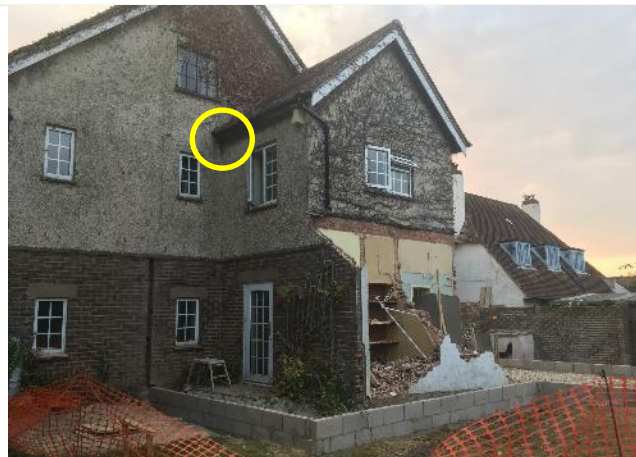
| <b>Summary of Bats Emerging: -</b> | Five common pipistrelle bats were seen to emerge from behind soffits on the southern aspect of the eastern extension of the main house. |

Location of bat emergence/re-entry.

The recorded access points must be retained. Consequently, any works to, or adjacent to, the

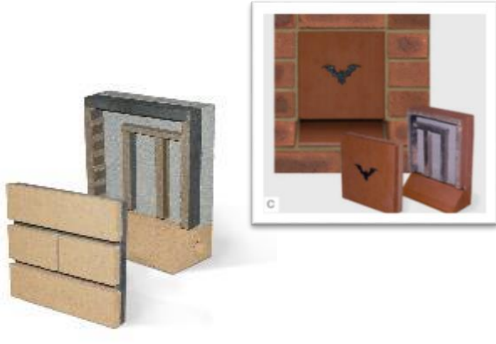
| <p>Half bat brick: Allows bats to create a natural home habitat within the cavity of the building<br/> <a href="http://www.ibstock.com/kevington/eco-products/">http://www.ibstock.com/kevington/eco-products/</a></p> | <p>Enclosed Bat Box suited to Pipistrelles<br/> <a href="http://www.ibstock.com/sustainability-ecozone.asp">http://www.ibstock.com/sustainability-ecozone.asp</a></p> | <p>Bat Access Slates<br/> <a href="https://www.nhbs.com/habibat-bat-access-slate">https://www.nhbs.com/habibat-bat-access-slate</a></p> | <p><a href="http://www.nhbs.com/title/158636/1ff-schwegler-bat-box-with-built-in-wooden-rear-panel">http://www.nhbs.com/title/158636/1ff-schwegler-bat-box-with-built-in-wooden-rear-panel</a><br/> Ideal for high trees, steep slopes and house walls.</p> |
| | | | <p><a href="http://www.nhbs.com/title/176914/improved-crevice-bat-box">http://www.nhbs.com/title/176914/improved-crevice-bat-box</a><br/> Suitable for walls/trees &amp; small British crevice-dwelling British bats</p> |

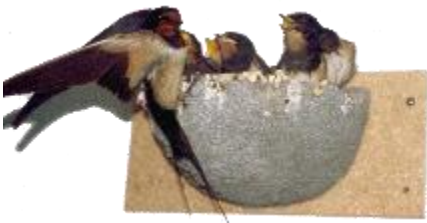
| <p>House Sparrow Terrace:<br/> <a href="http://www.nhbs.com/title/174850">http://www.nhbs.com/title/174850</a></p> | <p>Swallows:<br/> <a href="http://www.nhbs.com/title/158625/no-10-schwegler-swallow-nest">http://www.nhbs.com/title/158625/no-10-schwegler-swallow-nest</a><br/> <a href="https://www.cornwall.gov.uk/media/3626630/Accommodating-swallows-swifts-and-house-martins.pdf">https://www.cornwall.gov.uk/media/3626630/Accommodating-swallows-swifts-and-house-martins.pdf</a></p> | <p>Barn owl:<br/> <a href="http://www.nhbs.com/title/200041/barn-owl-nest-box">http://www.nhbs.com/title/200041/barn-owl-nest-box</a></p> | <p>Starling:<br/> <a href="http://www.nhbs.com/title/195291/vivara-pro-woodstone-starling-nest-box">http://www.nhbs.com/title/195291/vivara-pro-woodstone-starling-nest-box</a></p> |

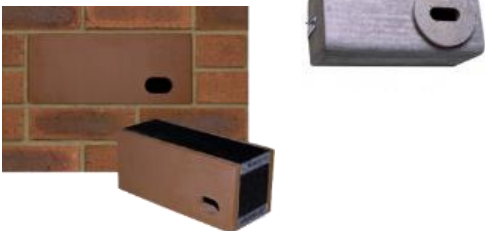
| <p>Swift:<br/> <a href="http://www.nhbs.com/title/187692/ibstoc-k-eco-habitat-for-swifts">http://www.nhbs.com/title/187692/ibstoc-k-eco-habitat-for-swifts</a><br/> <a href="http://www.nhbs.com/title/162187/no-17-schwegler-swift-nest-box-single-cavity">http://www.nhbs.com/title/162187/no-17-schwegler-swift-nest-box-single-cavity</a><br/> <a href="https://www.cornwall.gov.uk/media/3626630/Accommodating-swallows-swifts-and-house-martins.pdf">https://www.cornwall.gov.uk/media/3626630/Accommodating-swallows-swifts-and-house-martins.pdf</a></p> | <p>24,25,26 to suit varying bird sizes:<br/> <a href="http://www.nhbs.com/title/173236/schwegler-brick-nest-boxes">http://www.nhbs.com/title/173236/schwegler-brick-nest-boxes</a></p> | <p>House Martin:<br/> <a href="http://www.nhbs.com/title/173233/no-11-schwegler-house-martin-terrace">http://www.nhbs.com/title/173233/no-11-schwegler-house-martin-terrace</a><br/> <a href="https://www.cornwall.gov.uk/media/3626630/Accommodating-swallows-swifts-and-house-martins.pdf">https://www.cornwall.gov.uk/media/3626630/Accommodating-swallows-swifts-and-house-martins.pdf</a></p> | <p>Garden Birds:<br/> <a href="http://www.nhbs.com/title/158587/1b-schwegler-nest-box">http://www.nhbs.com/title/158587/1b-schwegler-nest-box</a></p> |
