## Preliminary Roost & Nest Assessment

Middleton House,  
Yapton Road,  
Middleton-on-Sea  
PO22 6DU

GR: SU 97450 00522  
July 2018

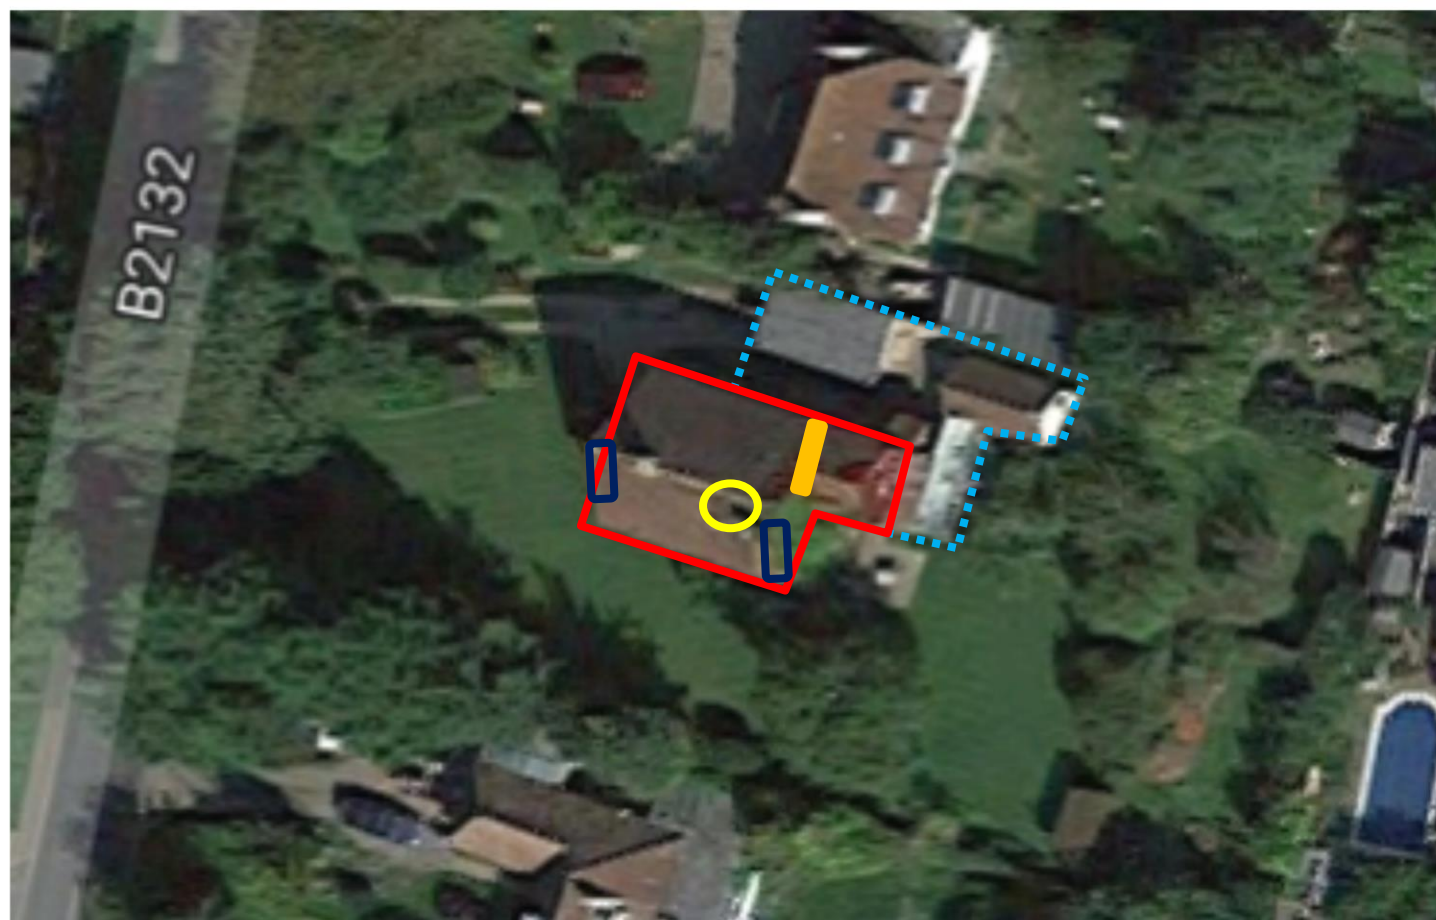
It is understood the client intends to renovate the property, with the construction of an extension around the north and east aspects. This will (and already has) directly impact roosting features. Planning has already been granted for these works.

| Locations are approx.<br>and not to scale. | |
| Structure<br>Remaining | |
| Structures<br>Removed | |
| Location of<br>bird nesting | |
| Location of bat<br>evidence | |
| Location of bat<br>ingress | |

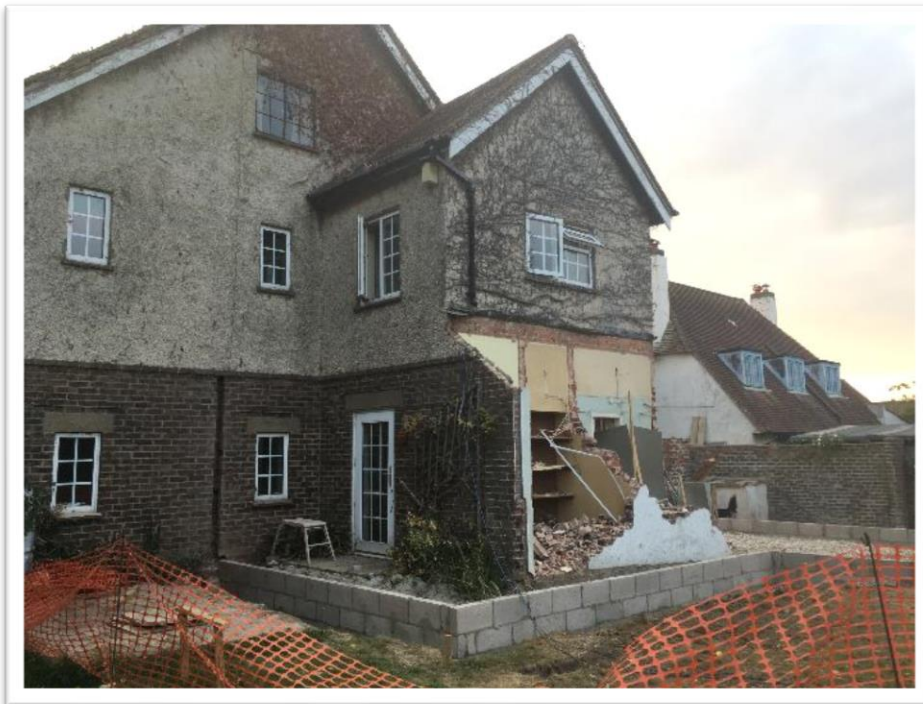
### BUILDING 1 - Main House.

| Structure | Roof Covering | Type of Roof | Lining | Insulation |
| House | Slate | Pitched | Sarking | None |
| Loft Void | Wall Construction Materials | External Cladding | Roof Fittings/ Additions | |
| None | Brick | Render | Chimneys present | |
| Cavity Wall | Cavity Insulation | | Other External Features | |
| Yes | None | | Lower extension on the eastern aspect | |

Bats: A number of gaps exist behind and on soffit boards on the eastern and western aspect of the house

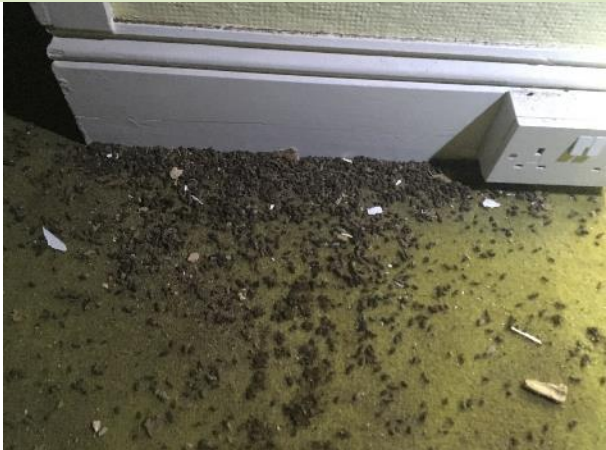
Bats: Large quantities of droppings were present in the cavity between the lower extension and the main part of the house. These were viewable as all ceilings in the house had been stripped out.

| <p>Large number of droppings fallen through after removal of ceiling.</p> | <p>Some droppings remained stuck in the cavity wall.</p> |

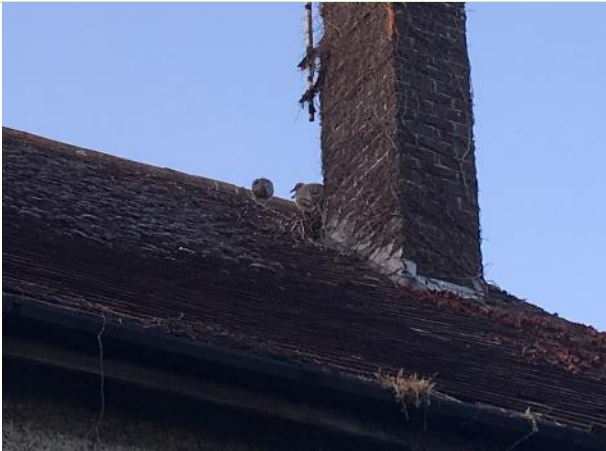
Birds: Herring Gull nest with fledgling was present next to the chimney of the eastern end of the southern pitch of the roof.

| <p>Fledgling Herring Gull in nest.</p> | <p>A number of structures from previous PEA and Bat Emergence surveys were no longer present.</p> |

- vi. A Herring Gull nest was recorded. Active bird nests, irrespective of species are protected by law. Works cannot take place until nestlings have fledged, and the nest is no longer in use. If birds nest prior to or during development works and this nest will be impacted by the proposal, work must cease until all chicks have fledged and flown and/or nesting has ceased.

| | Active bird nests, irrespective of species are protected by law. Works cannot take place until nestlings have fledged, and the nest is no longer in use. If birds nest prior to or during development works and this nest will be impacted by the proposal, work must cease until all chicks have fledged and flown and/or nesting has ceased. |
