**Report  
of  
Preliminary Ecological Bat Survey**

**46 Sea Lane  
Middleton on Sea  
December 8<sup>th</sup> 2015**

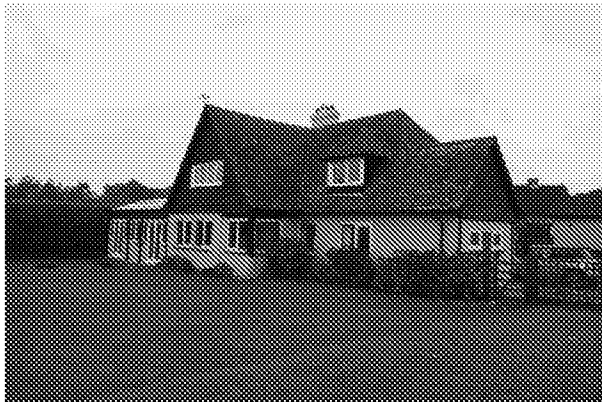
Southern aspect and eastern side

There was no roosting potential in the rendered walls or under tightly fitted timber cladding in good condition on the east facing walls of the small single storey gable ended extension and adjacent areas of the house.

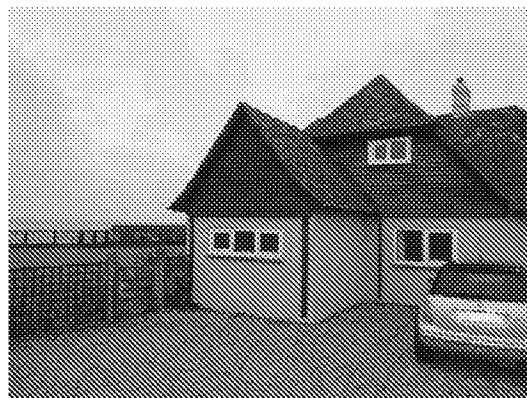
Extension on eastern end of house

There was potential for bats to access space under the clay tiles on the small single storey extension but there were no bat droppings or bats seen under the tiles many of which had lichen under them. There were no markings suggestive of bats accessing the tiles and there were large areas of undisturbed algae. There was also access under the adjacent roofing but no evidence of roosting could be seen.

It is recommended, as good practice, that the roof tiles are removed with care in case an opportunistic bat uses the tiling and contractors are advised to cease work and seek advice in the unlikely event that a bat is seen under tiling during preparation for demolition.

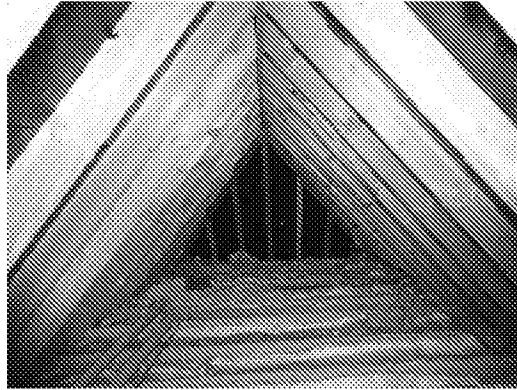
A large loft lay over the main house. The roof was lined with a black roofing felt and the floor was insulated. There was no evidence of any bat droppings or bats. There was no evidence that bats were or had ever accessed the void.

Example of roof void over main house

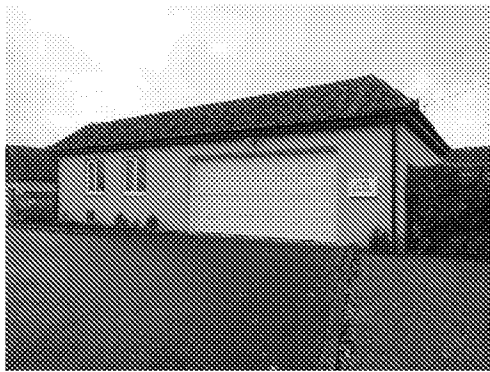
East facing frontage

A detached single storey outbuilding providing a double garage and a utility area lay to the north east of the bungalow. There was no potential for bats to enter or roost within the enclosed garage or utility or area.

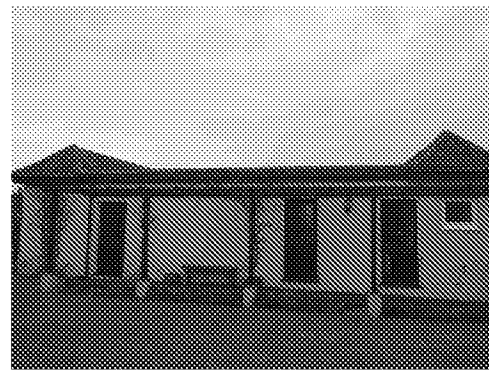
West facing rear

The soffits and barge board fitted were all well sealed.
