# **46 Sea Lane, Middleton-On-Sea, West Sussex Ecological Appraisal**

**For**  
James Burland Architects

**11<sup>th</sup> December 2015**

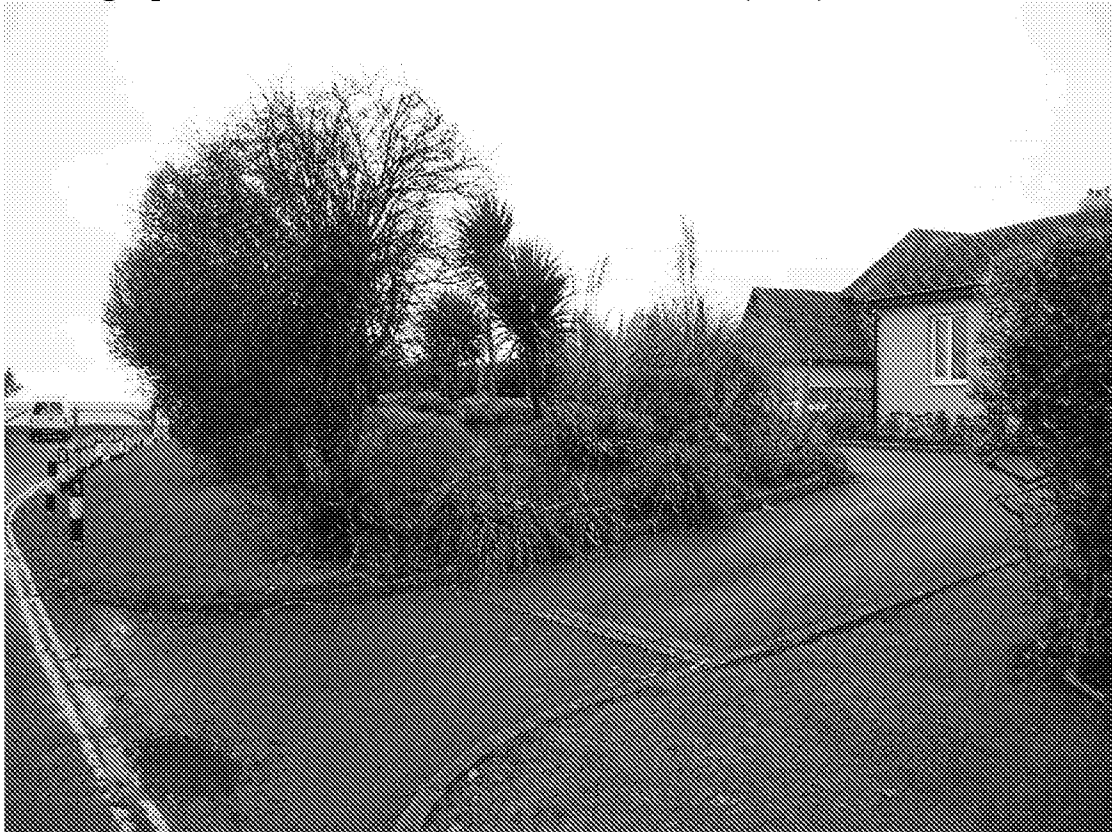
**Photo 1:** Access onto plot, hawthorn hedge on verge and buildings to be removed

The application site covers an area of about 0.175ha, supporting a detached dwelling, garage/office building with associated shingle vehicle access (see **Photos 1 to 3**), maintained lawn around property (see **Photo 4**), mature garden hedges; borders, bedding plants and rockery (see **Figure 1**). The new build would remove a small side-wing of the property and the garage/office, with associated landscaping removing some existing garden boundary vegetation. Habitats present are described in more detail below, those within the site boundary are generally considered ecological features of site value only, with exception of the semi-improved lawn area considered of Parish-value while Middleton Shingle SNCI is considered an ecological features of Borough/County value. However, the area of SNCI adjacent this site is degraded, well trampled and supported little shingle vegetation (see **Photo 5**).

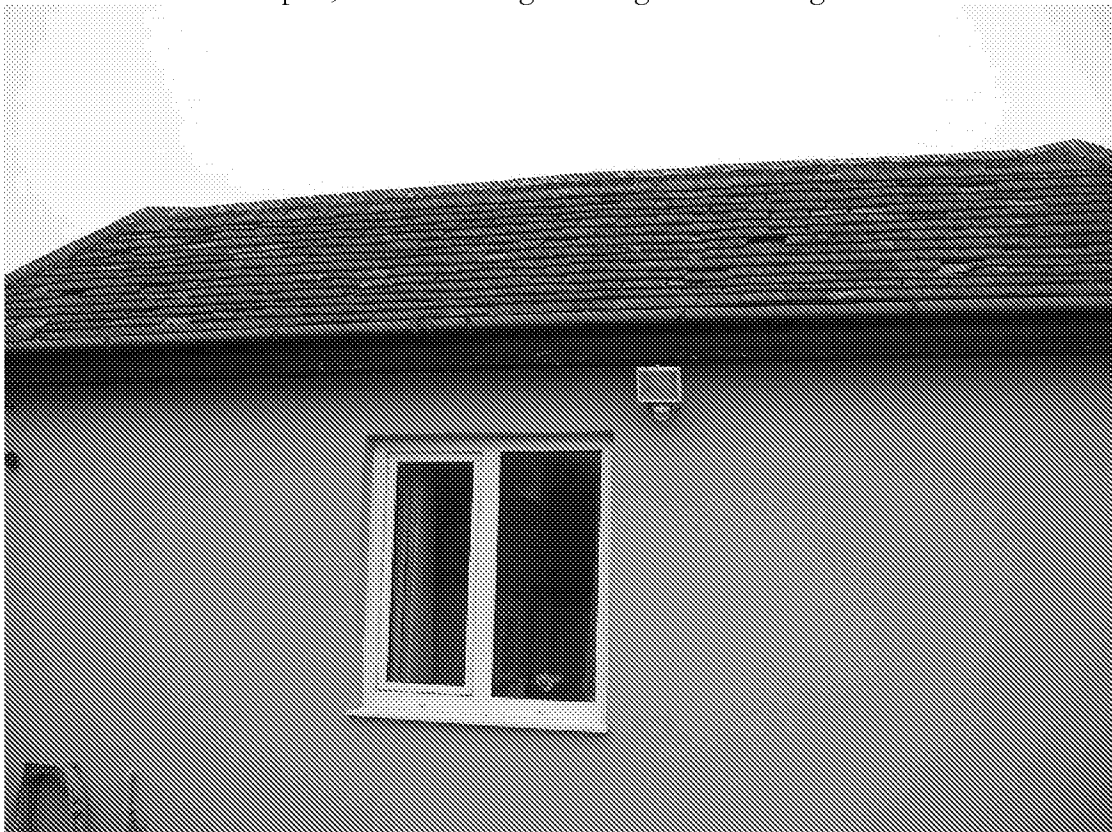
The house is believed to have been constructed around 1920-30s, while the garage/office is much more recent in origin. Missing tiles on the pitched roofs of these two properties (see **Photos 2** and **3**) provide potential access points for bats to roost within the roof. A more detailed building assessment for bats was conducted by licenced bat-worker, Sue Harris (see S. Harris December 2015<sup>4</sup> for detailed information). The existing drive and buildings impacted by development represent ecological features of site value only.

**Photo 2:** Missing tiles on office roof, potential access points for bats

bats observed following inspection of easily accessible potential roost access points, the exposed, windy location of the property and lack of existing records no further investigations related to bats are required. However, it is recommended as good practise roof tiles must be removed with care and if bat droppings or a bat is seen work should cease immediately and advice sought. Refer to the Bat Report by S. Harris (December 2015<sup>4</sup>) for detailed information.

Bat were not recorded on site (S. Harris, December 2015<sup>5</sup>) however, it is recommended as good practise that roof tiles are removed with care and if bat droppings or a bat is seen work should cease immediately and advice sought.

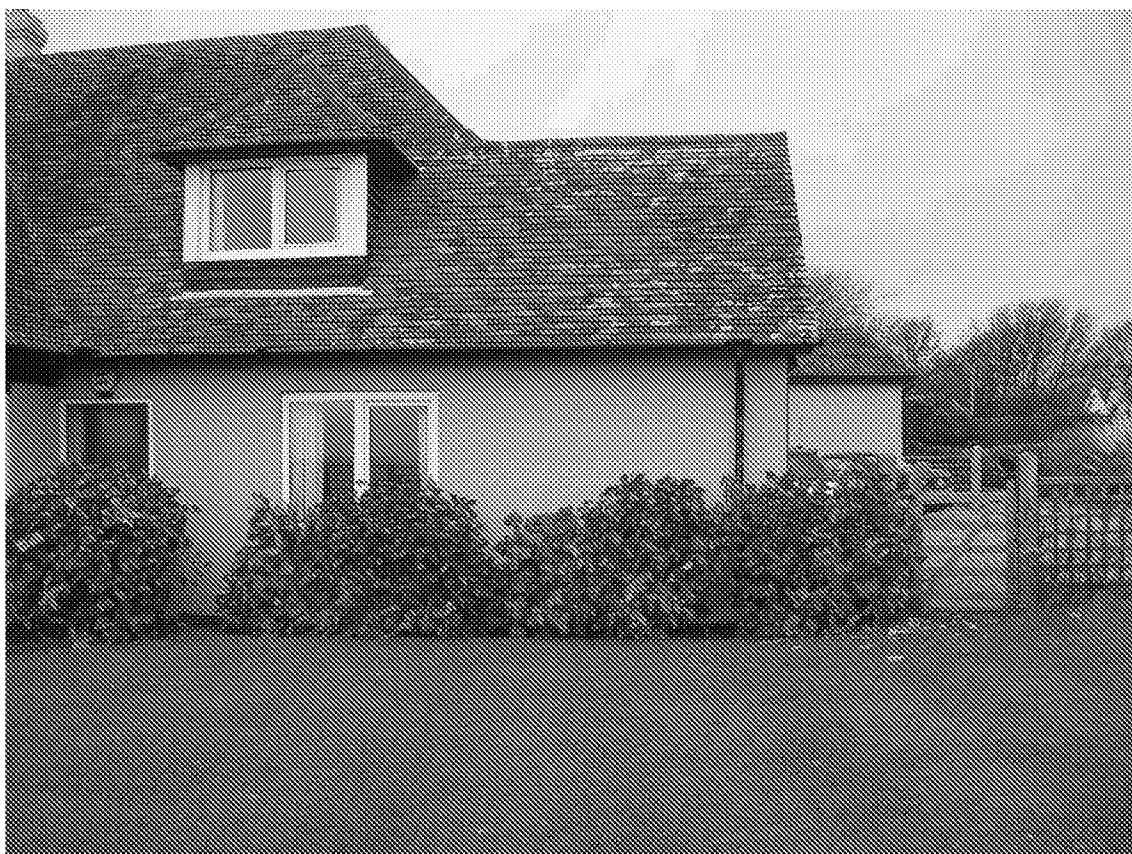
**Photo 3:** Lawn and side-wing of property to be demolished

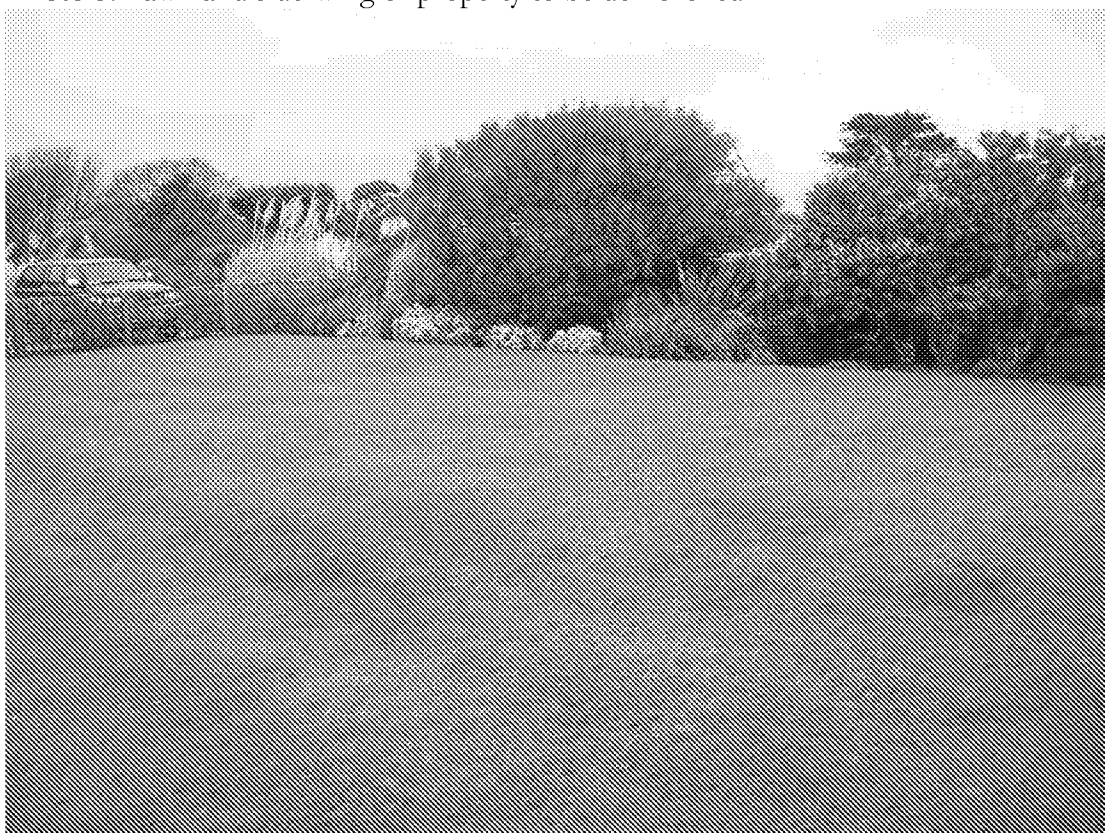
Areas of maintained lawn, south of the property had been influenced by the sea, with salt-spray having allowed species such as buck's-horn plantain *Plantago coronopus* abundant and thrift *Armeria maritima* was rare in occurrence. Clovers *Trifolium* spp., bryophytes and fescue-grass *Festuca* spp. were all abundant, with perennial rye-grass *Lolium perenne* and daisy *Bellis perennis* frequent. Within the sward several fungal-fruited were observed including *Galerina*, *Hygrocybe* and *Geoglossum* spp. (see **Photo 6**).

Due to the influences of coastal spray and abundance of forbs this lawn area was currently considered amenity / species-poor semi-improved grassland, as opposed to strict amenity lawn and an ecological feature of Parish-value. A more detailed botanical survey during a suitable time of year (spring-summer) will provide a greater range of species, some of which could be of local distribution. This lawn is a part of the coastal landscape, located to the rear of Middleton Shingle SNCI, where sand-dunes are likely to have previously occurred prior to the development of the village (recorded as rough grassland on 1<sup>st</sup> Edition OS Maps). The lawn is grazed by rabbits *Oryctolagus cuniculus* (although no warrens were observed within the grounds) and crows *Corvus corone* were observed feeding on invertebrates within the lawn. In total the development of the new property will remove about 50m<sup>2</sup> of this lawn, while a further area will be temporarily damaged during construction. However, it is considered that the lawn can be easily re-created with coastal spray likely to influence the lawn community over-time, so in the absence of mitigation impact upon the lawn is likely to be low to medium.

**Photo 4:** Area of coastal lawn mostly retained, with hedge / bedding plants on boundary

Due to the location of the application site to the coast-line and SNIC the landscape scheme will not include plant species such as Hottentot fig *Carpobrotus edulis*, listed in **Appendix II** (list of Schedule 9 plant species, WCA 1981, as amended 2010). In addition it is recommended that the lawns to the rear (south of the property) are laid with a fine-leaved lawn turf or allow grasses and lawn species to naturally seed, thereby allowing local species to colonise that maybe better adapted to the harsh coastal environment and providing a natural feature to compliment the adjacent SNCI.

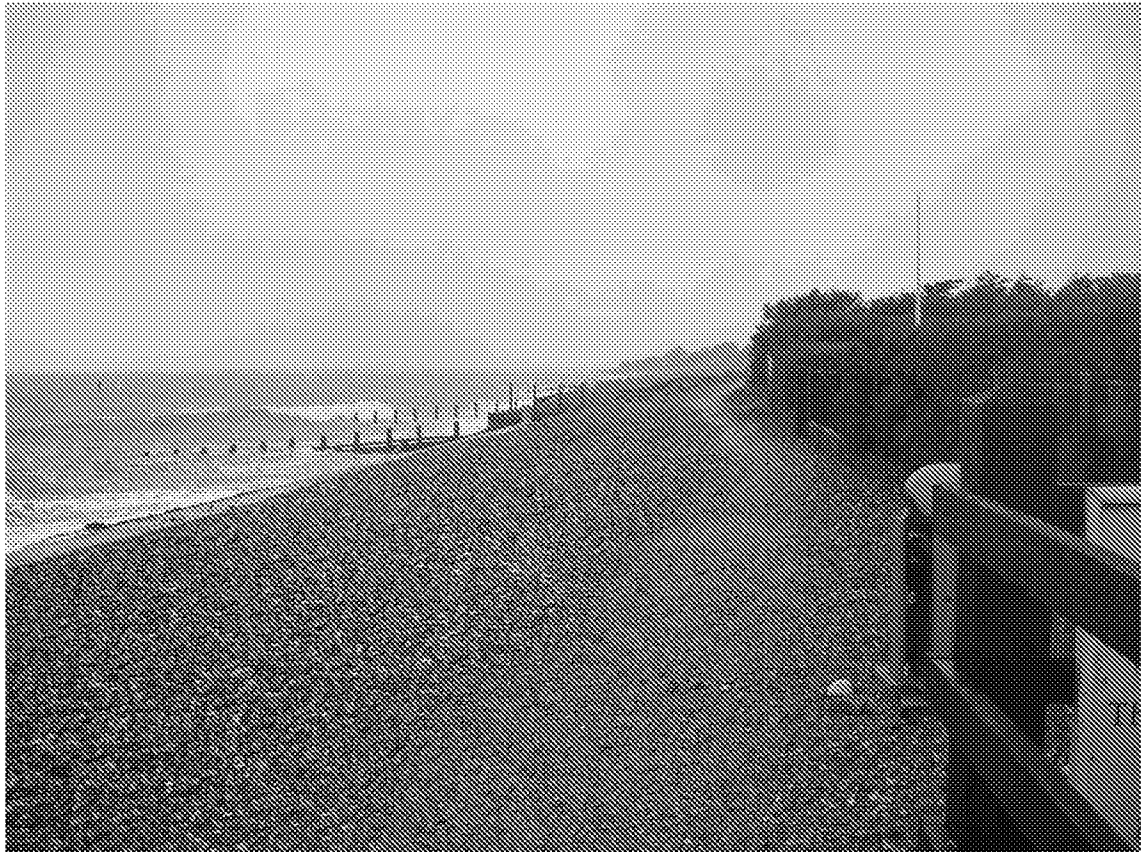
**Photo 5:** Tamarisk-hedge to rear of property adjacent Middleton Shingle SNCI

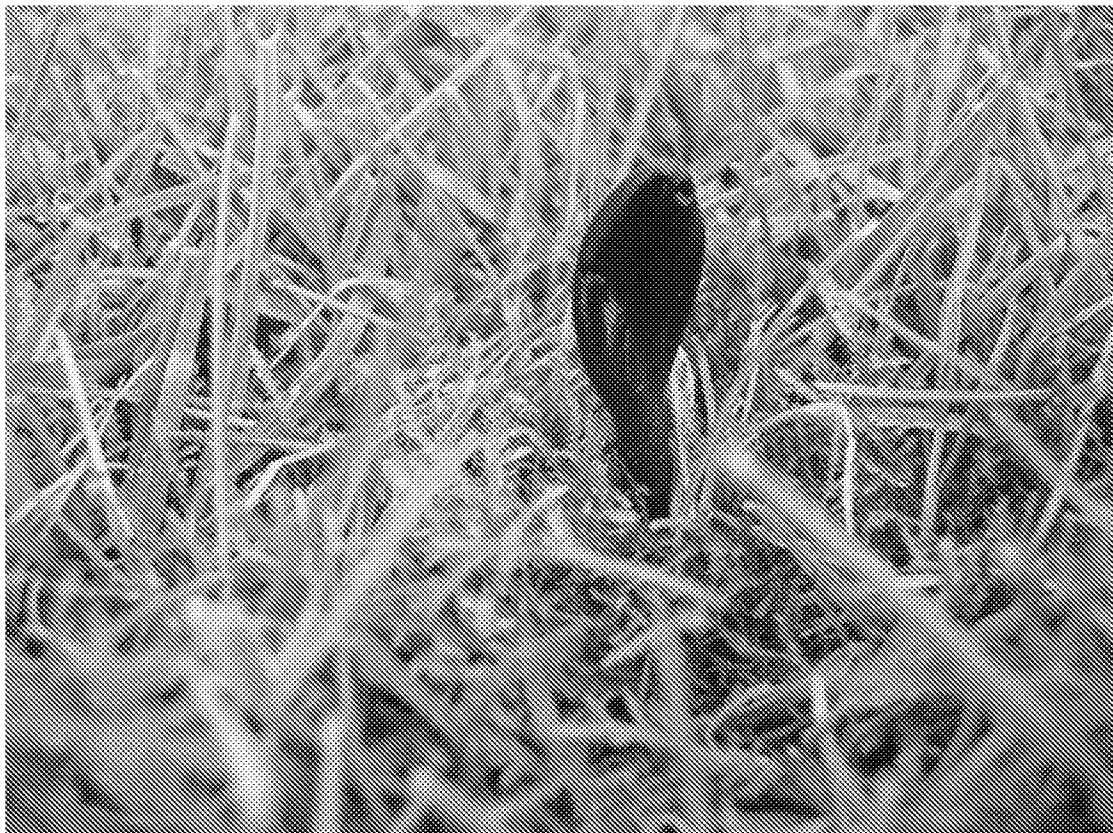
**Photo 6:** Fungi growing within the lawn included *Geoglossum* spp.
