**Report  
of  
Preliminary Ecological Bat Survey**

**46 Sea Lane  
Middleton on Sea  
December 8<sup>th</sup> 2015**

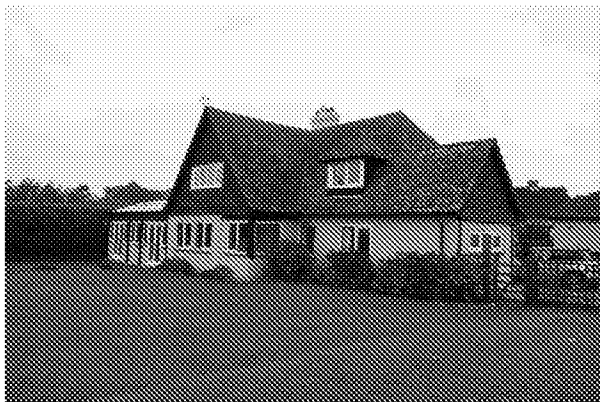
Southern aspect and eastern side

There was no roosting potential in the rendered walls or under tightly fitted timber cladding in good condition on the east facing walls of the small single storey gable ended extension and adjacent areas of the house.

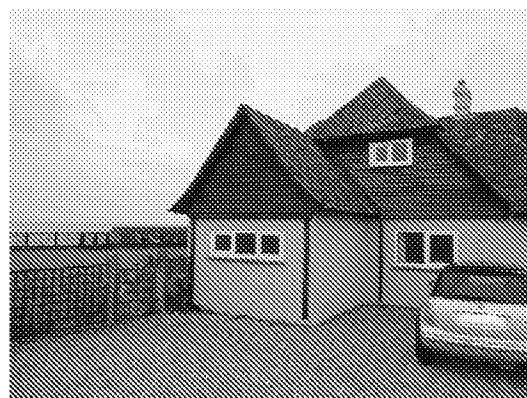
Extension on eastern end of house

There was potential for bats to access space under the clay tiles on the small single storey extension but there were no bat droppings or bats seen under the tiles many of which had lichen under them. There were no markings suggestive of bats accessing the tiles and there were large areas of undisturbed algae. There was also access under the adjacent roofing but no evidence of roosting could be seen.

It is recommended, as good practice, that the roof tiles are removed with care in case an opportunistic bat uses the tiling and contractors are advised to cease work and seek advice in the unlikely event that a bat is seen under tiling during preparation for demolition.

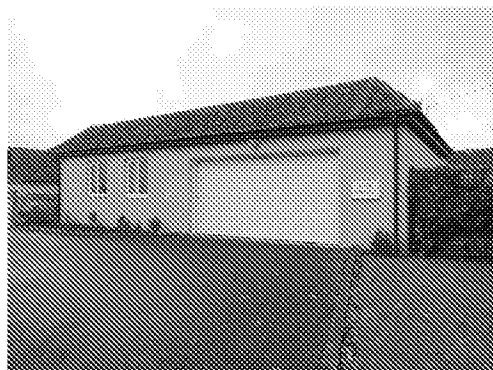
East facing frontage

A detached single storey outbuilding providing a double garage and a utility area lay to the north east of the bungalow. There was no potential for bats to enter or roost within the enclosed garage or utility or area.

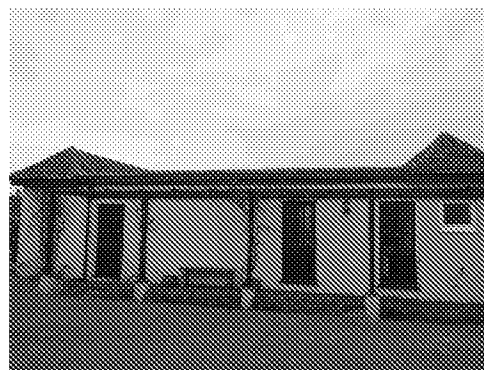
West facing rear

The soffits and barge board fitted were all well sealed.

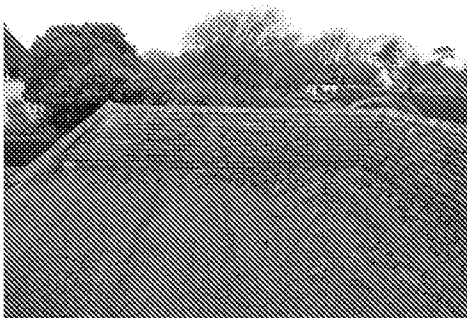
The flat roof was covered with roofing felt with a low pitched roof of approximately 1m in height covered with relatively flat clay tiles featured around three sides of the roof. There was access under some of the clay tiles on the roof and a small number of tiles were missing. There was high levels of undisturbed algae coating most tiles with some lichen and moss. There was no evidence of bat droppings or bats under the tiles and there were no markings on the tiles suggestive of bats passing under the tiles.

Low pitched roof on edge of flat roof
