08 View south west towards site from PRoW (YAP/146/3)

| Site A - Bognor Golf Club<br>Landscape Strategy and Visual Appraisal | | |

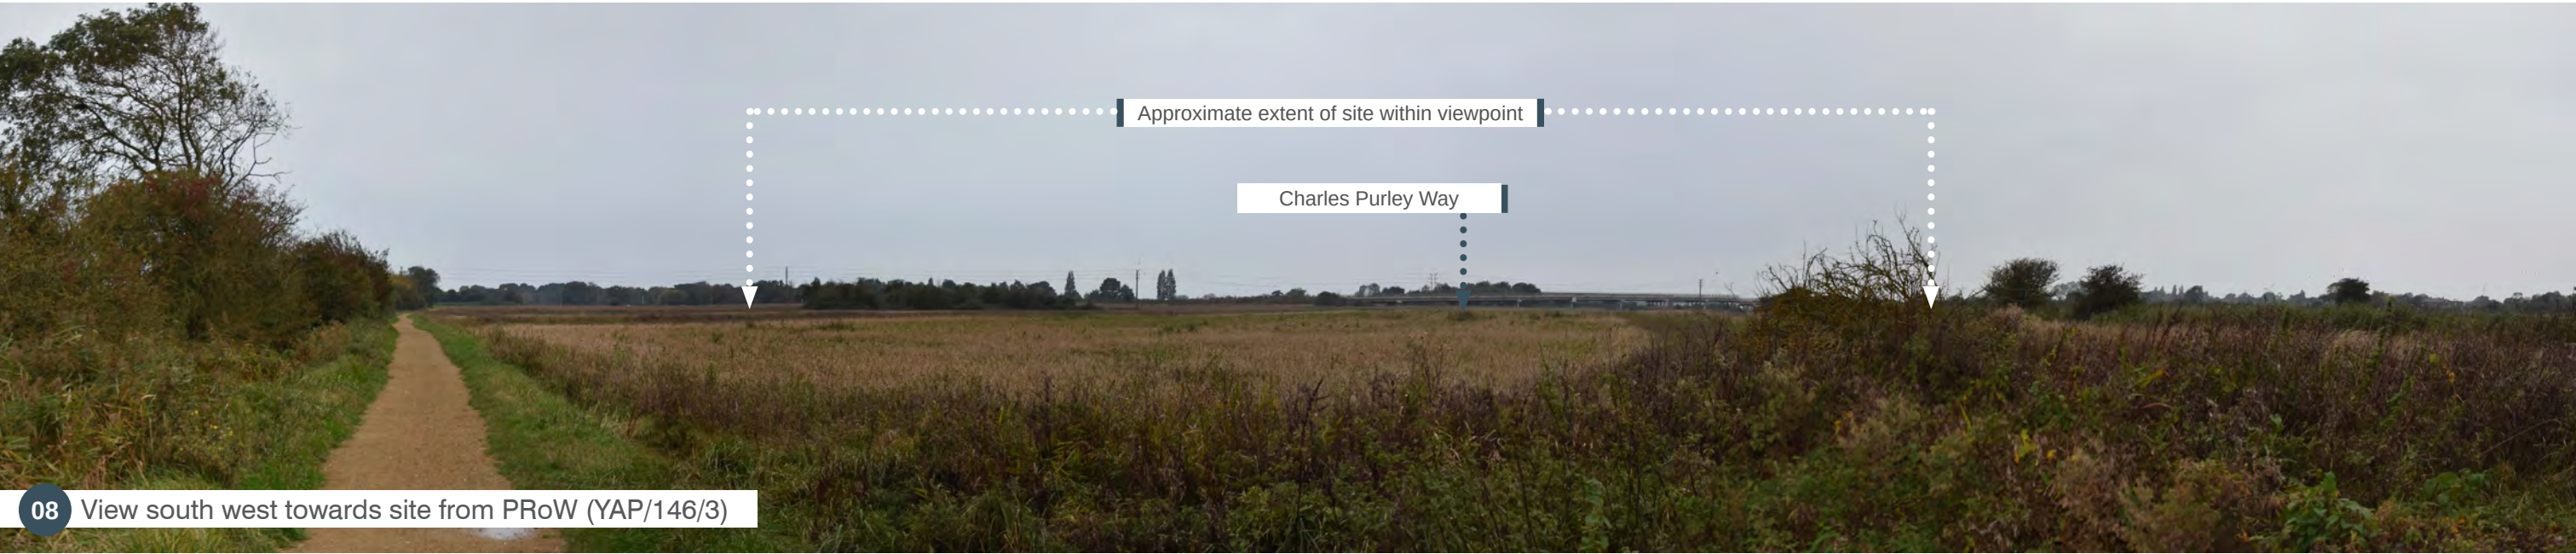
The north eastern boundary vegetation of the site is visible at distance across arable landscape. The boundary vegetation screens the interior of the site. Pylons are visible within the scene and the bridge of the relief road is prominent.

| Description of View / Type of Effect | Sensitivity to Change | Magnitude of Change | Effects of Change |
|---|---|---|---|
| Construction: If discernible, the upper levels of activity associated with ecological enhancement only, would be visible in the immediate context of the relief road and bridge. This would represent only a marginal and temporary component of the scene. | High | Minor adverse | Minor adverse |
| Year 1: It is not anticipated that built form would be perceptible in summer months. If visible, it would likely be limited to the sections of the care home roof line, representing a small component of the scene and not the focus of it. During winter months, further aspects of the care home may be seen revealed through the intervening dense boundary vegetation, however, owing to the distance and the density of the vegetation, it would likely be difficult to discern. | High | Minor adverse | Minor adverse |
| Year 15: By year 15 supplementary boundary vegetation would have matured and the building materials on site would have weathered. If views of built form remain visible, the materials themselves would be better integrated into the wider scene. | High | Minor adverse | Minor adverse |
