# Flood Risk Access Statement

Proposed New Residential Development

27 Central Drive  
Elmer  
PO22 7TT

# ECOLOGICAL IMPACT ASSESSMENT

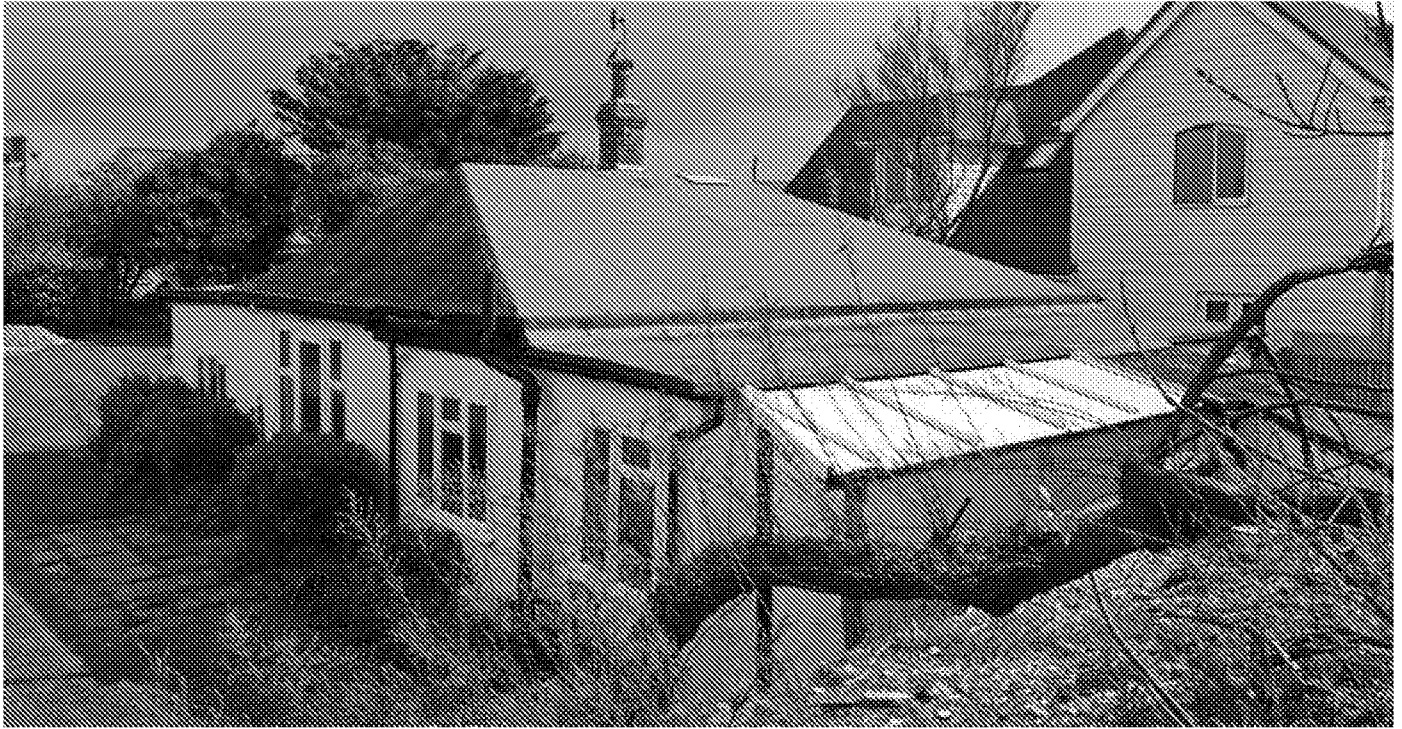
**Photograph No. 03 - Building B1, assessed as offering negligible bat roost suitability.**

4.2.3 2no. buildings are present on site; a small detached bungalow (B1) and a single garage (B2). The bungalow is of rendered brick construction with a pitched felt roof in good overall condition. Soffit boxes are of painted wooded construction and were in good condition throughout while the double-glazed windows are tightly fitting.

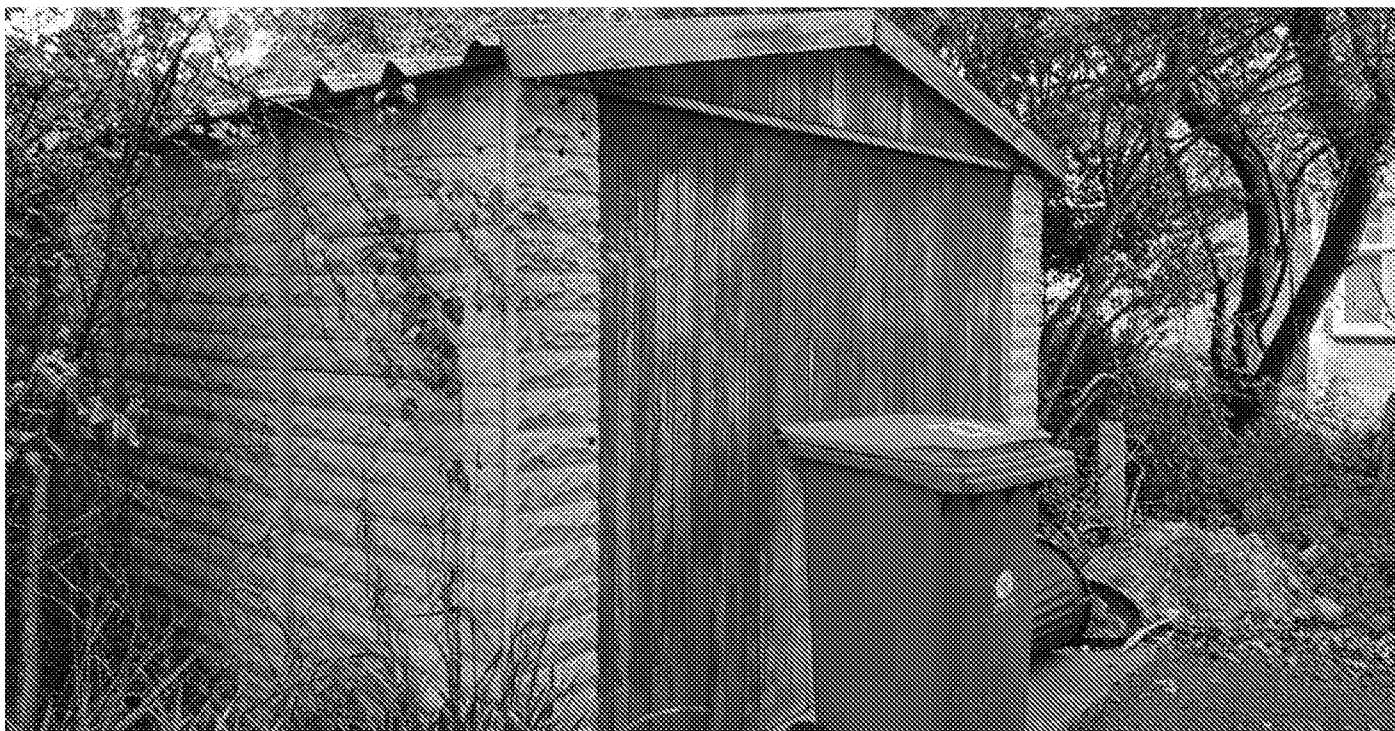
**Photograph No. 05 - Building B2; assessed as offering negligible bat roost suitability.**

4.2.4 The single garage is of typical pre-fabricated construction with corrugated asbestos roofing. The building appeared to be in good condition.

- 4.3.4 The garage (B2) on site contained no enclosed roof void while its single-skin construction means the building is of low thermal mass, negating its suitability as a bat roost. No evidence of roosting bats was found anywhere on site; the site is considered to be of **negligible value** to roosting bats.
