**Preliminary Ecological Appraisal  
Internal and External Bat Inspection**

**Middleton House  
Bognor Regis**

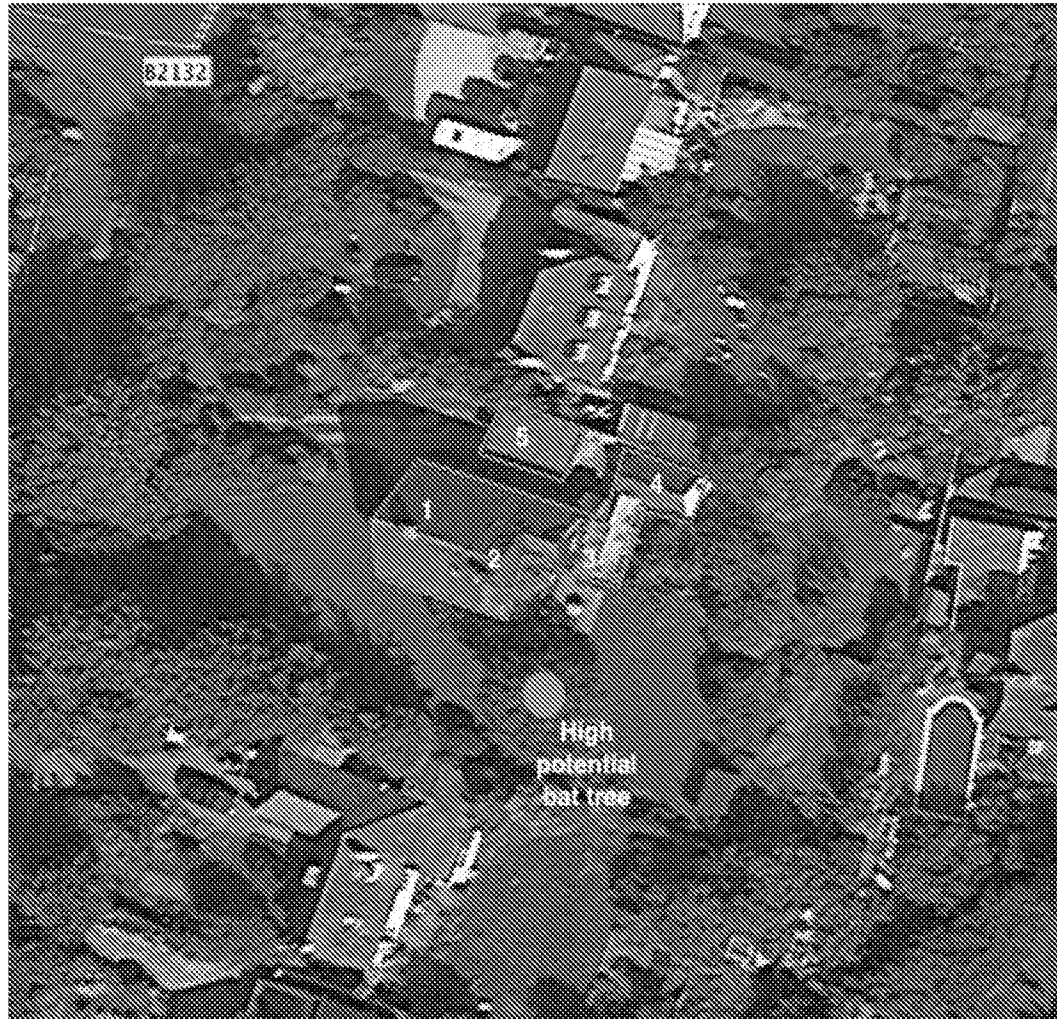
*Figure 3: Location of the sections of the house which were internally investigated for roosting bats. The ornamental tree on the southern aspect of the site supported rot holes – this has been labelled as a high potential bat tree.*

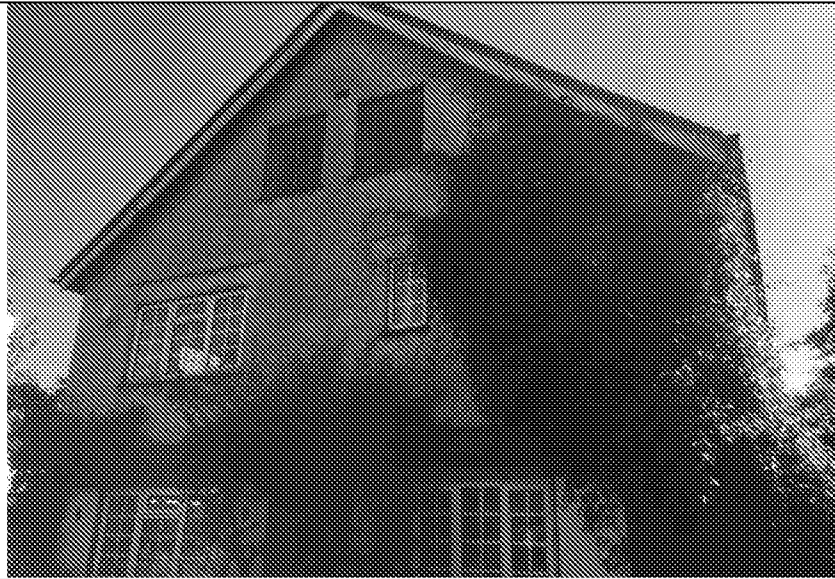
Photo 1: The western side of the house. The soffit board supported a hole in this end, however, no bats seen to emerge in September survey

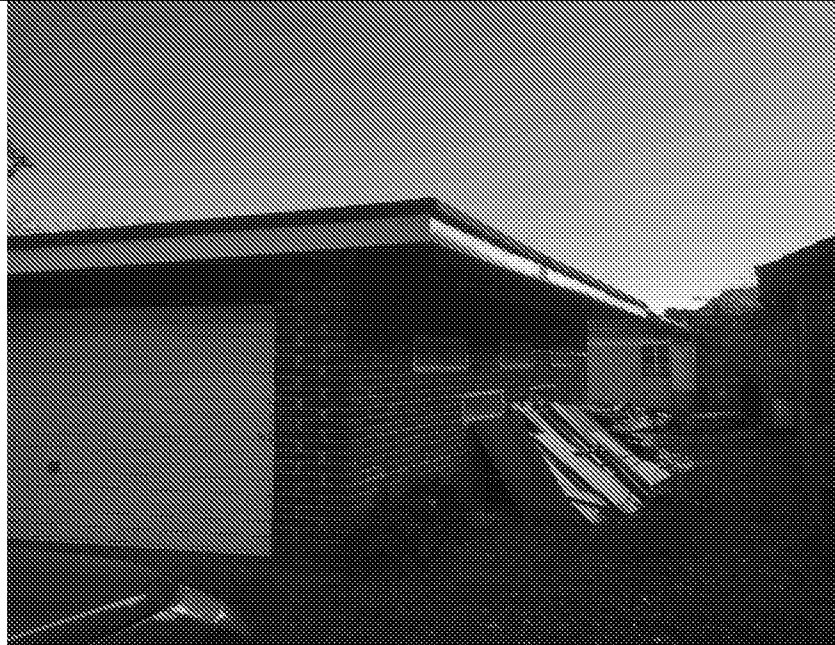
- 3.20 The separate garage (section 5) supported a flat roof structure. Internally there was no internal void and the garage was light and airy. Externally no features which could be exploited by bats was found. No evidence of bats was recorded and it was considered that this structure supported negligible potential to support roosting bats.

Photo 2: The garage negligible potential to support roosting bats.

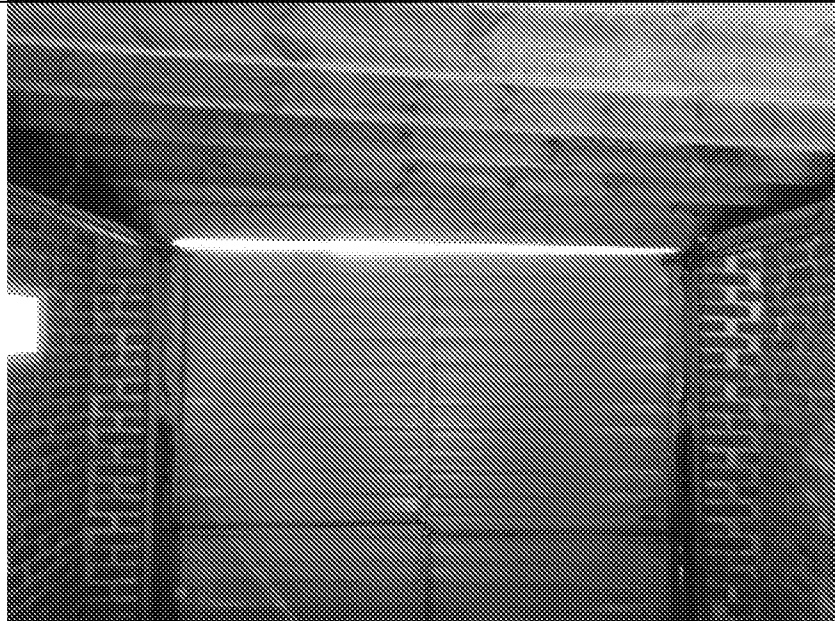
Photo 3: Inside the garage no evidence of roosting bats

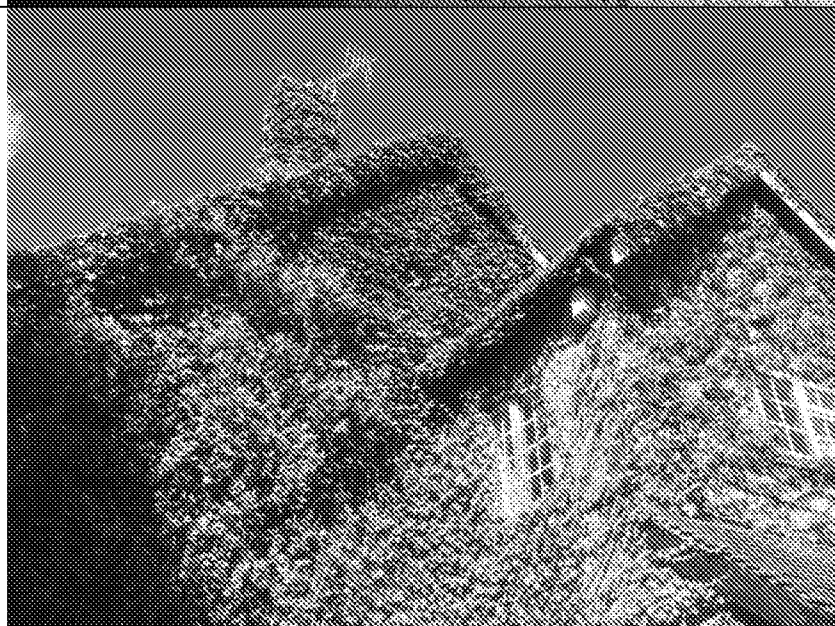
- 4.8 The house and the small annex were surveyed during September 2016. One single emergence from a common pipistrelle was recorded on the eastern elevation, considered from the soffit area of the taller apex of the building. No other bats were considered to have emerged from the building. It is considered that a low number of crevice dwelling species are likely to use the external features of the house and potentially individual serotines would utilise the gable end. It is recommended that further bat surveys are conducted in May – August. It is, however, considered that the initial bat survey provides a good initial assessment of the bat species using the site and which bat species would be present in the local area.

Photo 6: the eastern gable end. One common pipistrelle emerged from this location during the September survey

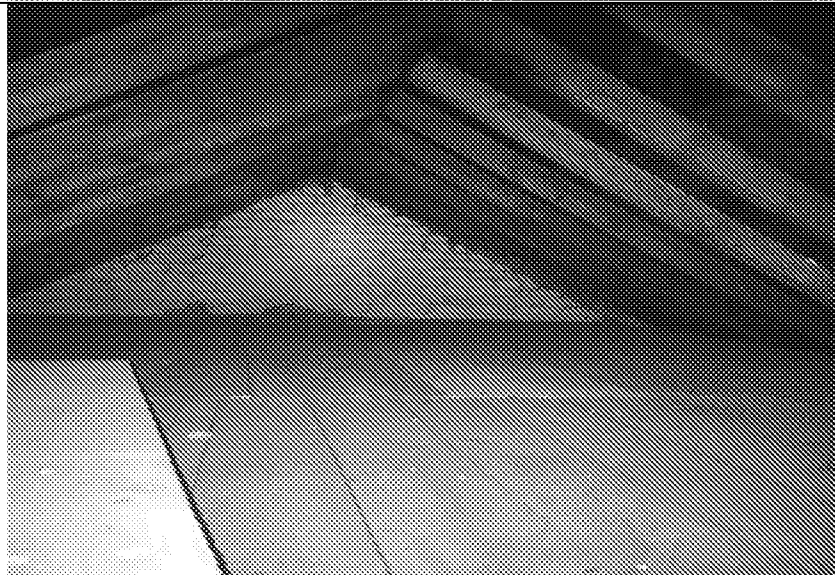
- 4.7 The small outbuilding with the void supported no internal evidence of bats, but did support some warped weatherboarding. This building was considered to have 'low' potential to support bats. As such one further survey was recommended. The remaining structures within the red line boundary were considered to have negligible potential for roosting bats.

Photo 8: The roof void inside the outhouse. No evidence of roosting bats.

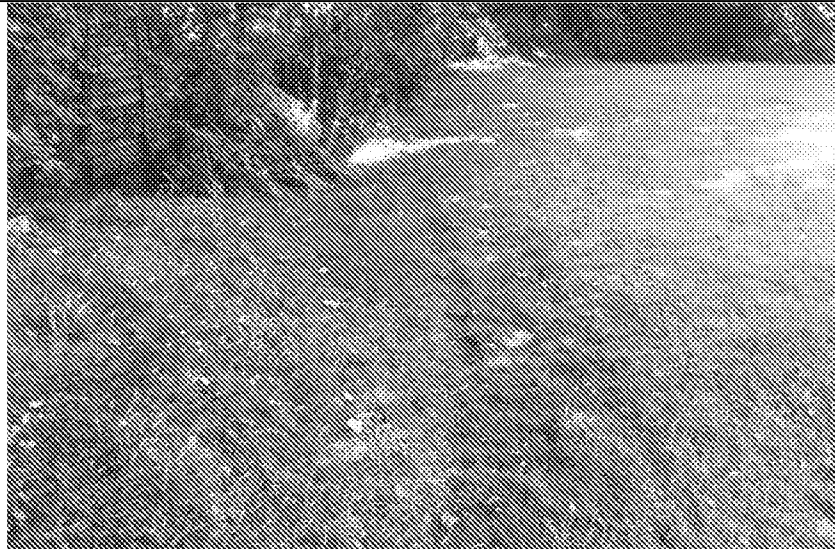
4.22 No evidence of badgers, such as setts, latrines or snuffle holes, was identified at the time of the survey. No active or inactive badger setts were identified on site. Mammal paths were identified however, no evidence of which species caused these was identified.

Photo 12: The mammal path across the southern aspect of the garden.
