**FORMER POULTRY FARM,  
SILVER BIRCH DRIVE, YAPTON**

**PROPOSED HIGHWAY ACCESS**

**STAGE 1  
ROAD SAFETY AUDIT REPORT**

Document: Stage 1 Road Safety Audit

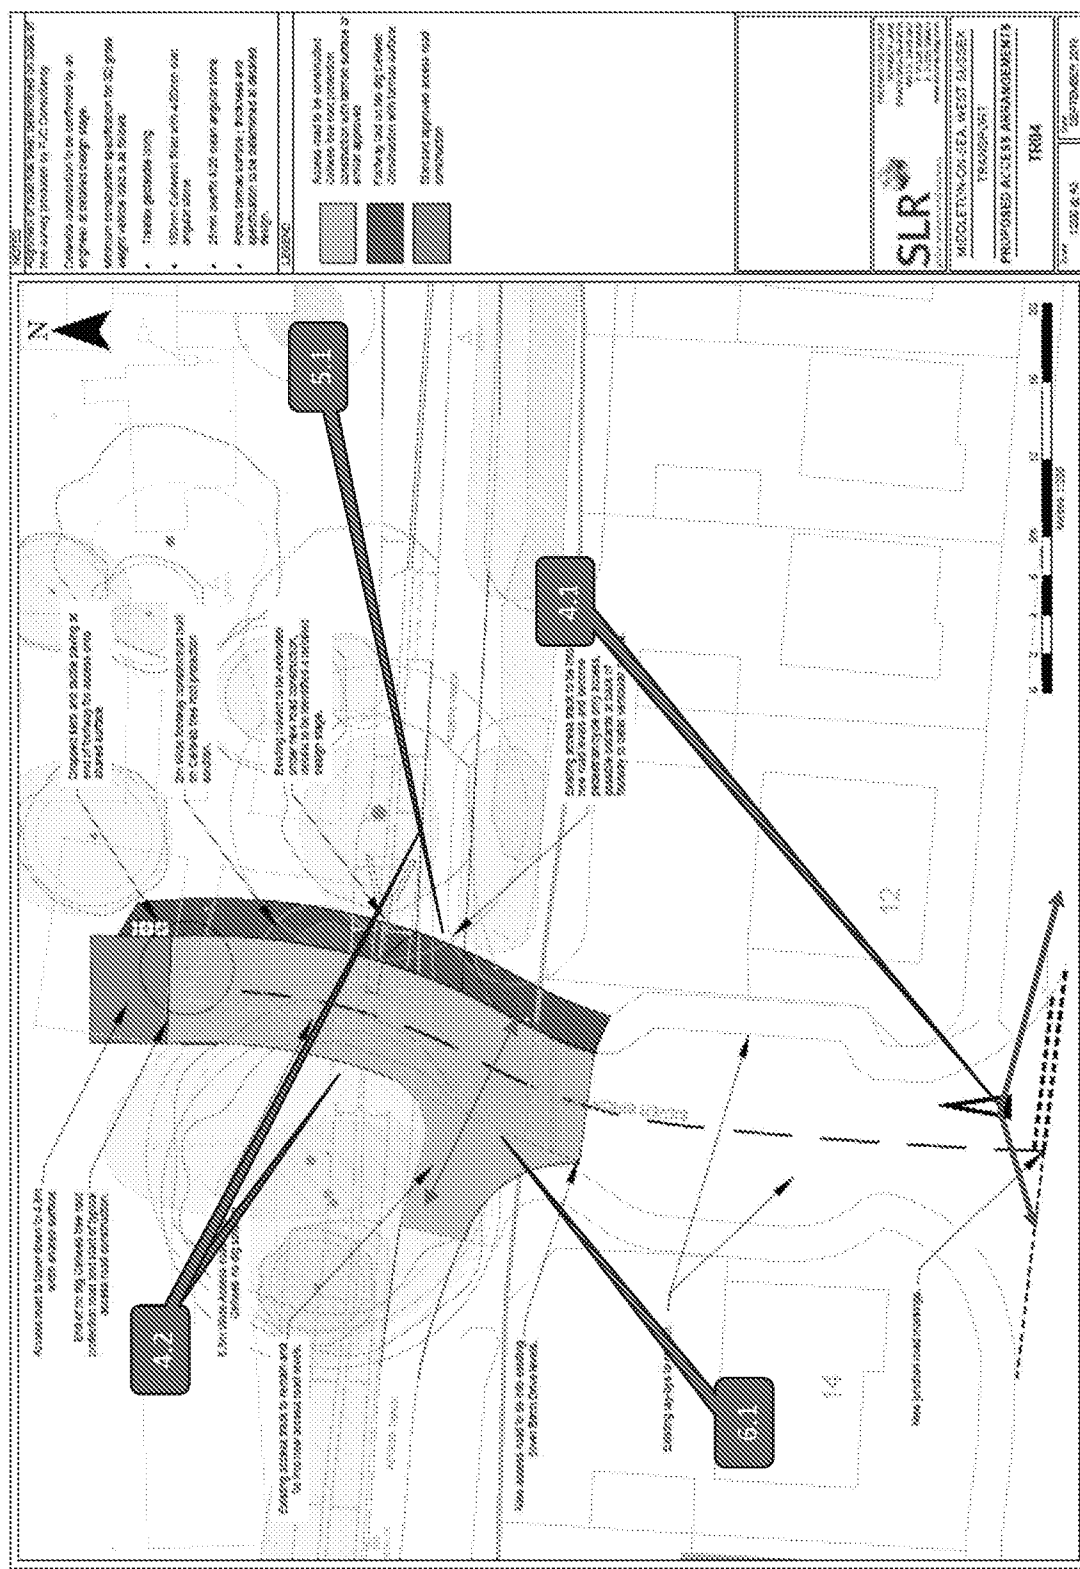
## **Appendix A**

- 1.7 The Safety Audit Team has examined only matters relating to road safety implications of the scheme and has not verified compliance of the design to any other criteria. All of the problems identified in this report are considered by the Audit Team to require action in order to improve the safety of the scheme and to minimise accident occurrence for all users. The location of the problems identified in this Safety Audit is shown in **Appendix A** where the reference numbers relate to the problems identified in this report.
