# **Bat Assessment Report**

**Peckhams**

**Poling Street  
Poling  
Arundel  
BN18 9PT**

**21-008  
April 2021**

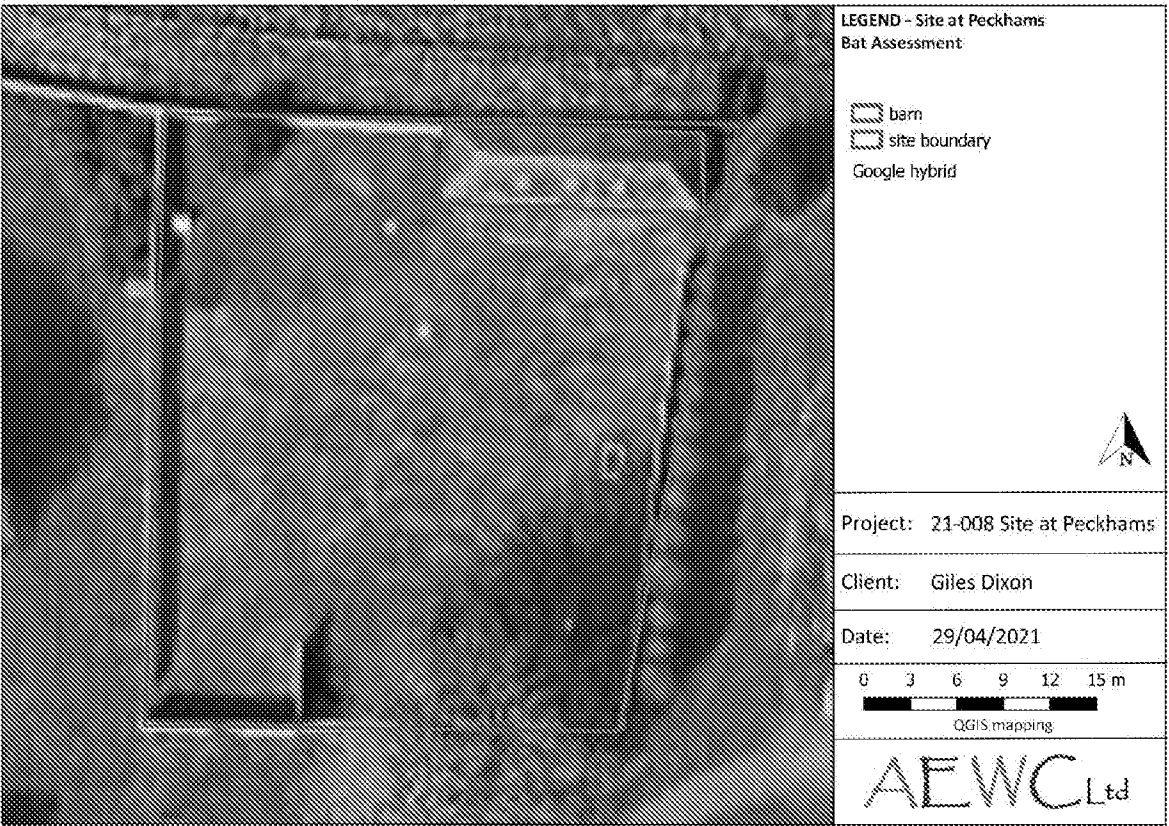
**FIGURE 2: SHOWING THE BUILDING SUBJECT TO SURVEY.**

1.8 The site contains a single-storey barn situated within a plot of amenity grassland.

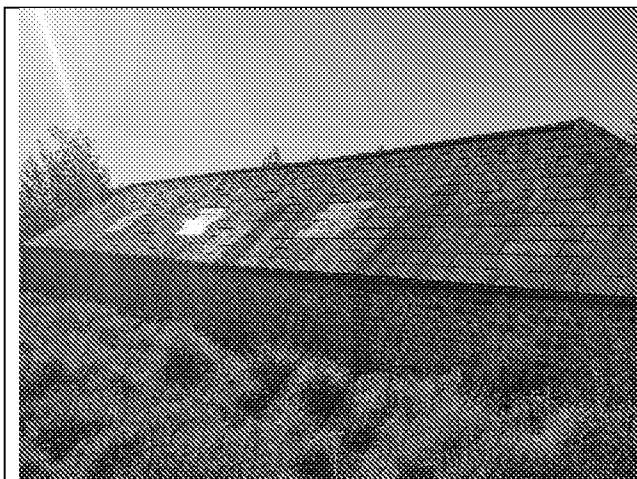
**Photograph 1:** Northern elevation

- 4.1 The barn is a single storey structure constructed from a mixture of materials. The north, east and west walls are constructed of brick and stone whilst the southern

elevation is single-skin wooden weatherboarding. The building has an unlined, hipped slate roof with glass tiles present on the northern and southern pitches.

- 4.2 The roof was well-sealed with only one section of missing mortar below a ridge tile towards the eastern end of the building.
- 4.3 The eaves were open allowing access into the building, and the southern wall had numerous gaps leading into the building.
- 4.4 Internally the building was very light and draughty and in use for storage. There was extensive cobwebbing noted at the ridge.
- 4.5 Where the mortar was missing the underside of the ridge tile was visible from inside the building and noted to be highly cobwebbed and filled with debris.
- 4.6 No evidence of bats was identified anywhere internally or externally around the building.

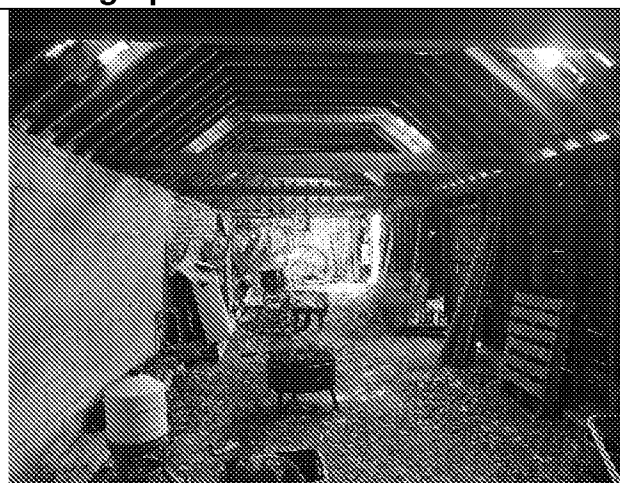
**Photograph 4:** Internal view

- 5.1 The barn was considered to have low potential to support roosting bats due to the small crevice formed where the mortar is missing below a ridge tile, and the open access internally.
- 5.2 Due to the level of cobwebbing identified, and the light and draughty nature internally, it is considered that the building has not been used by bats in some time, if ever and therefore it would be disproportionate to the level of potential to postpone works until an emergence survey has been carried out, as it is unlikely to alter the proposed mitigation.
- 5.3 A lack of any mitigation could result in a negative impact on bats if present, through potential death, disturbance or loss of roost space, a mitigation plan is therefore required for works to proceed.

- 6.4 All areas with potential for bats will be soft-stripped under direct supervision of the licensed ecologist, able to handle and check any bats found and move them to a safe place.

- 6.7 The roof of the barn should not be lined with a modern breathable roofing membrane, it must have a traditional Bitumen Type 1F (with a hessian Matrix) roofing felt. Polypropylene filaments used in the manufacture of modern breathable underlays are

known to entangle and kill bats and warranty can be invalidated; therefore, they must not be used in known or potential bat roosts.
