A  
HERITAGE IMPACT ASSESSMENT  
for a  
Farmyard Wall  
at  
SEFTER FARM  
PAGHAM

JANUARY 2015

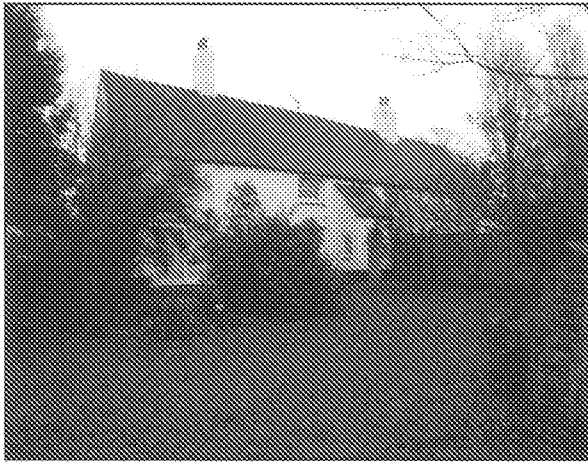
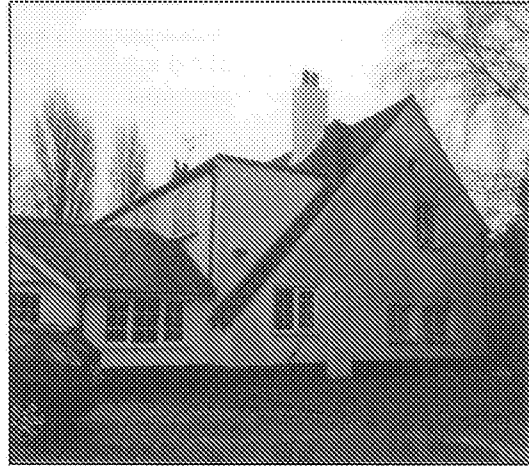
One building. C18. Two storeys. Four windows. Stuccoed. Tiles roof. Vertical glazing intact. C19 castellated porch. Modern addition behind.

*Sefter Granary, from the south-west (above left) and from the west (above right).*

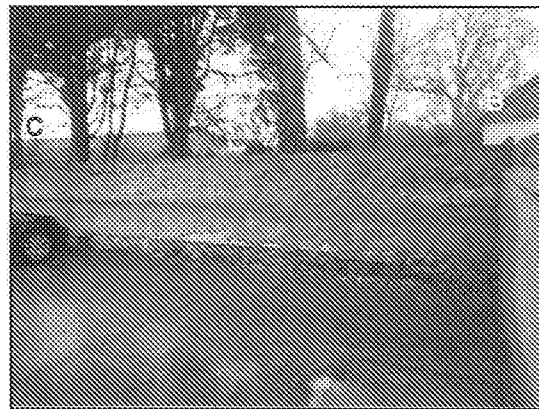
The first part of the north return (B-C) measures about 10.12 metres in length and is constructed of rather random lumps of stone and some bricks to a height of about 1 metre. The lower part of the masonry is exposed but above a height of about 30 centimetres it has been rendered with cement to a step reducing the thickness of the wall at about 1 metre above ground level. The upper part of the wall comprises eight courses of red bricks, laid in a random mixture of headers and stretchers. On its north side there up to about thirteen courses of brickwork exposed for a distance of about ten metres and to the west it is faced with flints.

*The east end of the farmyard wall (B-C), from the south.*

*The east end of the farmyard wall (B-C), from the north..*

This was evidently the north wall of the farmyard against which were constructed the four pigsties shown on all the editions of the Ordnance Survey plans, but now demolished. The first 7 or 8 metres also formed the garden wall of the Listed building.

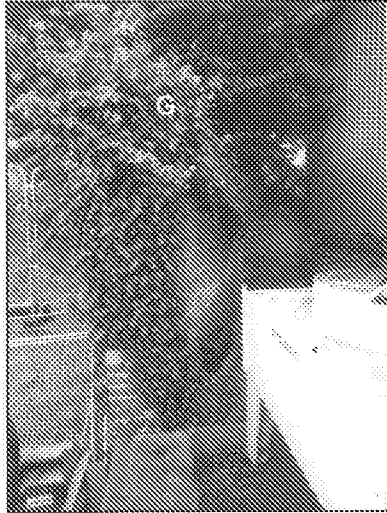
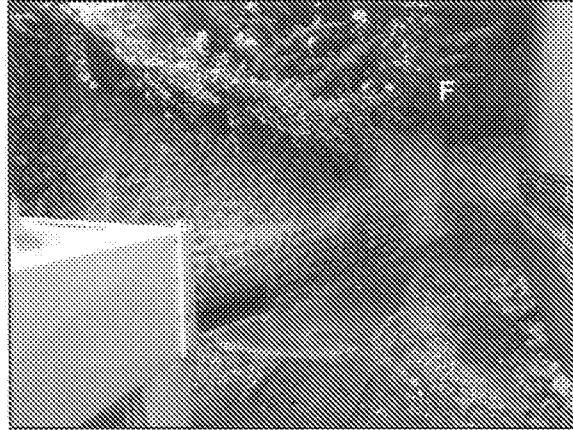
The wall then returns north for a distance of 1.95 metres (E-F) and then returns west, at more than a right angle, for a distance of 7.7 metres where it terminates in a brick abutment.

*The farmyard wall (F-G).*

These sections of wall (E-F and F-G) are both constructed of stone with brick corners, a brick coping, and a brick abutment (G).

This wall (E-G) is shown on all editions of the Ordnance survey plan and on the earlier ones there appears to have been a structure built up against its south face.

The current proposal is to demolish the section of the farmyard wall, extending roughly from between C and D to the west end (G) in order to accommodate new farm development.
