| PHOTOGRAPHIC LOG | | 305035 L01 (00) |
| Site Location: Land at Sefter Road, Bognor Regis, PO21 3EE | | Appendix D |

# **APPENDIX D**

## **TRIAL PIT SOAKAWAY TEST DATA**

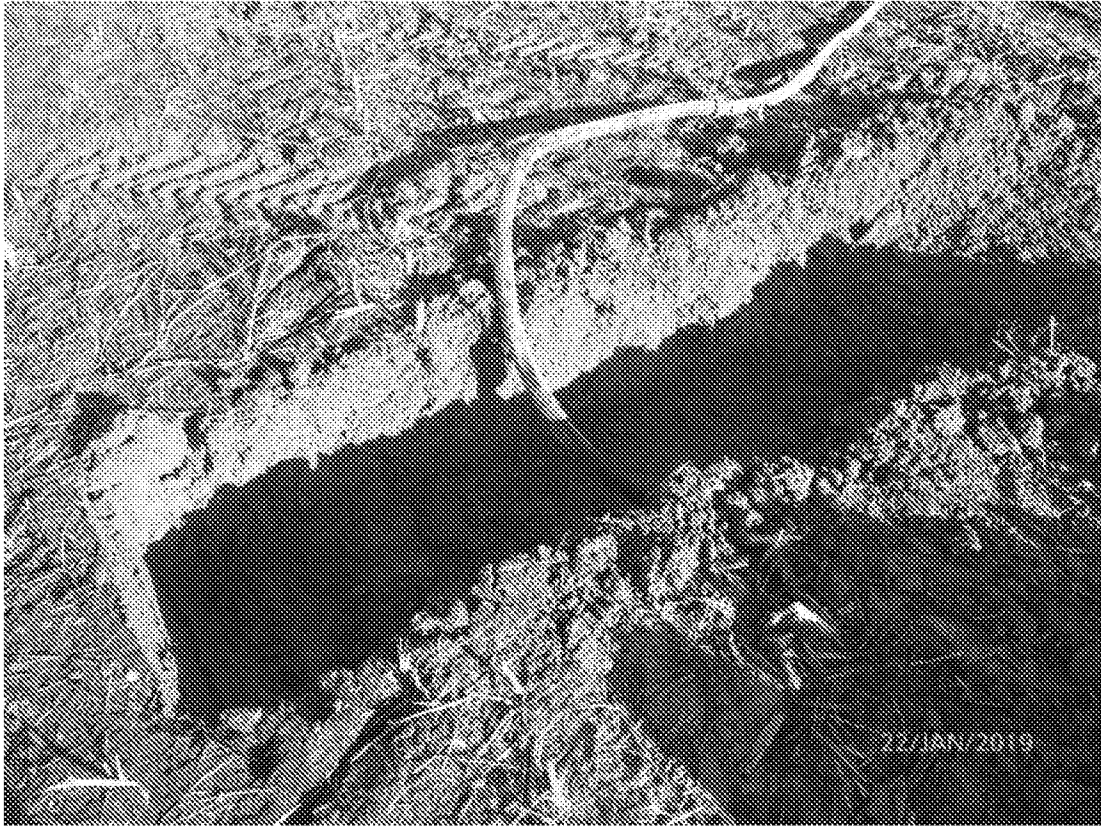
| PHOTOGRAPHIC LOG | | 305035 L01 (00) |
|---|---|---|
| Photo No.<br>41 | | |

| PHOTOGRAPHIC LOG | | 305035 L01 (00) |
|---|---|---|
| View of TP220 | | |

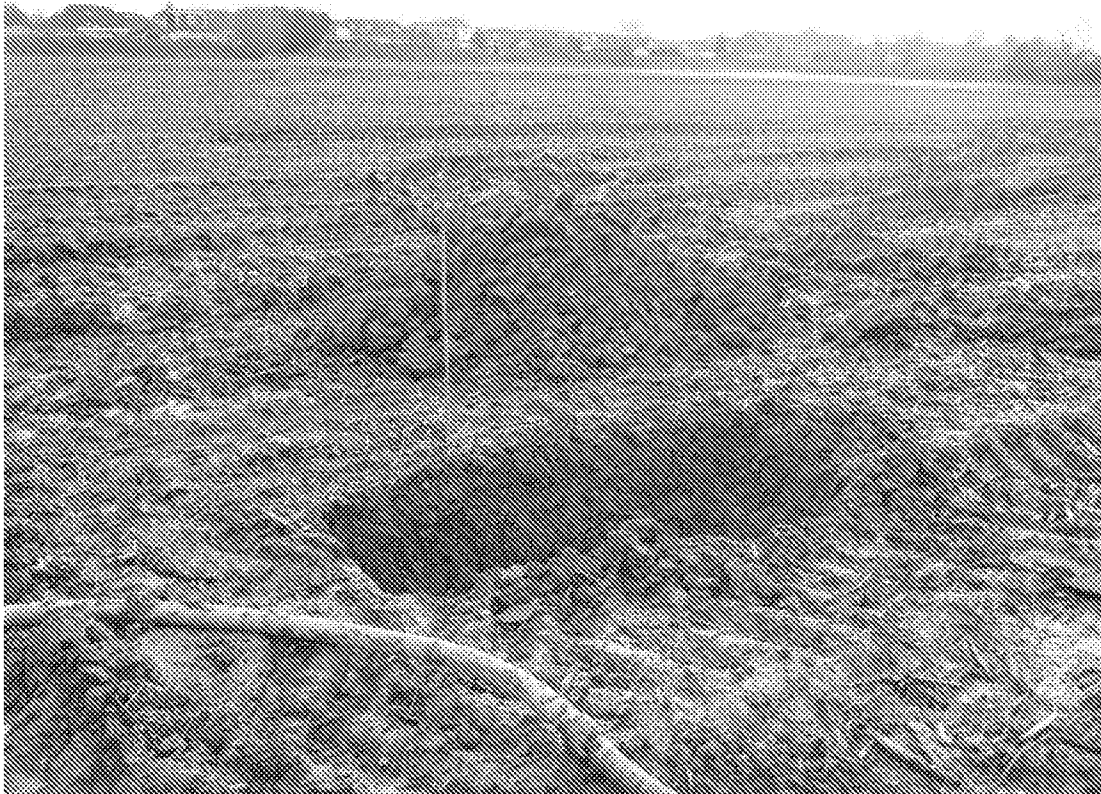
| PHOTOGRAPHIC LOG | | 305035 L01 (00) |
|---|---|---|
| Photo No.<br>42 | | |

| PHOTOGRAPHIC LOG | | 305035 L01 (00) |
|---|---|---|
| Facing east,<br>view of TP221<br>and arisings | | |

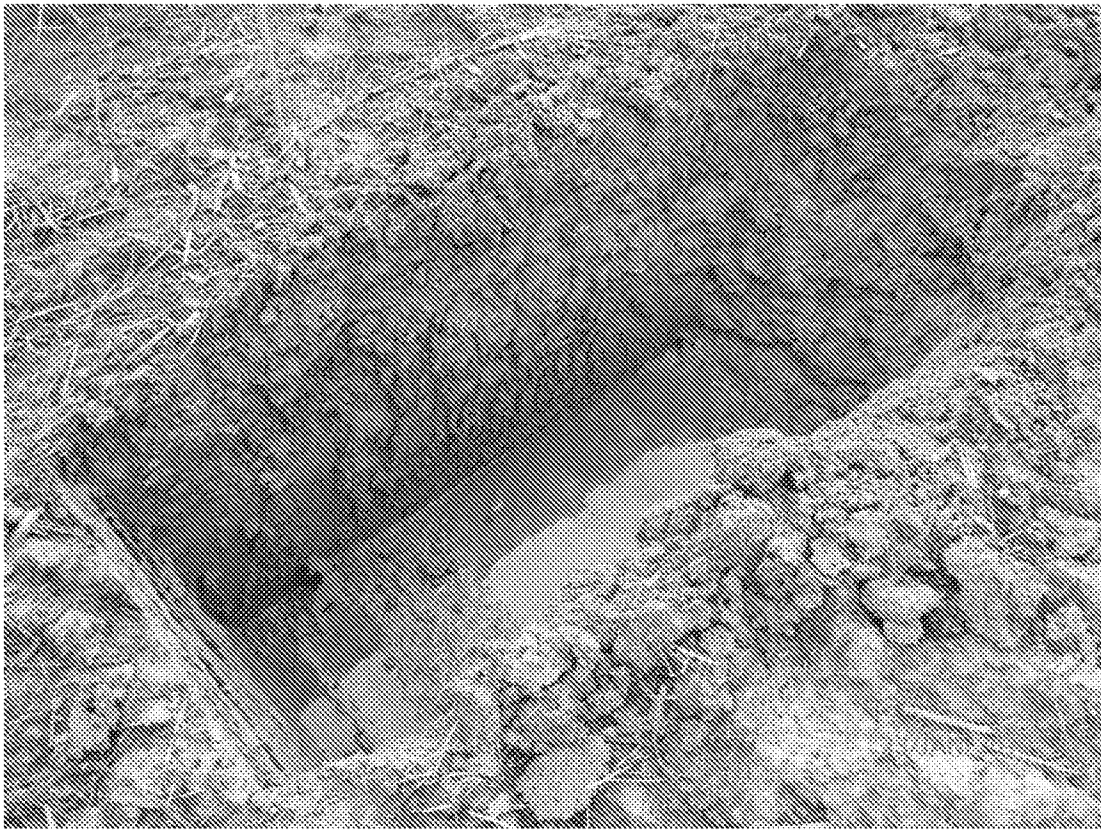
| PHOTOGRAPHIC LOG | | 305035 L01 (00) |
|---|---|---|
| Photo No.<br>43 | | |

| PHOTOGRAPHIC LOG | | 305035 L01 (00) |
|---|---|---|
| Downhole view of TP221 during soakage test | | |

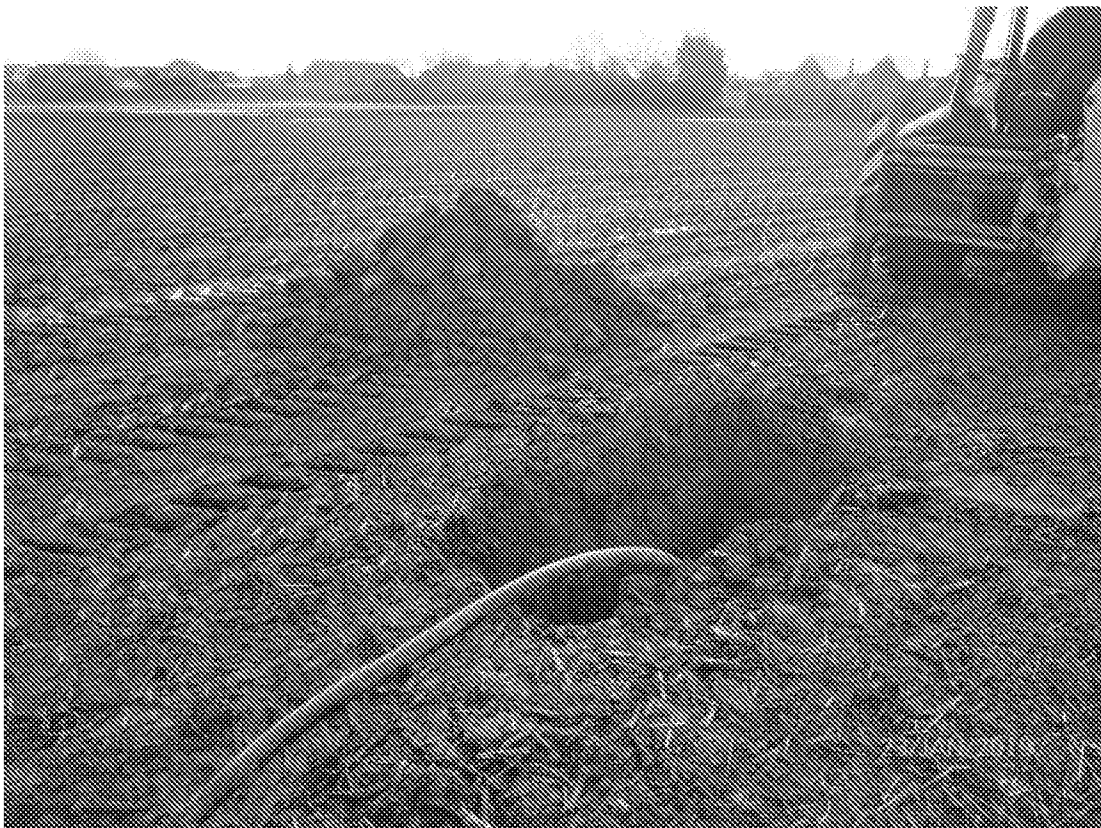
| PHOTOGRAPHIC LOG | | 305035 L01 (00) |
|---|---|---|
| Photo No.<br>44 | | |

| PHOTOGRAPHIC LOG | | 305035 L01 (00) |
|---|---|---|
| Facing southeast, view of TP222 | | |

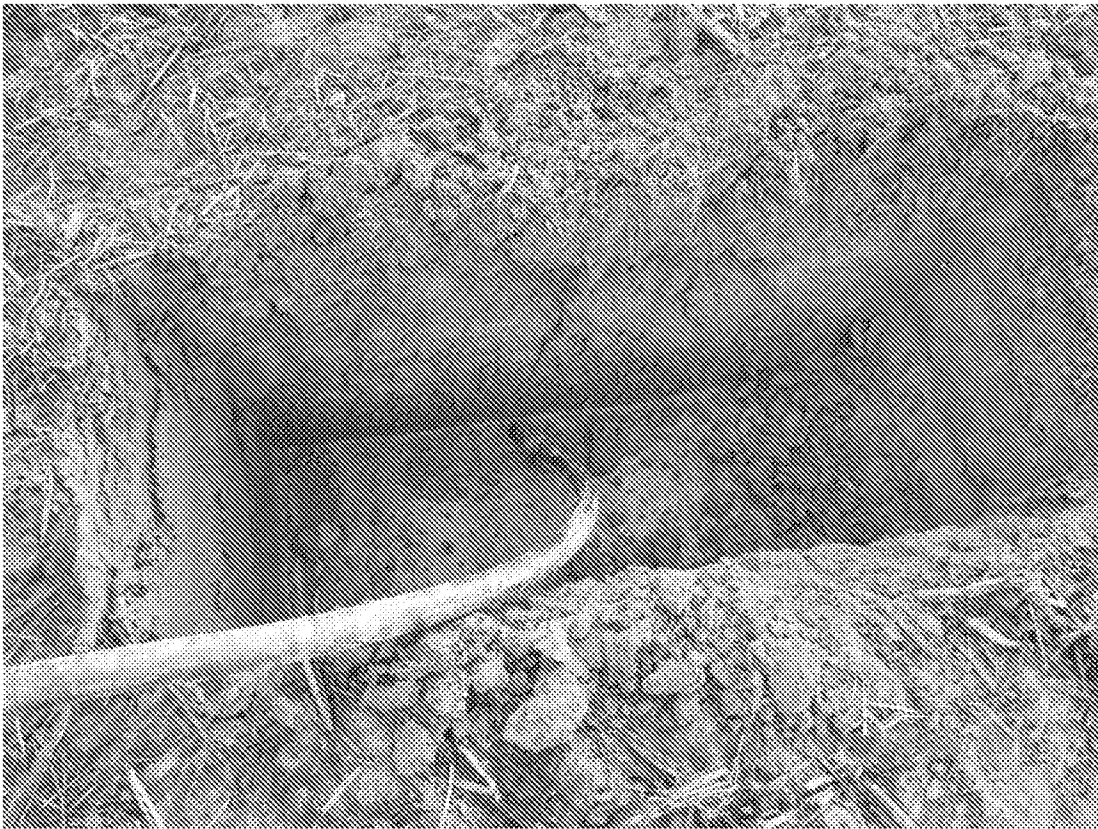
| PHOTOGRAPHIC LOG | | 305035 L01 (00) |
|---|---|---|
| Photo No.<br>45 | | |

| PHOTOGRAPHIC LOG | | 305035 L01 (00) |
|---|---|---|
| Downhole view<br>of TP222 | | |

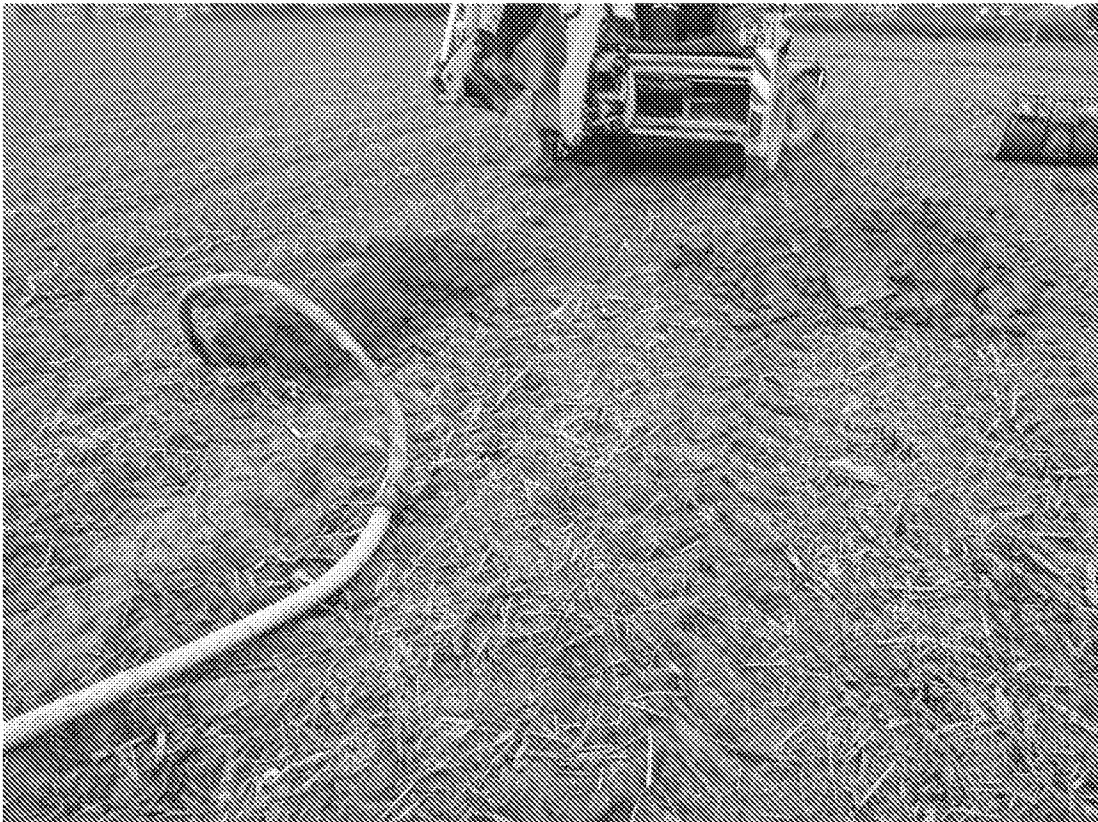
| PHOTOGRAPHIC LOG | | 305035 L01 (00) |
|---|---|---|
| Photo No.<br>46 | | |

| PHOTOGRAPHIC LOG | | 305035 L01 (00) |
|---|---|---|
| Facing south,<br>view of TP223 | | |

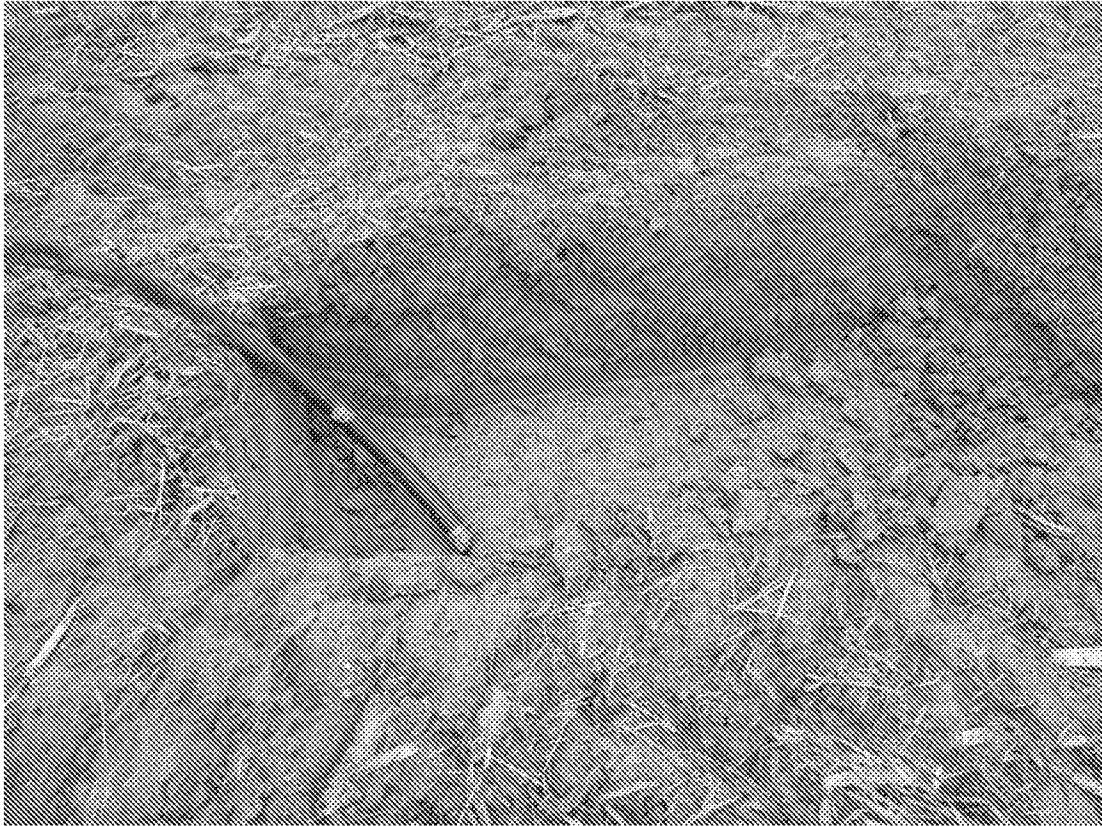
| PHOTOGRAPHIC LOG | | 305035 L01 (00) |
|---|---|---|
| Photo No.<br>47 | | |

| PHOTOGRAPHIC LOG | | 305035 L01 (00) |
|---|---|---|
| Downhole view<br>of TP223 | | |

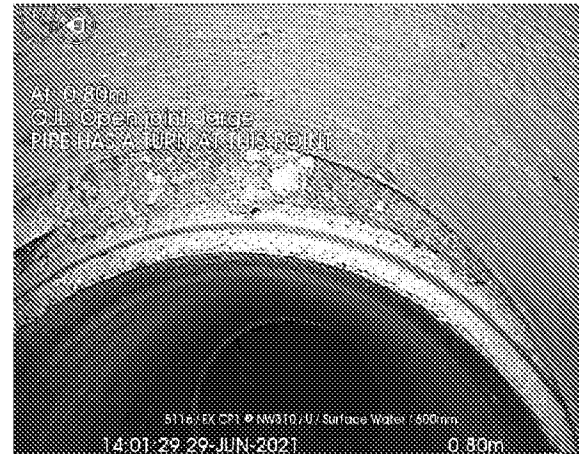
1-1-2A, 00:00:50, 0.80 m  
Open joint, large, PIPE HAS A TURN AT THIS POINT

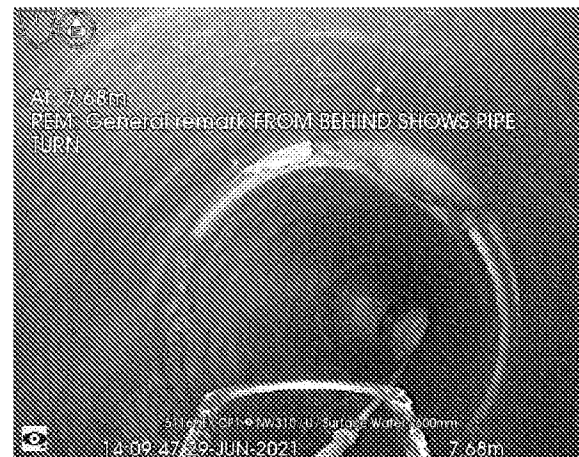
1-1-11A, 00:05:43, 7.68 m  
General remark, FROM BEHIND SHOWS PIPE TURN
