# Land At Hook Lane Pagham

FRA Addendum pursuant to the discharge of conditions  
10,11,12

**Document Title** FRA Addendum pursuant to the discharge of conditions 10,11,12  
**Document Ref** DR01  
**Project Name** Hook Lane Pagham  
**Project Number** 10461  
**Client** Hallam Land

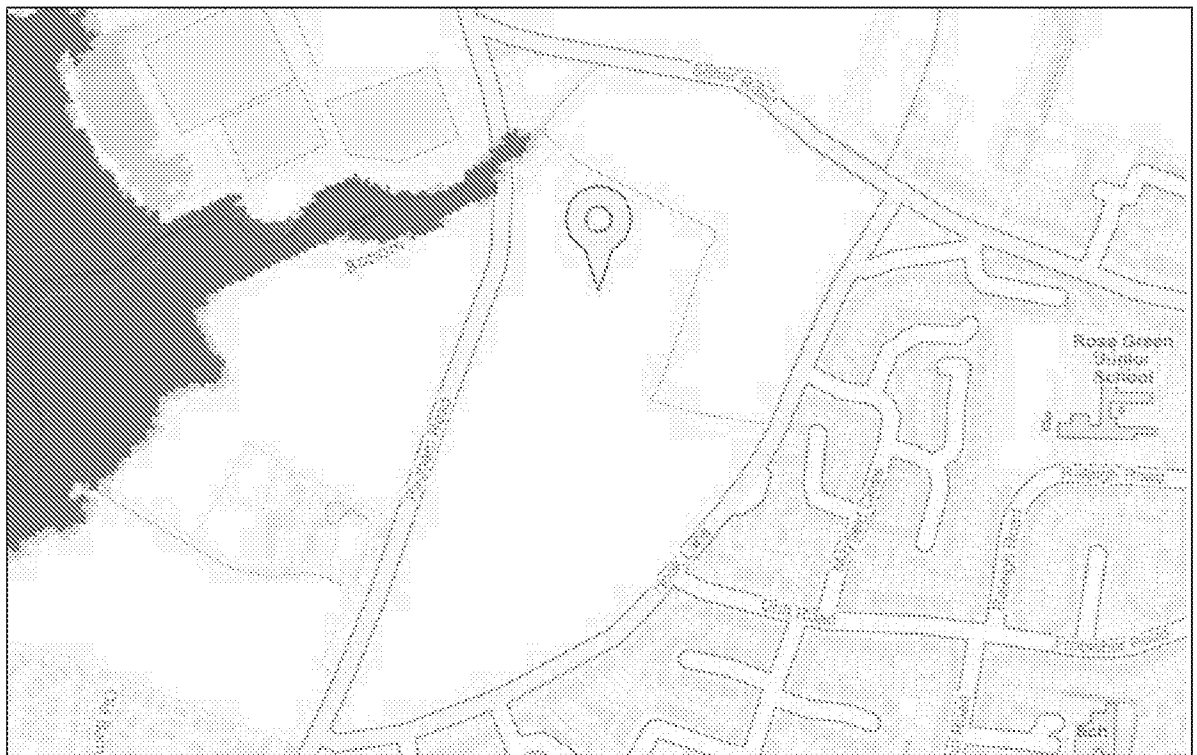
Figure 4-1: – Flood Map for Planning from Environment Agency mapping database

- 4.4 The approved FRA refers to the SFRA where it mentions the watercourse Pagham Rife that is in close proximity to the west of the site. The SFRA does not discuss flood impact zones but does reference flood defences present towards Pagham Harbour. The defences in place along the western part of Pagham Village include embankments and raised walls with condition grading recorded as good and fair.
- 4.5 Fluvial Flood Zones were produced as part of the SFRA and show the site to be located in Flood Zone with regard to fluvial flooding.
- 4.6 The mapping shows the proposed Hook Lane development to lie within Flood Zone 1, being an area of Low Probability of flooding, outside both the 1 in 100 (1% AEP) and 1 in 1,000 (0.1% AEP) year flood events. The current Environment Agency (EA) Flood Zone Map is shown in Figure 4-1

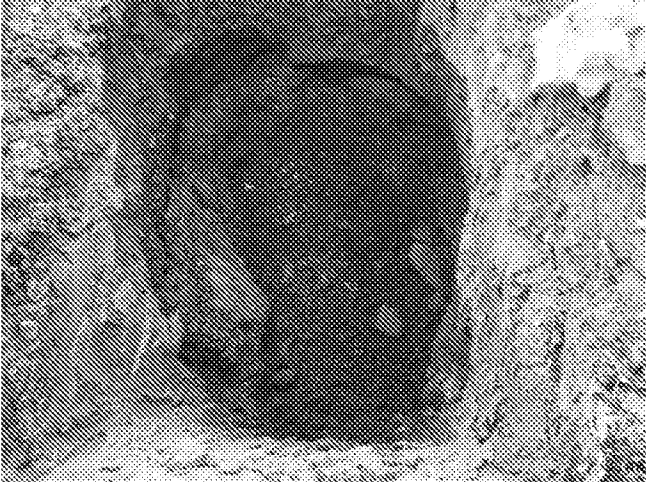
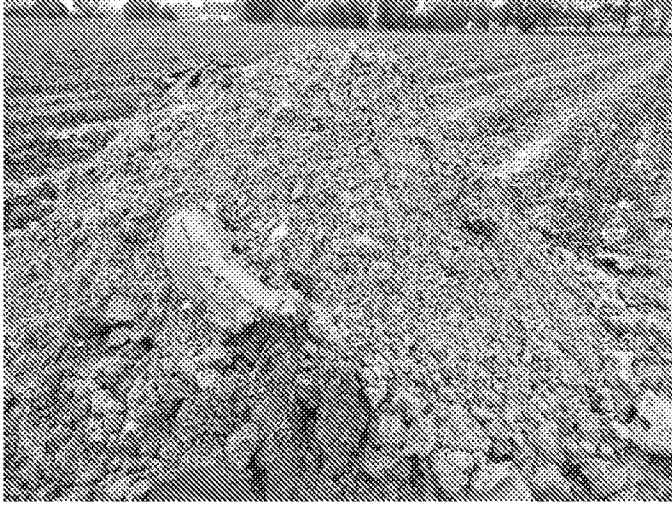
| <p><b>Photo 1:</b> Excavation of trial pit TP01.</p> | <p><b>Photo 2:</b> Arisings from trial pit TP01.</p> | |

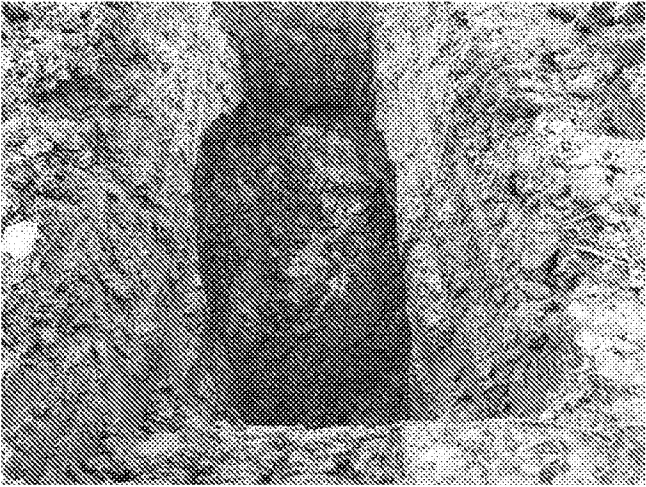
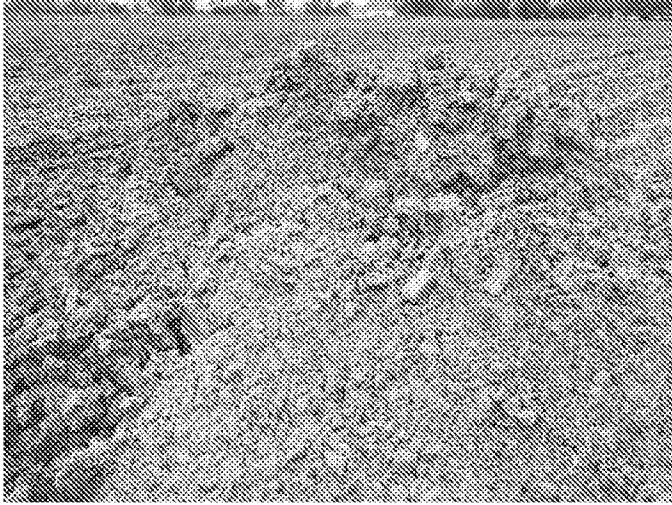
| <p><b>Photo 3:</b> Excavation of trial pit TP02.</p> | <p><b>Photo 4:</b> Arisings from trial pit TP02.</p> | |
