# **Land At Hook Lane Pagham – Phase 2**

FRA Addendum

10<sup>th</sup> February 2022

***PHASE I REVIEW & PHASE II GEO-ENVIRONMENTAL  
ASSESSMENT***

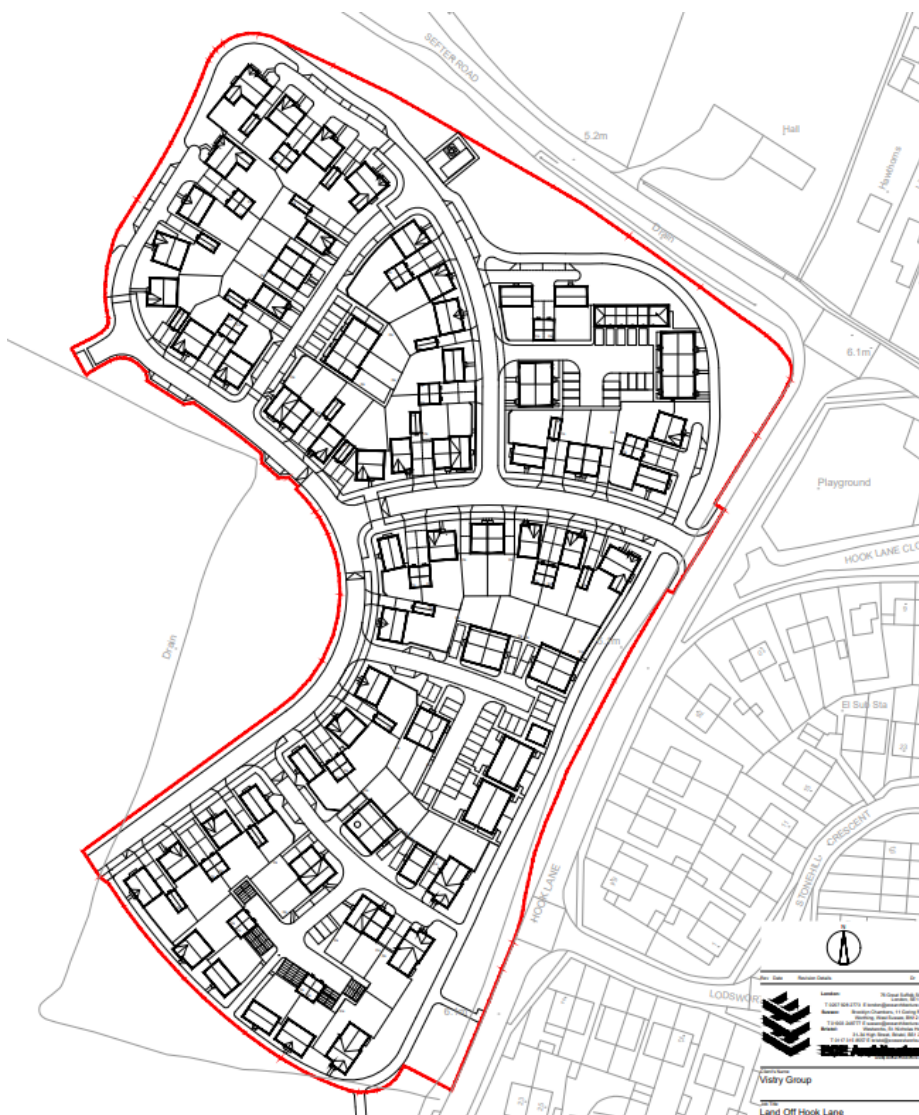
**Figure 2-1: – Illustrative Masterplan**

- 2.4** Development description - 'Section 73 Variation of Condition Application: Proposed Variation of Condition 1 pursuant to Reserved Matters Planning Permission P/132/20/RES (Approval of reserved matters following P/30/19/OUT for 300 No. new homes, internal roads, footpaths & cycleways, car parking & landscaping) for the substitution of 88no. units in the northern parcel to amend the layout, mix, appearance, car and cycle parking provision and landscaping at Land north of Hook Lane, Pagham.'

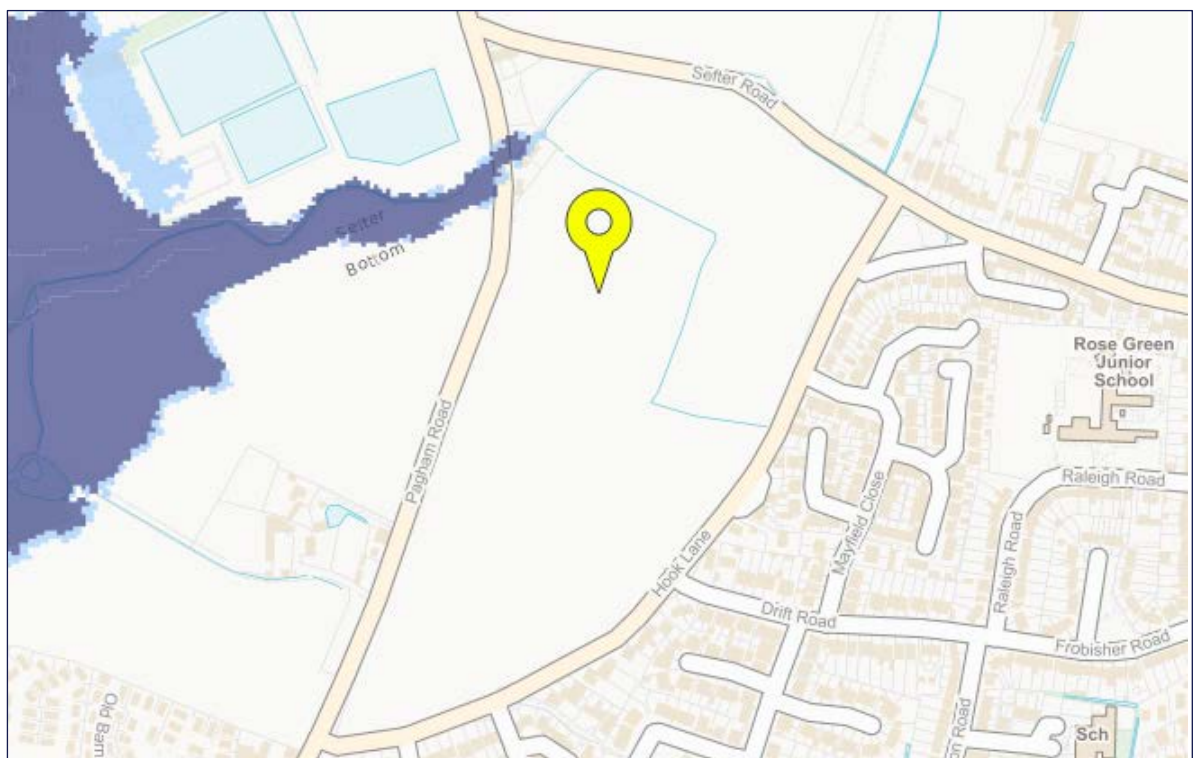
**Figure 4-1: – Flood Map for Planning from Environment Agency mapping database**

- 4.4 The approved FRA refers to the SFRA where it mentions the watercourse Pagham Rife that is in close proximity to the west of the site. The SFRA does not discuss flood impact zones but does reference flood defences present towards Pagham Harbour. The defences in place along the western part of Pagham Village include embankments and raised walls with condition grading recorded as good and fair.
- 4.5 Fluvial Flood Zones were produced as part of the SFRA and show the site to be located in Flood Zone with regard to fluvial flooding.
- 4.6 The mapping shows the proposed Hook Lane development to lie within Flood Zone 1, being an area of Low Probability of flooding, outside both the 1 in 100 (1% AEP) and 1 in 1,000 (0.1% AEP) year flood events. The current Government's Flood Maps for Planning is shown in Figure 4-1

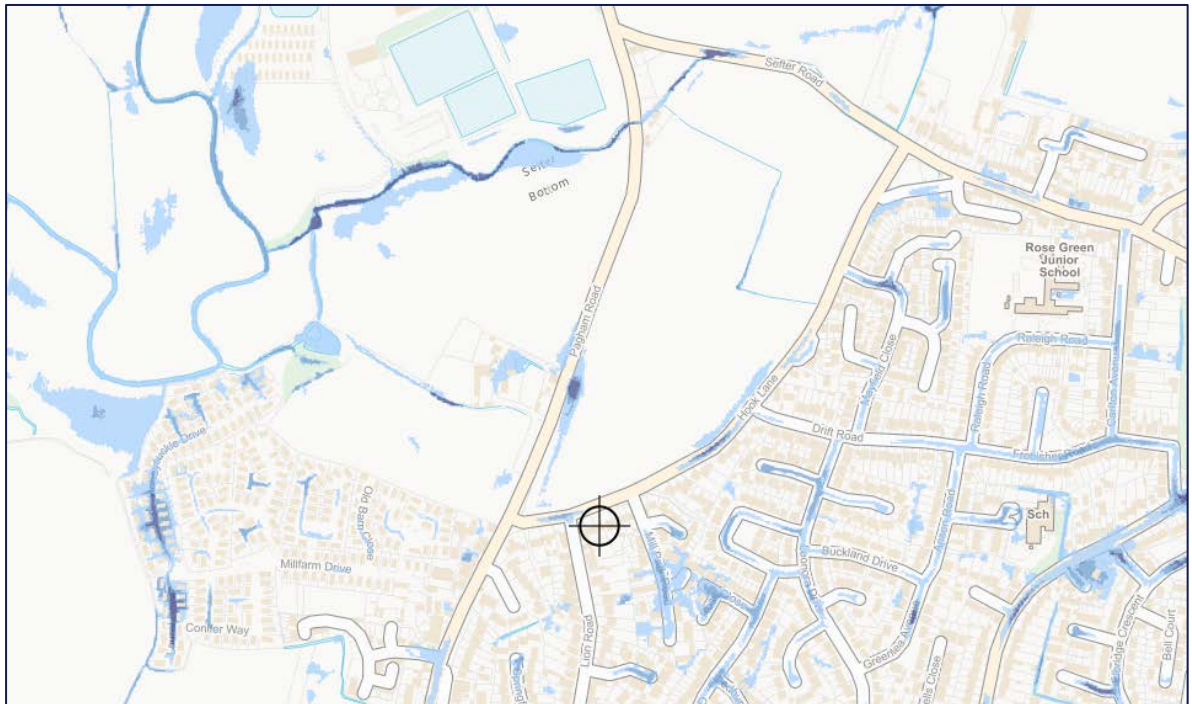
**Figure 4-2: – Surface Water Flood Map from Environment Agency mapping database**

- 4.18** The EA's Surface Water Flood Mapping identifies a number of areas that are at high risk from surface water flooding as illustrated in Figure 4-2 below. The mapping shows there is low to medium risk of flooding from the ditches and a high risk area to the south that corresponds with a low area on the topographical survey.

- 4.19** A site visit was undertaken as part of the approved FRA and found a gully grate in the south west corner of the site likely to allow runoff to drain beneath Pagham Road. Public consultations raised concern over surface water flooding in the area with anecdotal evidence suggesting highway flooding on a “semi-regular” basis.
- 4.20** A review of the existing highway cross sections and proposed development including the recommended earthworks found that the proposed development will drain to the west and will not exacerbate the flooding in Hook Lane .
- 4.21** The approved FRA concluded Given that the highest risk areas are in the low points of the site where SuDS drainage is to be situated, the sequential approach to masterplan development and the minor earthworks required to ensure catchments fall towards basins, the risk of flooding from surface water sources will be low.

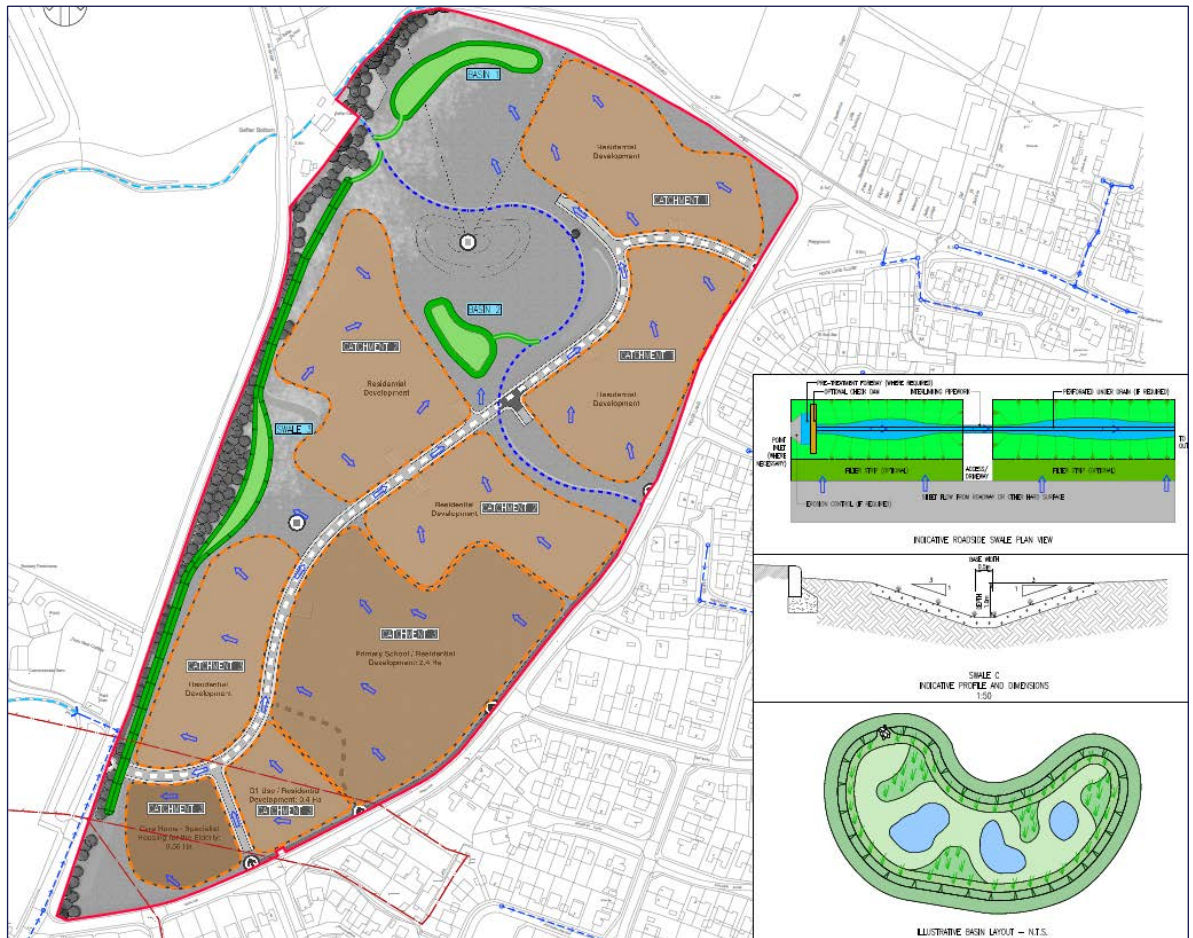
**Figure 4-3: Extract from illustrative drainage strategy WSP drawing ref 4147-D-02**

- 4.22** The drainage strategy in Section 5 will discuss the exceedance flows in further detail as recommended in the approved FRA. A principal exceedance strategy was presented in WSP Drawing Ref 4147-D-02 presented in Figure 4-3 below

- 4.23** The risk from exceedance flows is considered low.

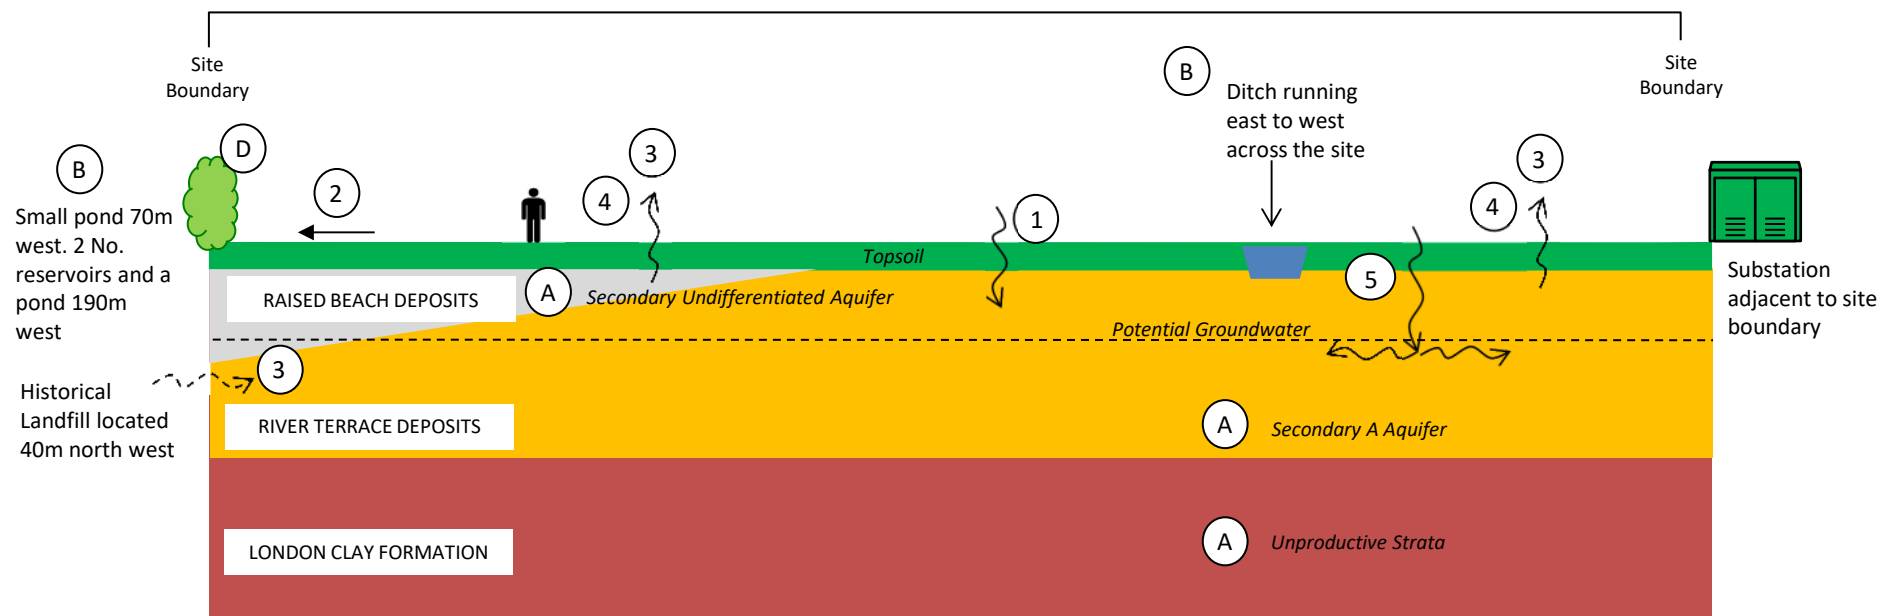
**PATHWAYS**

- ① Infiltration of precipitation
- ② Surface water run off
- ③ Migration of ground gases (methane and carbon dioxide)
- ④ Potential dermal contact, ingestion of contaminated soil and/or dust and inhalation of gases/vapours
- ⑤ Potential leaching/mobilisation of contaminants and lateral and vertical migration

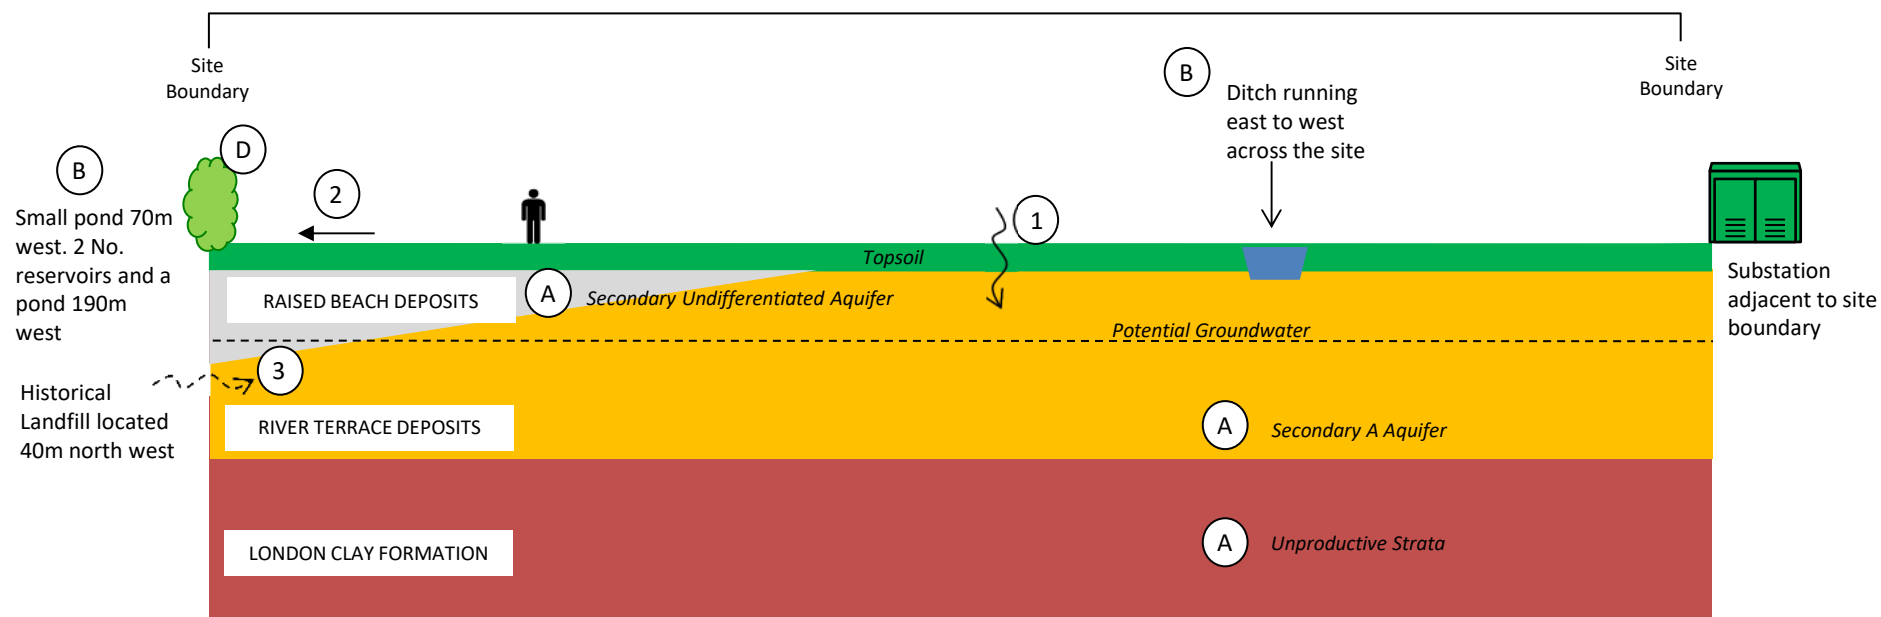
## PATHWAYS

- 1 Infiltration of precipitation
- 2 Surface water run off
- 3 Migration of ground gases (methane and carbon dioxide)
- 4 Potential dermal contact, ingestion of contaminated soil and/or dust and inhalation of gases/vapours
- 5 Potential leaching/mobilisation of contaminants and lateral and vertical migration

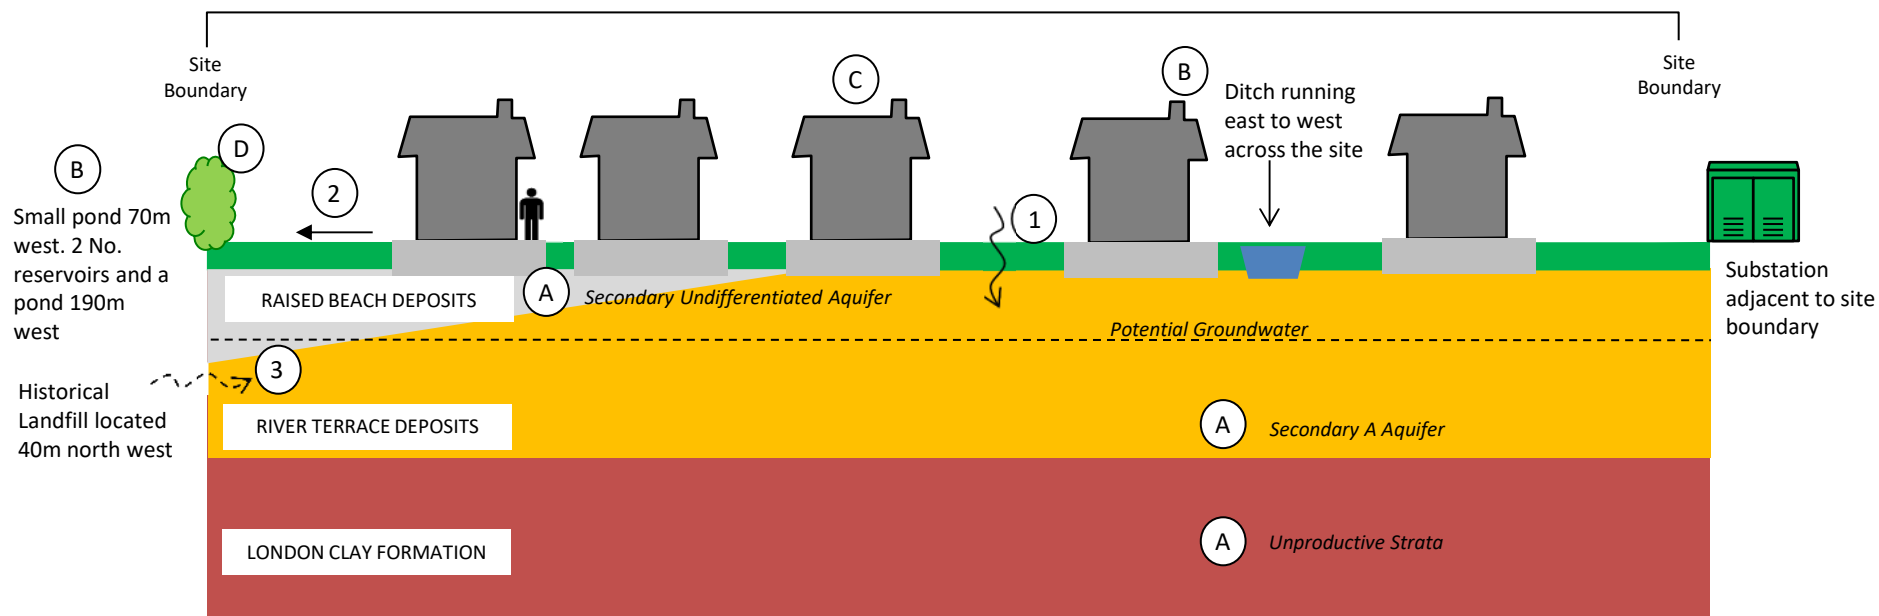
## PATHWAYS

- 1 Infiltration of precipitation
- 2 Surface water run off
- 3 Migration of ground gases (methane and carbon dioxide)
- 4 Potential dermal contact, ingestion of contaminated soil and/or dust and inhalation of gases/vapours
- 5 Potential leaching/mobilisation of contaminants and lateral and vertical migration

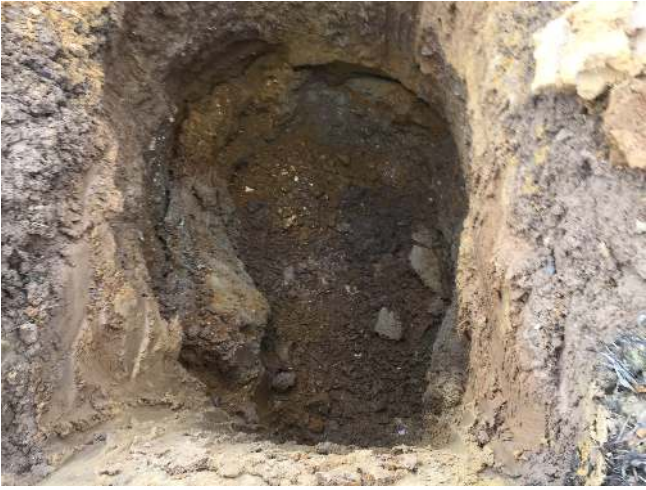
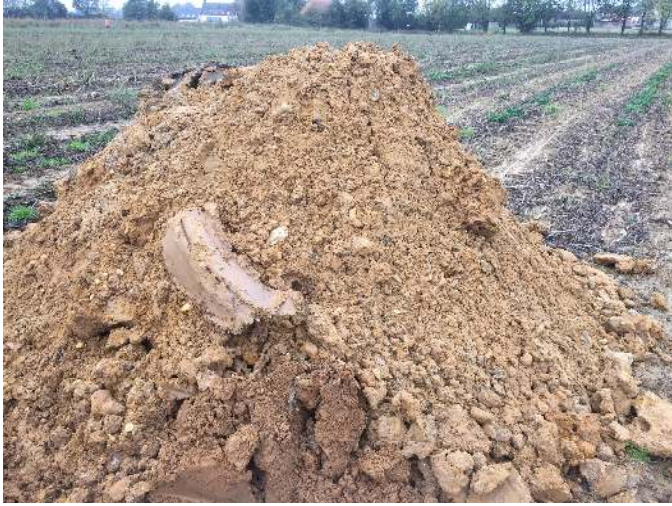
| <p><b>Photo 1:</b> Excavation of trial pit TP01.</p> | <p><b>Photo 2:</b> Arisings from trial pit TP01.</p> | |

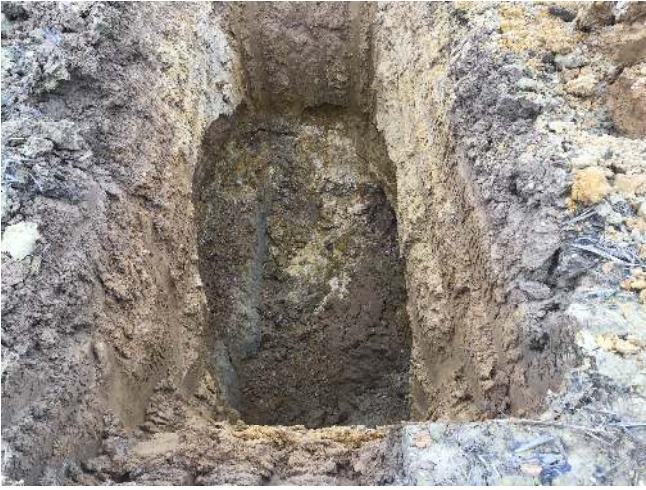
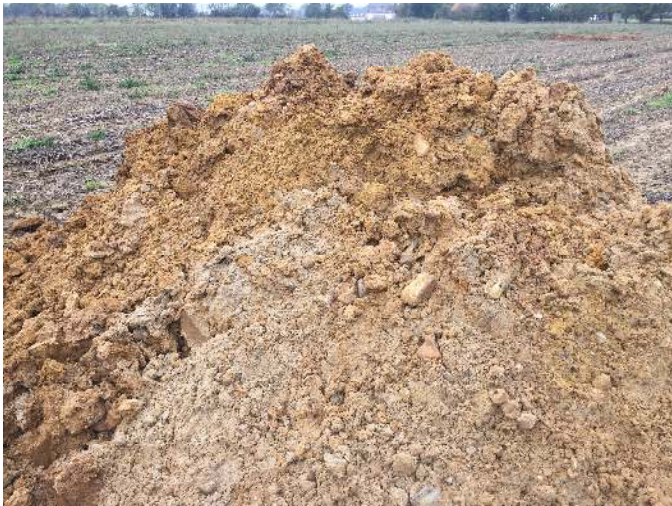
| <p><b>Photo 3:</b> Excavation of trial pit TP02.</p> | <p><b>Photo 4:</b> Arisings from trial pit TP02.</p> | |

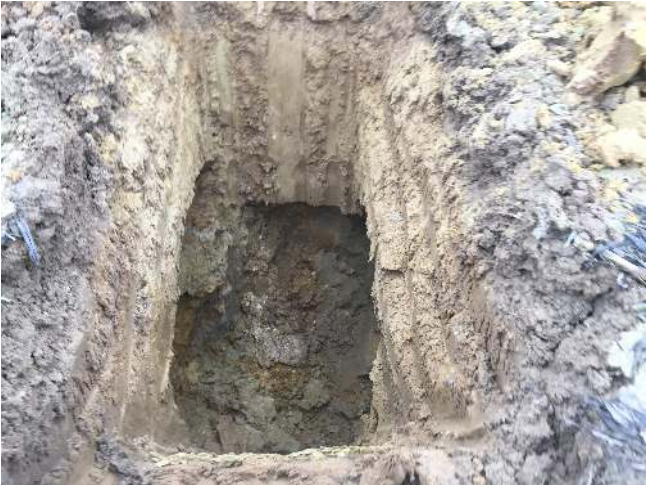
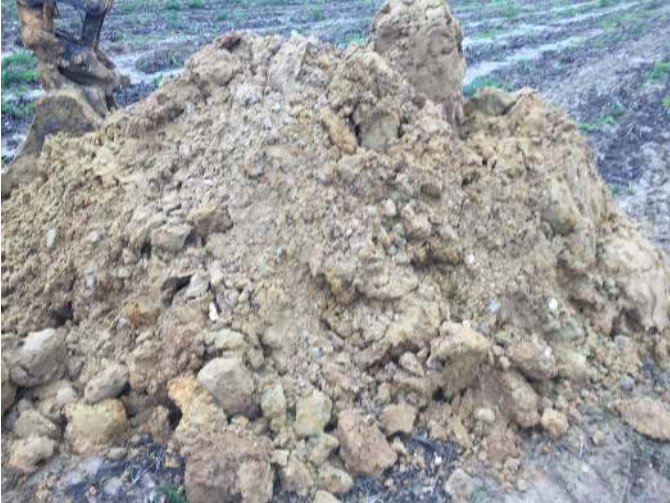
| <p><b>Photo 5:</b> Excavation of trial pit TP03.</p> | <p><b>Photo 6:</b> Arisings from trial pit TP03.</p> | |

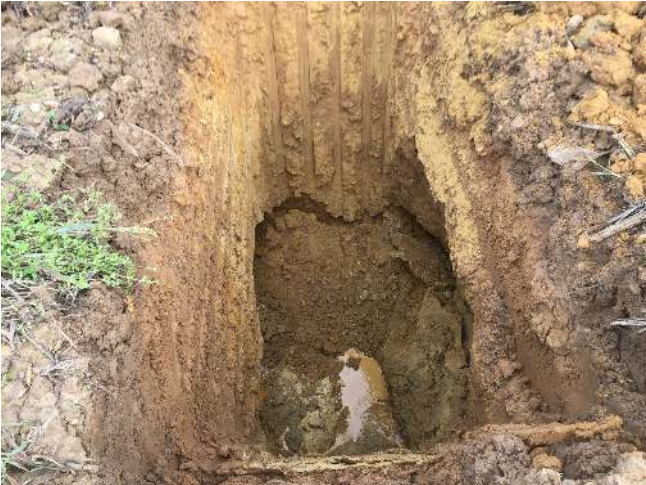
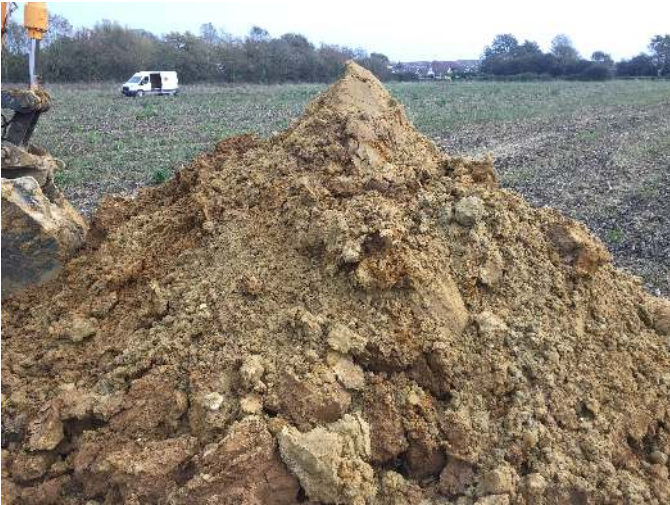
| <p><b>Photo 7:</b> Excavation of trial pit TP04.</p> | <p><b>Photo 8:</b> Arisings from trial pit TP04.</p> | |

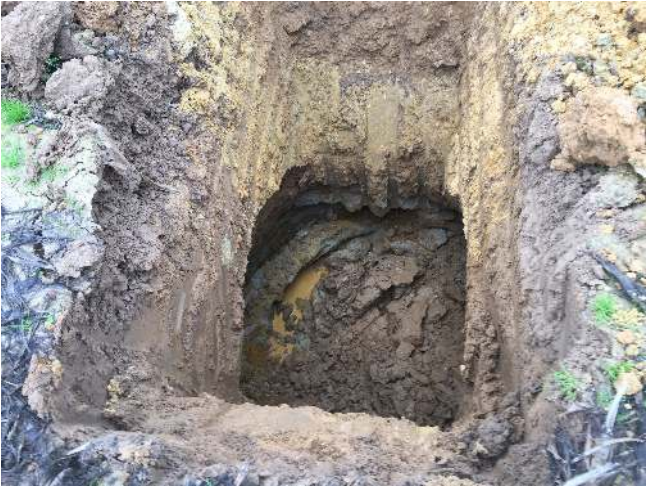
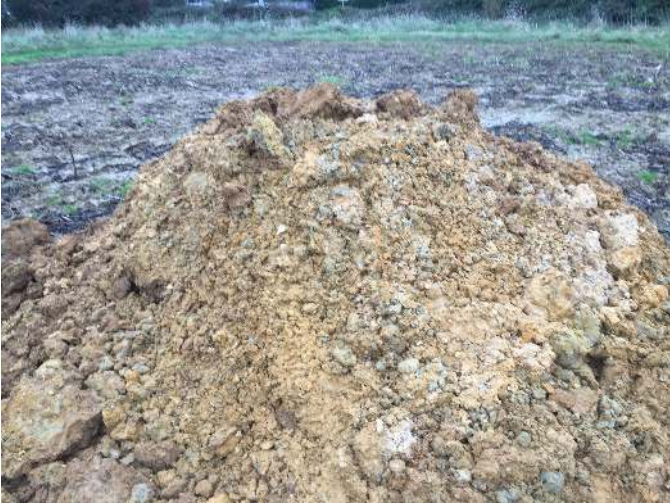
| <p><b>Photo 9:</b> Excavation of trial pit TP05.</p> | <p><b>Photo 10:</b> Arisings from trial pit TP05.</p> | |

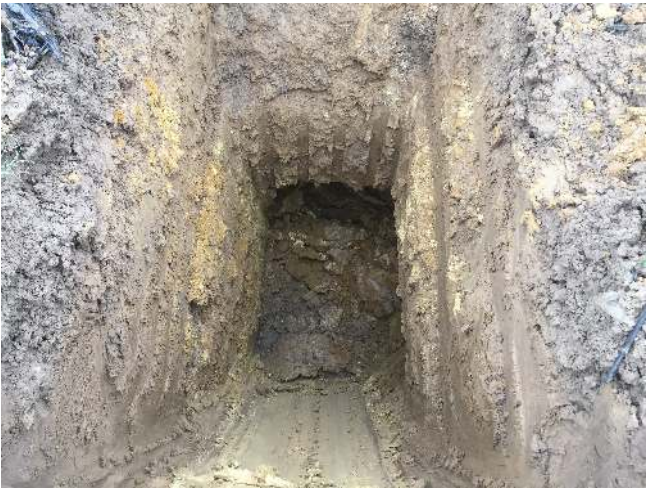
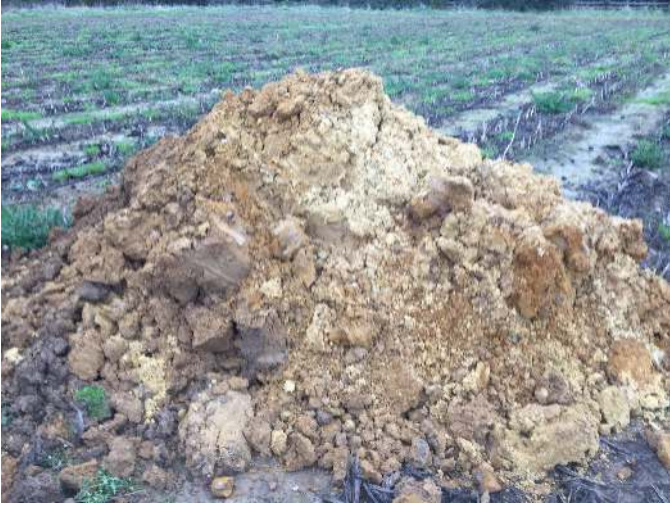
| <p><b>Photo 11:</b> Excavation of trial pit TP06.</p> | <p><b>Photo 12:</b> Arisings from trial pit TP06.</p> | |

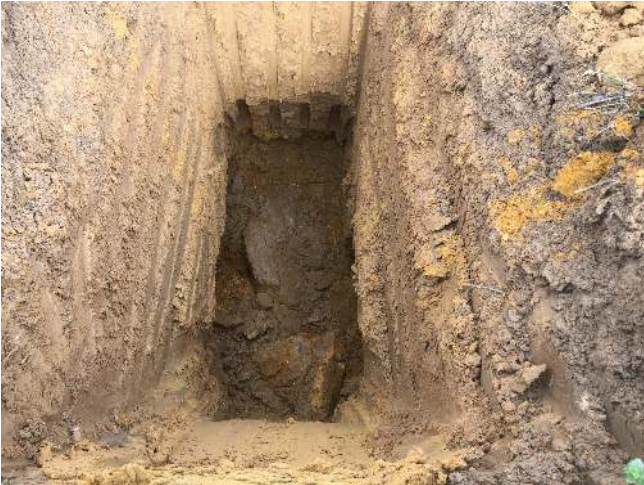
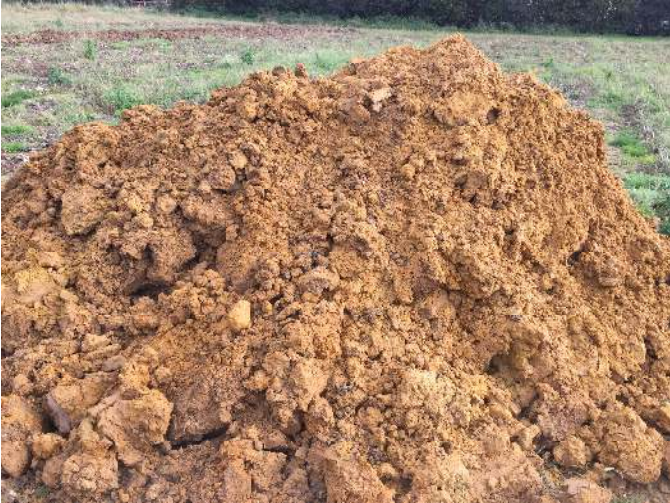
| <p><b>Photo 13:</b> Excavation of trial pit TP08.</p> | <p><b>Photo 14:</b> Arisings from trial pit TP08.</p> | |

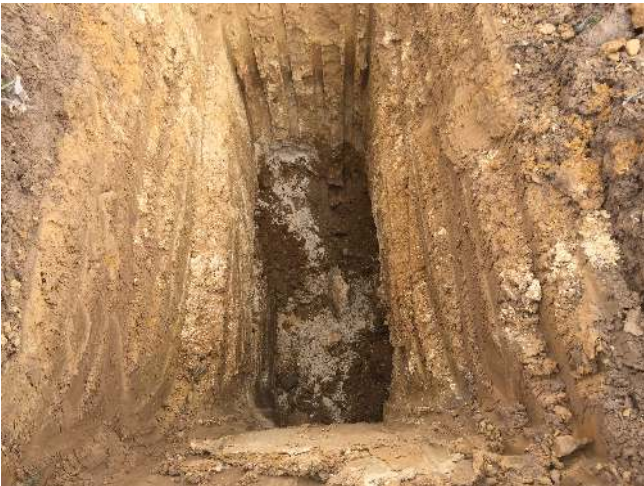
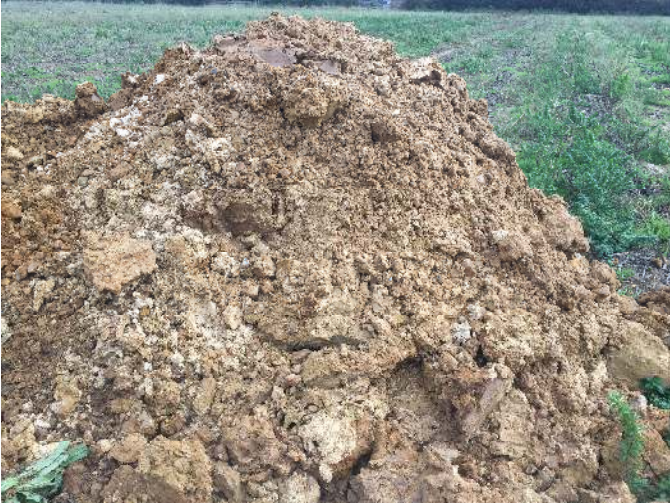
| <p><b>Photo 15:</b> Excavation of trial pit TP09.</p> | <p><b>Photo 16:</b> Arisings from trial pit TP09.</p> | |

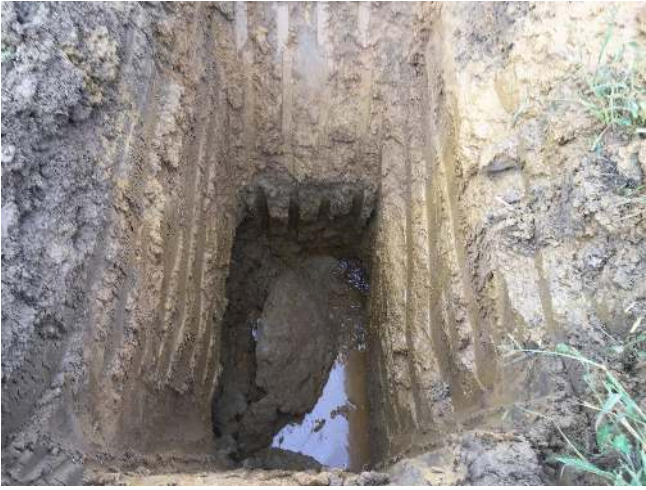
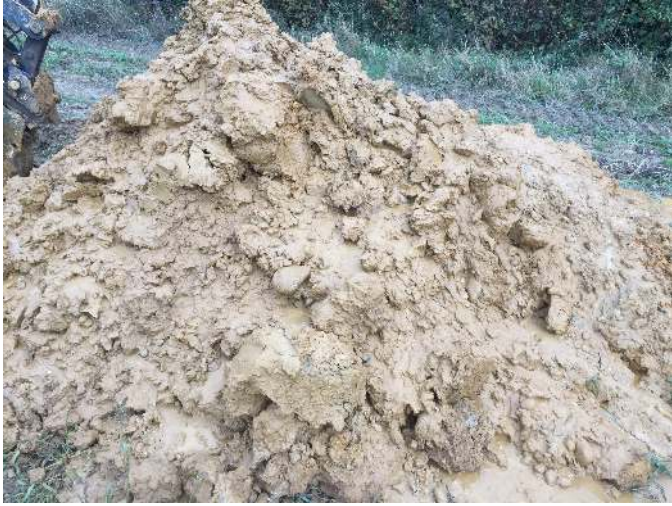
| <p><b>Photo 17:</b> Excavation of trial pit TP10.</p> | <p><b>Photo 18:</b> Arisings from trial pit TP10.</p> | |

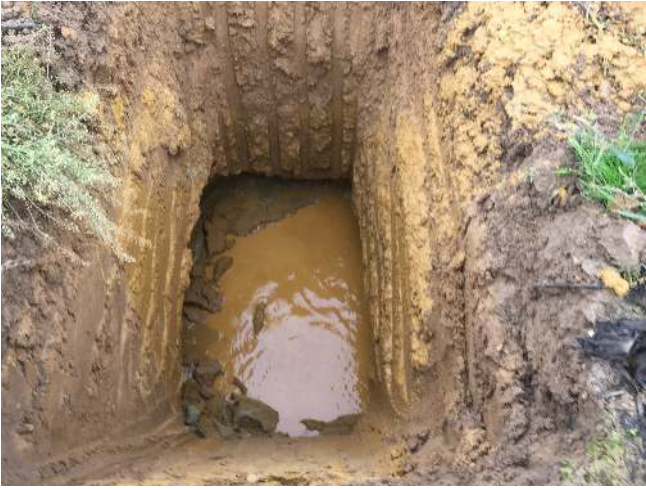
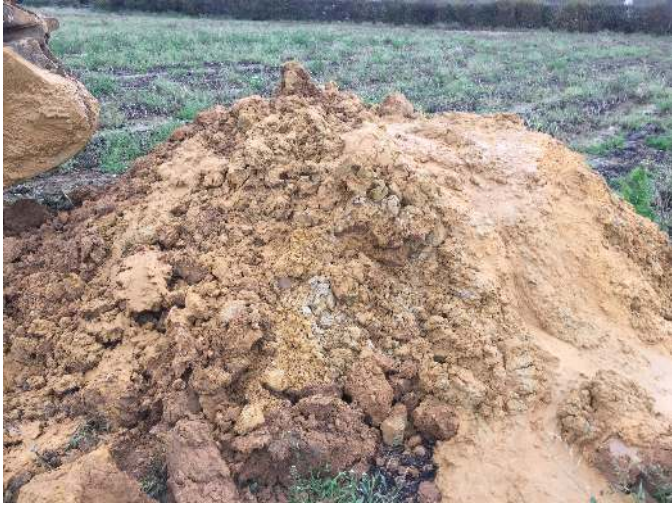
| <p><b>Photo 19:</b> Excavation of trial pit TP11.</p> | <p><b>Photo 20:</b> Arisings from trial pit TP11.</p> | |

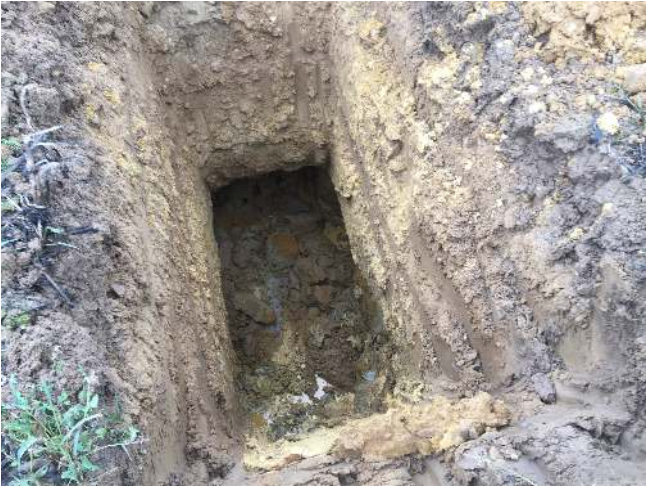
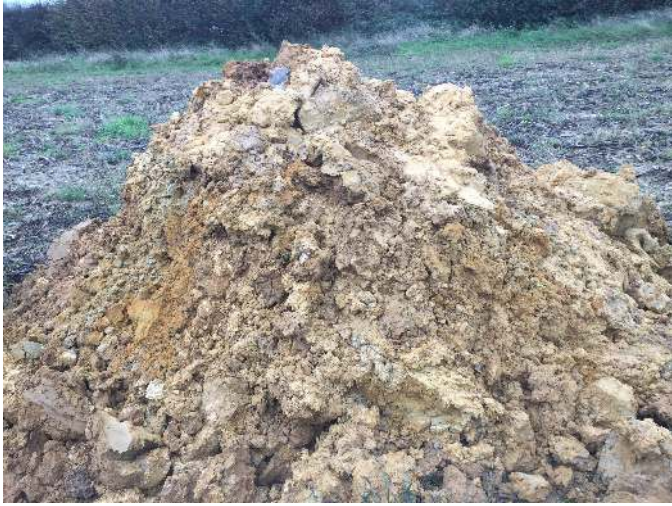
| <p><b>Photo 21:</b> Excavation of trial pit TP12.</p> | <p><b>Photo 22:</b> Arisings from trial pit TP12.</p> | |

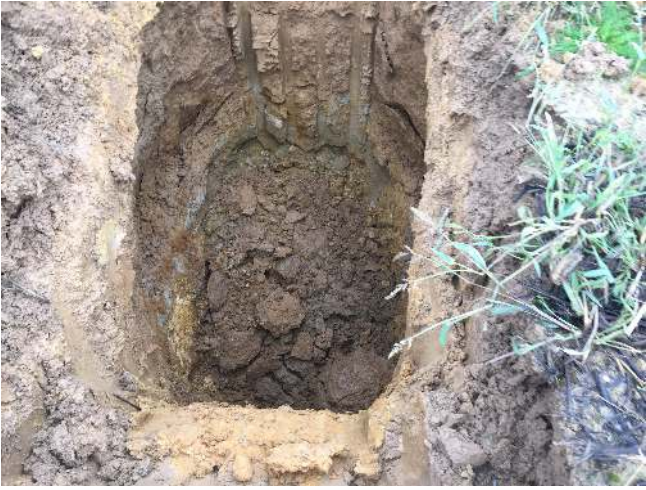
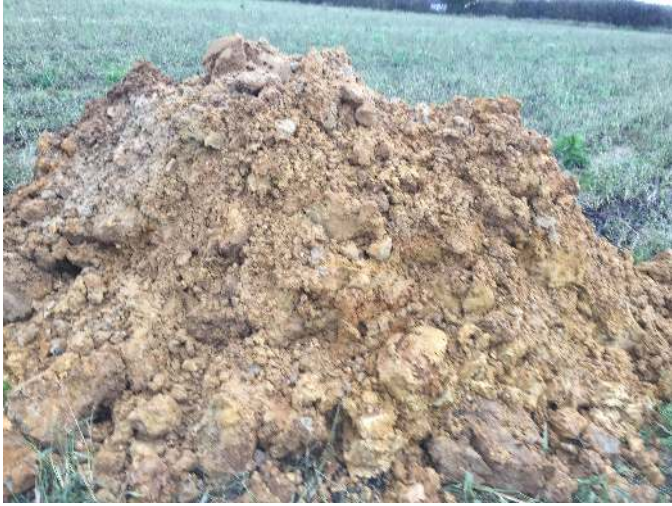
| <p><b>Photo 23:</b> Excavation of trial pit TP13.</p> | <p><b>Photo 24:</b> Arisings from trial pit TP13.</p> | |

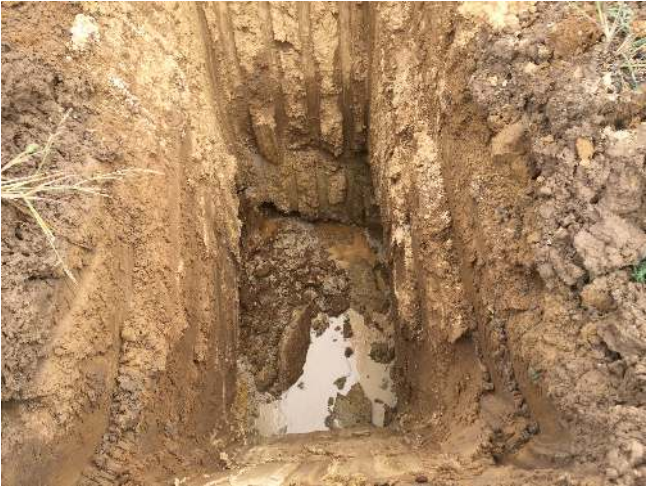
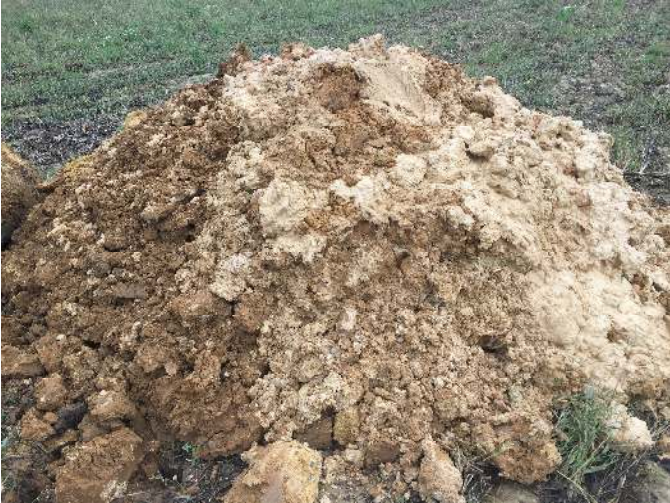
| <p><b>Photo 25:</b> Excavation of trial pit TP14.</p> | <p><b>Photo 26:</b> Arisings from trial pit TP14.</p> | |

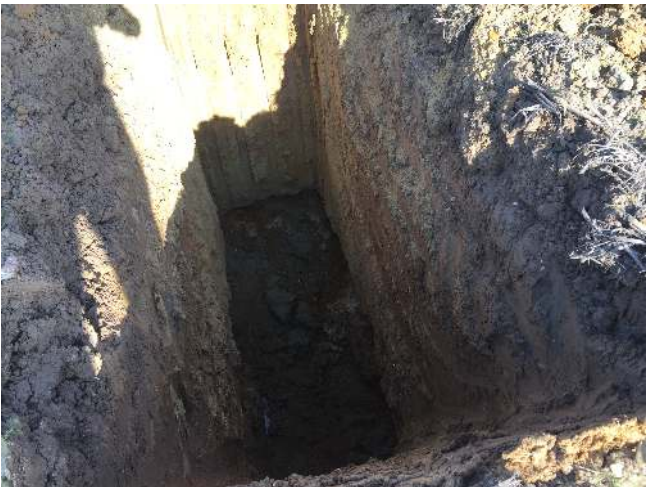
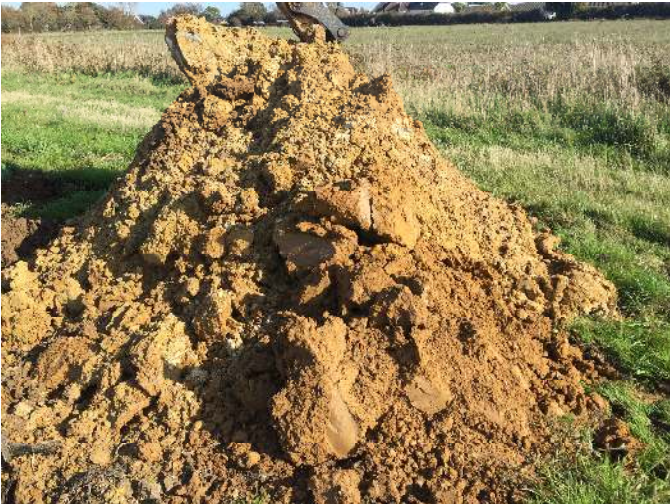
| <p><b>Photo 27:</b> Excavation of trial pit TP15.</p> | <p><b>Photo 28:</b> Arisings from trial pit TP15.</p> | |

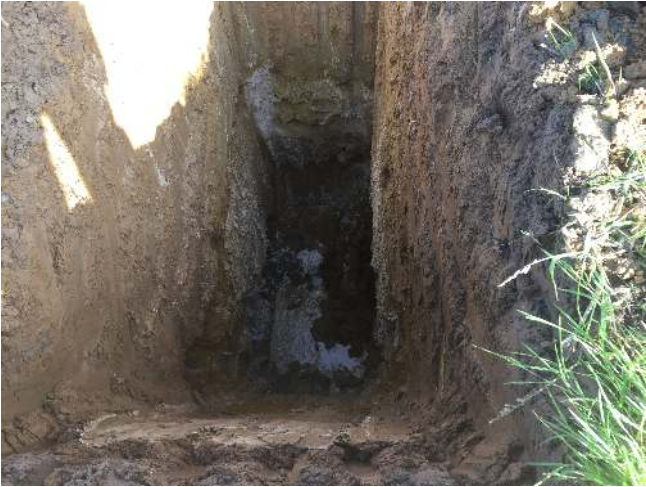
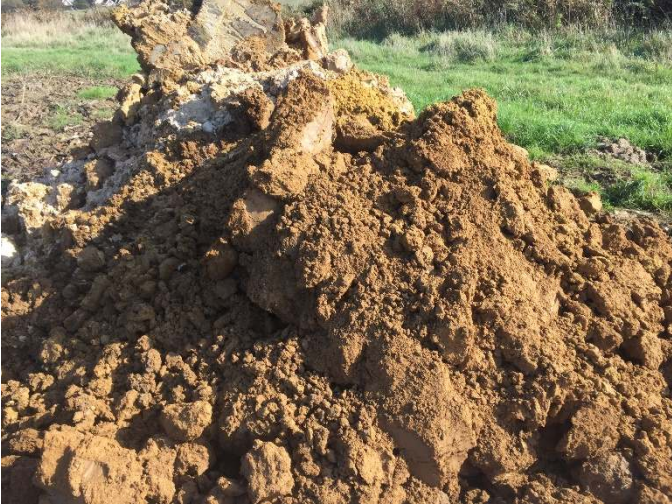
| <p><b>Photo 29:</b> Excavation of trial pit TP16.</p> | <p><b>Photo 30:</b> Arisings from trial pit TP16.</p> | |

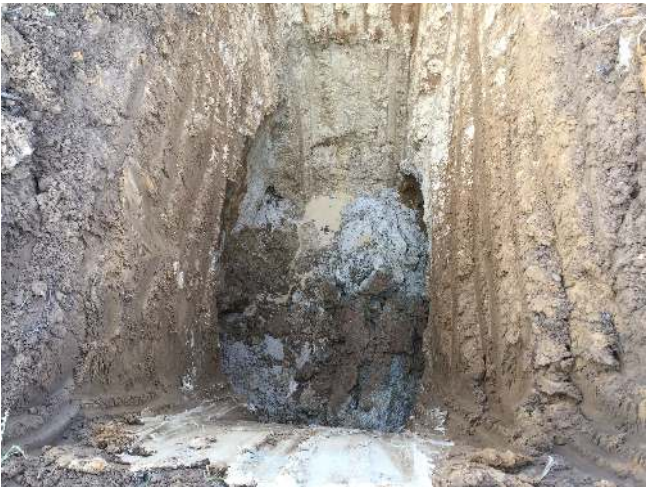
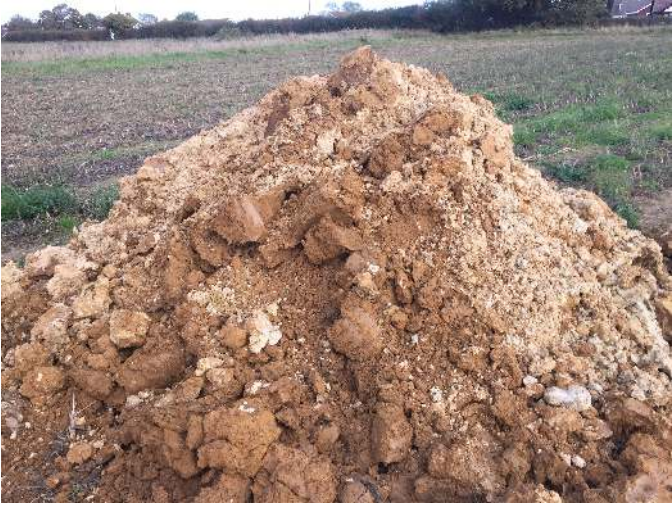
| <p><b>Photo 31:</b> Excavation of trial pit TP17.</p> | <p><b>Photo 32:</b> Arisings from trial pit TP17.</p> | |
