# **Land At Hook Lane Pagham – Phase 2**

FRA Addendum

10<sup>th</sup> February 2022

***PHASE I REVIEW & PHASE II GEO-ENVIRONMENTAL  
ASSESSMENT***

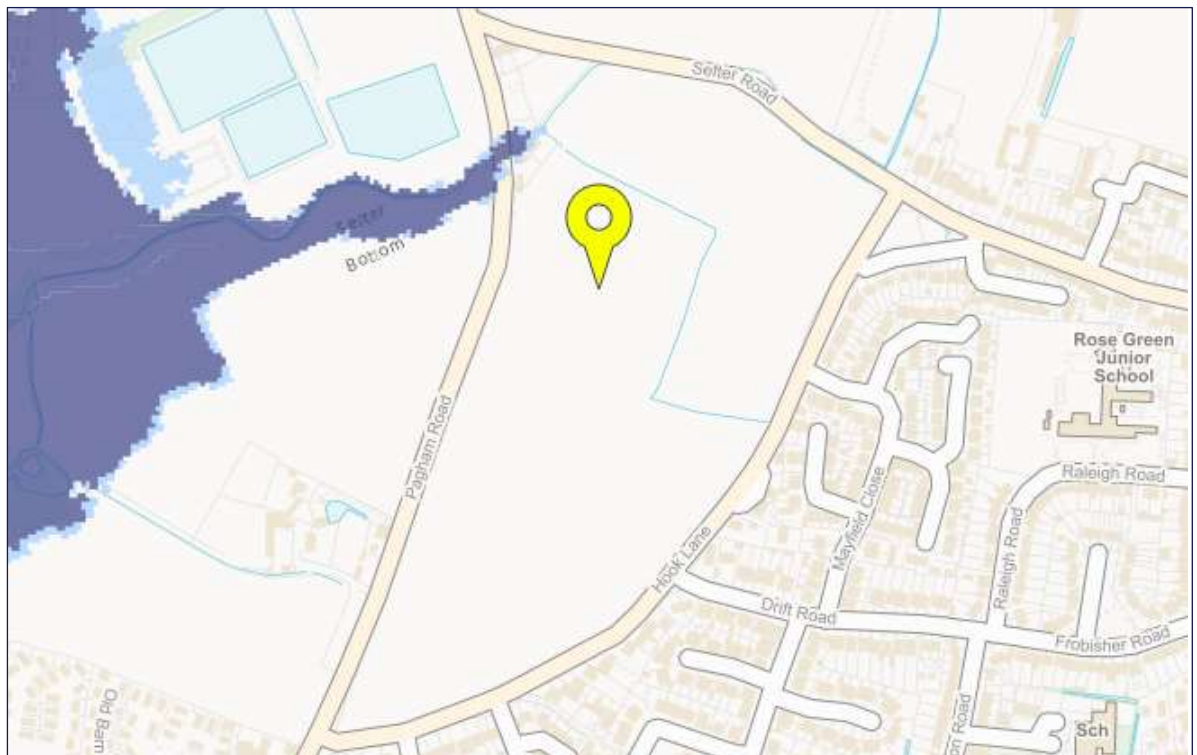
**Figure 4-1: – Flood Map for Planning from Environment Agency mapping database**

- 4.4 The approved FRA refers to the SFRA where it mentions the watercourse Pagham Rife that is in close proximity to the west of the site. The SFRA does not discuss flood impact zones but does reference flood defences present towards Pagham Harbour. The defences in place along the western part of Pagham Village include embankments and raised walls with condition grading recorded as good and fair.
- 4.5 Fluvial Flood Zones were produced as part of the SFRA and show the site to be located in Flood Zone with regard to fluvial flooding.
- 4.6 The mapping shows the proposed Hook Lane development to lie within Flood Zone 1, being an area of Low Probability of flooding, outside both the 1 in 100 (1% AEP) and 1 in 1,000 (0.1% AEP) year flood events. The current Government's Flood Maps for Planning is shown in Figure 4-1

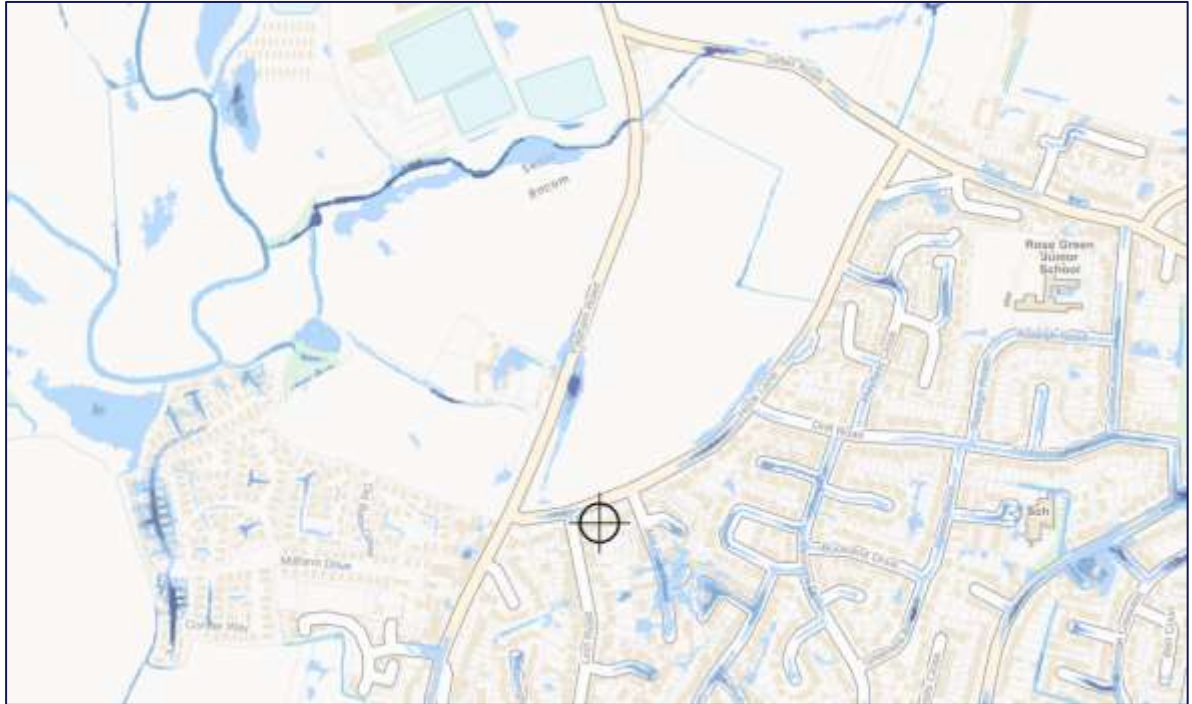
**Figure 4-2: – Surface Water Flood Map from Environment Agency mapping database**

- 4.18** The EA's Surface Water Flood Mapping identifies a number of areas that are at high risk from surface water flooding as illustrated in Figure 4-2 below. The mapping shows there is low to medium risk of flooding from the ditches and a high risk area to the south that corresponds with a low area on the topographical survey.

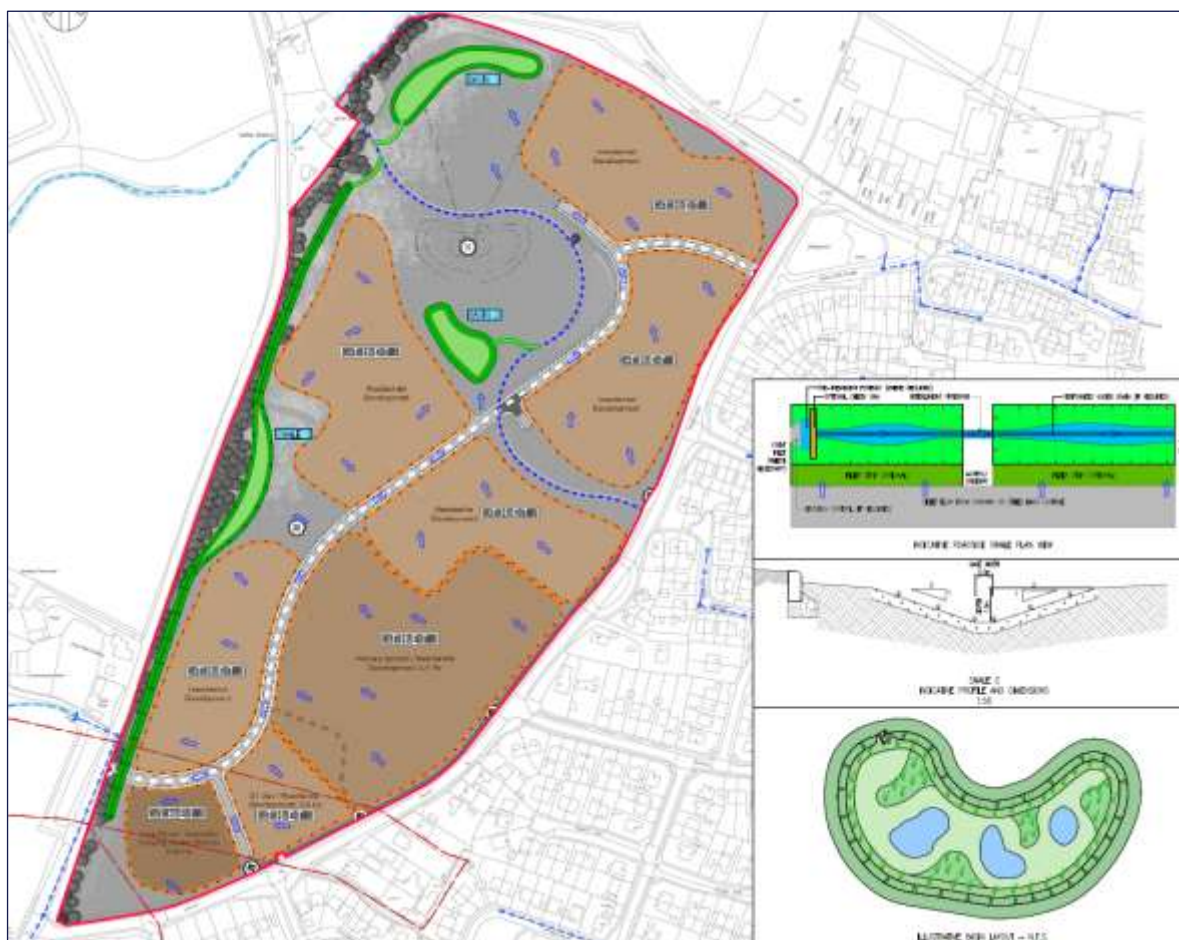
Figure 4-3: Extract from illustrative drainage strategy WSP drawing ref 4147-D-02

- 4.22** The drainage strategy in Section 5 will discuss the exceedance flows in further detail as recommended in the approved FRA. A principal exceedance strategy was presented in WSP Drawing Ref 4147-D-02 presented in Figure 4-3 below

- 4.23** The risk from exceedance flows is considered low.

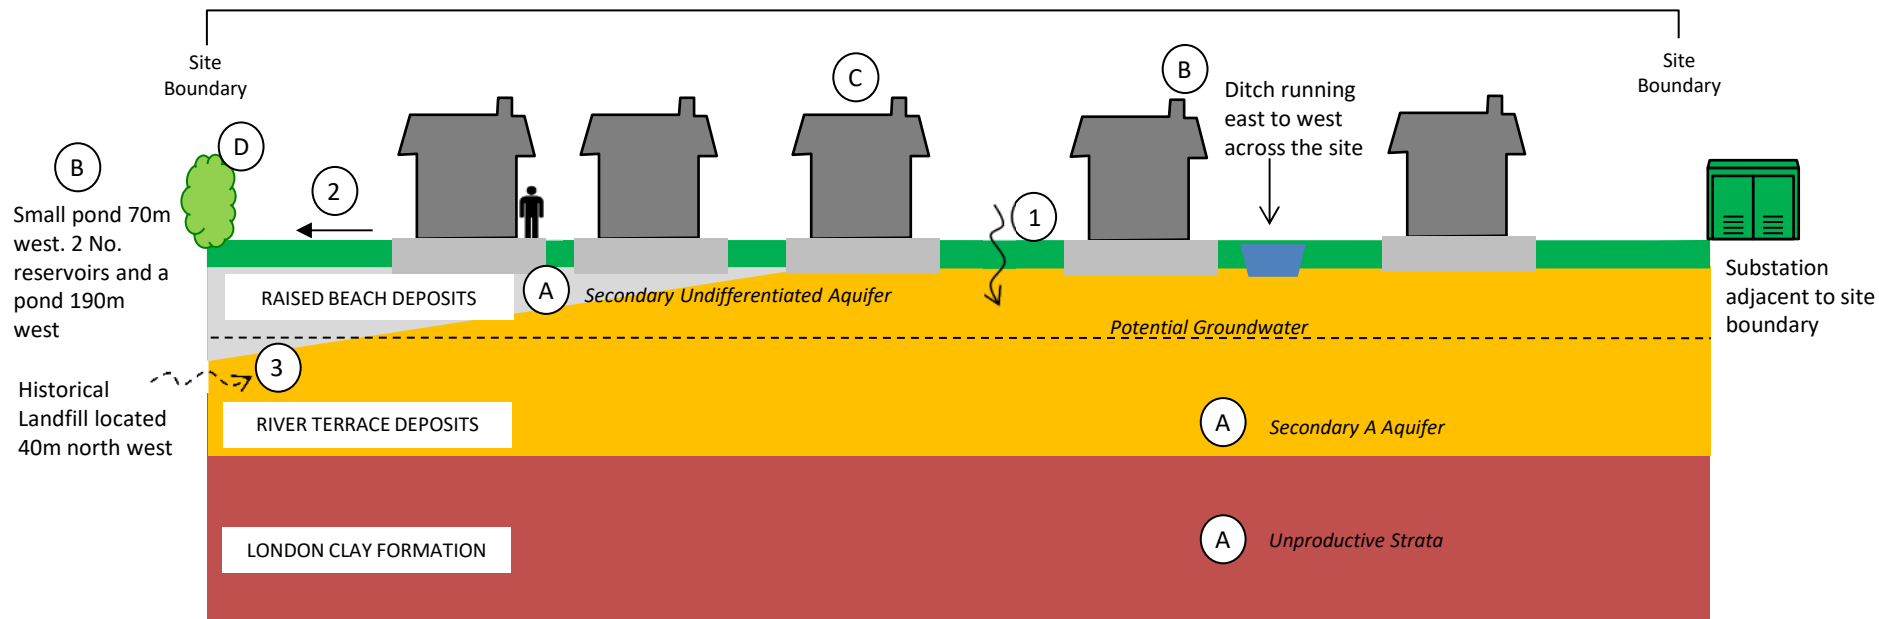
- 1 Infiltration of precipitation
- 2 Surface water run off
- 3 Migration of ground gases (methane and carbon dioxide)
- 4 Potential dermal contact, ingestion of contaminated soil and/or dust and inhalation of gases/vapours
- 5 Potential leaching/mobilisation of contaminants and lateral and vertical migration

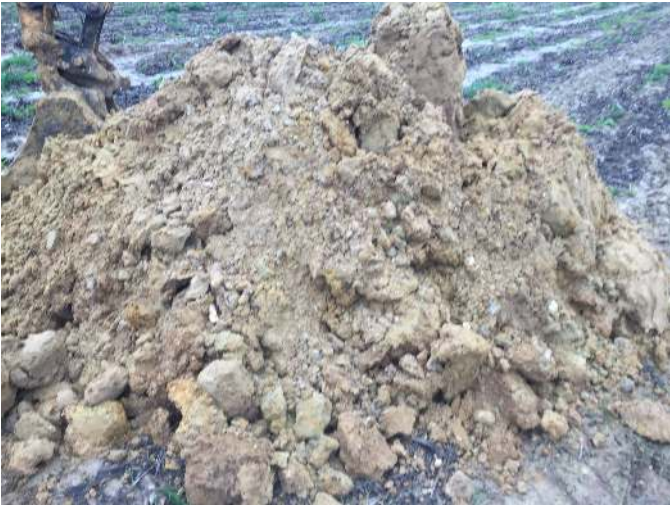
| <p><b>Photo 5:</b> Excavation of trial pit TP03.</p> | <p><b>Photo 6:</b> Arisings from trial pit TP03.</p> | |

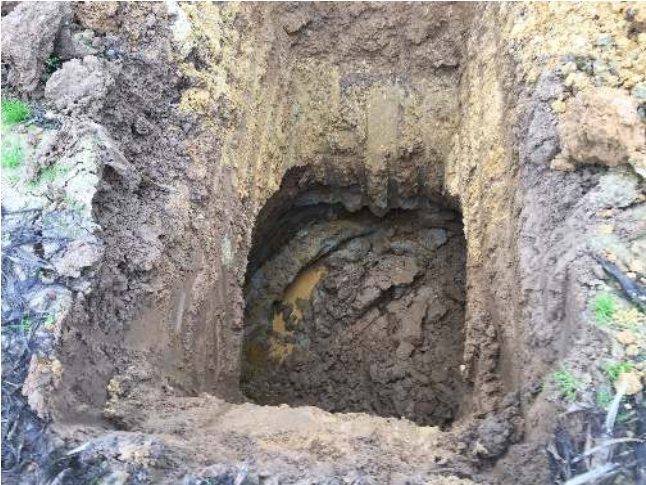
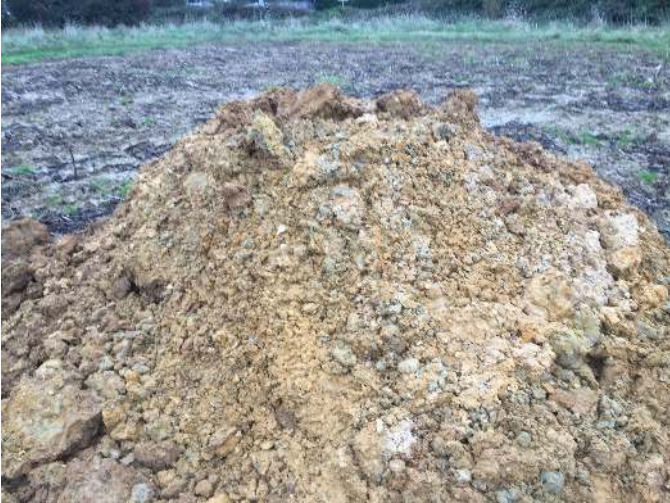
| <p><b>Photo 9:</b> Excavation of trial pit TP05.</p> | <p><b>Photo 10:</b> Arisings from trial pit TP05.</p> | |

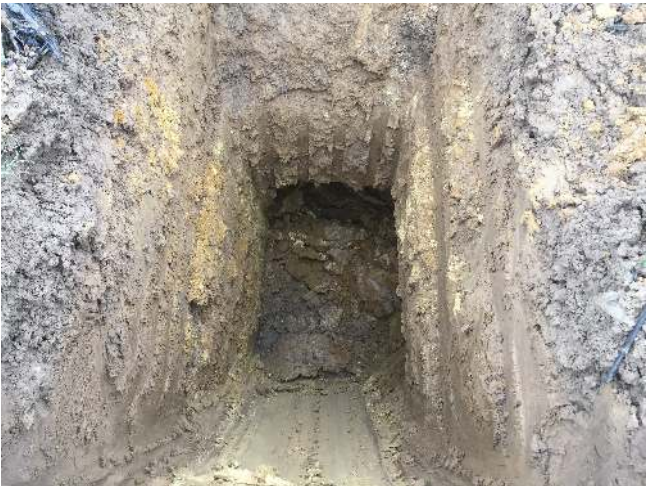
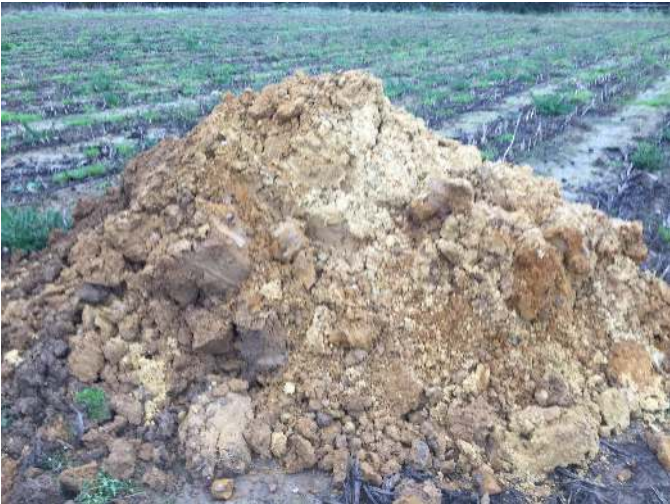
| <p><b>Photo 11:</b> Excavation of trial pit TP06.</p> | <p><b>Photo 12:</b> Arisings from trial pit TP06.</p> | |

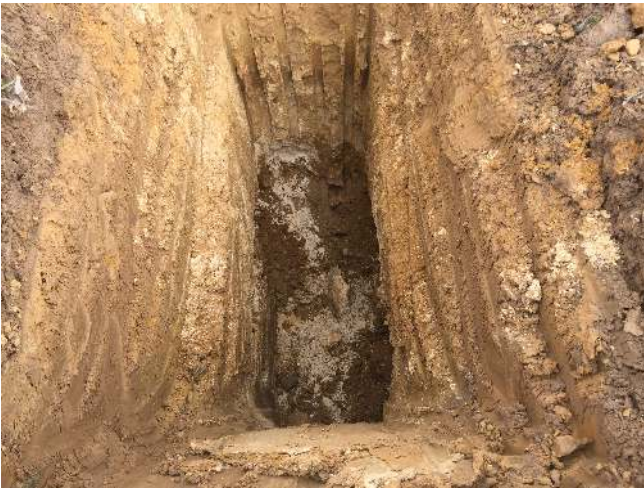
| <p><b>Photo 15:</b> Excavation of trial pit TP09.</p> | <p><b>Photo 16:</b> Arisings from trial pit TP09.</p> | |

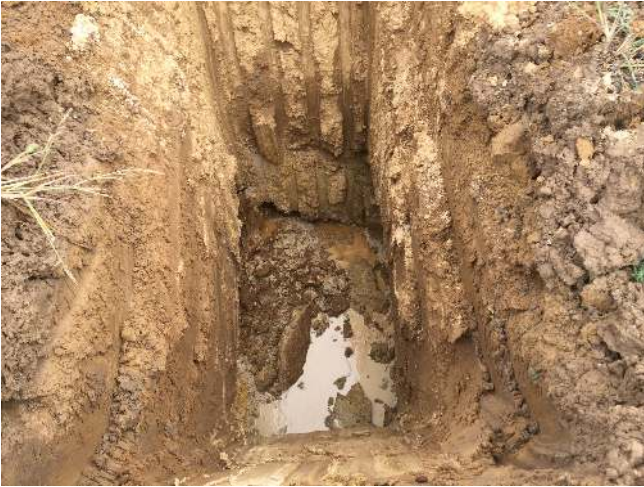
| <p><b>Photo 25:</b> Excavation of trial pit TP14.</p> | <p><b>Photo 26:</b> Arisings from trial pit TP14.</p> | |

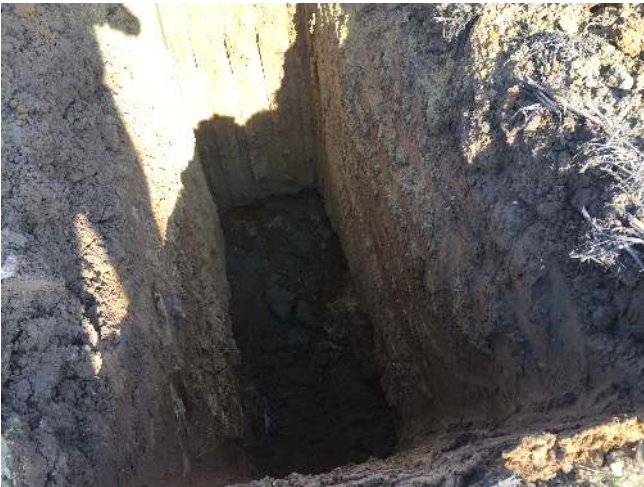
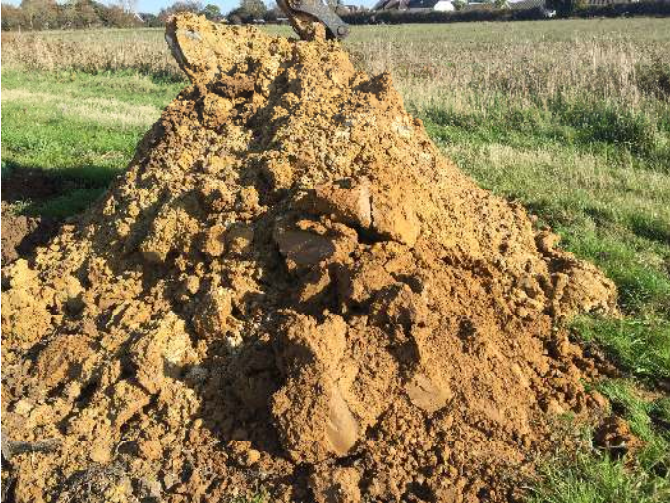
| <p><b>Photo 27:</b> Excavation of trial pit TP15.</p> | <p><b>Photo 28:</b> Arisings from trial pit TP15.</p> | |

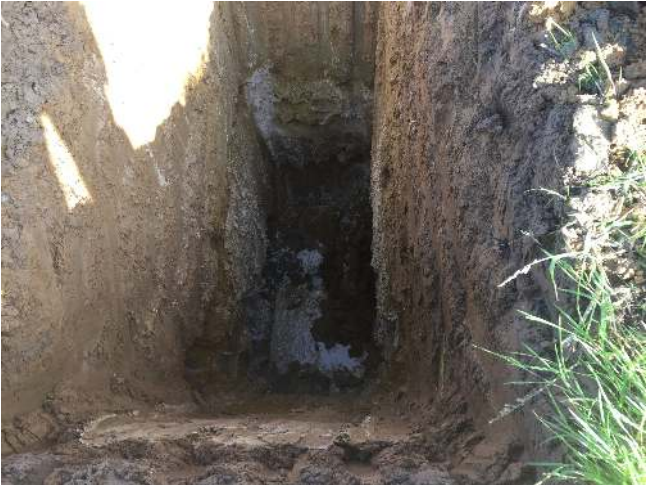
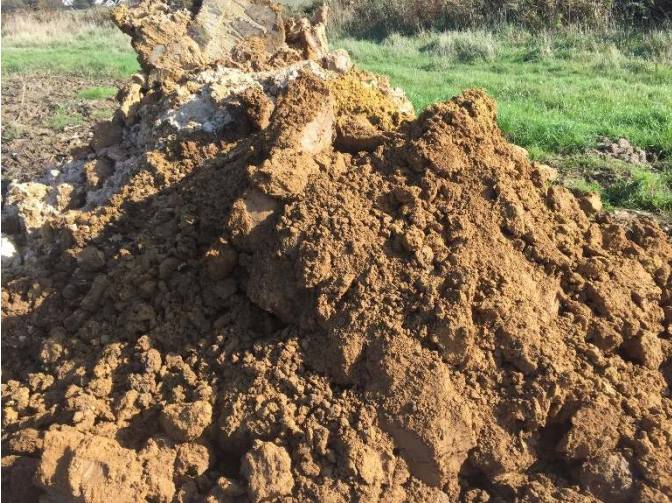
| <p><b>Photo 29:</b> Excavation of trial pit TP16.</p> | <p><b>Photo 30:</b> Arisings from trial pit TP16.</p> | |

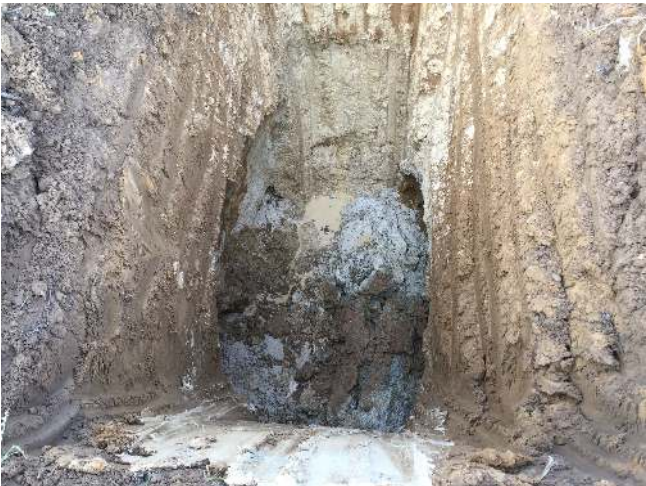
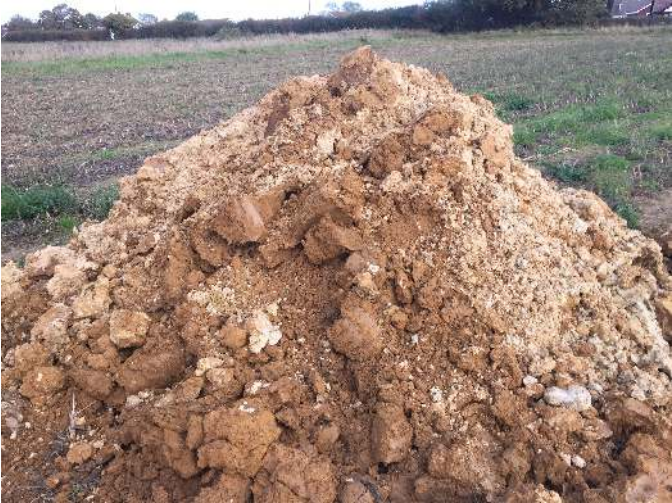
| <p><b>Photo 31:</b> Excavation of trial pit TP17.</p> | <p><b>Photo 32:</b> Arisings from trial pit TP17.</p> | |

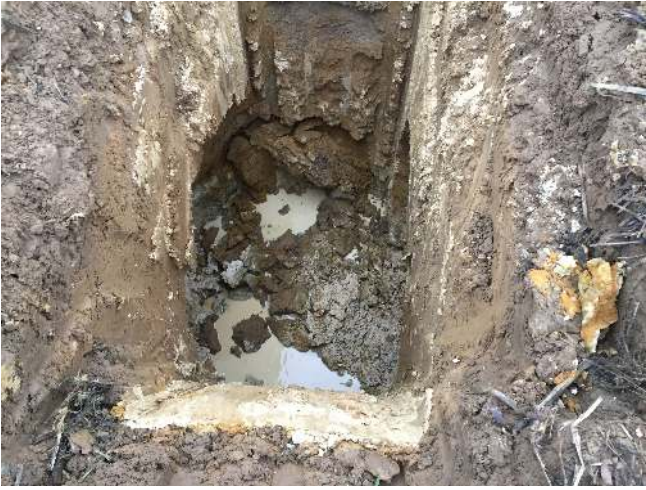
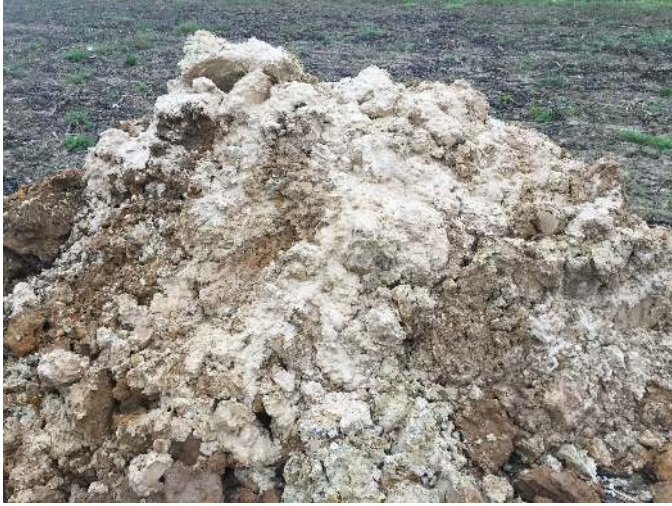
| <p><b>Photo 33:</b> Excavation of trial pit TP18.</p> | <p><b>Photo 34:</b> Arisings from trial pit TP18.</p> | |

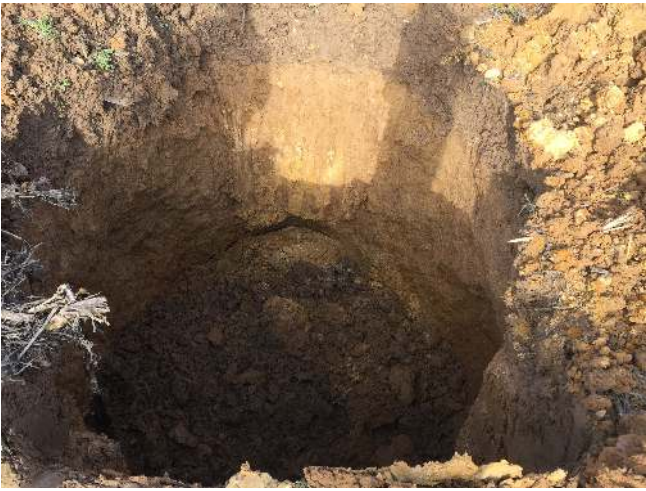
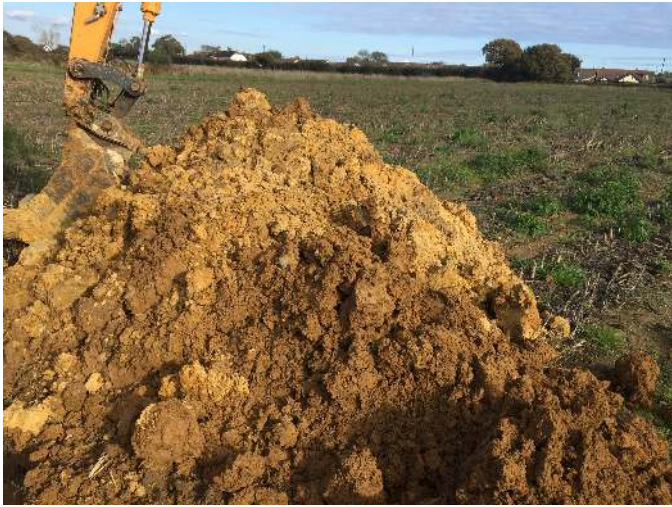
| <p><b>Photo 35:</b> Excavation of trial pit TP19.</p> | <p><b>Photo 36:</b> Arisings from trial pit TP19.</p> | |

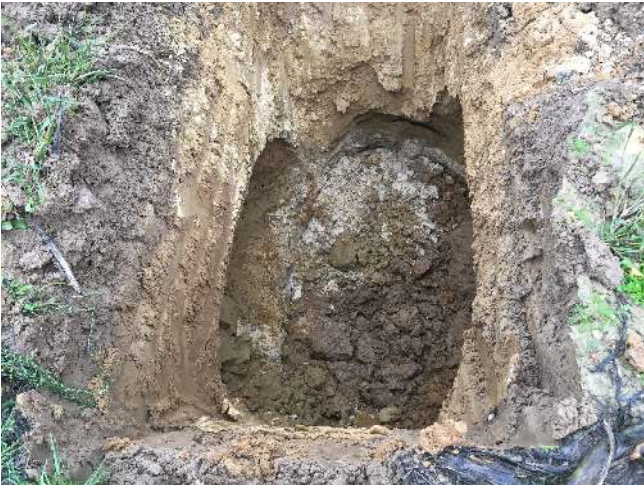
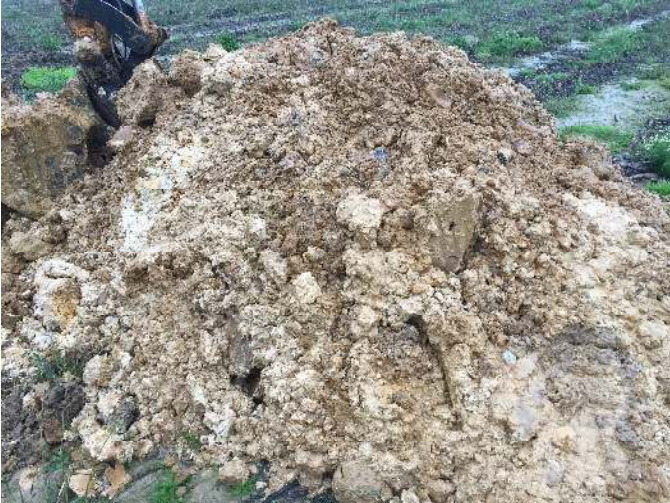
| <p><b>Photo 37:</b> Excavation of trial pit TP21.</p> | <p><b>Photo 38:</b> Arisings from trial pit TP21.</p> | |

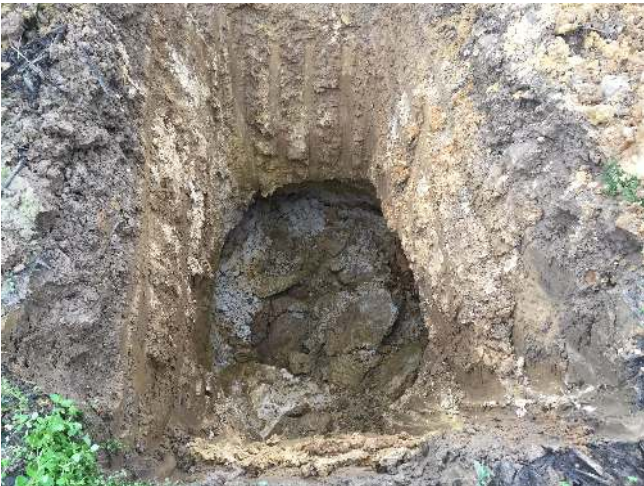
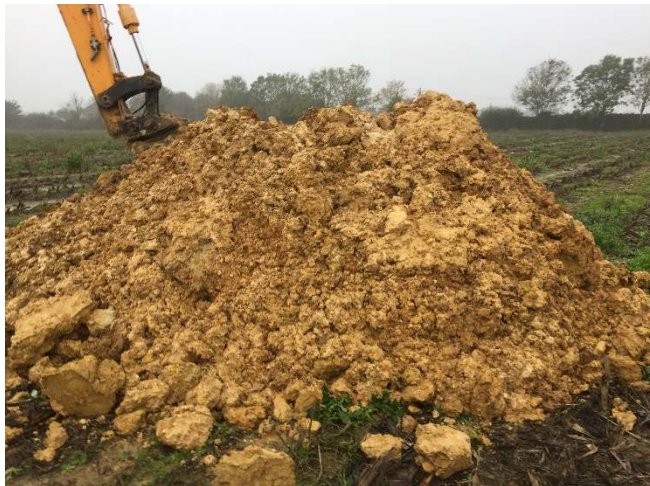
| <p><b>Photo 39:</b> Excavation of trial pit TP22.</p> | <p><b>Photo 40:</b> Arisings from trial pit TP22.</p> | |
