# **APPENDIX C**

## **PHOTOGRAPHIC LOG**

| PHOTOGRAPHIC LOG | | 305035 L01 (00) |
|---|---|---|
| Site Location: Land at Sefter Road, Bognor Regis, PO21 3EE | | Appendix D |

## **TRIAL PIT SOAKAWAY TEST DATA**

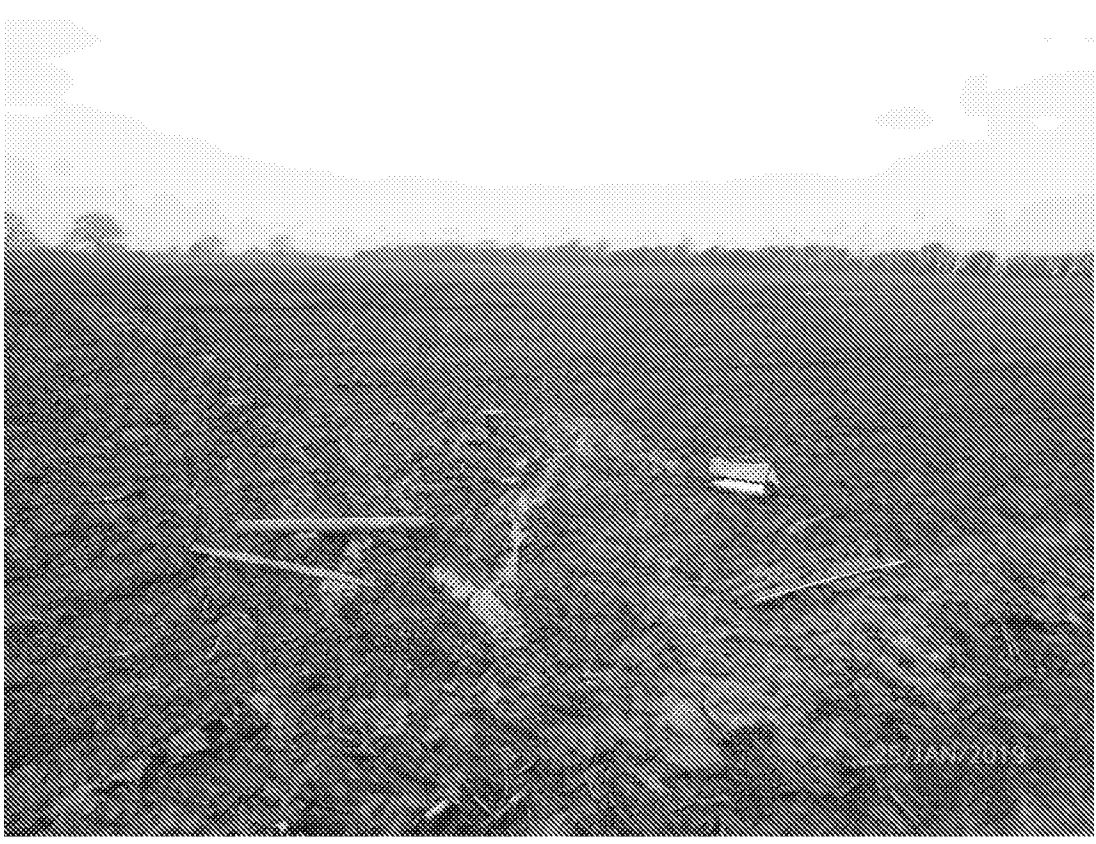
| PHOTOGRAPHIC LOG | | 305035 L01 (00) |
|---|---|---|
| <b>Photo No.</b><br>1 | | |

| PHOTOGRAPHIC LOG | | 305035 L01 (00) |
|---|---|---|
| Facing northwest, overview of BH206 | | |

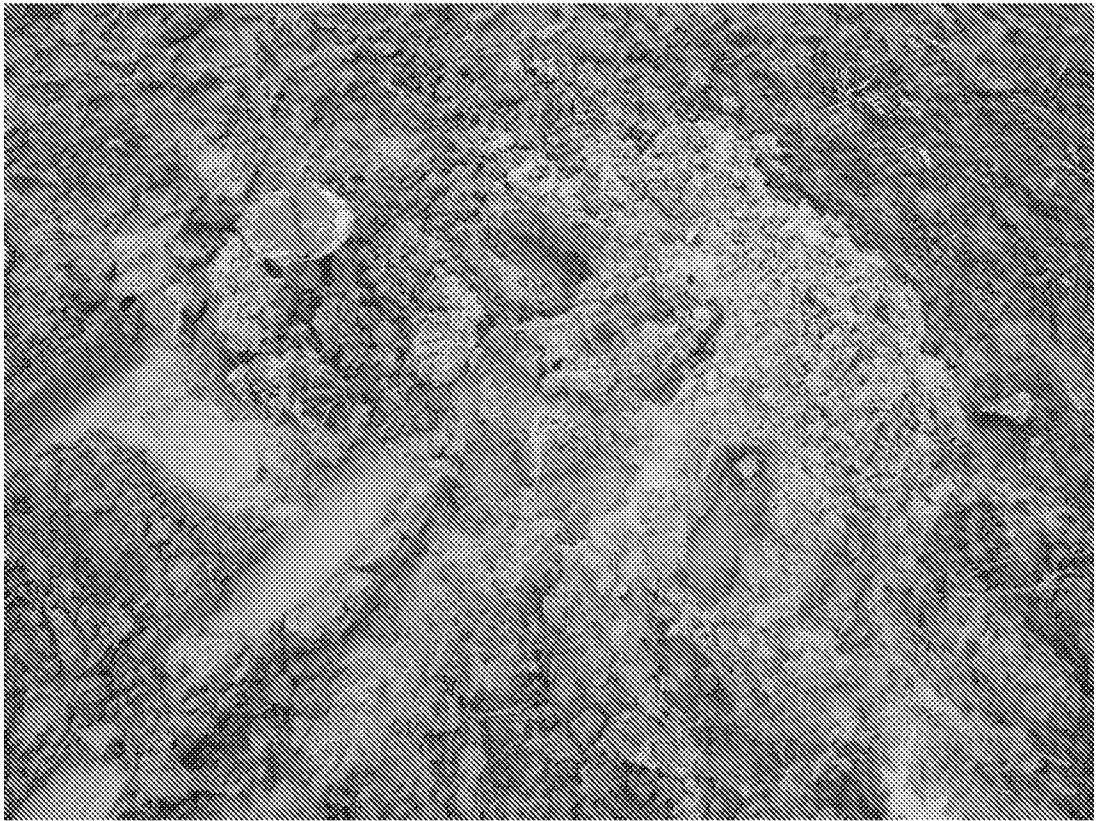
| PHOTOGRAPHIC LOG | | 305035 L01 (00) |
|---|---|---|
| <b>Photo No.</b><br>2 | | |

| PHOTOGRAPHIC LOG | | 305035 L01 (00) |
|---|---|---|
| BH206 hand pit arisings | | |

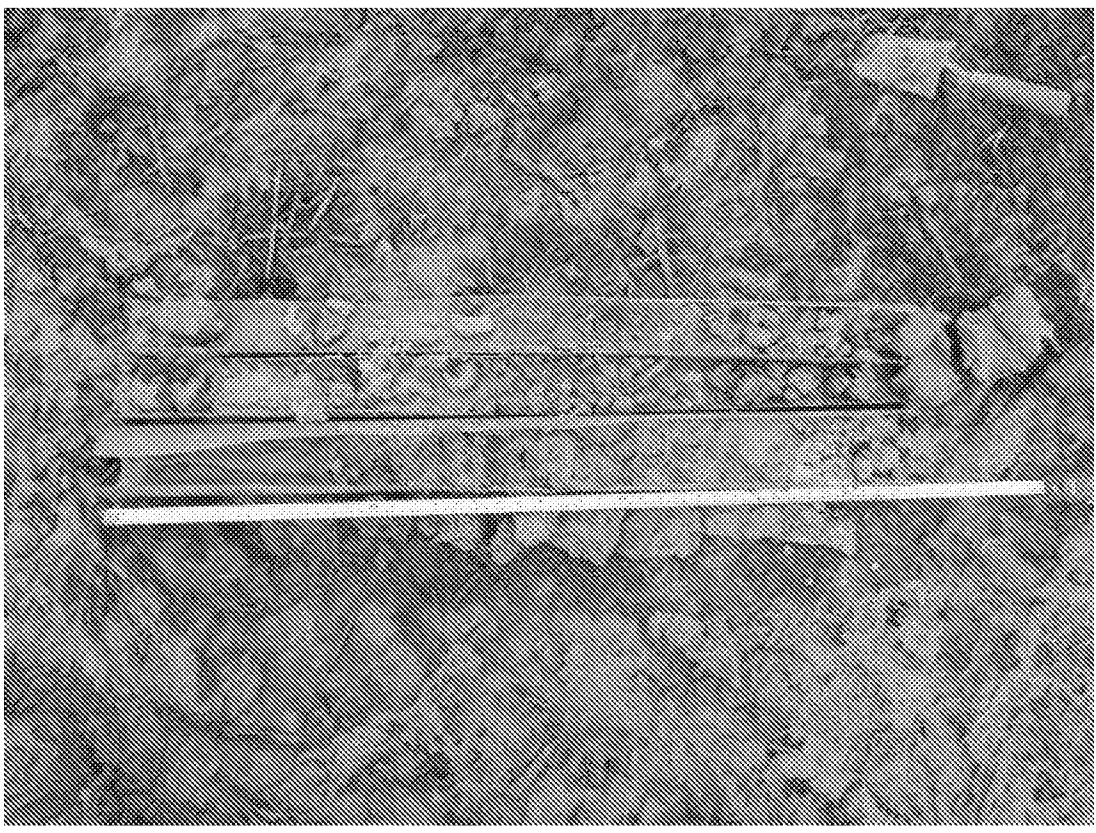
| PHOTOGRAPHIC LOG | | 305035 L01 (00) |
|---|---|---|
| <b>Photo No.</b><br>3 | | |

| PHOTOGRAPHIC LOG | | 305035 L01 (00) |
|---|---|---|
| BH206 core<br>soils recovery:<br>1. 2-3 m (L-R)<br>2. 1-2 m (L-R) | | |

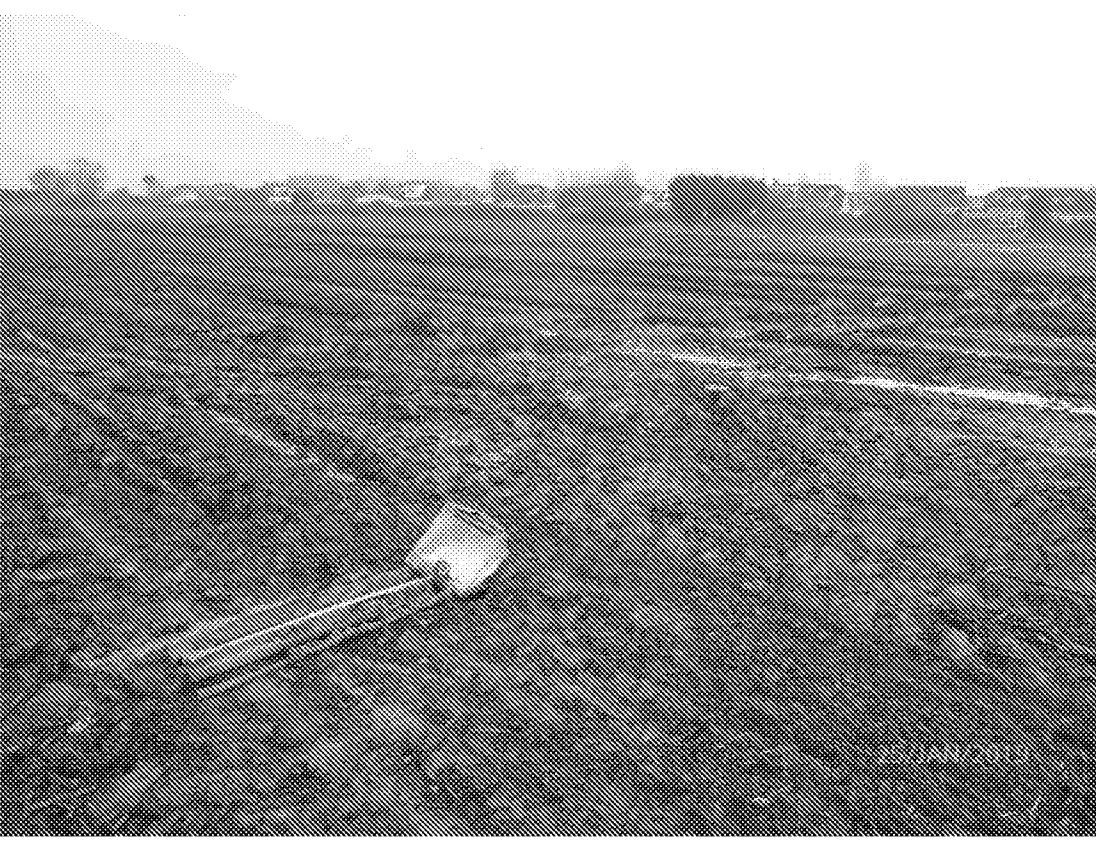
| PHOTOGRAPHIC LOG | | 305035 L01 (00) |
|---|---|---|
| <b>Photo No.</b><br>4 | | |

| PHOTOGRAPHIC LOG | | 305035 L01 (00) |
|---|---|---|
| Facing<br>northeast,<br>overview of<br>BH207 | | |

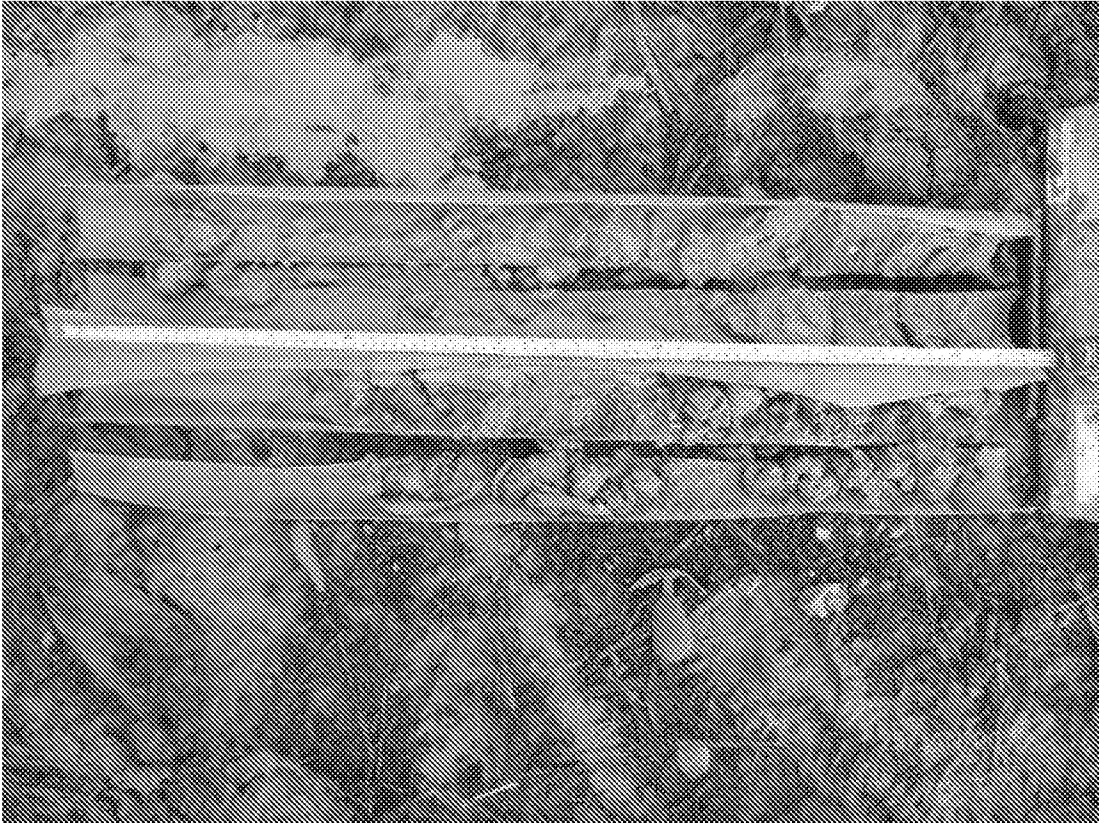
| PHOTOGRAPHIC LOG | | 305035 L01 (00) |
|---|---|---|
| <b>Photo No.</b><br>5 | | |

| PHOTOGRAPHIC LOG | | 305035 L01 (00) |
|---|---|---|
| BH207 core<br>soils recovery:<br>1. 2-3 m (L-R)<br>2. 1-2 m (L-R) | | |

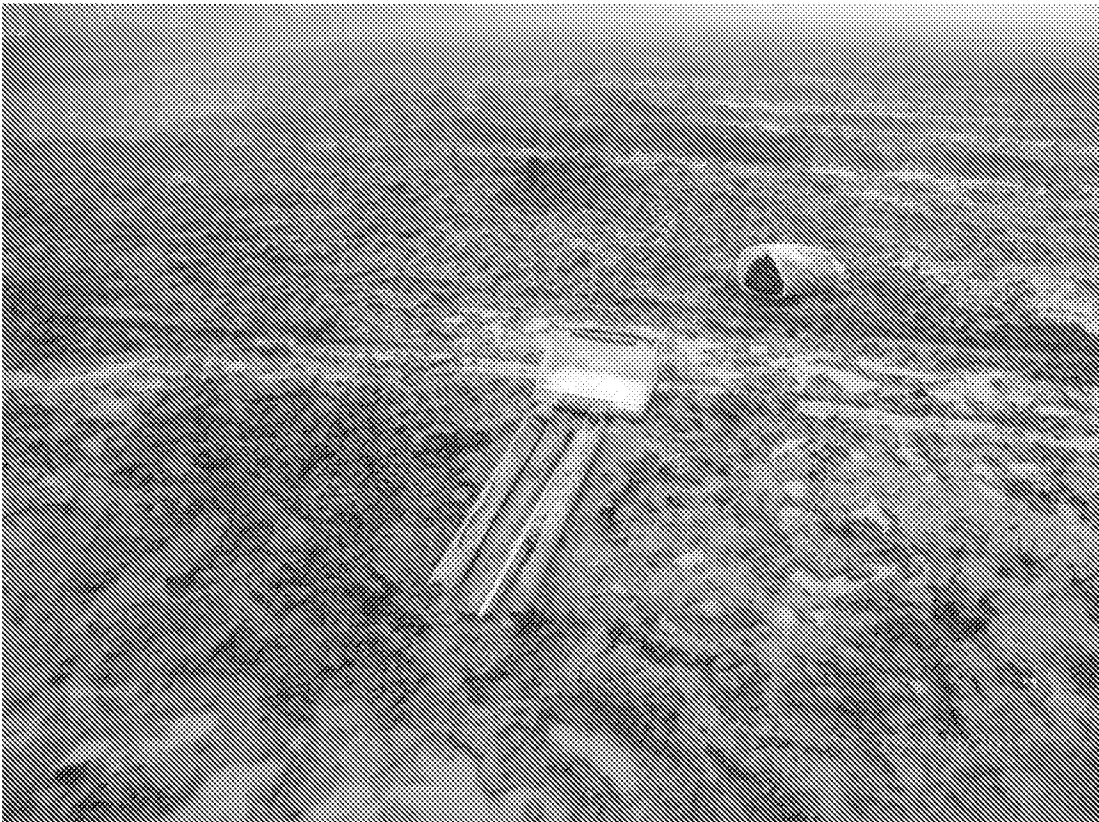
| PHOTOGRAPHIC LOG | | 305035 L01 (00) |
|---|---|---|
| <b>Photo No.</b><br>6 | | |

| PHOTOGRAPHIC LOG | | 305035 L01 (00) |
|---|---|---|
| Facing<br>northwest,<br>overview of<br>BH208 | | |

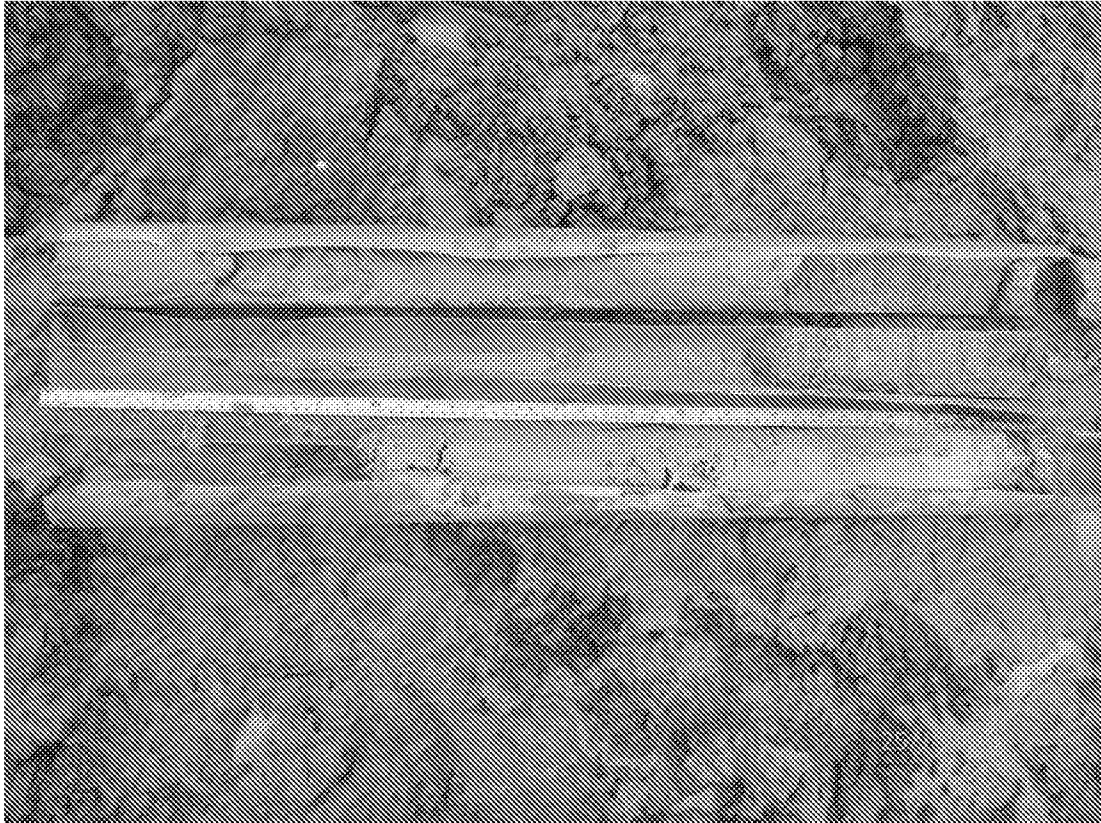
| PHOTOGRAPHIC LOG | | 305035 L01 (00) |
|---|---|---|
| <b>Photo No.</b><br>7 | | |

| PHOTOGRAPHIC LOG | | 305035 L01 (00) |
|---|---|---|
| BH208 core<br>soils recovery:<br>1. 2-3 m (L-R)<br>2. 1-2 m (L-R) | | |

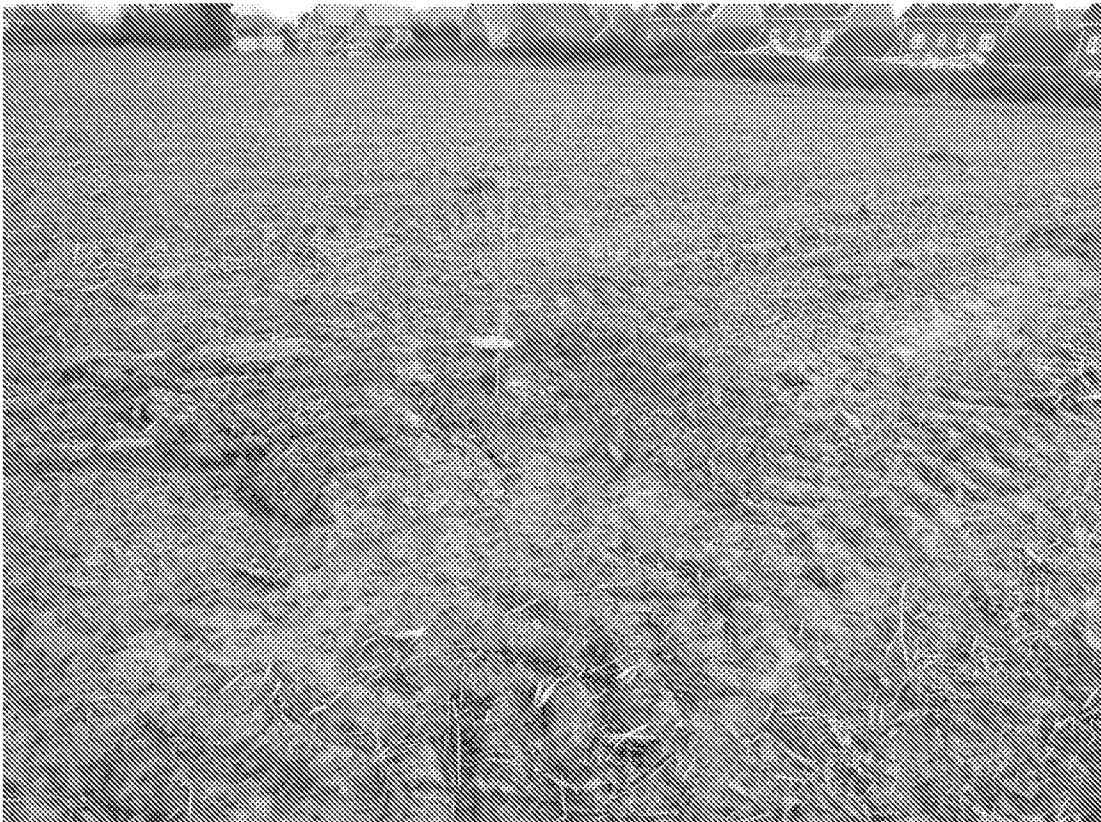
| PHOTOGRAPHIC LOG | | 305035 L01 (00) |
|---|---|---|
| <b>Photo No.</b><br>8 | | |

| PHOTOGRAPHIC LOG | | 305035 L01 (00) |
|---|---|---|
| Facing<br>northeast,<br>overview of<br>BH209 | | |

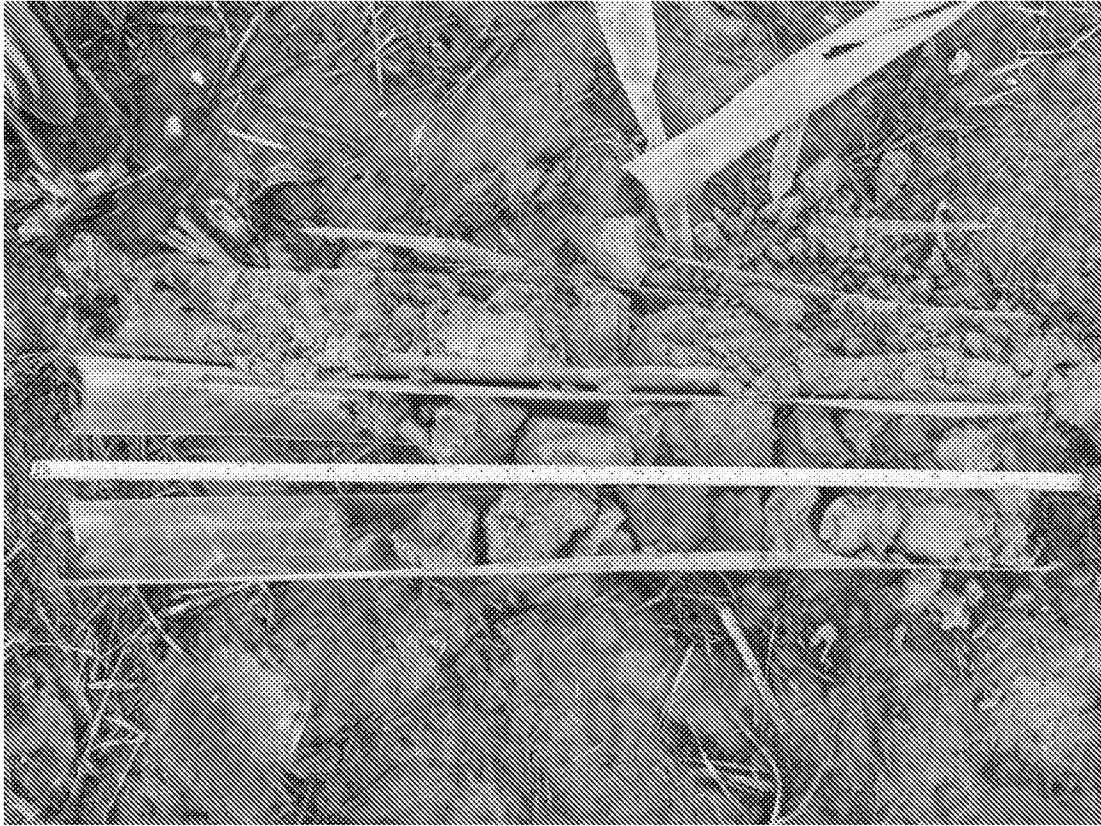
| PHOTOGRAPHIC LOG | | 305035 L01 (00) |
|---|---|---|
| <b>Photo No.</b><br>9 | | |

| PHOTOGRAPHIC LOG | | 305035 L01 (00) |
|---|---|---|
| BH209 core<br>soils recovery:<br>1. 2-3 m (L-R)<br>2. 1-2 m (L-R) | | |

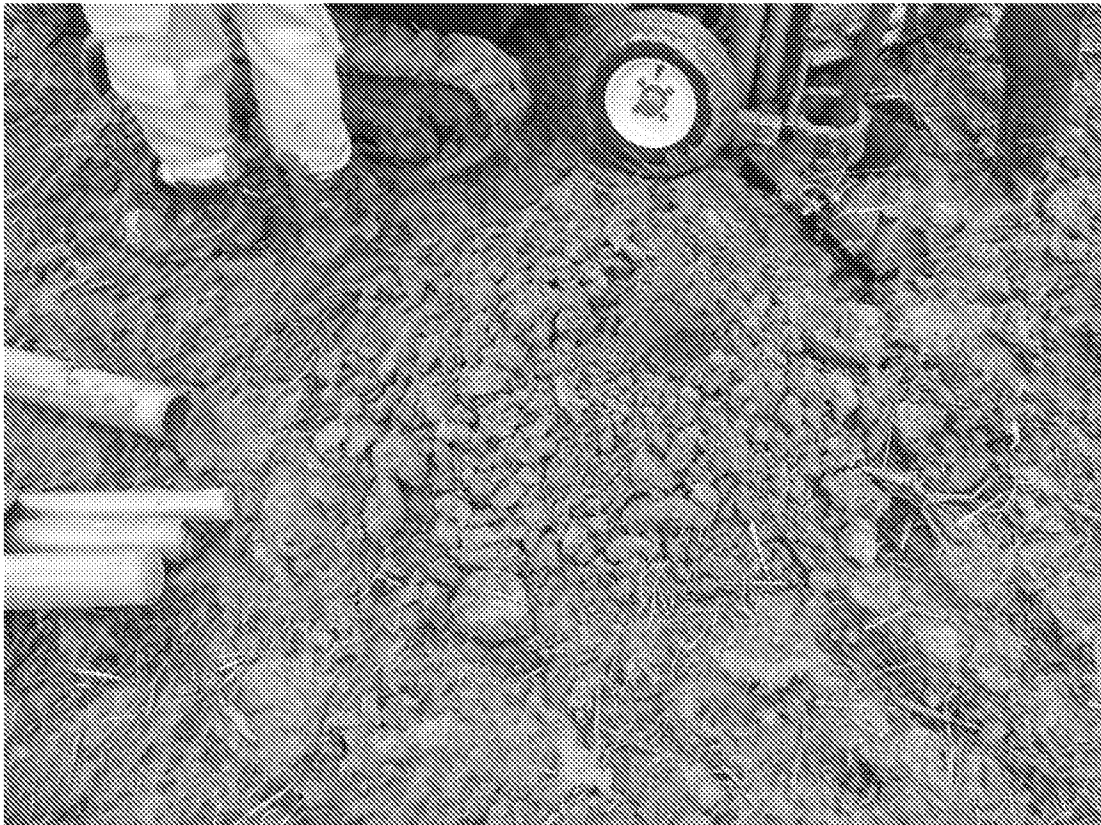
| PHOTOGRAPHIC LOG | | 305035 L01 (00) |
|---|---|---|
| <b>Photo No.</b><br>10 | | |

| PHOTOGRAPHIC LOG | | 305035 L01 (00) |
|---|---|---|
| BH210 handpit<br>arisings | | |

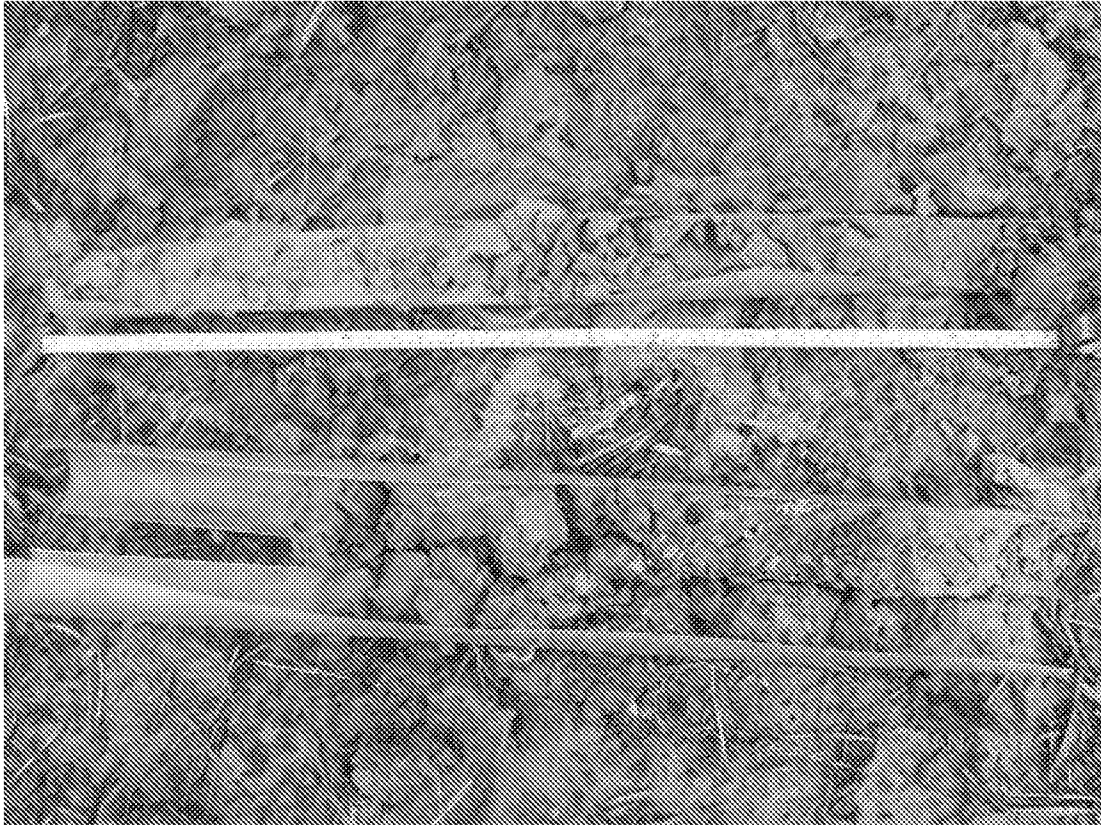
| PHOTOGRAPHIC LOG | | 305035 L01 (00) |
|---|---|---|
| <b>Photo No.</b><br>11 | | |

| PHOTOGRAPHIC LOG | | 305035 L01 (00) |
|---|---|---|
| BH210 core<br>soils recovery:<br>1. 2-3 m (L-R)<br>2. 1-2 m (L-R) | | |

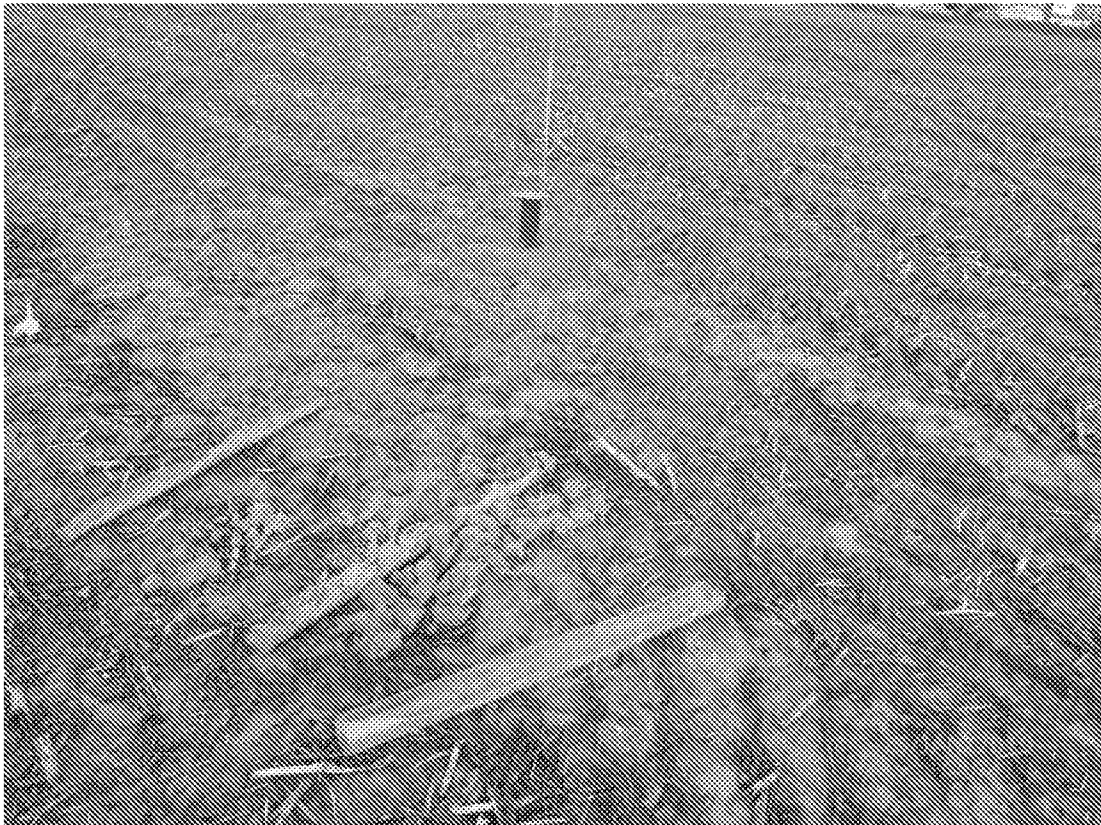
| PHOTOGRAPHIC LOG | | 305035 L01 (00) |
|---|---|---|
| <b>Photo No.</b><br>12 | | |

| PHOTOGRAPHIC LOG | | 305035 L01 (00) |
|---|---|---|
| Facing<br>northwest,<br>overview of<br>BH211 | | |

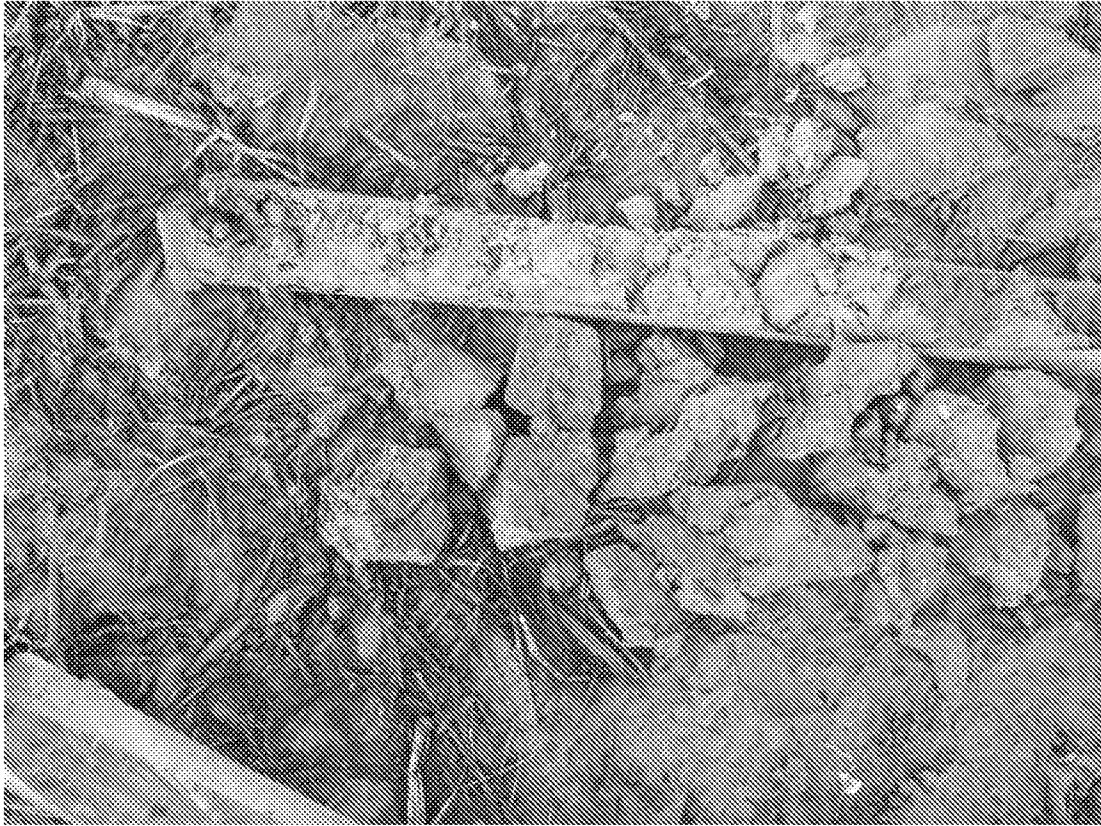
| PHOTOGRAPHIC LOG | | 305035 L01 (00) |
|---|---|---|
| <b>Photo No.</b><br>13 | | |

| PHOTOGRAPHIC LOG | | 305035 L01 (00) |
|---|---|---|
| BH211 core<br>soils recovery:<br>1. 2-3 m (L-R)<br>2. 1-2 m (L-R) | | |

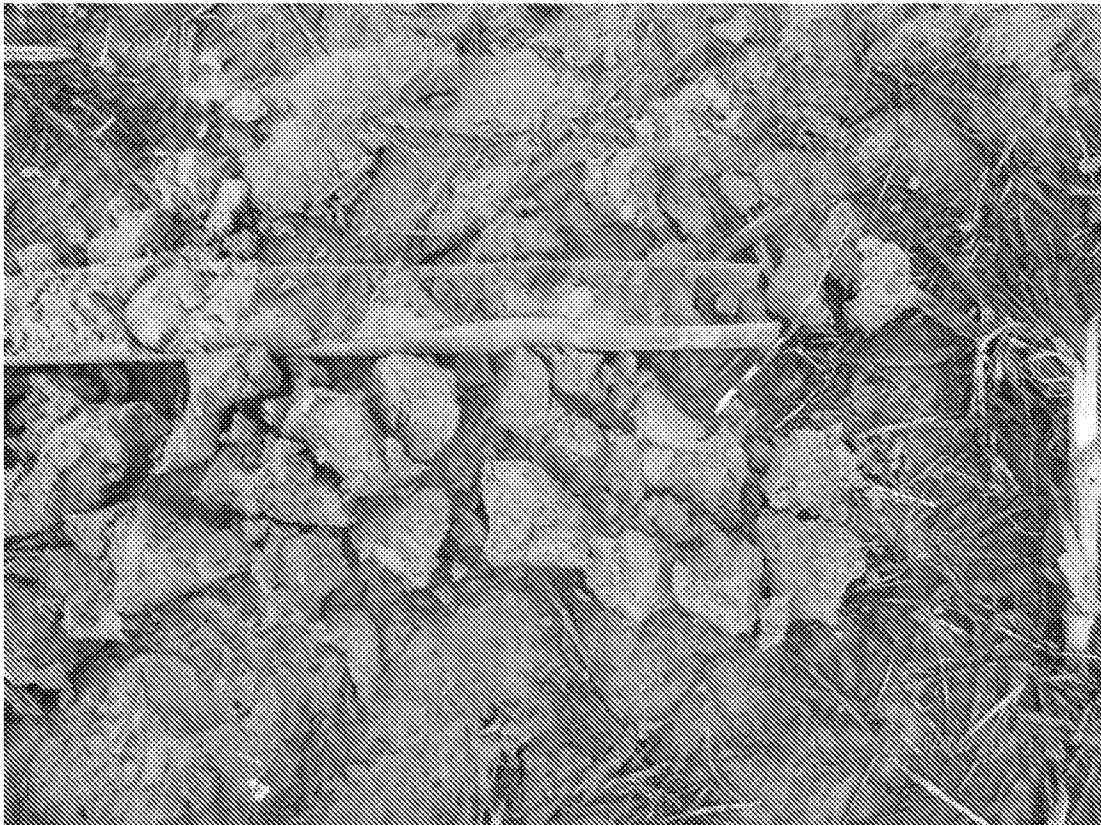
| PHOTOGRAPHIC LOG | | 305035 L01 (00) |
|---|---|---|
| <b>Photo No.</b><br>14 | | |

| PHOTOGRAPHIC LOG | | 305035 L01 (00) |
|---|---|---|
| BH211 core<br>soils recovery:<br>1. 2-3 m (L-R)<br>2. 1-2 m (L-R) | | |

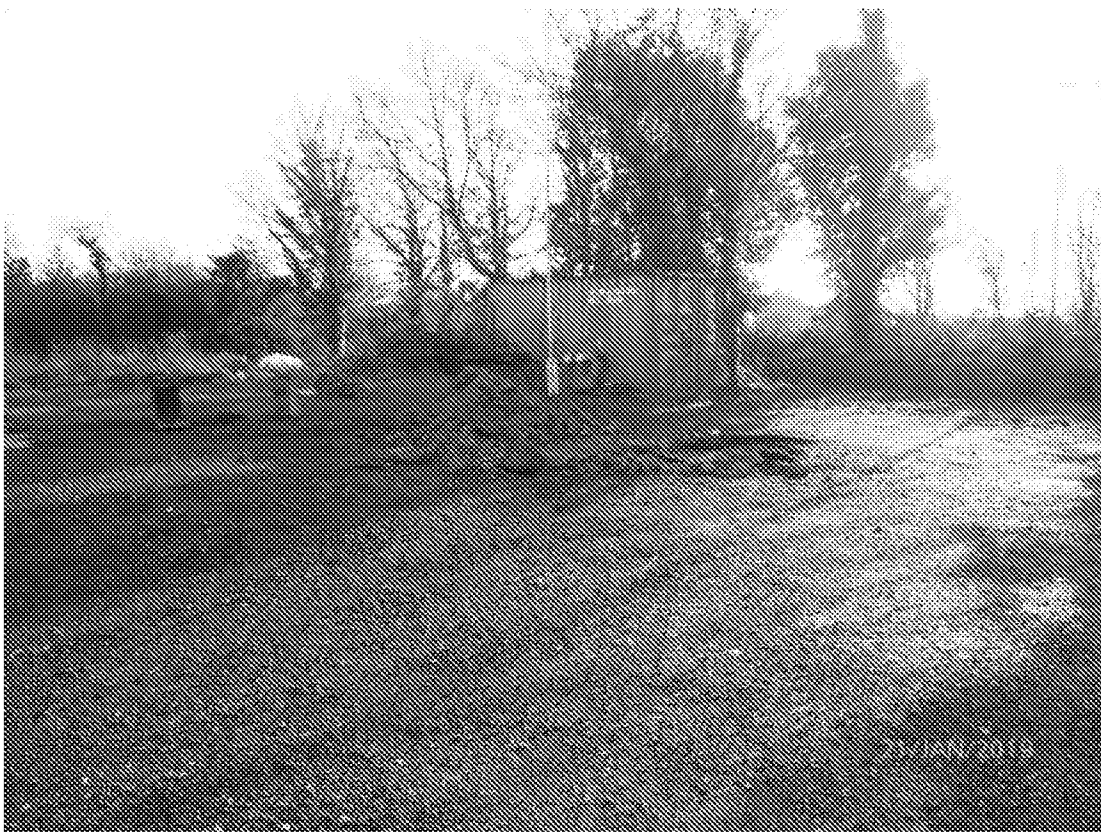
| PHOTOGRAPHIC LOG | | 305035 L01 (00) |
|---|---|---|
| <b>Photo No.</b><br>15 | | |

| PHOTOGRAPHIC LOG | | 305035 L01 (00) |
|---|---|---|
| Facing southeast, overview of TP201 | | |

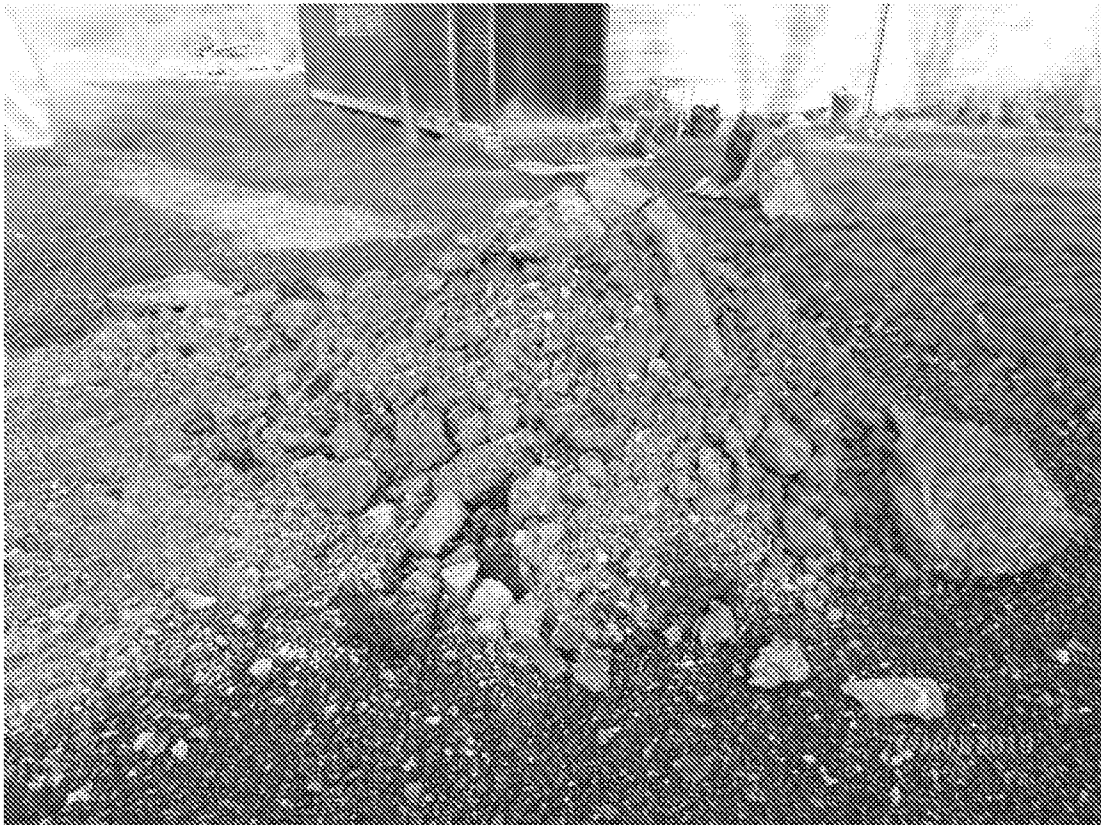
| PHOTOGRAPHIC LOG | | 305035 L01 (00) |
|---|---|---|
| <b>Photo No.</b><br>16 | | |

| PHOTOGRAPHIC LOG | | 305035 L01 (00) |
|---|---|---|
| Arisings from TP201 | | |

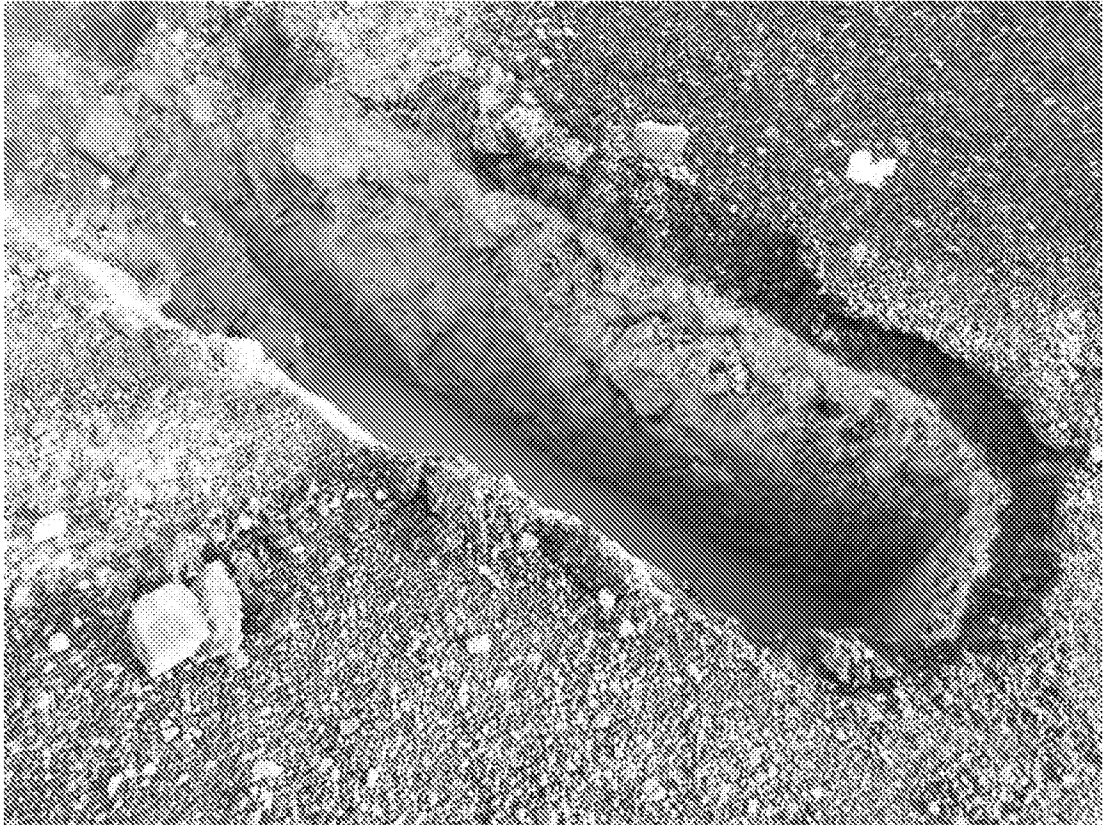
| PHOTOGRAPHIC LOG | | 305035 L01 (00) |
|---|---|---|
| <b>Photo No.</b><br>17 | | |

| PHOTOGRAPHIC LOG | | 305035 L01 (00) |
|---|---|---|
| View downhole of TP201, during soakaway test | | |

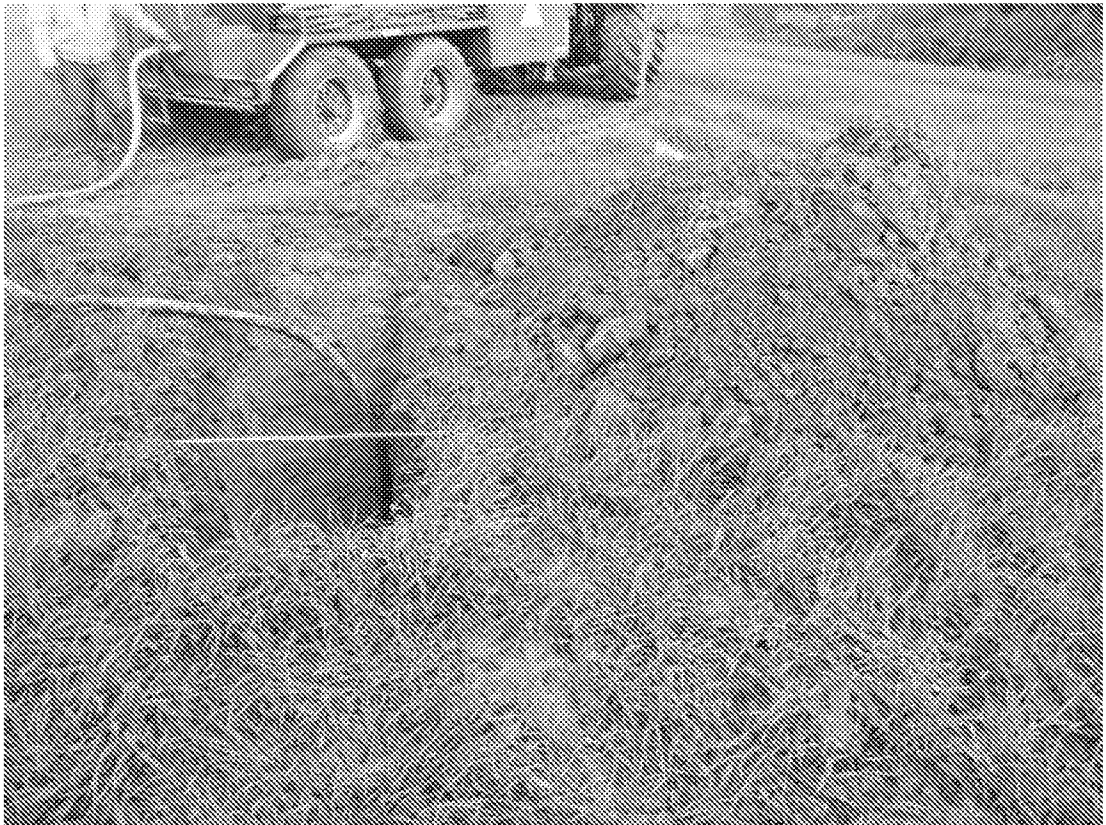
| PHOTOGRAPHIC LOG | | 305035 L01 (00) |
|---|---|---|
| <b>Photo No.</b><br>18 | | |

| PHOTOGRAPHIC LOG | | 305035 L01 (00) |
|---|---|---|
| Facing east, overview of TP202 and arisings | | |

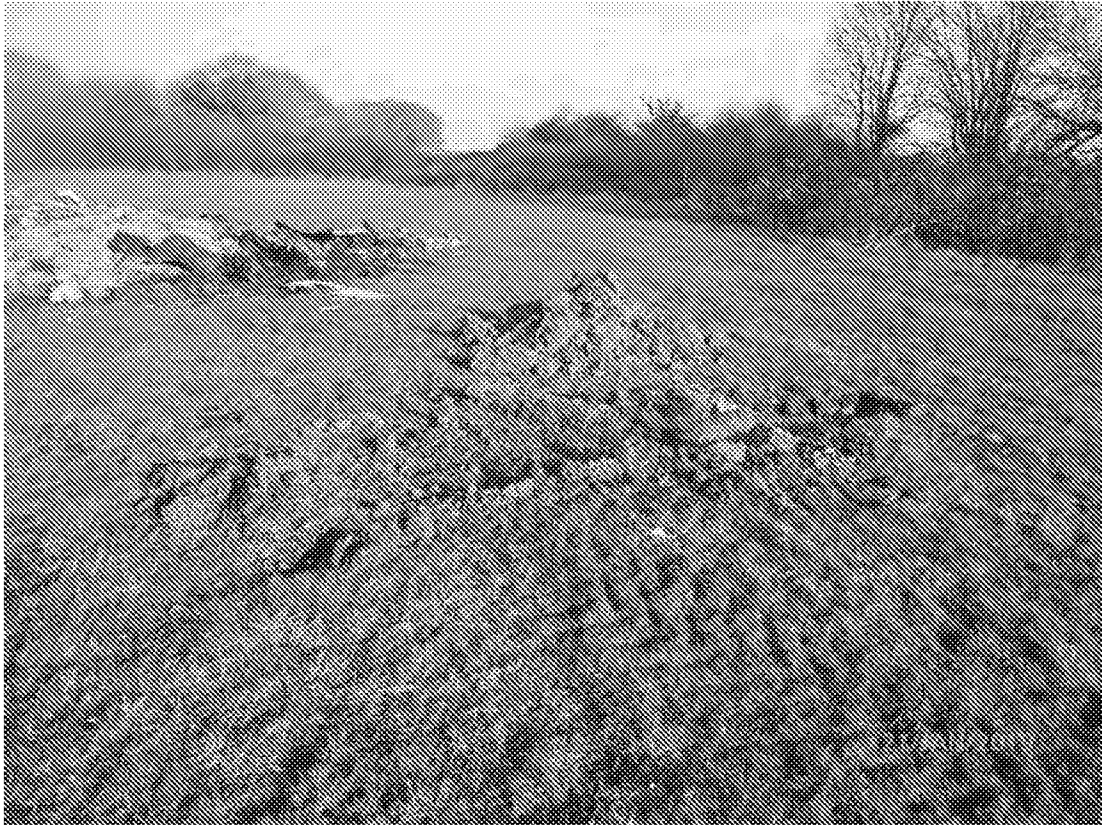
| PHOTOGRAPHIC LOG | | 305035 L01 (00) |
|---|---|---|
| <b>Photo No.</b><br>19 | | |

| PHOTOGRAPHIC LOG | | 305035 L01 (00) |
|---|---|---|
| Facing northeast, view of TP203 and arisings | | |

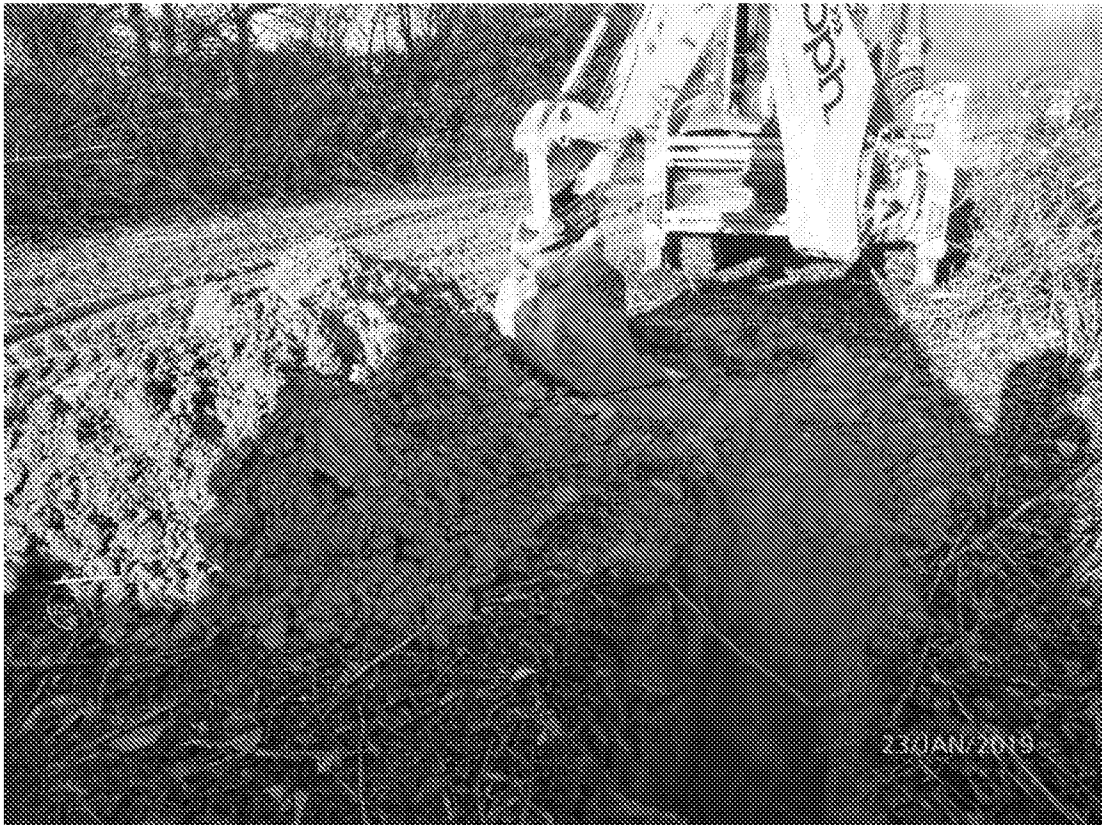
| PHOTOGRAPHIC LOG | | 305035 L01 (00) |
|---|---|---|
| <b>Photo No.</b><br>20 | | |

| PHOTOGRAPHIC LOG | | 305035 L01 (00) |
|---|---|---|
| Facing north, view of TP204 and arisings | | |

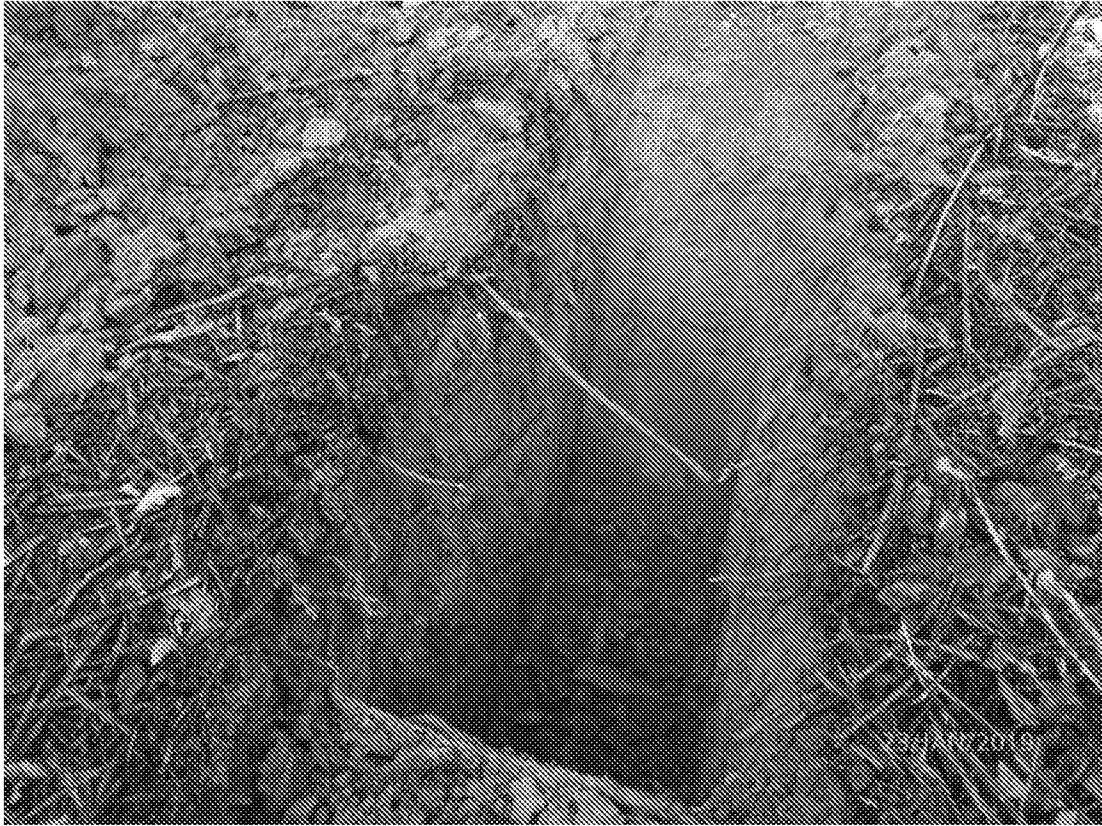
| PHOTOGRAPHIC LOG | | 305035 L01 (00) |
|---|---|---|
| Photo No.<br>21 | | |

| PHOTOGRAPHIC LOG | | 305035 L01 (00) |
|---|---|---|
| Downhole view of TP204 | | |

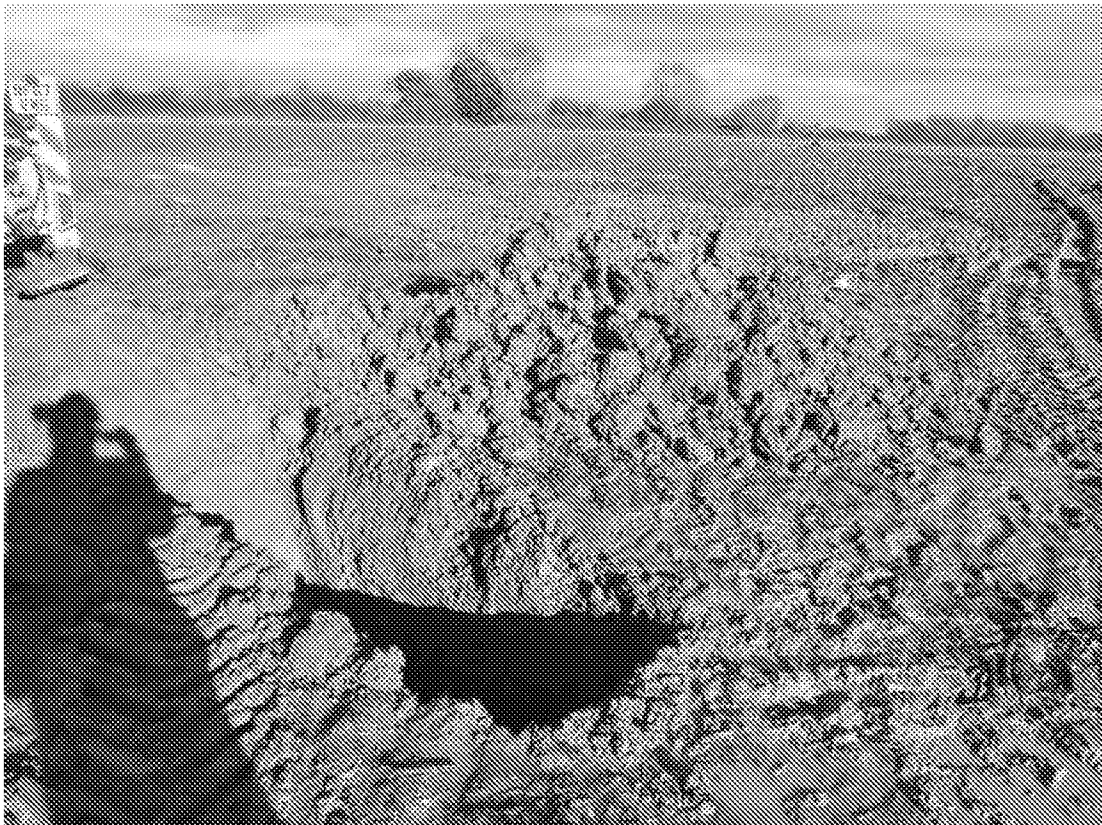
| PHOTOGRAPHIC LOG | | 305035 L01 (00) |
|---|---|---|
| Photo No.<br>22 | | |

| PHOTOGRAPHIC LOG | | 305035 L01 (00) |
|---|---|---|
| Facing northeast, view of TP205 and arisings | | |

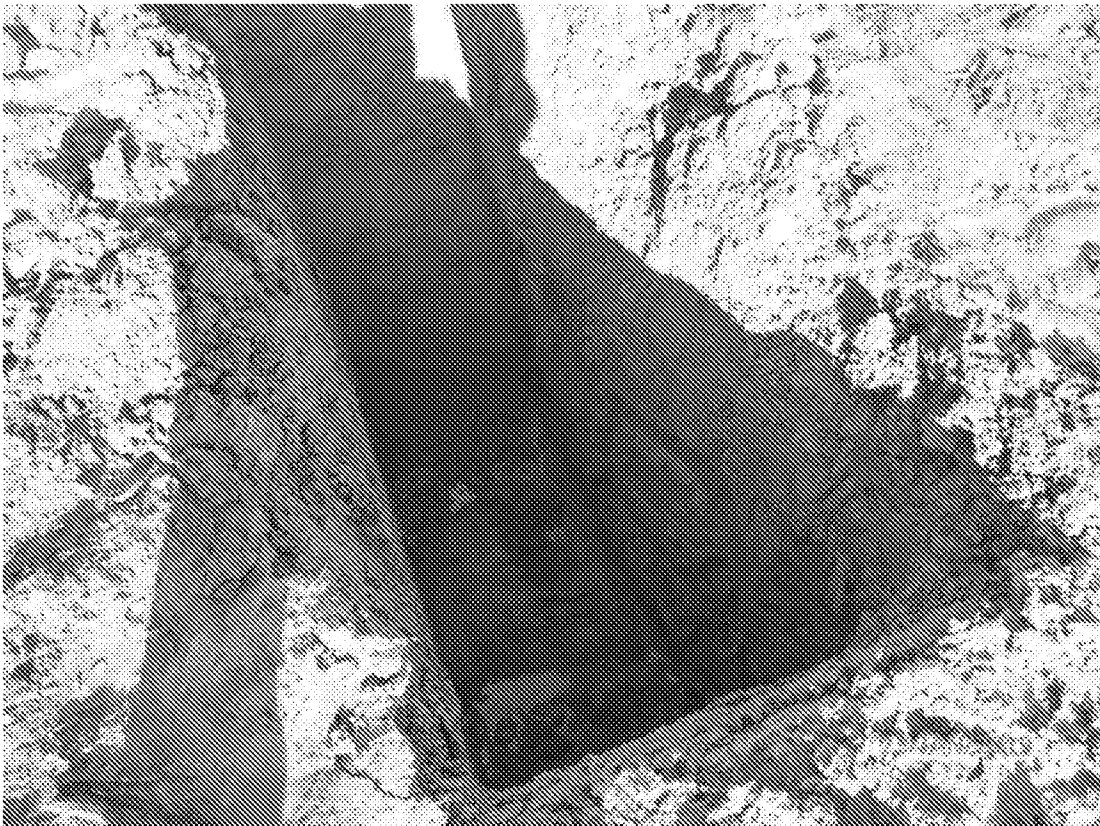
| PHOTOGRAPHIC LOG | | 305035 L01 (00) |
|---|---|---|
| Photo No.<br>23 | | |

| PHOTOGRAPHIC LOG | | 305035 L01 (00) |
|---|---|---|
| Downhole view of TP205 | | |

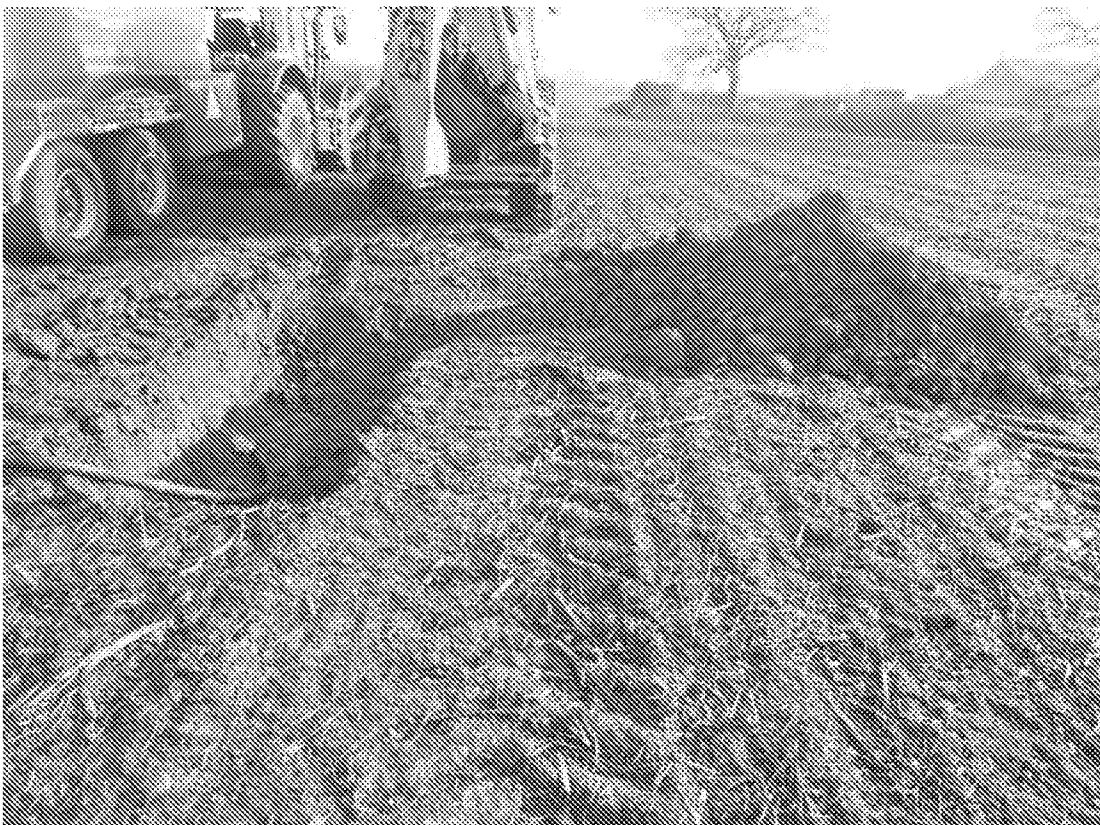
| PHOTOGRAPHIC LOG | | 305035 L01 (00) |
|---|---|---|
| Photo No.<br>24 | | |

| PHOTOGRAPHIC LOG | | 305035 L01 (00) |
|---|---|---|
| Facing east, view of TP206 and arisings | | |
