# **APPENDIX C**

## **PHOTOGRAPHIC LOG**

| PHOTOGRAPHIC LOG | | 305035 L01 (00) |
|---|---|---|
| Site Location: Land at Sefter Road, Bognor Regis, PO21 3EE | | Appendix D |

## **TRIAL PIT SOAKAWAY TEST DATA**

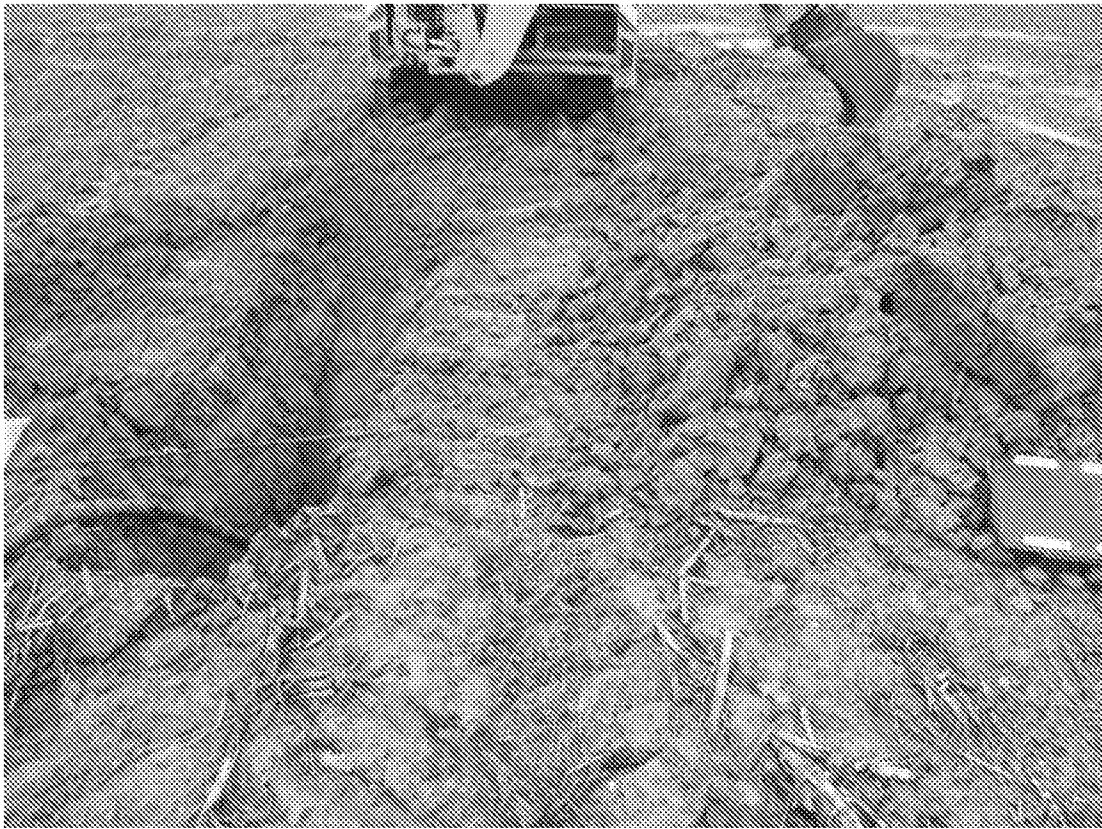
| PHOTOGRAPHIC LOG | | 305035 L01 (00) |
|---|---|---|
| <b>Photo No.</b><br>25 | | |

| PHOTOGRAPHIC LOG | | 305035 L01 (00) |
|---|---|---|
| Facing east,<br>view of TP207 | | |

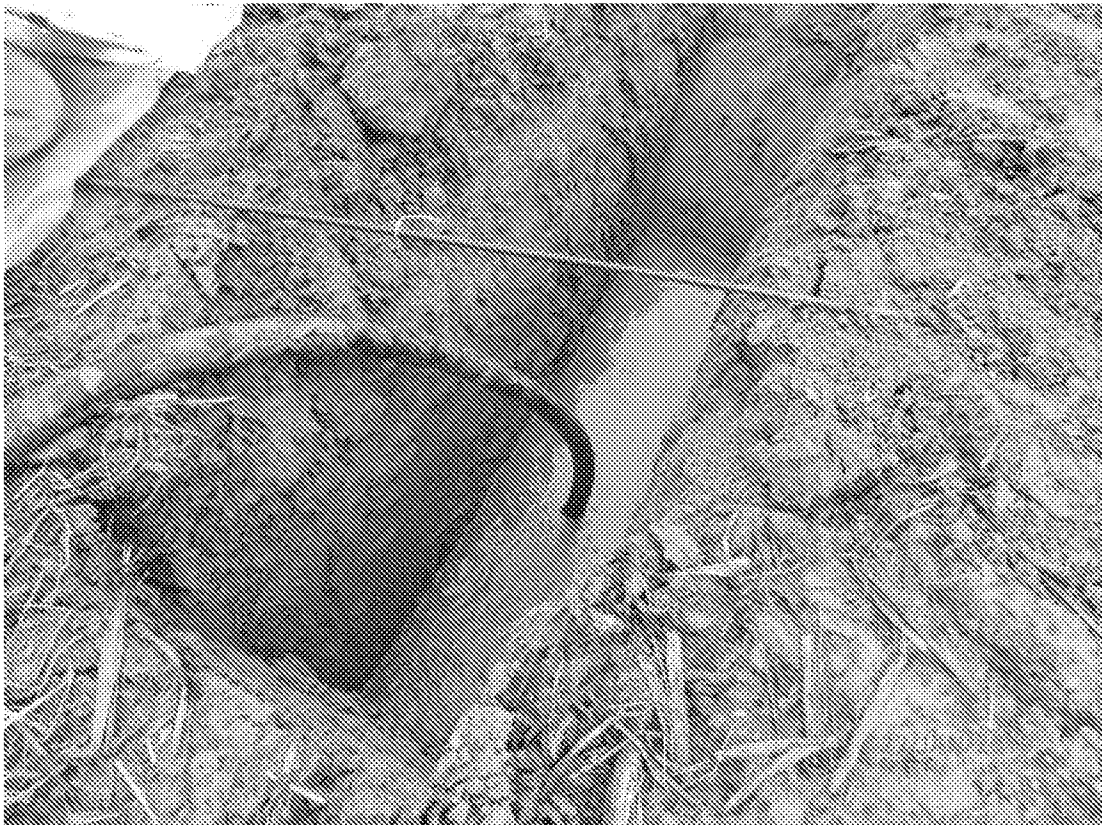
| PHOTOGRAPHIC LOG | | 305035 L01 (00) |
|---|---|---|
| <b>Photo No.</b><br>26 | | |

| PHOTOGRAPHIC LOG | | 305035 L01 (00) |
|---|---|---|
| Downhole view<br>of TP207 | | |

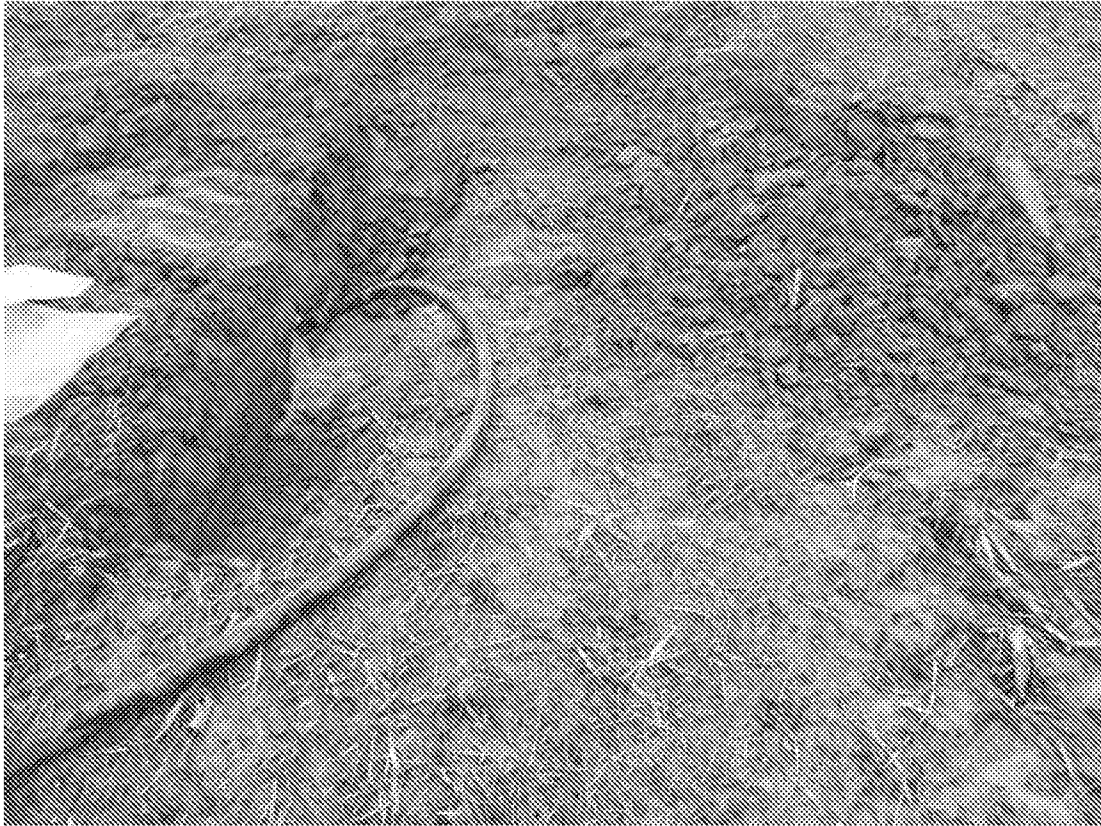
| PHOTOGRAPHIC LOG | | 305035 L01 (00) |
|---|---|---|
| Photo No.<br>27 | | |

| PHOTOGRAPHIC LOG | | 305035 L01 (00) |
|---|---|---|
| Facing<br>northeast, view<br>of TP208 | | |

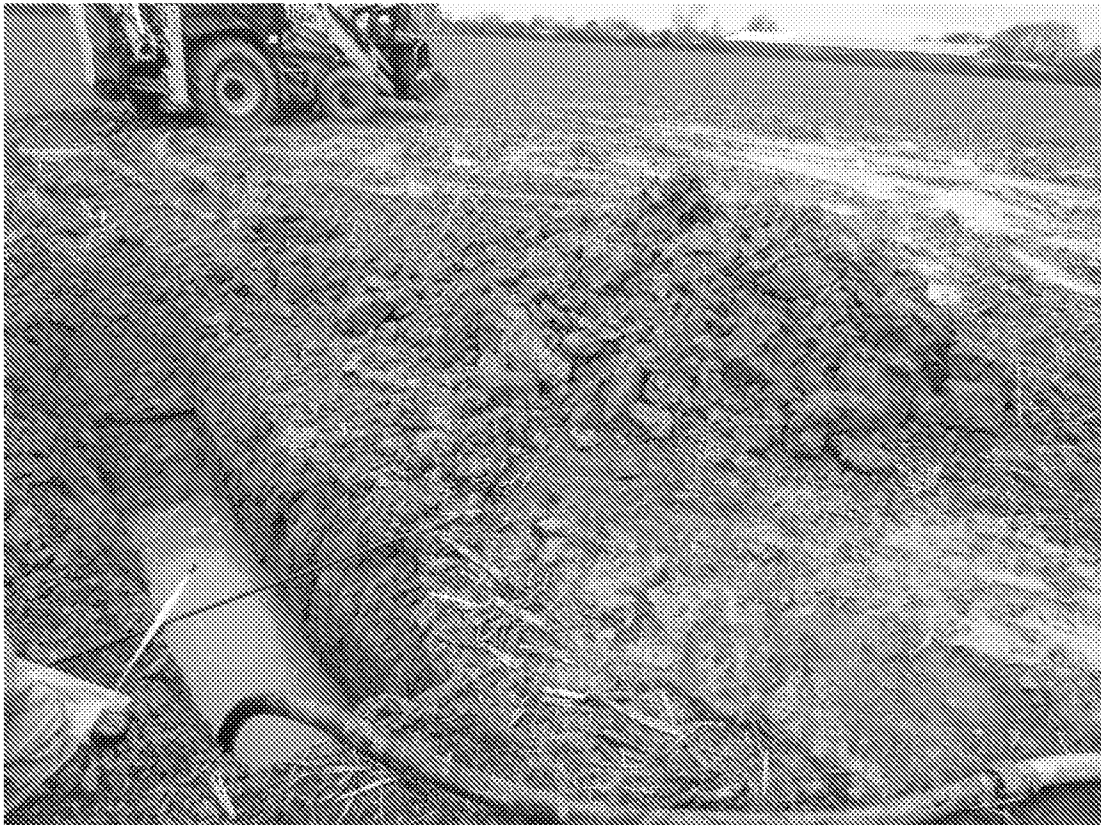
| PHOTOGRAPHIC LOG | | 305035 L01 (00) |
|---|---|---|
| Photo No.<br>28 | | |

| PHOTOGRAPHIC LOG | | 305035 L01 (00) |
|---|---|---|
| Facing<br>southwest,<br>view of TP209 | | |

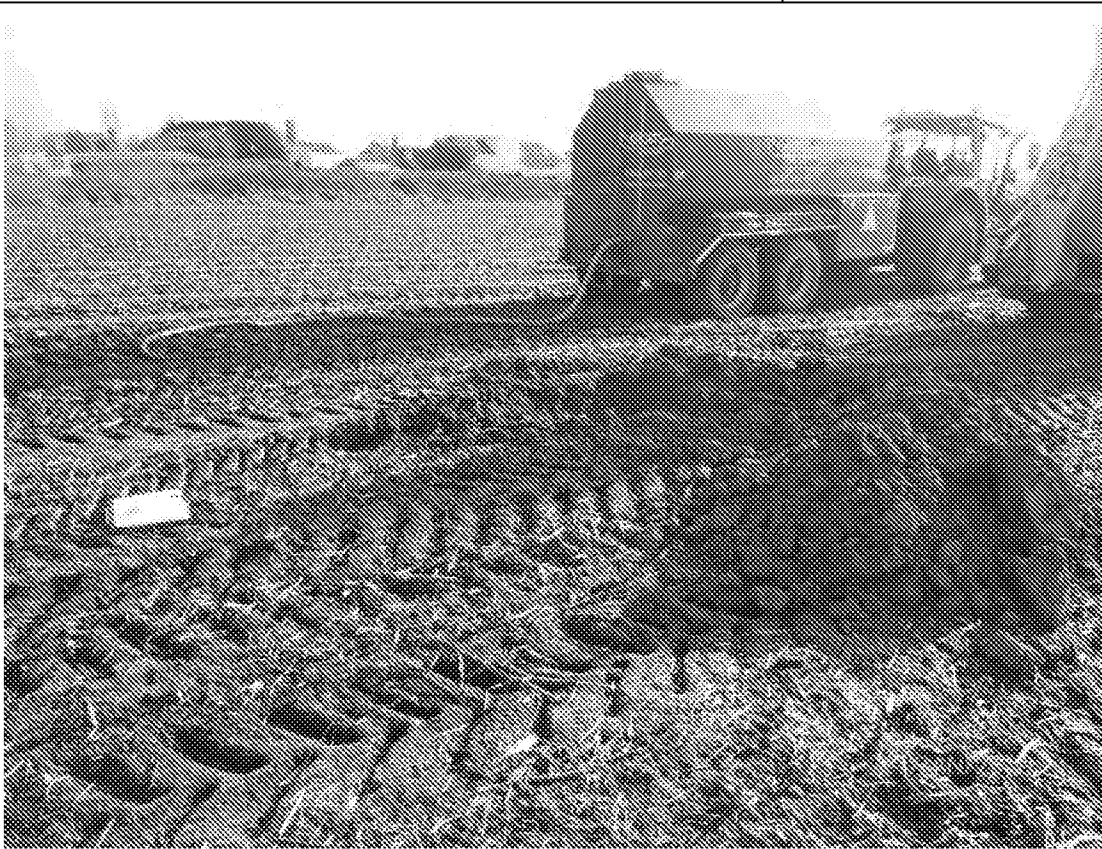
| PHOTOGRAPHIC LOG | | 305035 L01 (00) |
|---|---|---|
| <b>Photo No.</b><br>29 | | |

| PHOTOGRAPHIC LOG | | 305035 L01 (00) |
|---|---|---|
| Facing southeast, overview of TP210 and arisings | | |

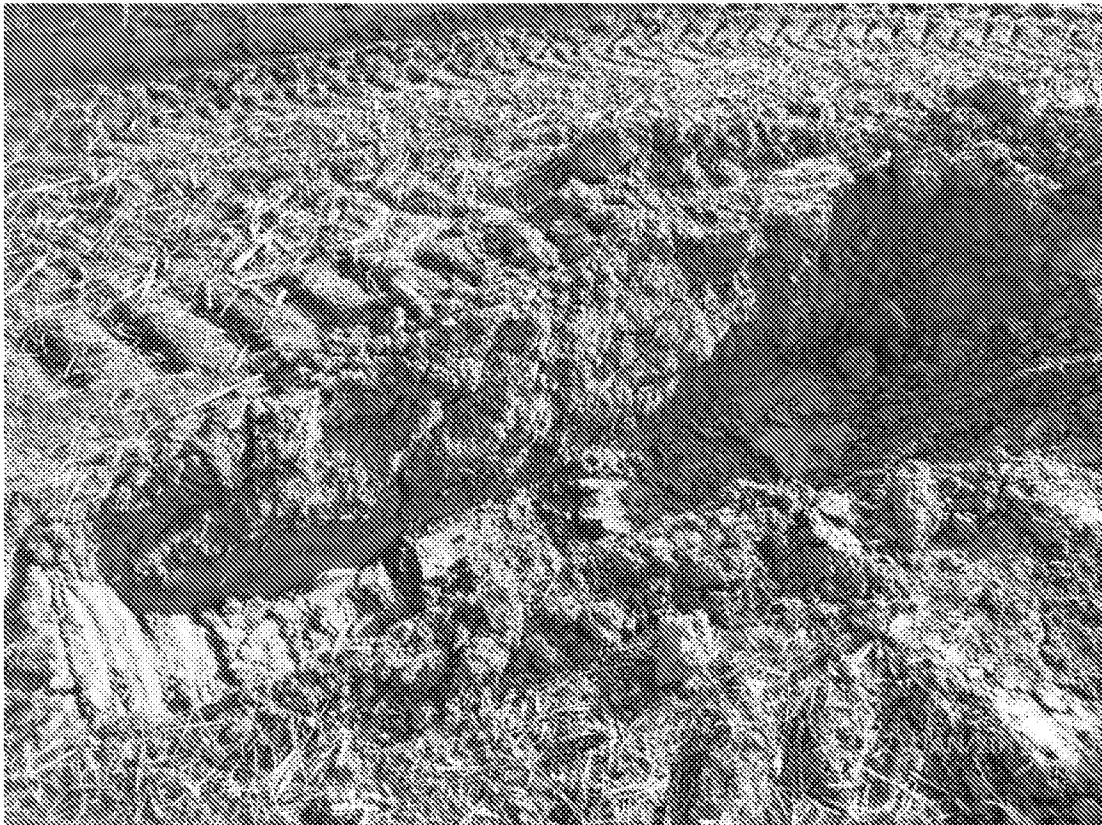
| PHOTOGRAPHIC LOG | | 305035 L01 (00) |
|---|---|---|
| <b>Photo No.</b><br>30 | | |

| PHOTOGRAPHIC LOG | | 305035 L01 (00) |
|---|---|---|
| Downhole view of TP210 | | |

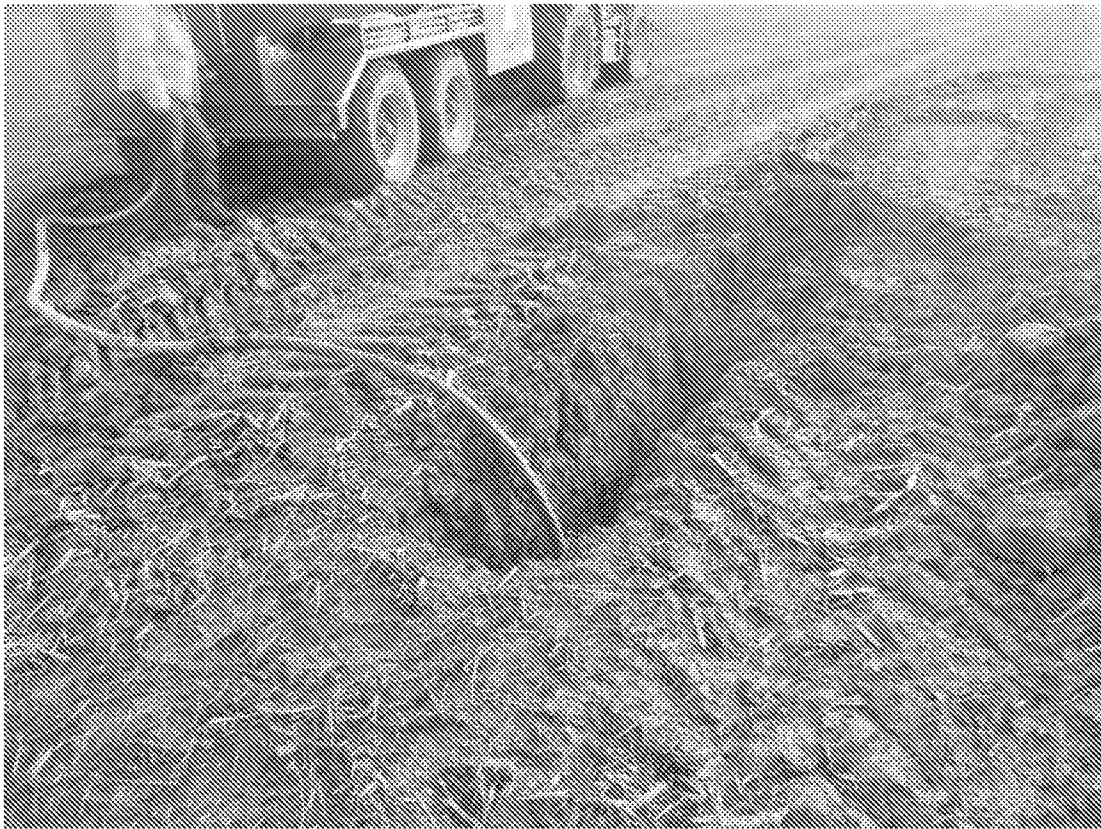
| PHOTOGRAPHIC LOG | | 305035 L01 (00) |
|---|---|---|
| <b>Photo No.</b><br>31 | | |

| PHOTOGRAPHIC LOG | | 305035 L01 (00) |
|---|---|---|
| Facing southwest,<br>view of TP211 | | |

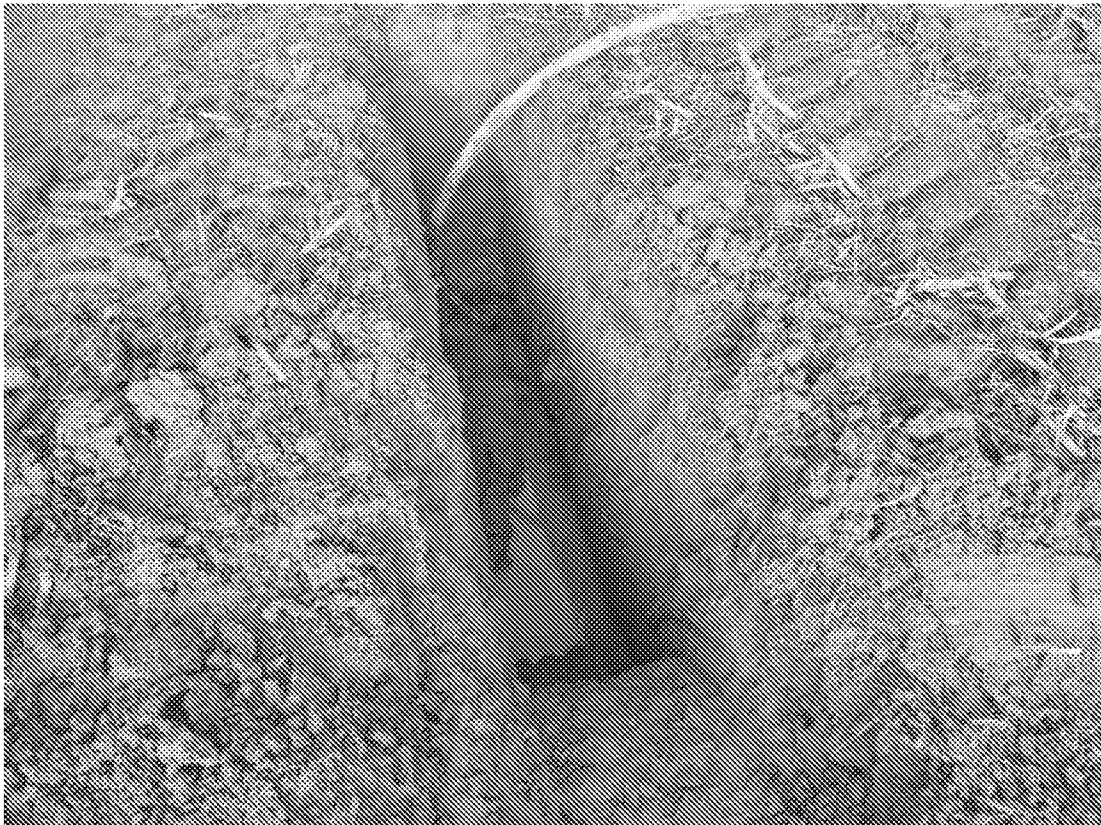
| PHOTOGRAPHIC LOG | | 305035 L01 (00) |
|---|---|---|
| <b>Photo No.</b><br>32 | | |

| PHOTOGRAPHIC LOG | | 305035 L01 (00) |
|---|---|---|
| Downhole view<br>of TP211 | | |

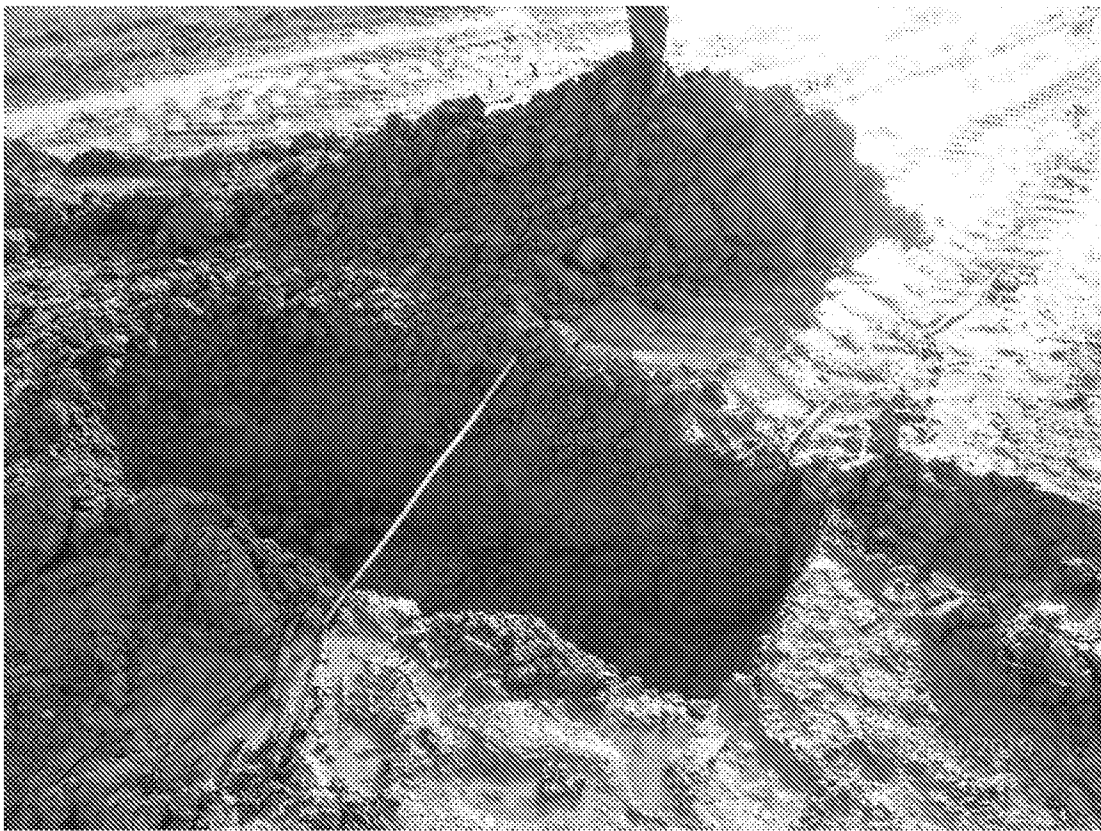
| PHOTOGRAPHIC LOG | | 305035 L01 (00) |
|---|---|---|
| <b>Photo No.</b><br>33 | | |

| PHOTOGRAPHIC LOG | | 305035 L01 (00) |
|---|---|---|
| Facing southwest,<br>view of TP212<br>and arisings | | |

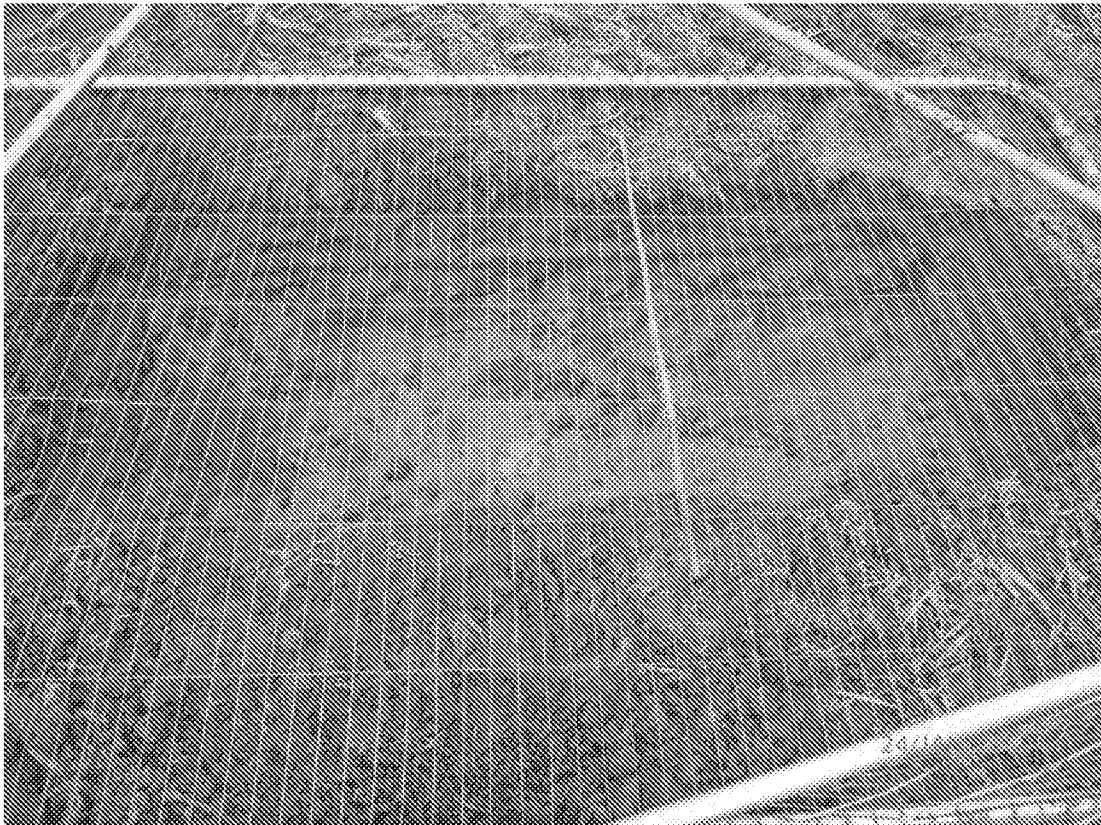
| PHOTOGRAPHIC LOG | | 305035 L01 (00) |
|---|---|---|
| <b>Photo No.</b><br>34 | | |

| PHOTOGRAPHIC LOG | | 305035 L01 (00) |
|---|---|---|
| View of<br>TP2123 | | |

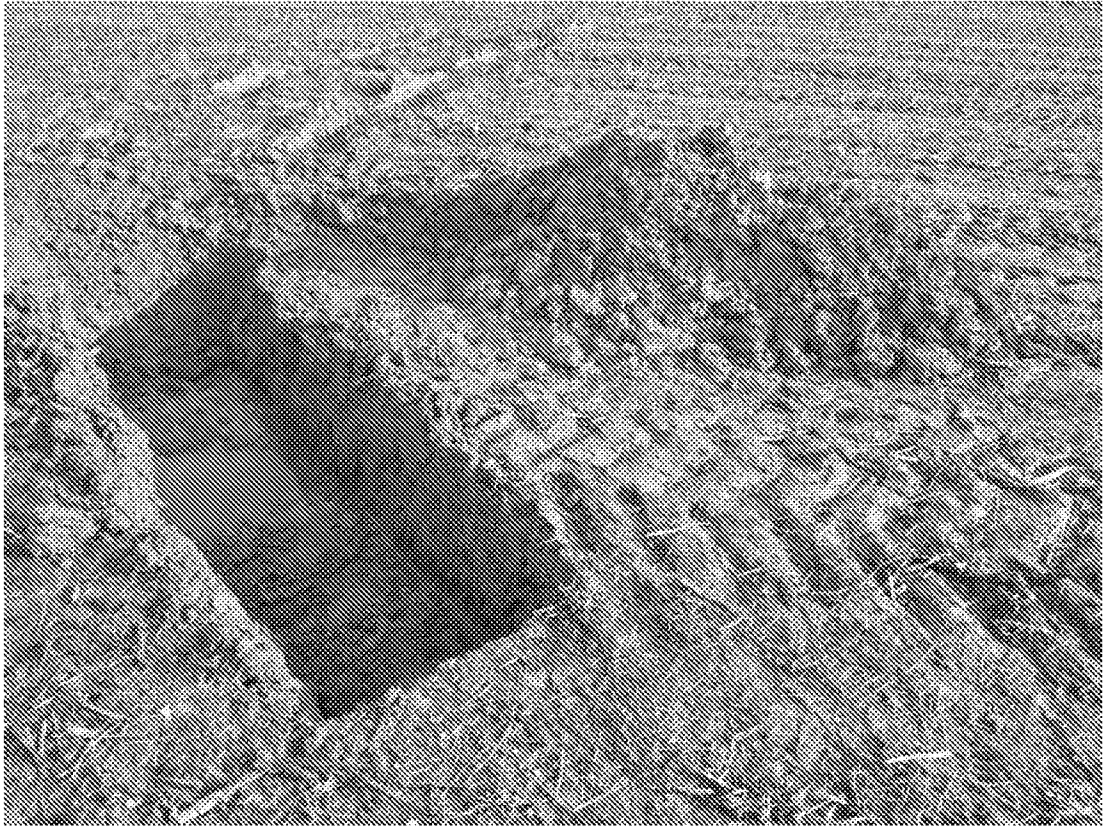
| PHOTOGRAPHIC LOG | | 305035 L01 (00) |
|---|---|---|
| <b>Photo No.</b><br>35 | | |

| PHOTOGRAPHIC LOG | | 305035 L01 (00) |
|---|---|---|
| Facing east,<br>view of TP214 | | |

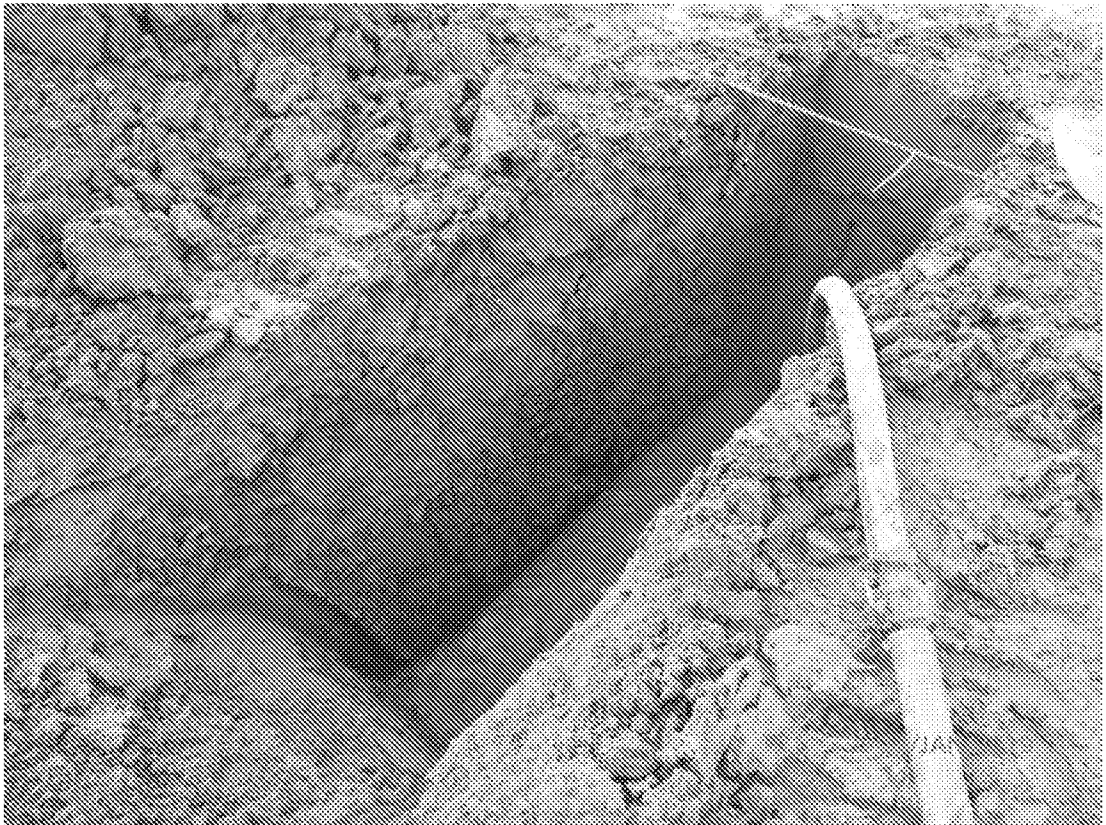
| PHOTOGRAPHIC LOG | | 305035 L01 (00) |
|---|---|---|
| <b>Photo No.</b><br>36 | | |

| PHOTOGRAPHIC LOG | | 305035 L01 (00) |
|---|---|---|
| Downhole view<br>of TP215 | | |

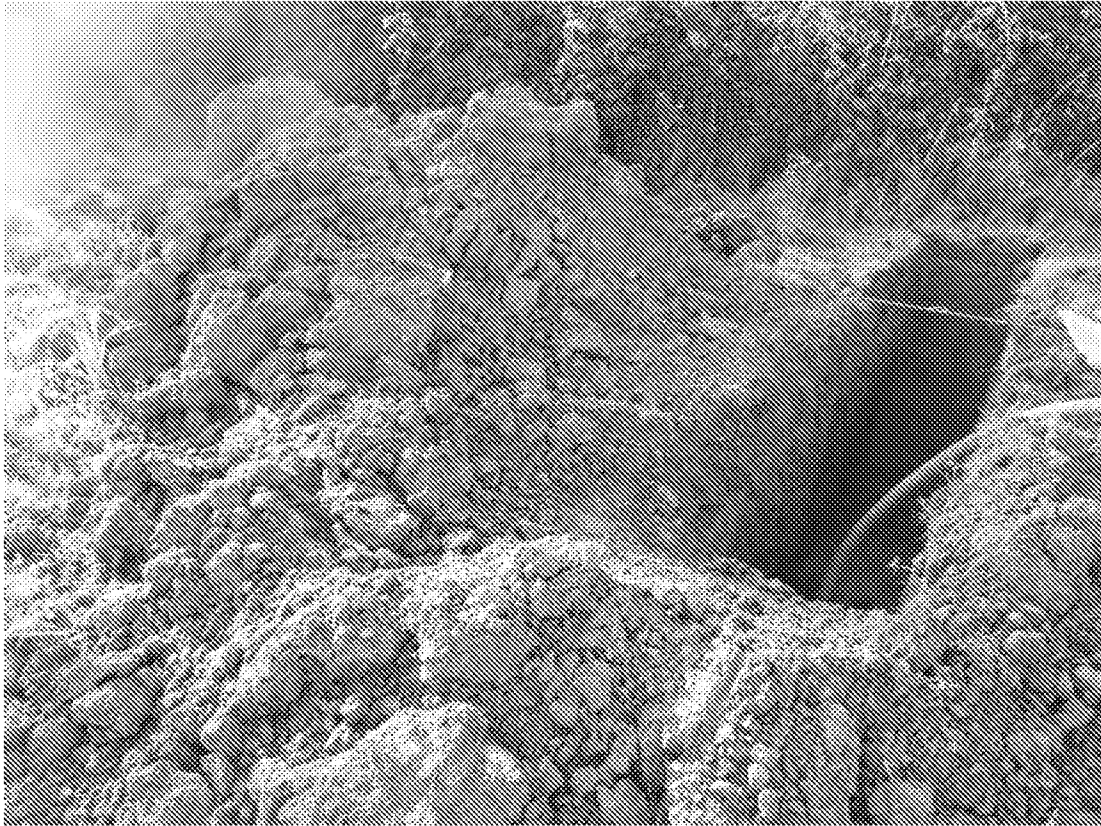
| PHOTOGRAPHIC LOG | | 305035 L01 (00) |
|---|---|---|
| <b>Photo No.</b><br>37 | | |

| PHOTOGRAPHIC LOG | | 305035 L01 (00) |
|---|---|---|
| Facing southwest,<br>view of TP216 | | |

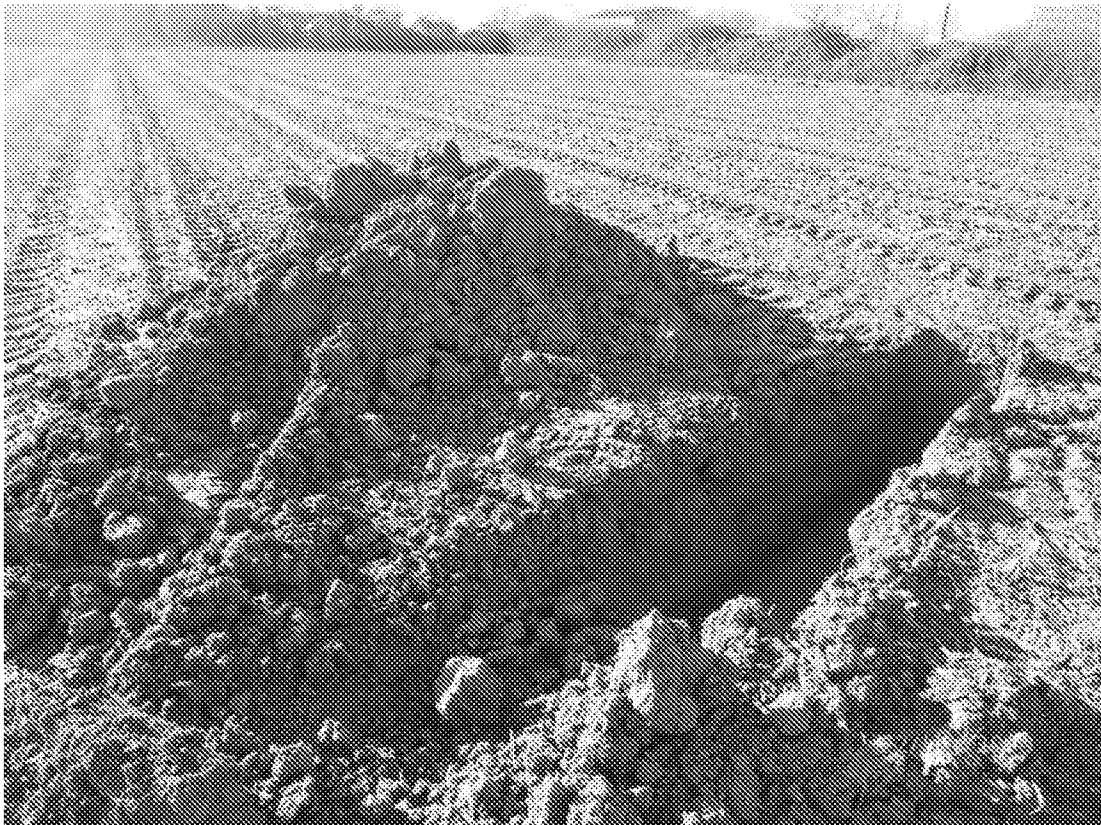
| PHOTOGRAPHIC LOG | | 305035 L01 (00) |
|---|---|---|
| <b>Photo No.</b><br>38 | | |

| PHOTOGRAPHIC LOG | | 305035 L01 (00) |
|---|---|---|
| Facing southwest,<br>view of TP218<br>and arisings | | |

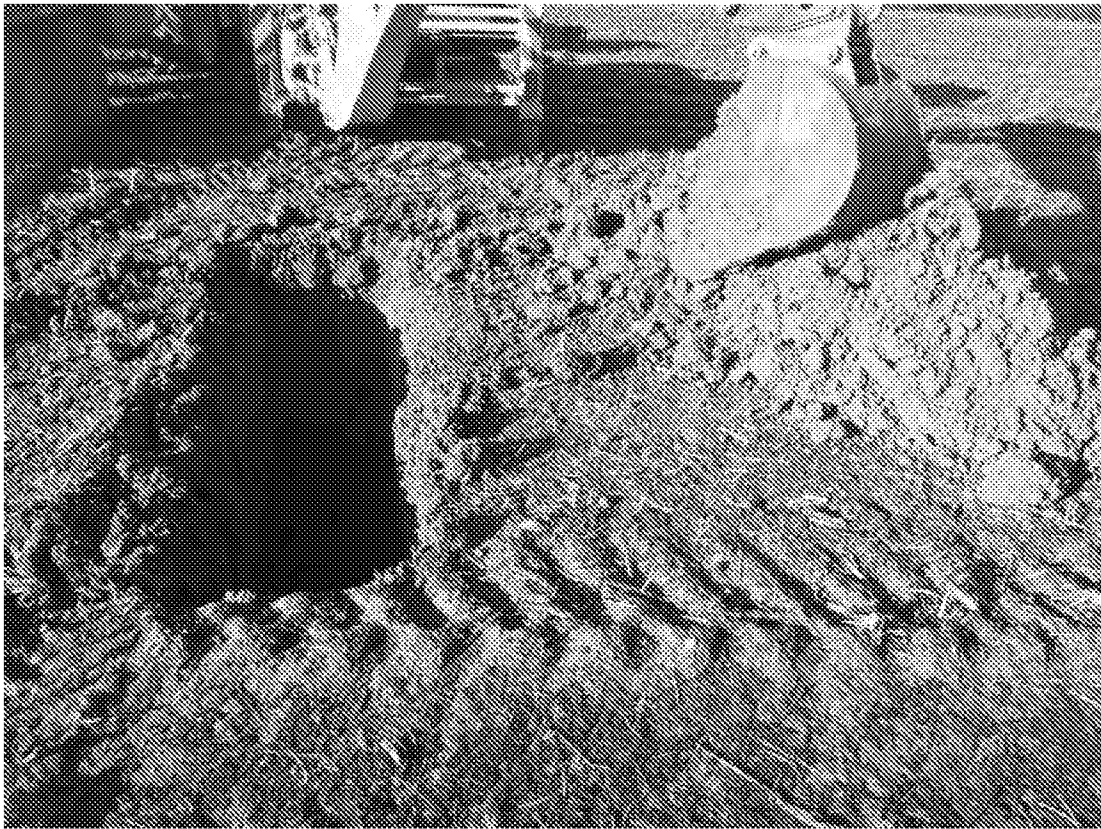
| PHOTOGRAPHIC LOG | | 305035 L01 (00) |
|---|---|---|
| <b>Photo No.</b><br>39 | | |

| PHOTOGRAPHIC LOG | | 305035 L01 (00) |
|---|---|---|
| Facing west,<br>view of TP219<br>and arisings | | |

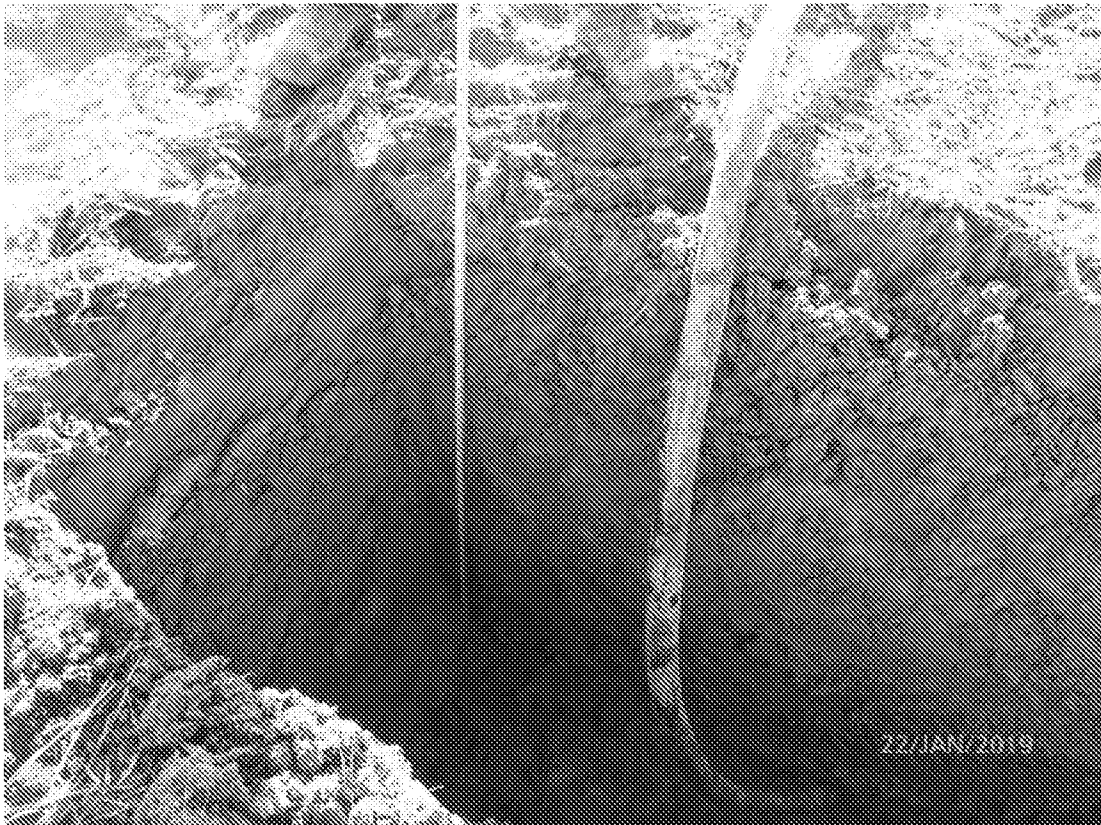
| PHOTOGRAPHIC LOG | | 305035 L01 (00) |
|---|---|---|
| <b>Photo No.</b><br>40 | | |

| PHOTOGRAPHIC LOG | | 305035 L01 (00) |
|---|---|---|
| Downhole view<br>of TP219 | | |

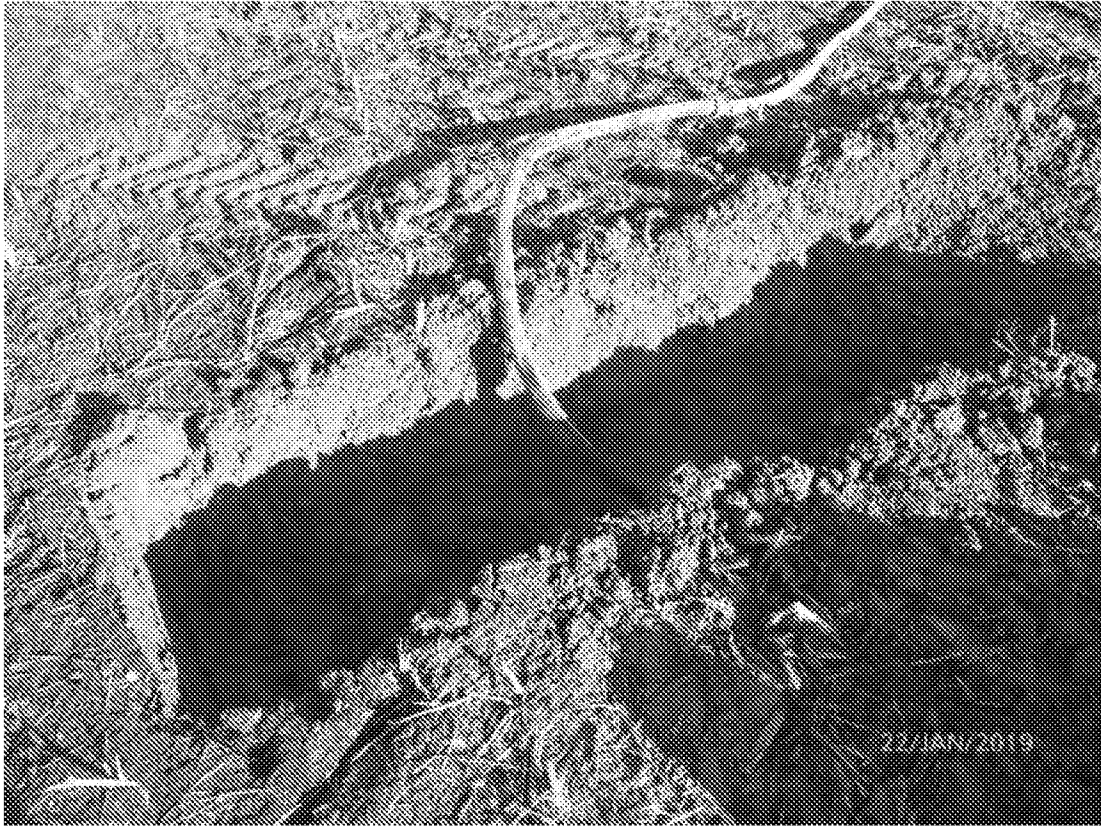
| PHOTOGRAPHIC LOG | | 305035 L01 (00) |
|---|---|---|
| Photo No.<br>41 | | View of TP220 |

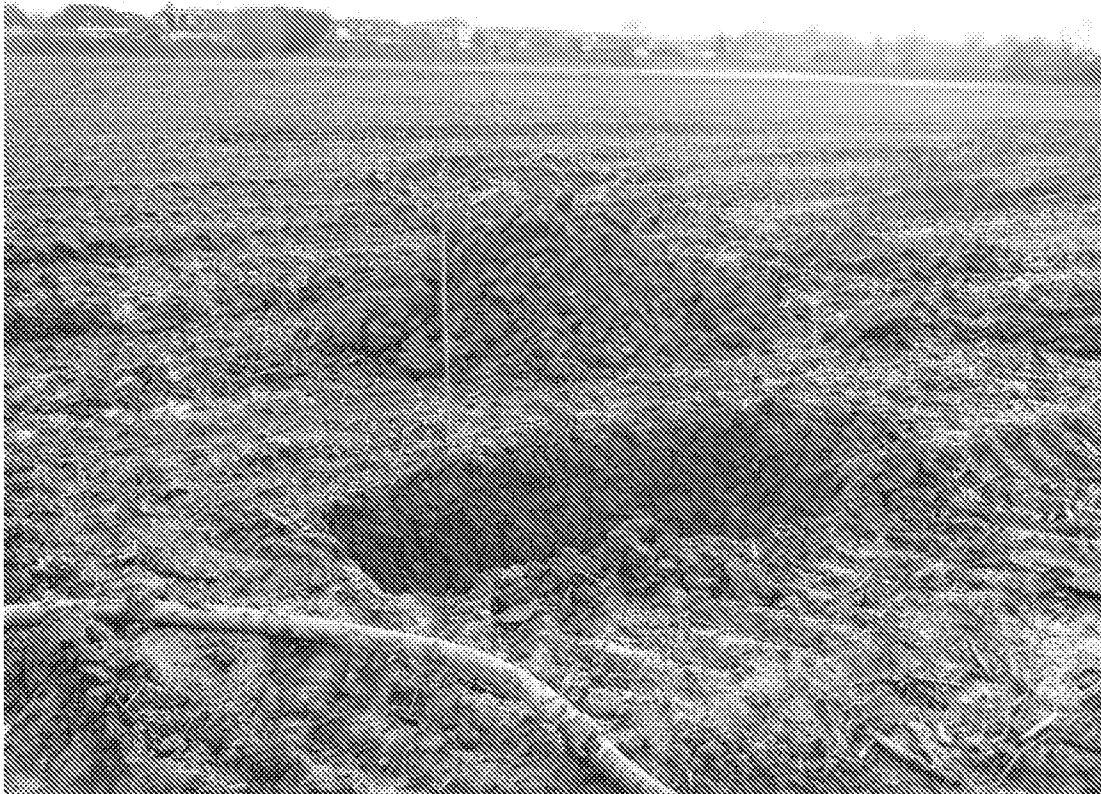
| PHOTOGRAPHIC LOG | | 305035 L01 (00) |
|---|---|---|
| Photo No.<br>42 | | Facing east,<br>view of TP221<br>and arisings |

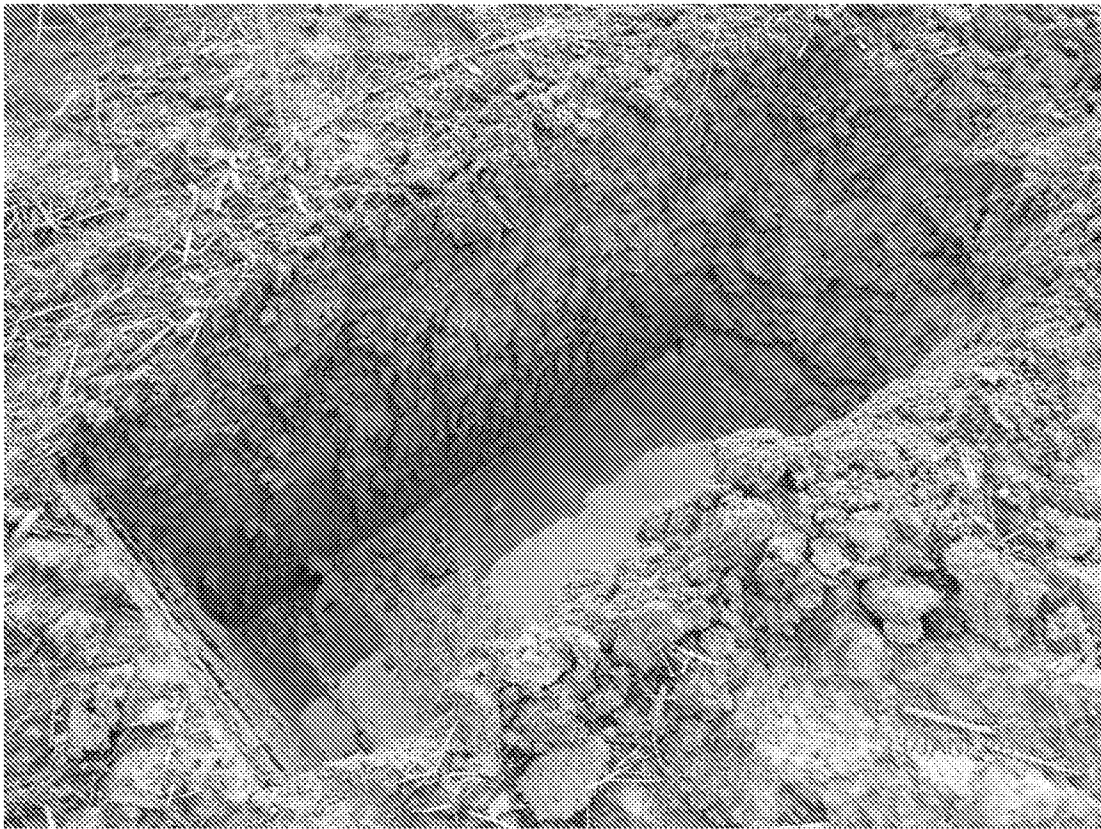
| PHOTOGRAPHIC LOG | | 305035 L01 (00) |
|---|---|---|
| Photo No.<br>43 | | |

| PHOTOGRAPHIC LOG | | 305035 L01 (00) |
|---|---|---|
| Downhole view of TP221 during soakage test | | |

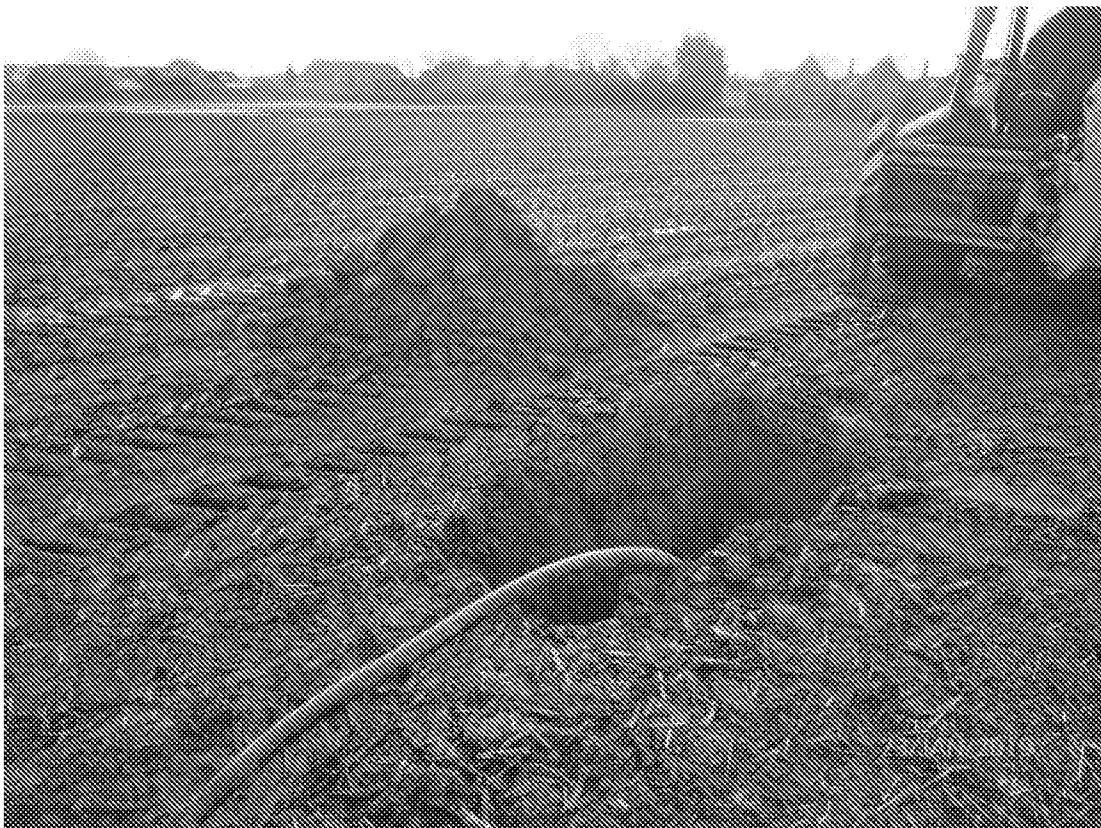
| PHOTOGRAPHIC LOG | | 305035 L01 (00) |
|---|---|---|
| Photo No.<br>44 | | |

| PHOTOGRAPHIC LOG | | 305035 L01 (00) |
|---|---|---|
| Facing southeast, view of TP222 | | |

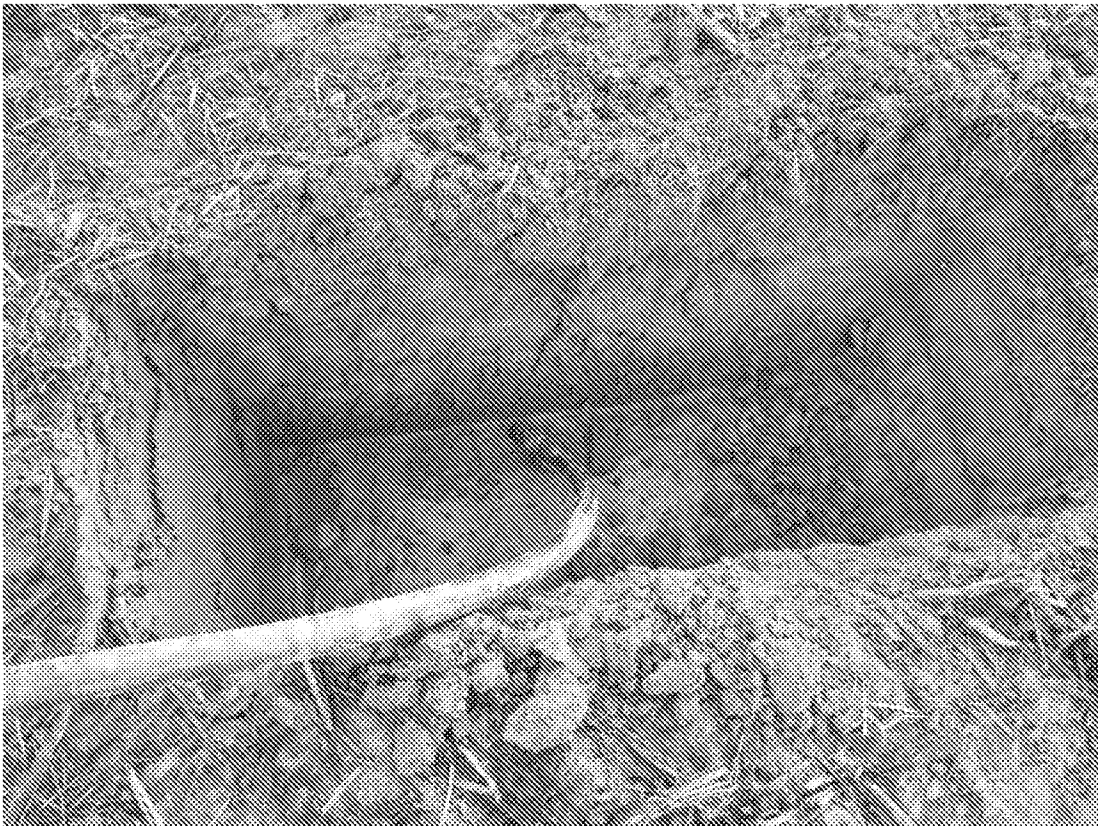
| PHOTOGRAPHIC LOG | | 305035 L01 (00) |
|---|---|---|
| Photo No.<br>45 | | |

| PHOTOGRAPHIC LOG | | 305035 L01 (00) |
|---|---|---|
| Downhole view<br>of TP222 | | |

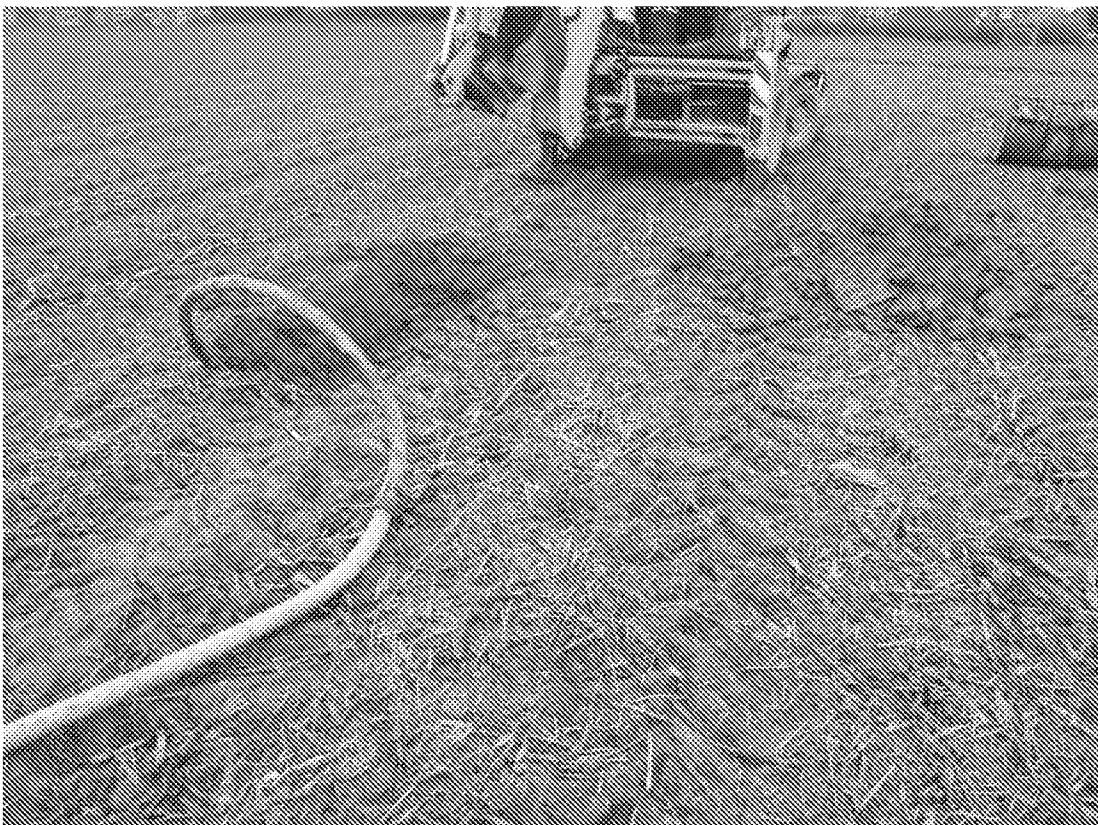
| PHOTOGRAPHIC LOG | | 305035 L01 (00) |
|---|---|---|
| Photo No.<br>46 | | |

| PHOTOGRAPHIC LOG | | 305035 L01 (00) |
|---|---|---|
| Facing south,<br>view of TP223 | | |

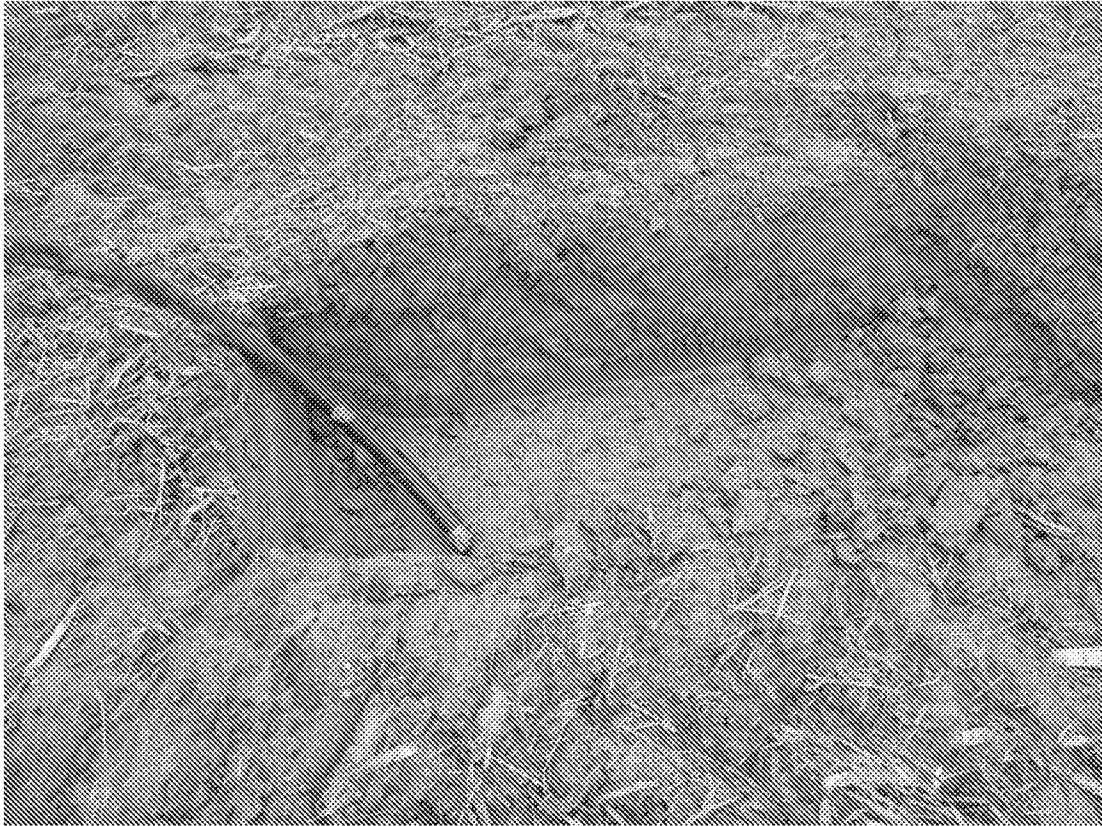
| PHOTOGRAPHIC LOG | | 305035 L01 (00) |
|---|---|---|
| Photo No.<br>47 | | |

| PHOTOGRAPHIC LOG | | 305035 L01 (00) |
|---|---|---|
| Downhole view<br>of TP223 | | |

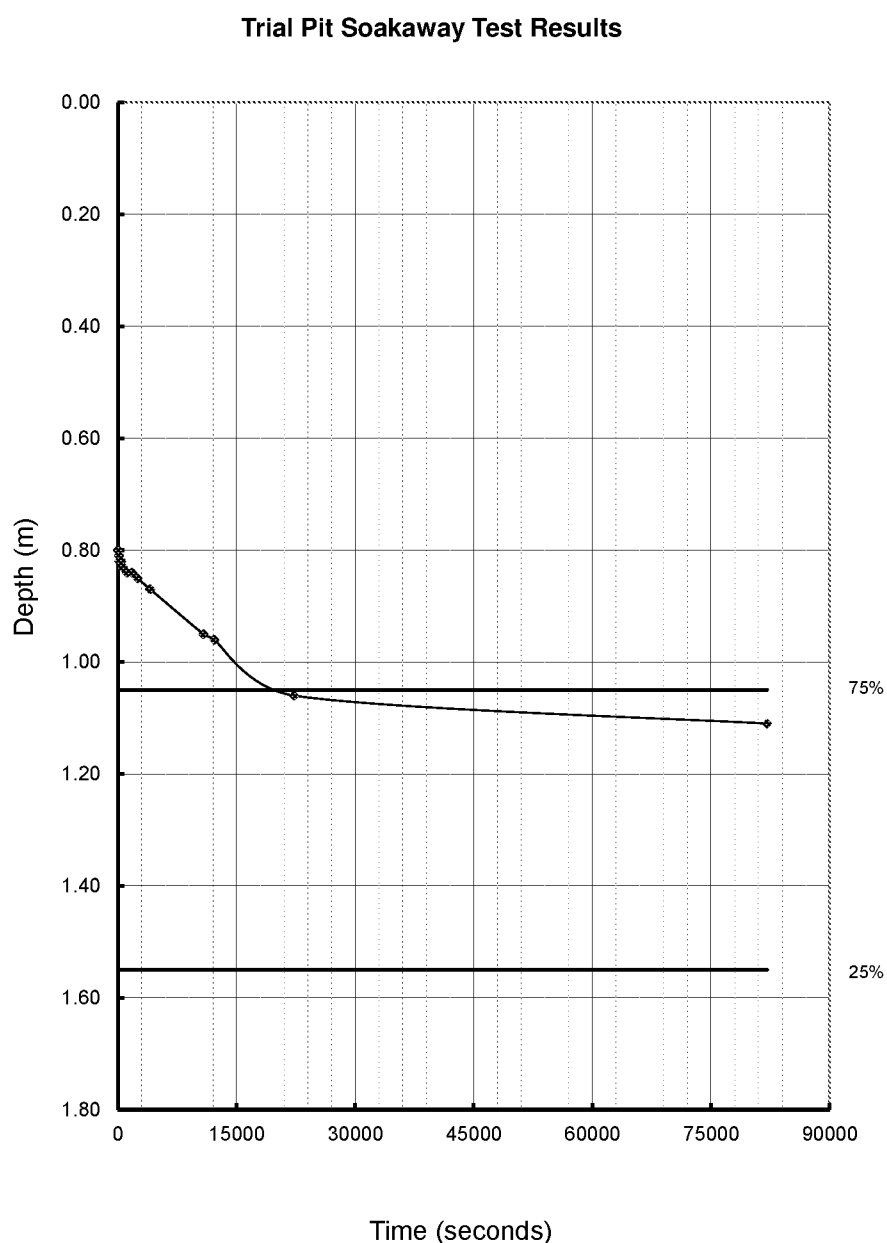
| <b>Location</b> | TP201 | <b>Test number</b> | 1 |

| Results | | Comments |
|---|---|---|
| Vp 75-25 (m3) | 0.495 | 1. Trial pit dry prior to soakaway test. |
| Infiltration Rate (m/s) | - | |
