# **APPENDIX C**

## **PHOTOGRAPHIC LOG**

| PHOTOGRAPHIC LOG | | 305035 L01 (00) |
|---|---|---|
| Site Location: Land at Sefter Road, Bognor Regis, PO21 3EE | | Appendix D |

## **TRIAL PIT SOAKAWAY TEST DATA**

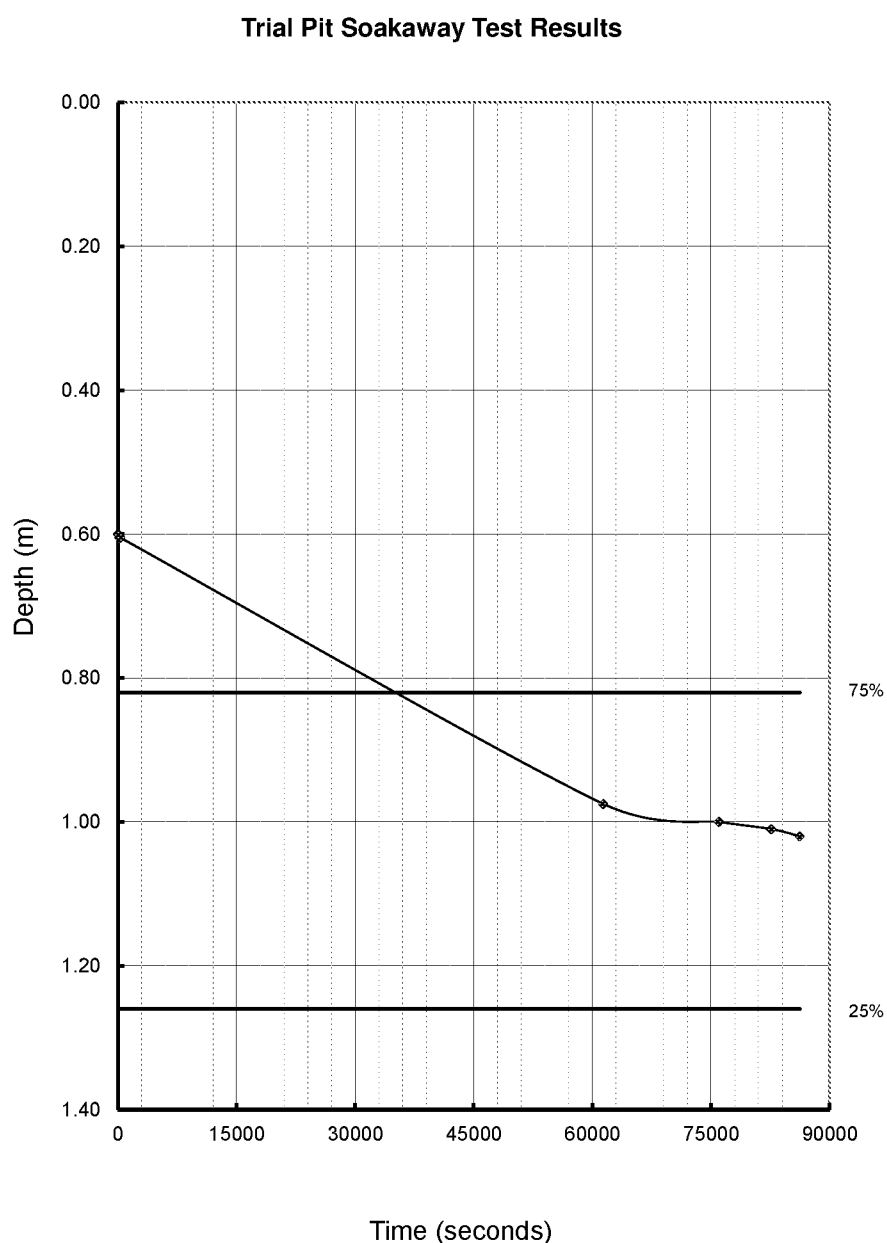
| <b>Location</b> | TP202 | <b>Test number</b> | 1 |

| Results | | Comments |
|---|---|---|
| Vp 75-25 (m3) | 0.57 | 1. Groundwater at 1.60 m prior to soakaway test. |
| Infiltration Rate (m/s) | - | |

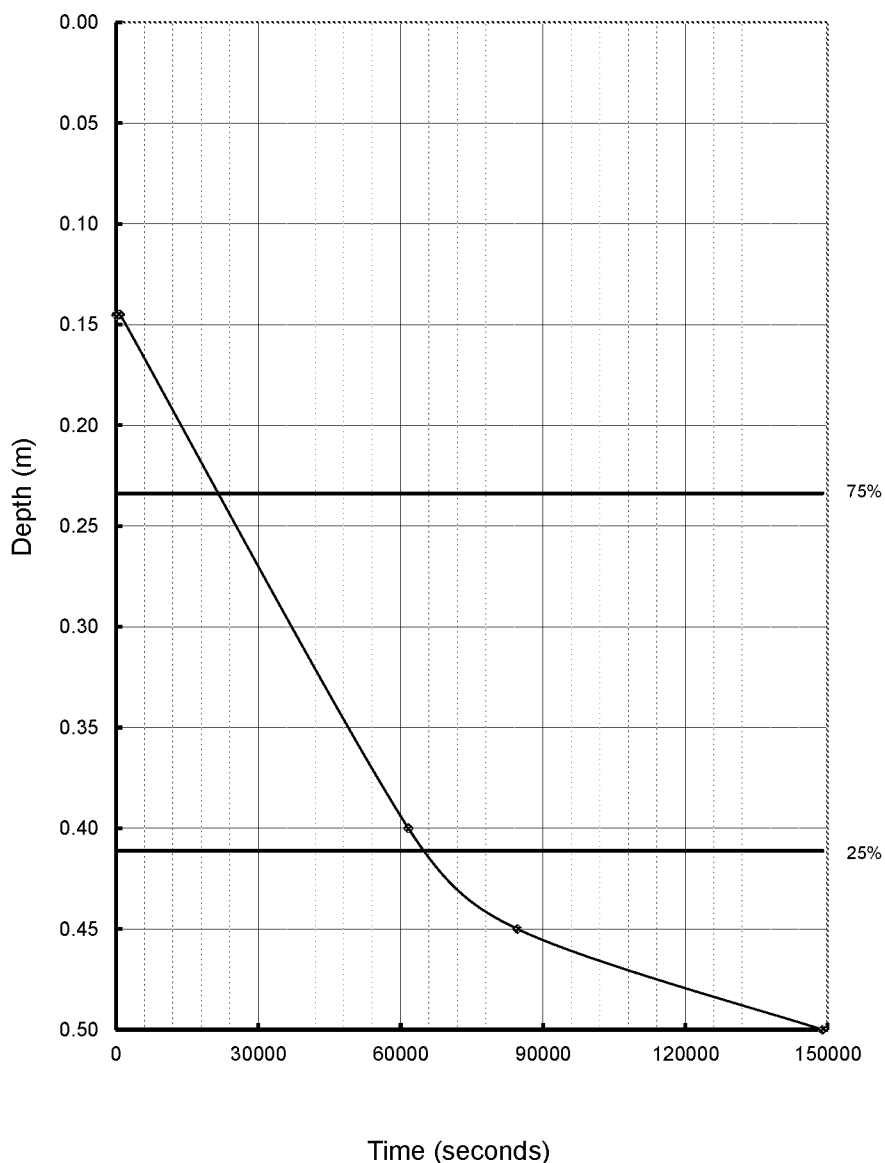
### **Trial Pit Soakaway Test Results**

| tp 75-25 (s) | 44000 |
| Infiltration Rate (m/s) | 2.08E-06 |

1. Trial pit dry prior to soakaway test.

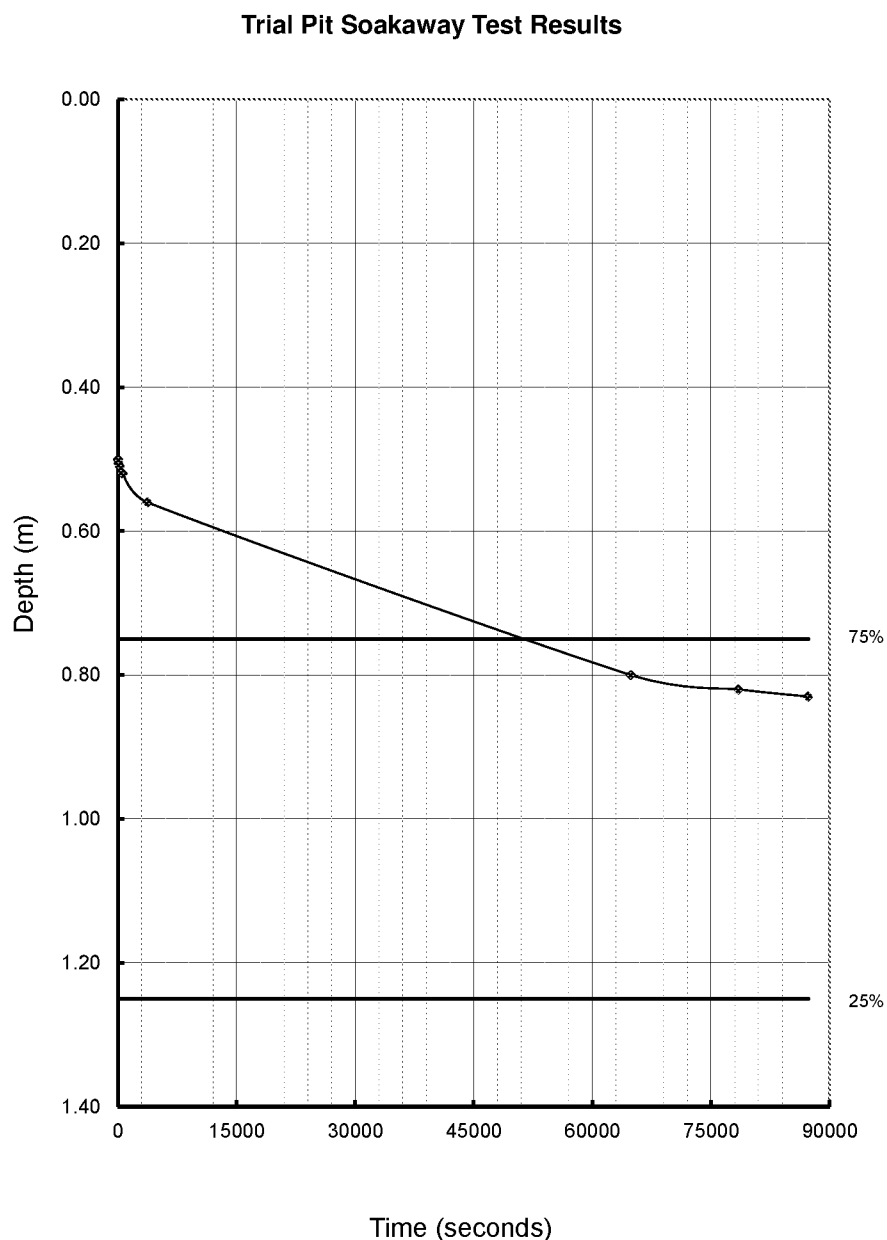
| <b>Location</b> | TP204 | <b>Test number</b> | 1 |

| Results | | Comments |
|---|---|---|
| Vp 75-25 (m3) | 0.66 | 1. Groundwater at 1.50 m prior to soakaway test. |
| Infiltration Rate (m/s) | - | |

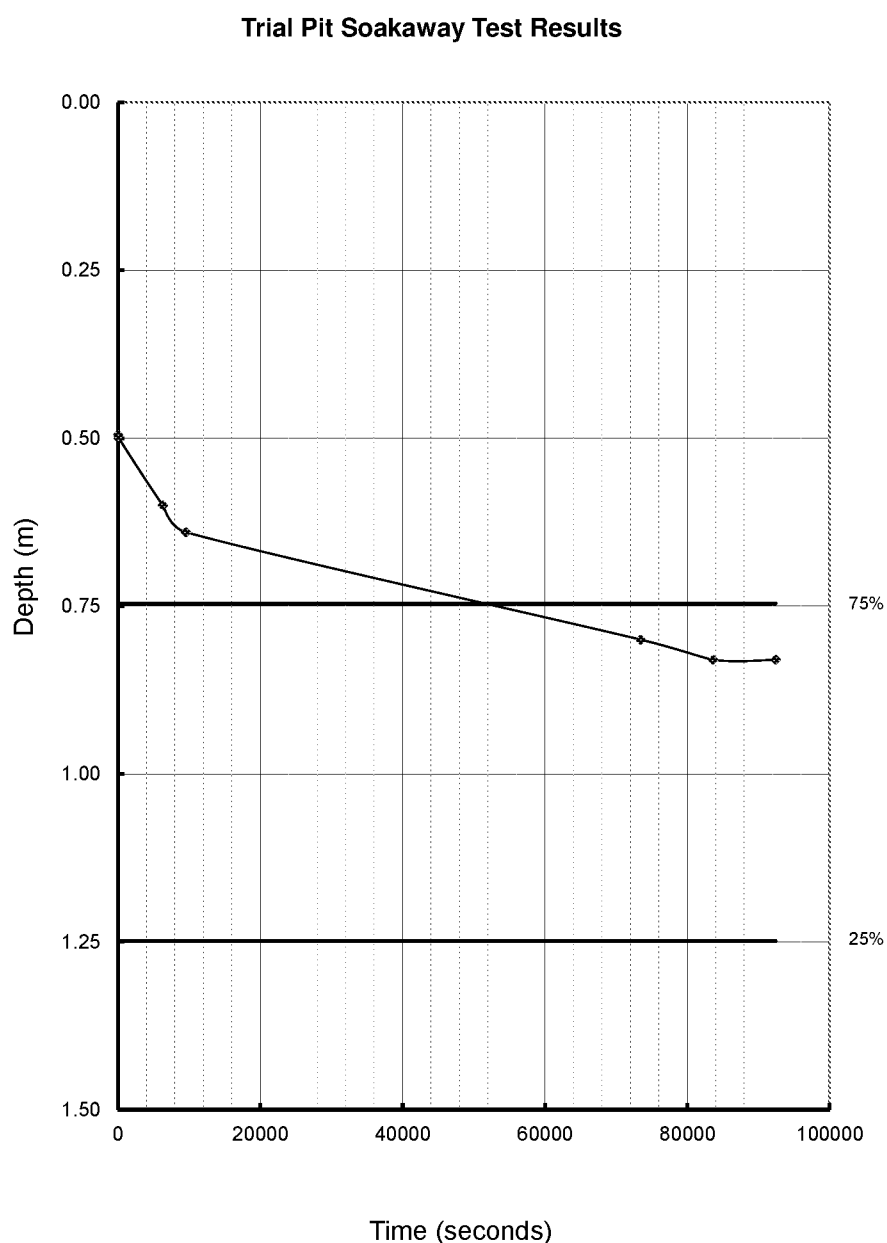
| <b>Location</b> | TP205 | <b>Test number</b> | 1 |

| Results | | Comments |
|---|---|---|
| Vp 75-25 (m3) | 0.69 | 1. Groundwater at 1.45 m prior to soakaway test. |
| Infiltration Rate (m/s) | - | |

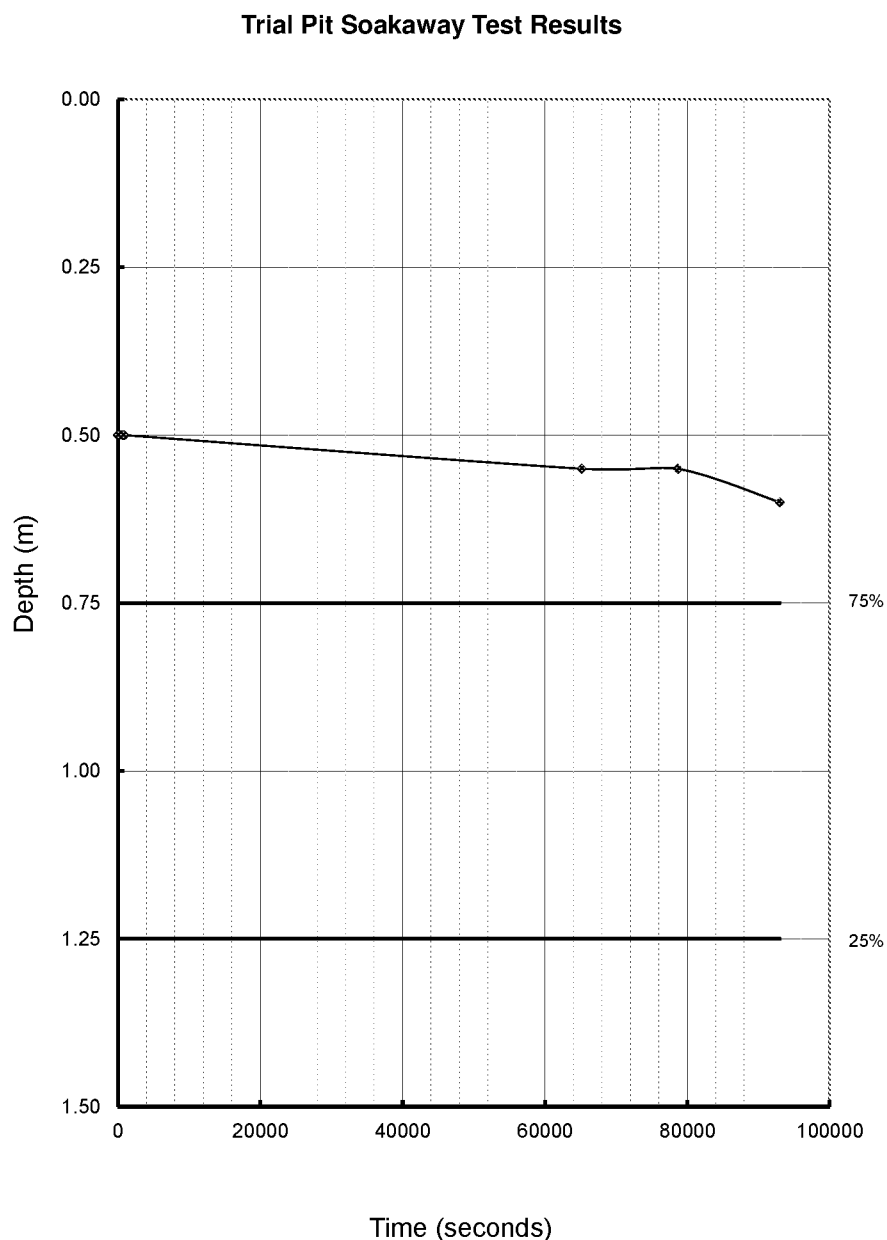
| <b>Location</b> | TP209 | <b>Test number</b> | 1 |

| Results | | Comments |
|---|---|---|
| Vp 75-25 (m3) | 0.54 | 1. Trial pit dry prior to soakaway test. |
| Infiltration Rate (m/s) | - | |

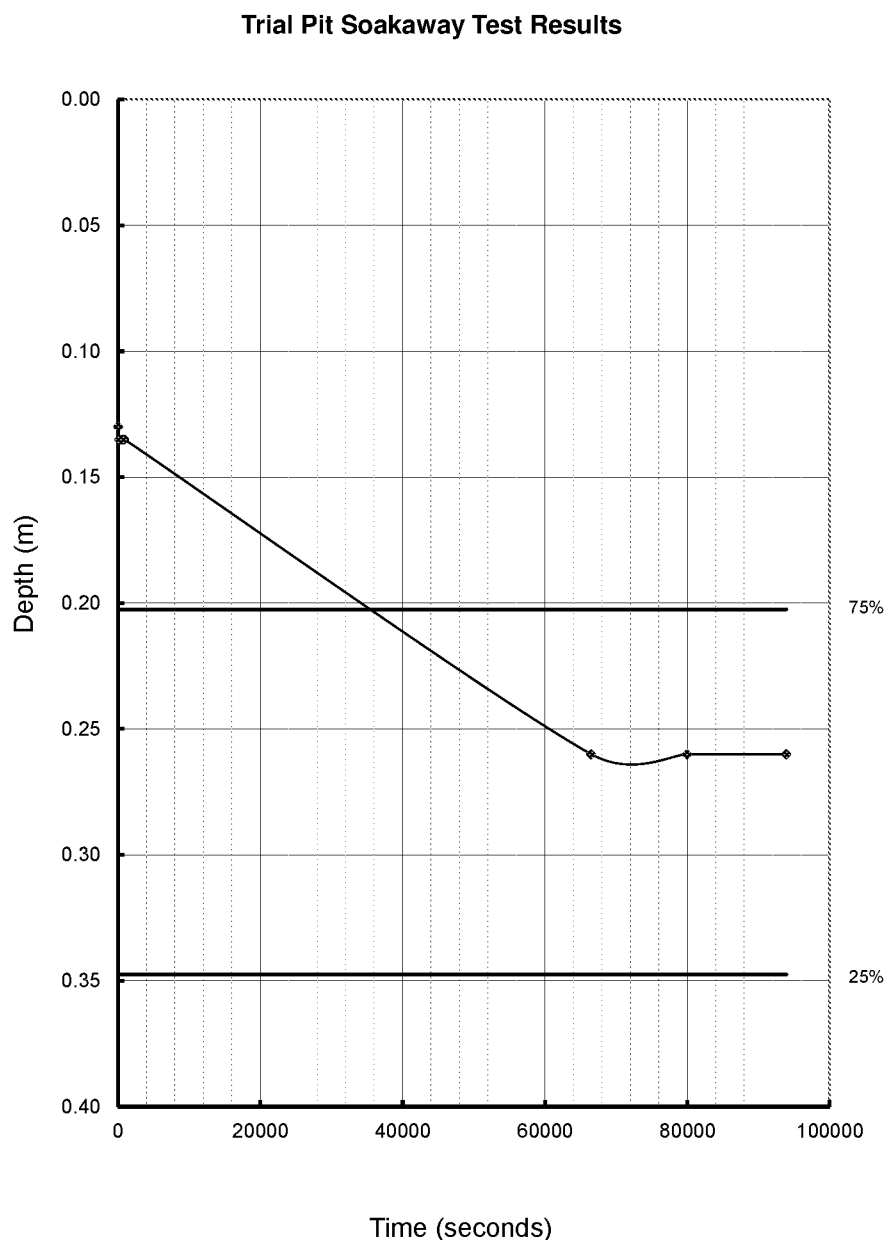
| <b>Location</b> | TP210 | <b>Test number</b> | 1 |

| Results | | Comments |
|---|---|---|
| Vp 75-25 (m3) | 0.24 | 1. Trial pit dry prior to soakaway test. |
| Infiltration Rate (m/s) | - | |

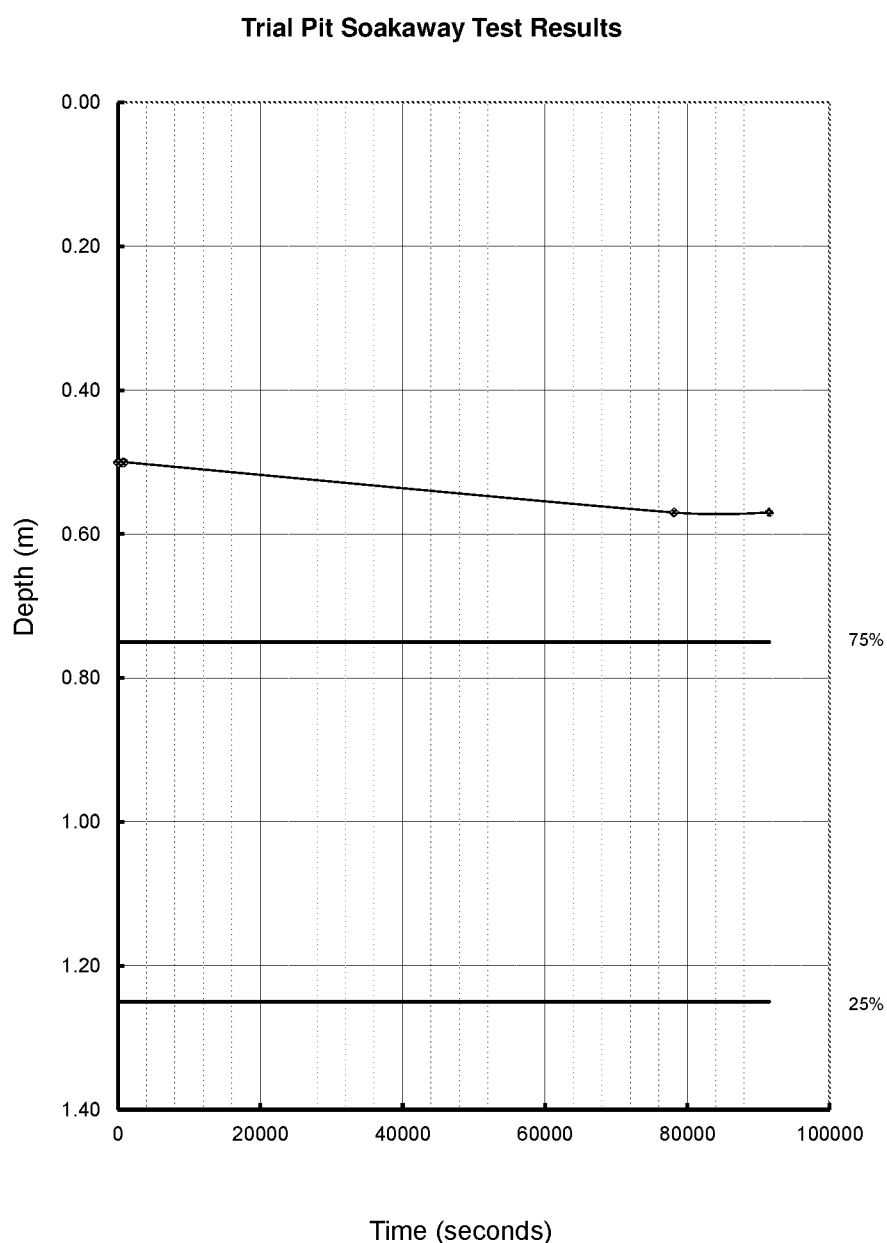
| <b>Location</b> | TP216 | <b>Test number</b> | 1 |

| Results | | Comments |
|---|---|---|
| Vp 75-25 (m3) | 0.87 | 1. Trial pit dry prior to soakaway test. |
| Infiltration Rate (m/s) | - | |

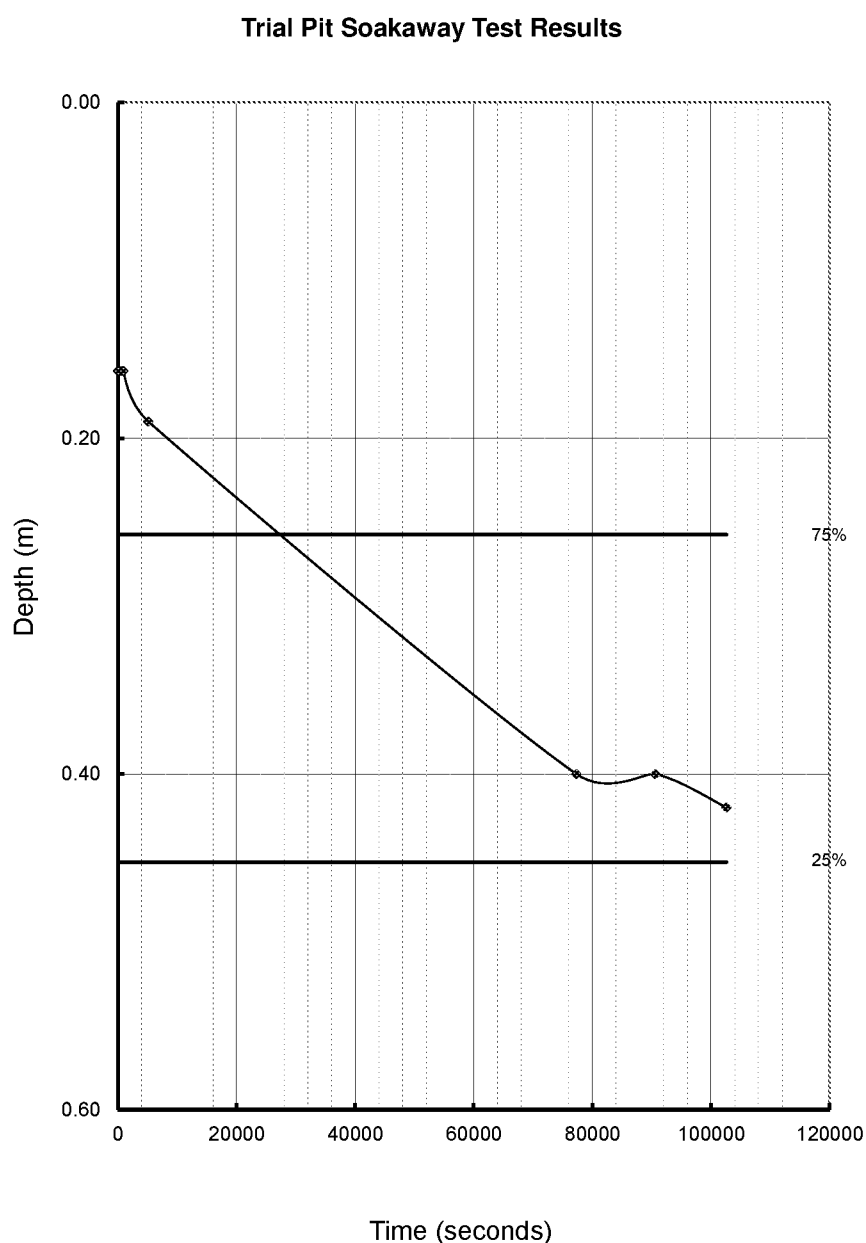
| <b>Location</b> | TP217 | <b>Test number</b> | 1 |

| Results | |
|---|---|
| Infiltration Rate (m/s) | - |

1. Trial pit dry prior to soakaway test.

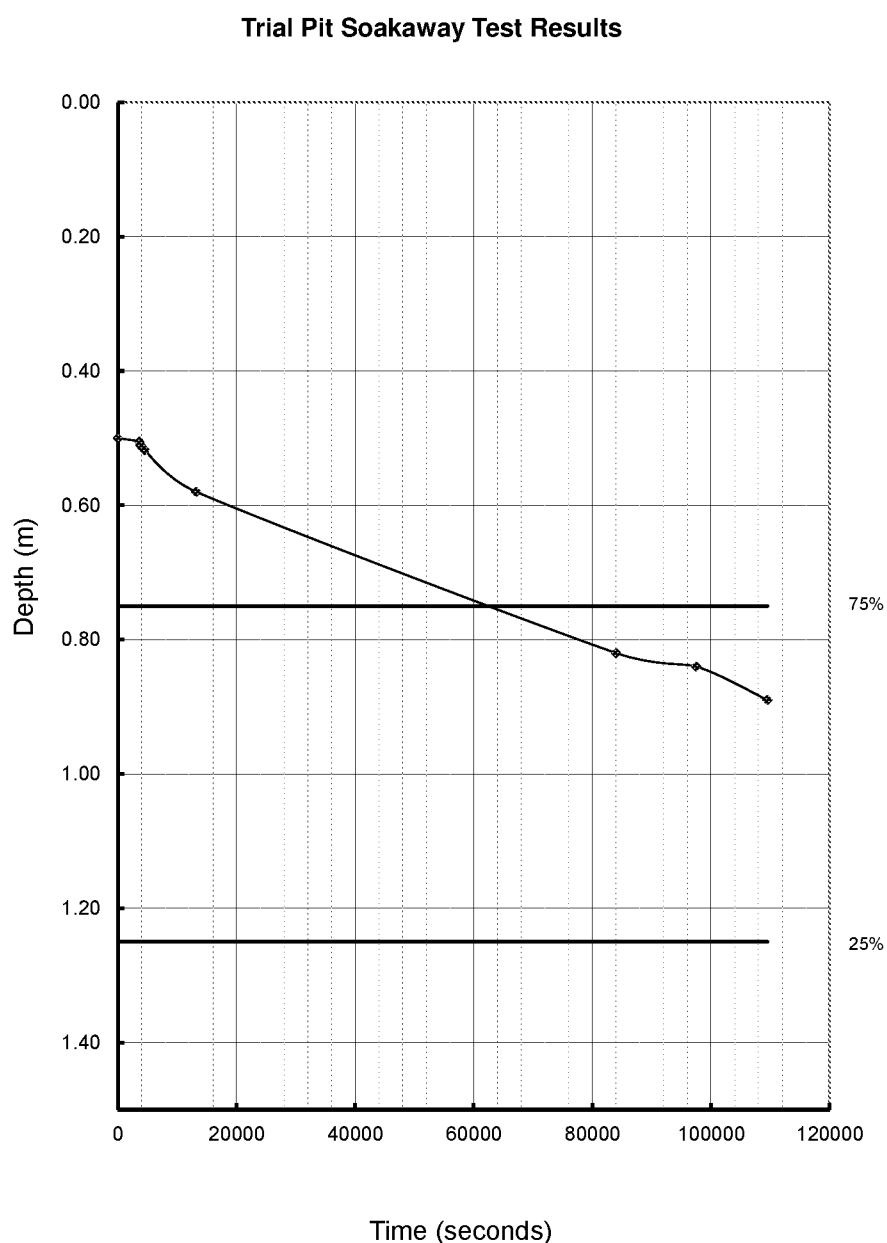
| <b>Location</b> | TP219 | <b>Test number</b> | 1 |

| Results | | Comments |
|---|---|---|
| Vp 75-25 (m3) | 0.72 | 1. Trial pit dry prior to soakaway test. |
| Infiltration Rate (m/s) | - | |

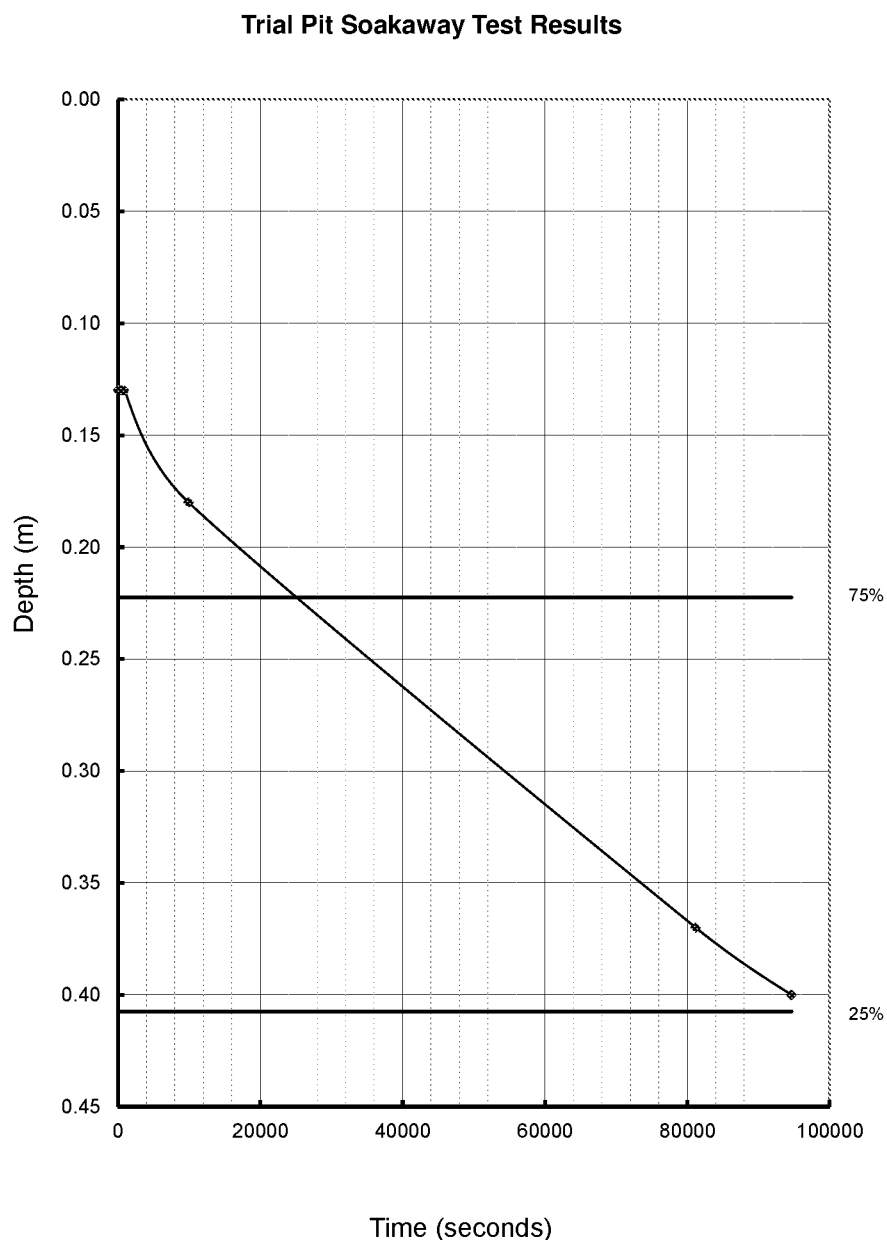
| <b>Location</b> | TP220 | <b>Test number</b> | 1 |

| Results | | Comments |
|---|---|---|
| Vp 75-25 (m3) | 2.96 | 1. Trial pit dry prior to soakaway test. |
| Infiltration Rate (m/s) | - | |

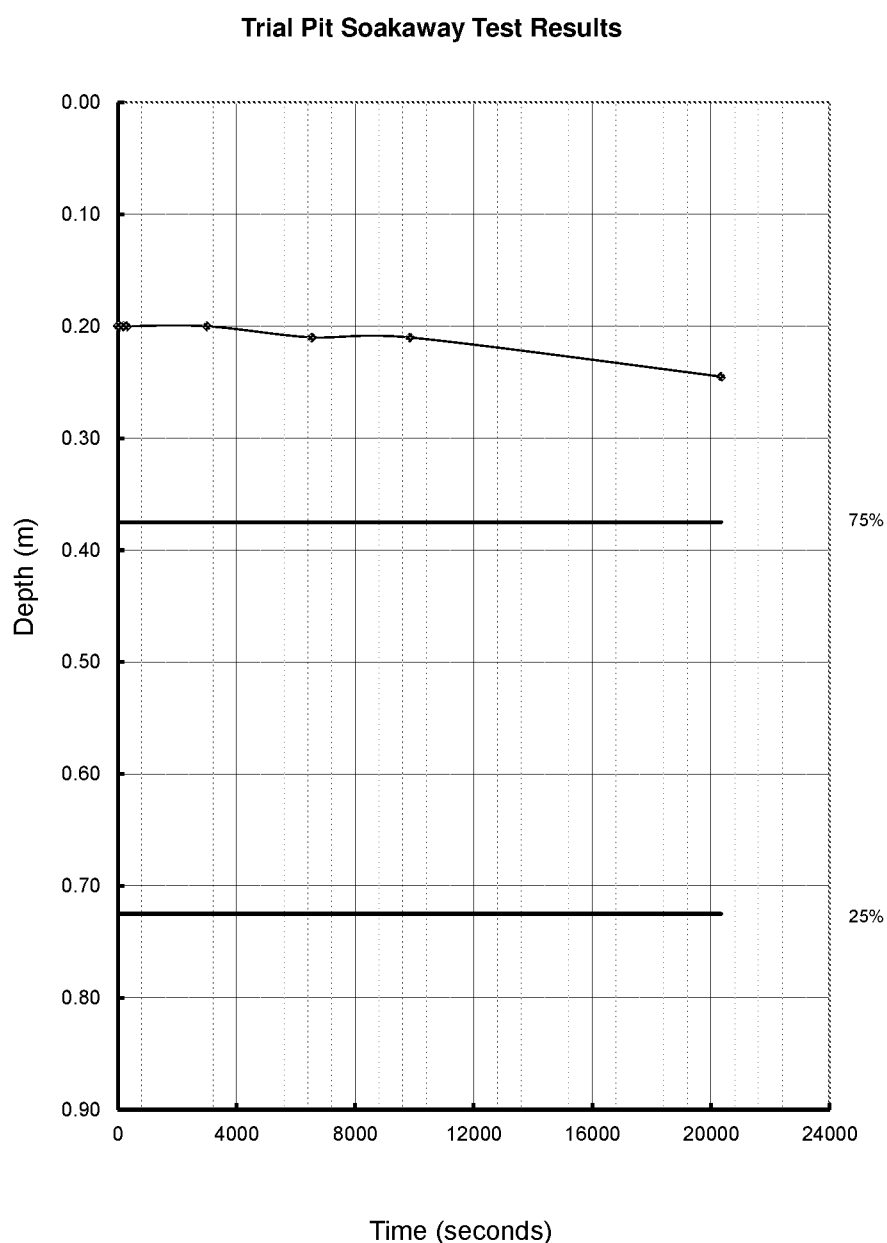
| <b>Location</b> | TP222 | <b>Test number</b> | 1 |

| Results | | Comments |
|---|---|---|
| Vp 75-25 (m3) | 0.39 | 1. Groundwater at 0.90 m prior to soakaway test. |
| Infiltration Rate (m/s) | - | |

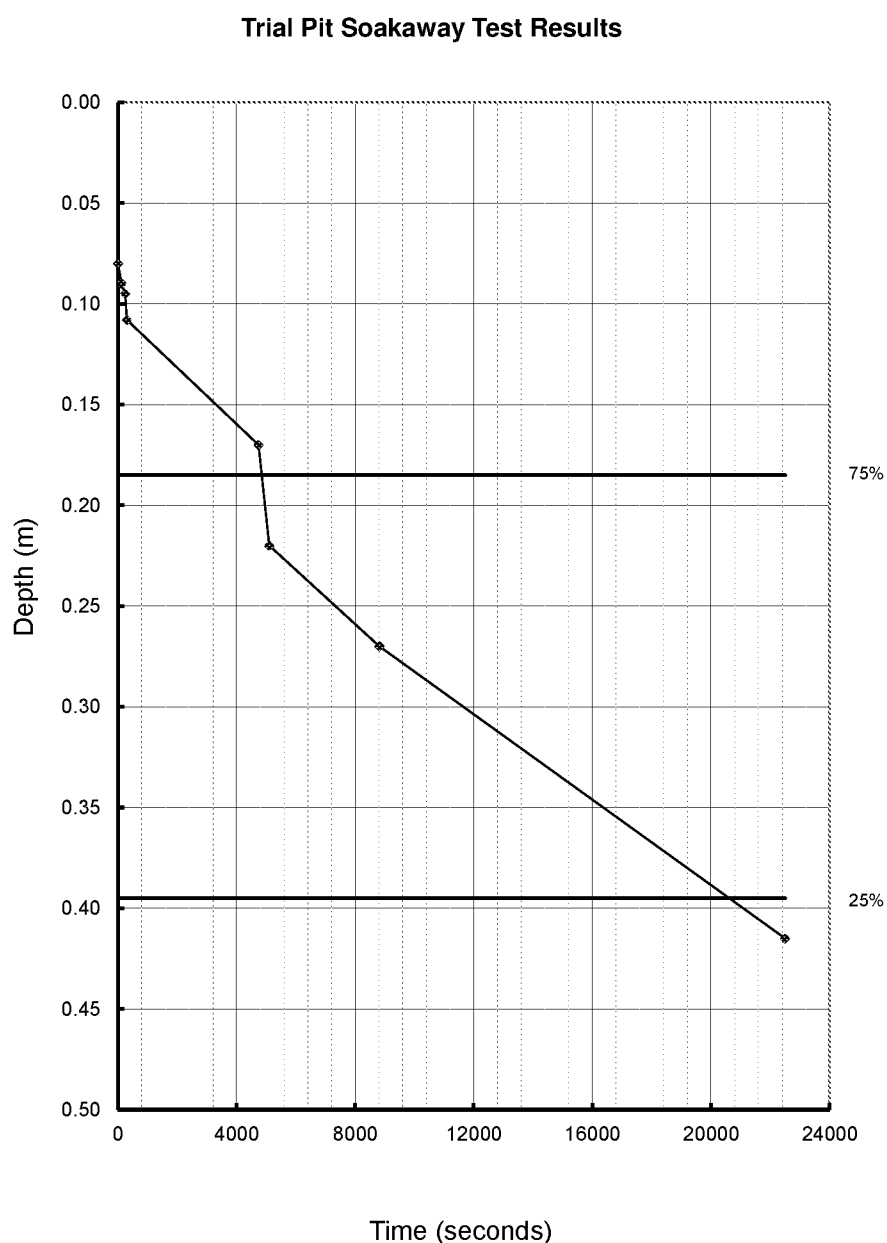
| <b>Location</b> | TP223 | <b>Test number</b> | 1 |

| Results | | Comments |
|---|---|---|
| Vp 75-25 (m3) | 0.26 | 1. Trial pit dry prior to soakaway test. |
| tp 75-25 (s) | 15500 | |
| Infiltration Rate (m/s) | 7.13E-06 | |
