**Phase II Ground Investigation Report**

**251 Pagham Road, Bognor Regis,  
West Sussex PO21 3QB**

**Orchard Homes**

***REPORT 14011/GIR***

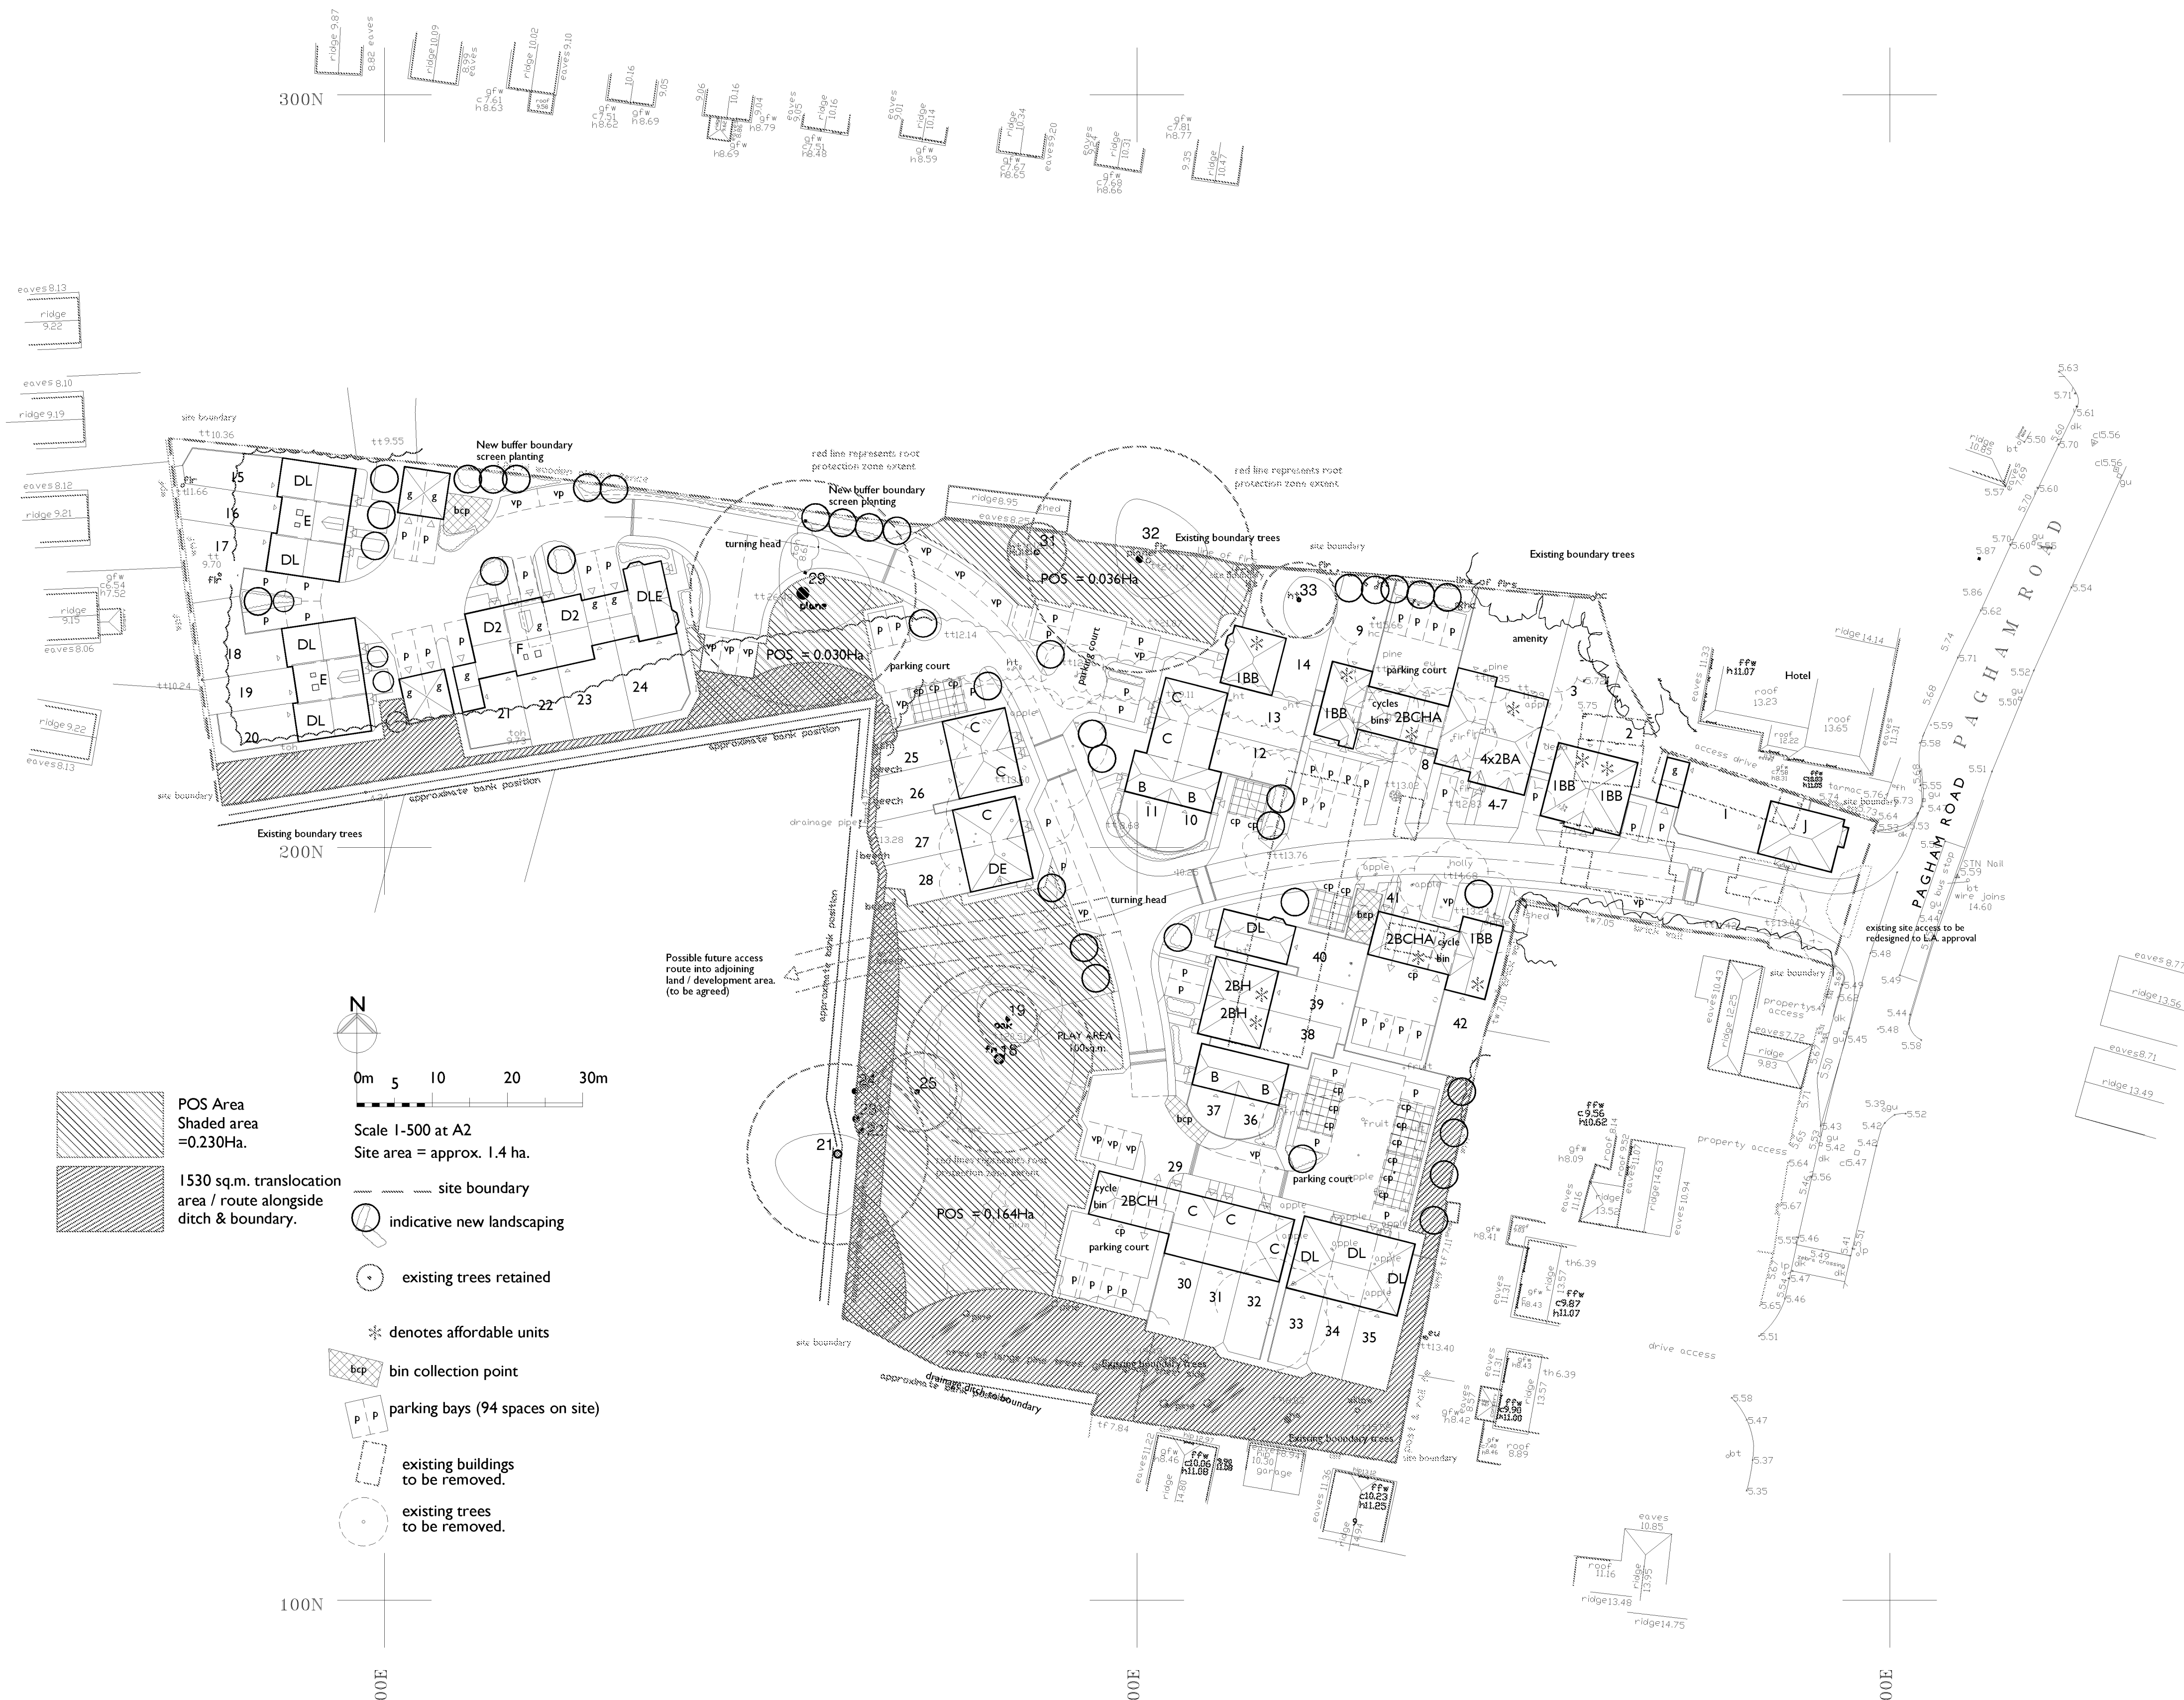
**Appendix E**  
**Information Provided By The Client**

At the time of reporting, February 2014, anticipated foundation loads were not known to Soils Limited however the proposed development layout had been provided and a copy is presented in Appendix E.
