# Drainage Strategy & SuDS Statement

Land at Summer Lane  
Pagham  
Reserved Matters Application  
Planning Update

**Report Title** Drainage Strategy &  
SuDS Statement

**Doc. ref:** TRS/E4761/17424

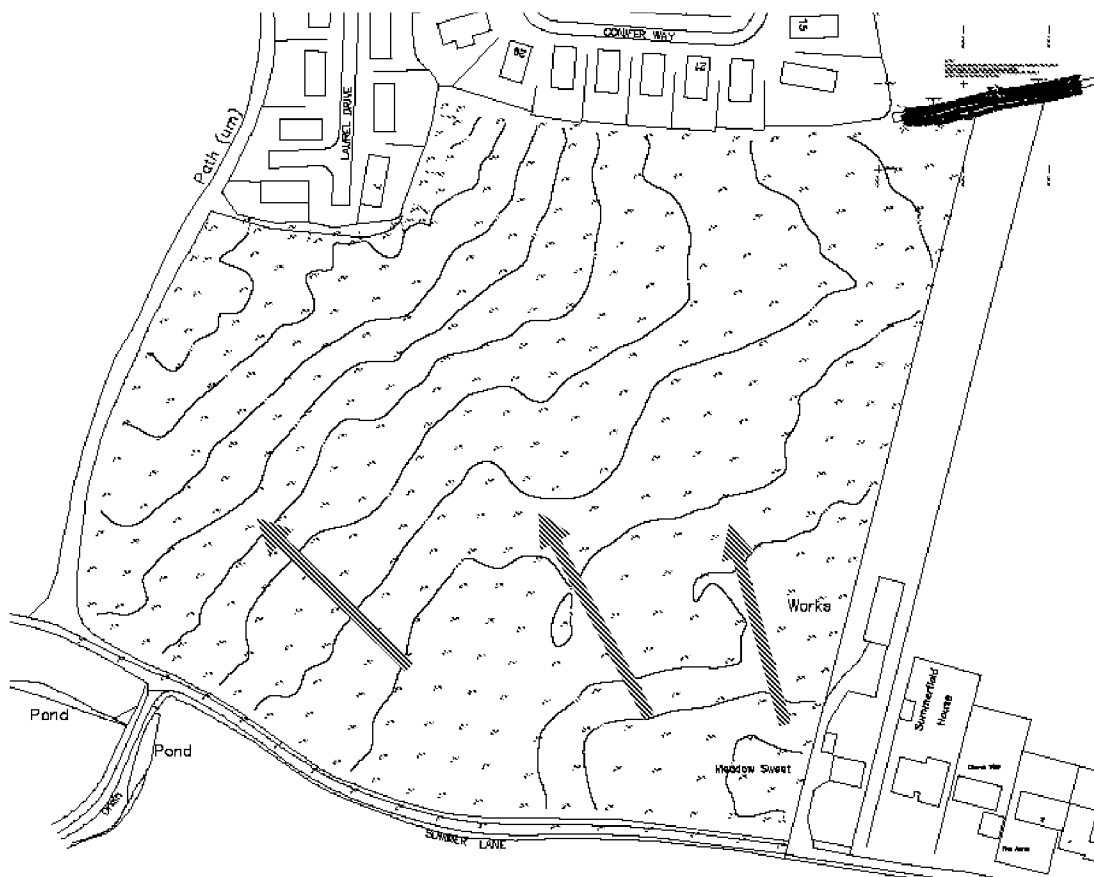
Figure 2: Site Topography

The application site generally falls in a westerly direction from the south eastern corner to the north west. An overview of the change in topography in this part of the wider site is presented as **Figure 2** overleaf. A copy of the topographical survey can be found in **Appendix A**.

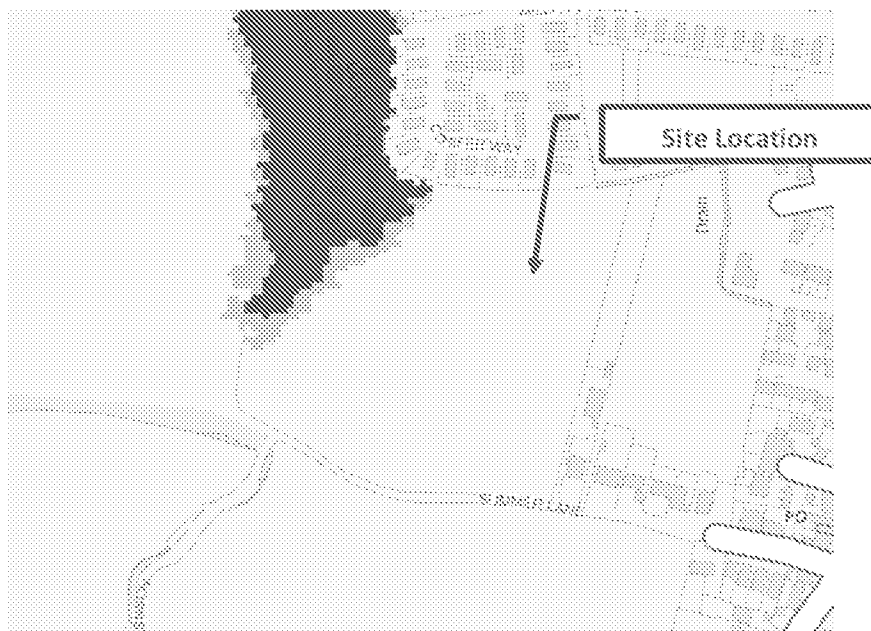
*Figure 3: Extract of Flood Map from the EA's website*

Based on a review of the EA's Flood Zone maps (see **Figure 3**), the development site appears to lie wholly within Flood Zone 1, considered to be at low risk from fluvial and tidal flooding.

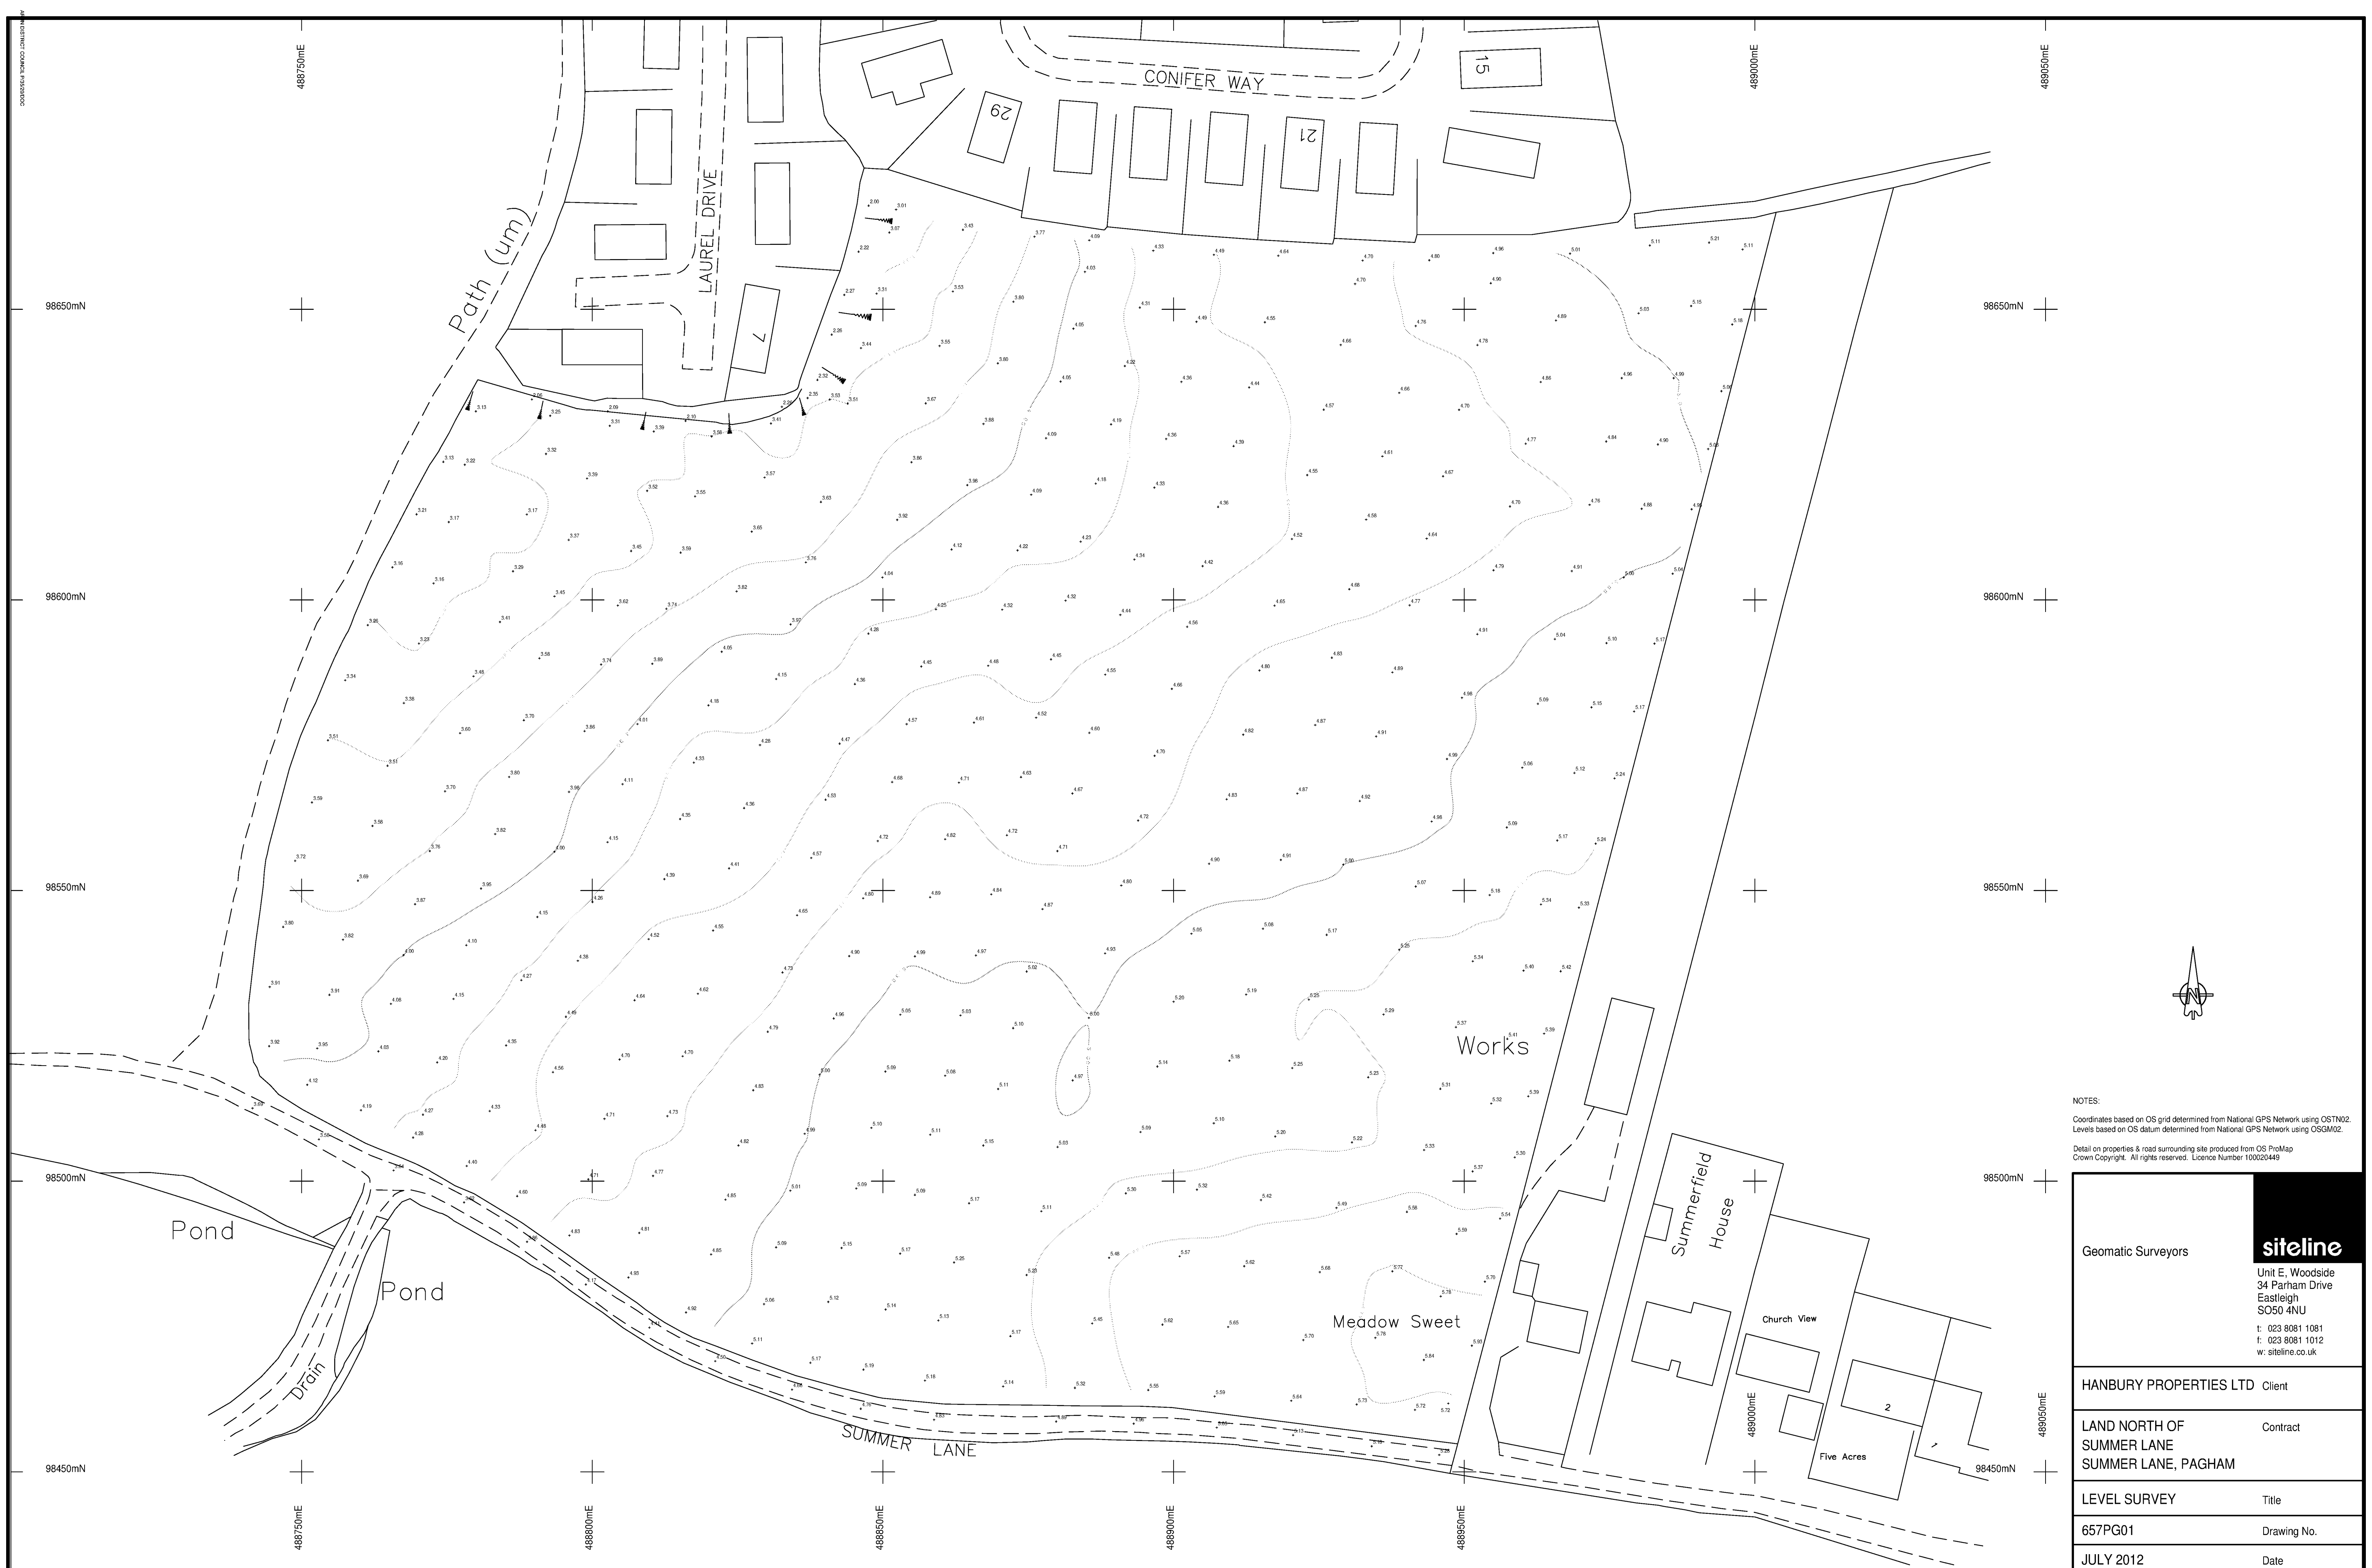
Topographic Survey

NOTES:  
Coordinates based on OS grid determined from National GPS Network using OSTN02.  
Levels based on OS datum determined from National GPS Network using OSGM02.  
Detail on properties & road surrounding site produced from OS ProMap  
Crown Copyright. All rights reserved. Licence Number 100020449

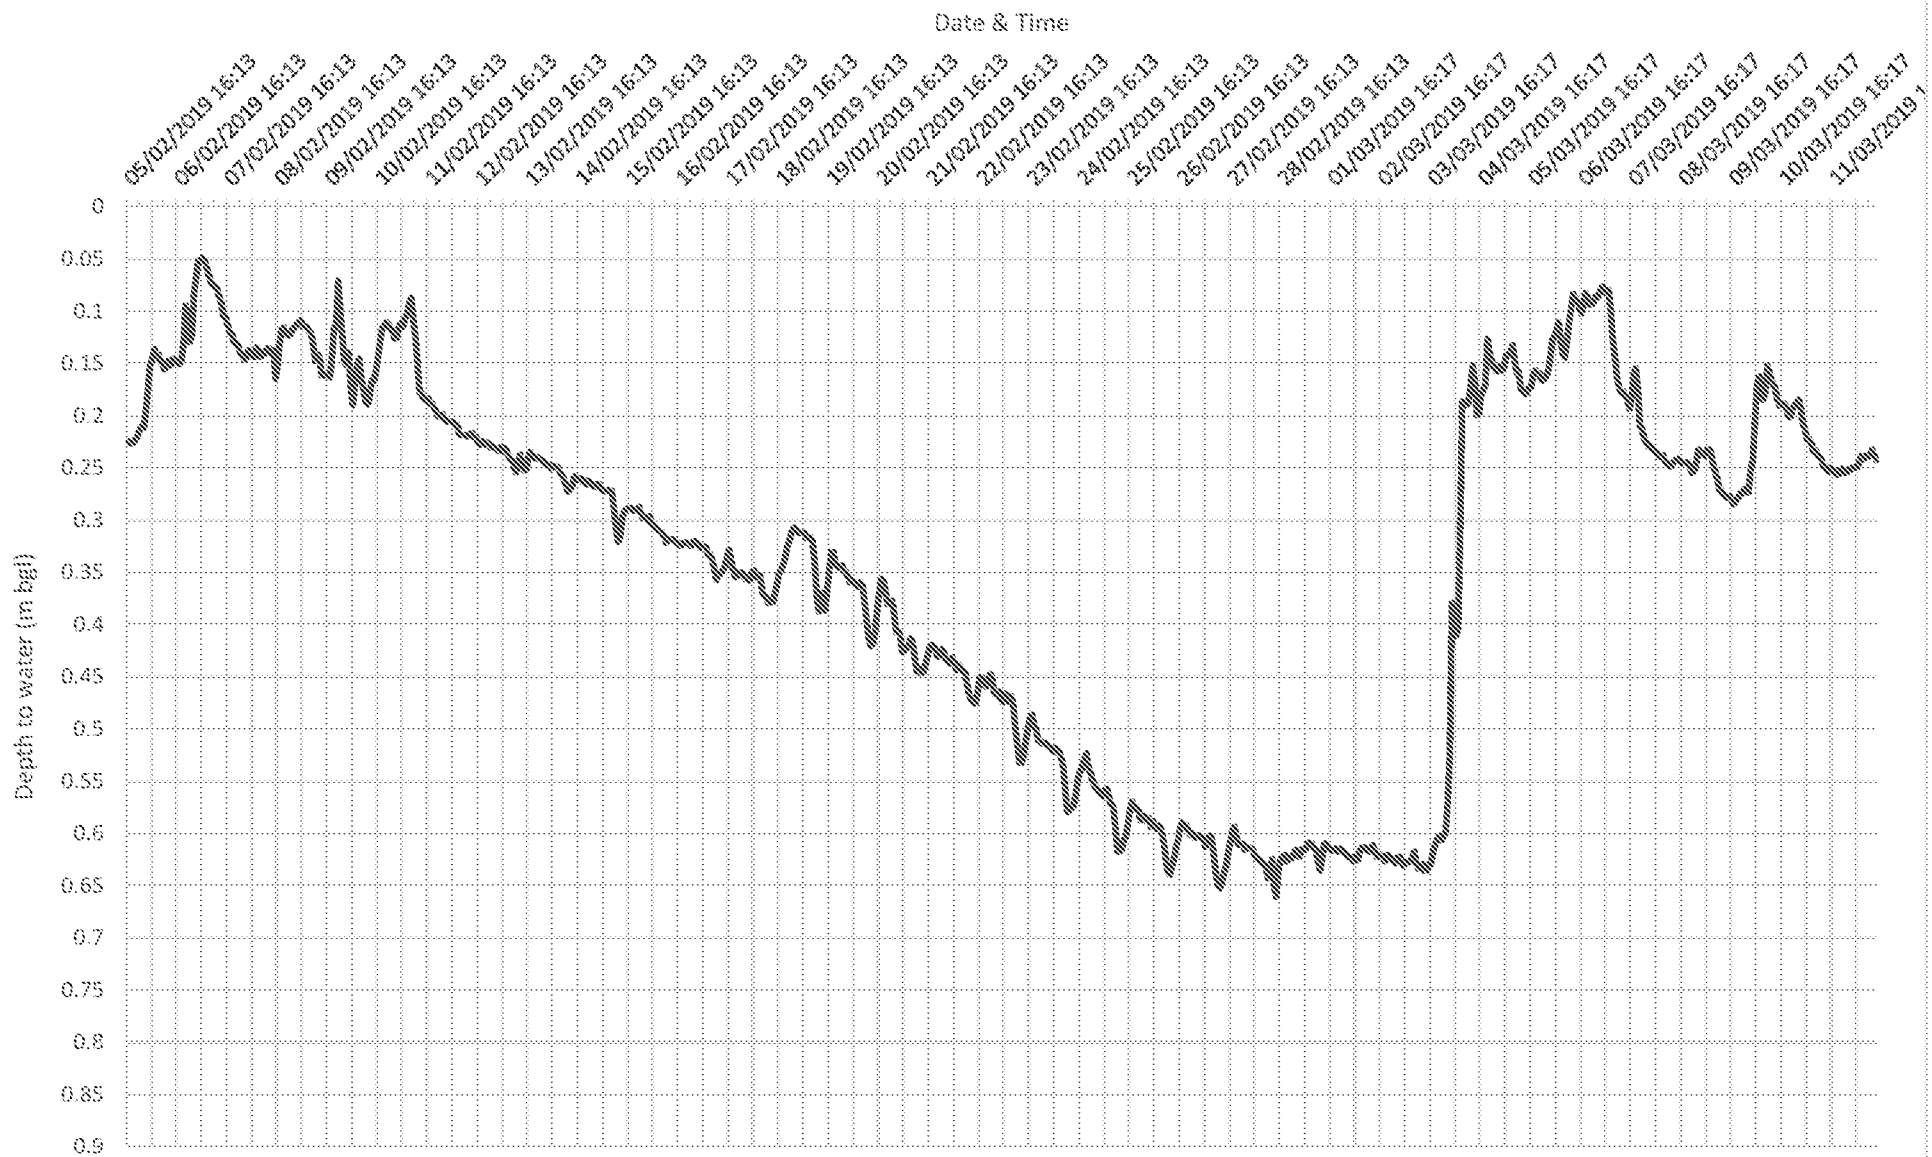
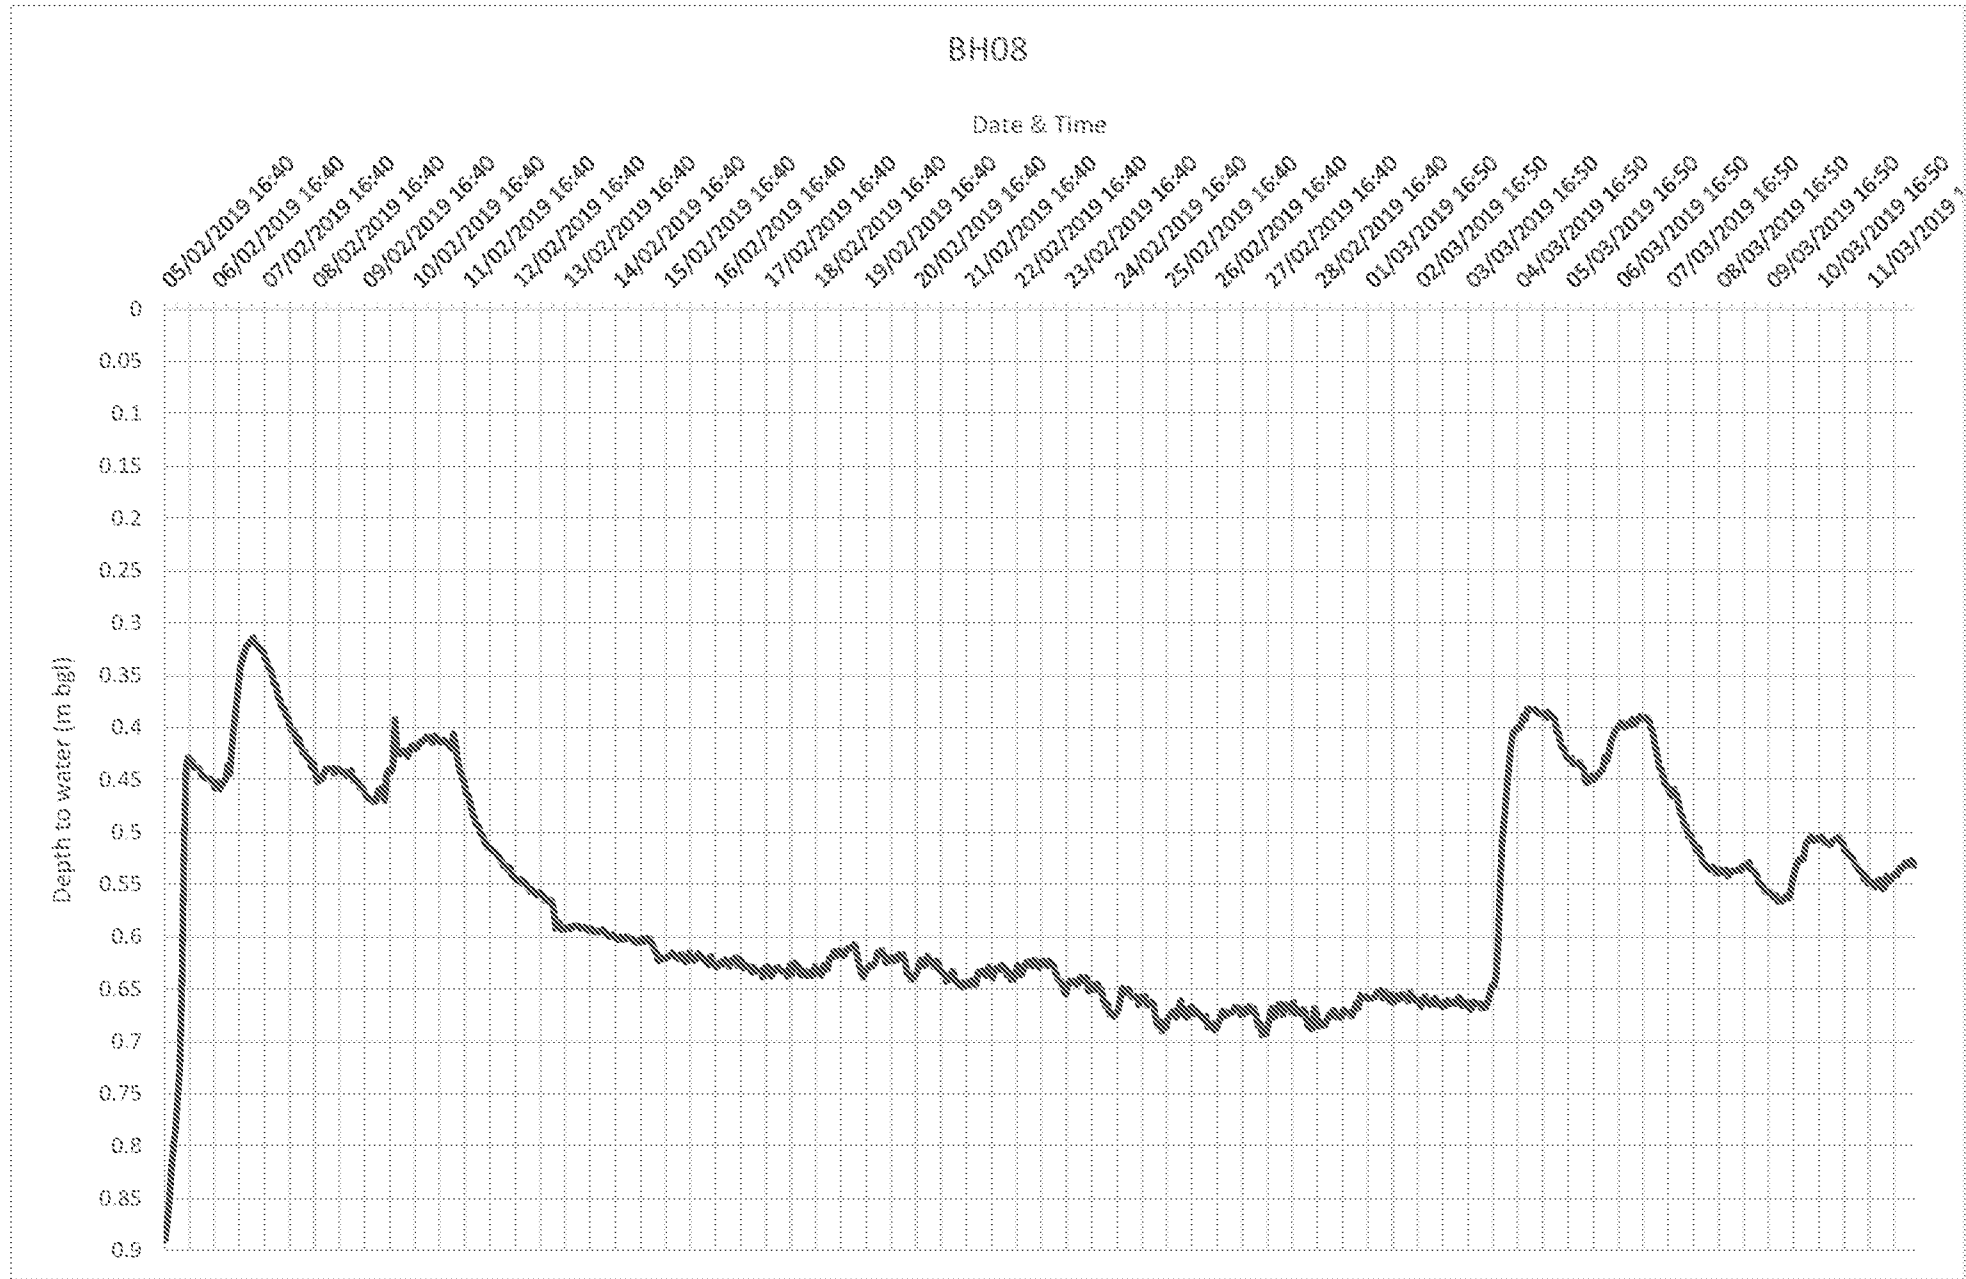
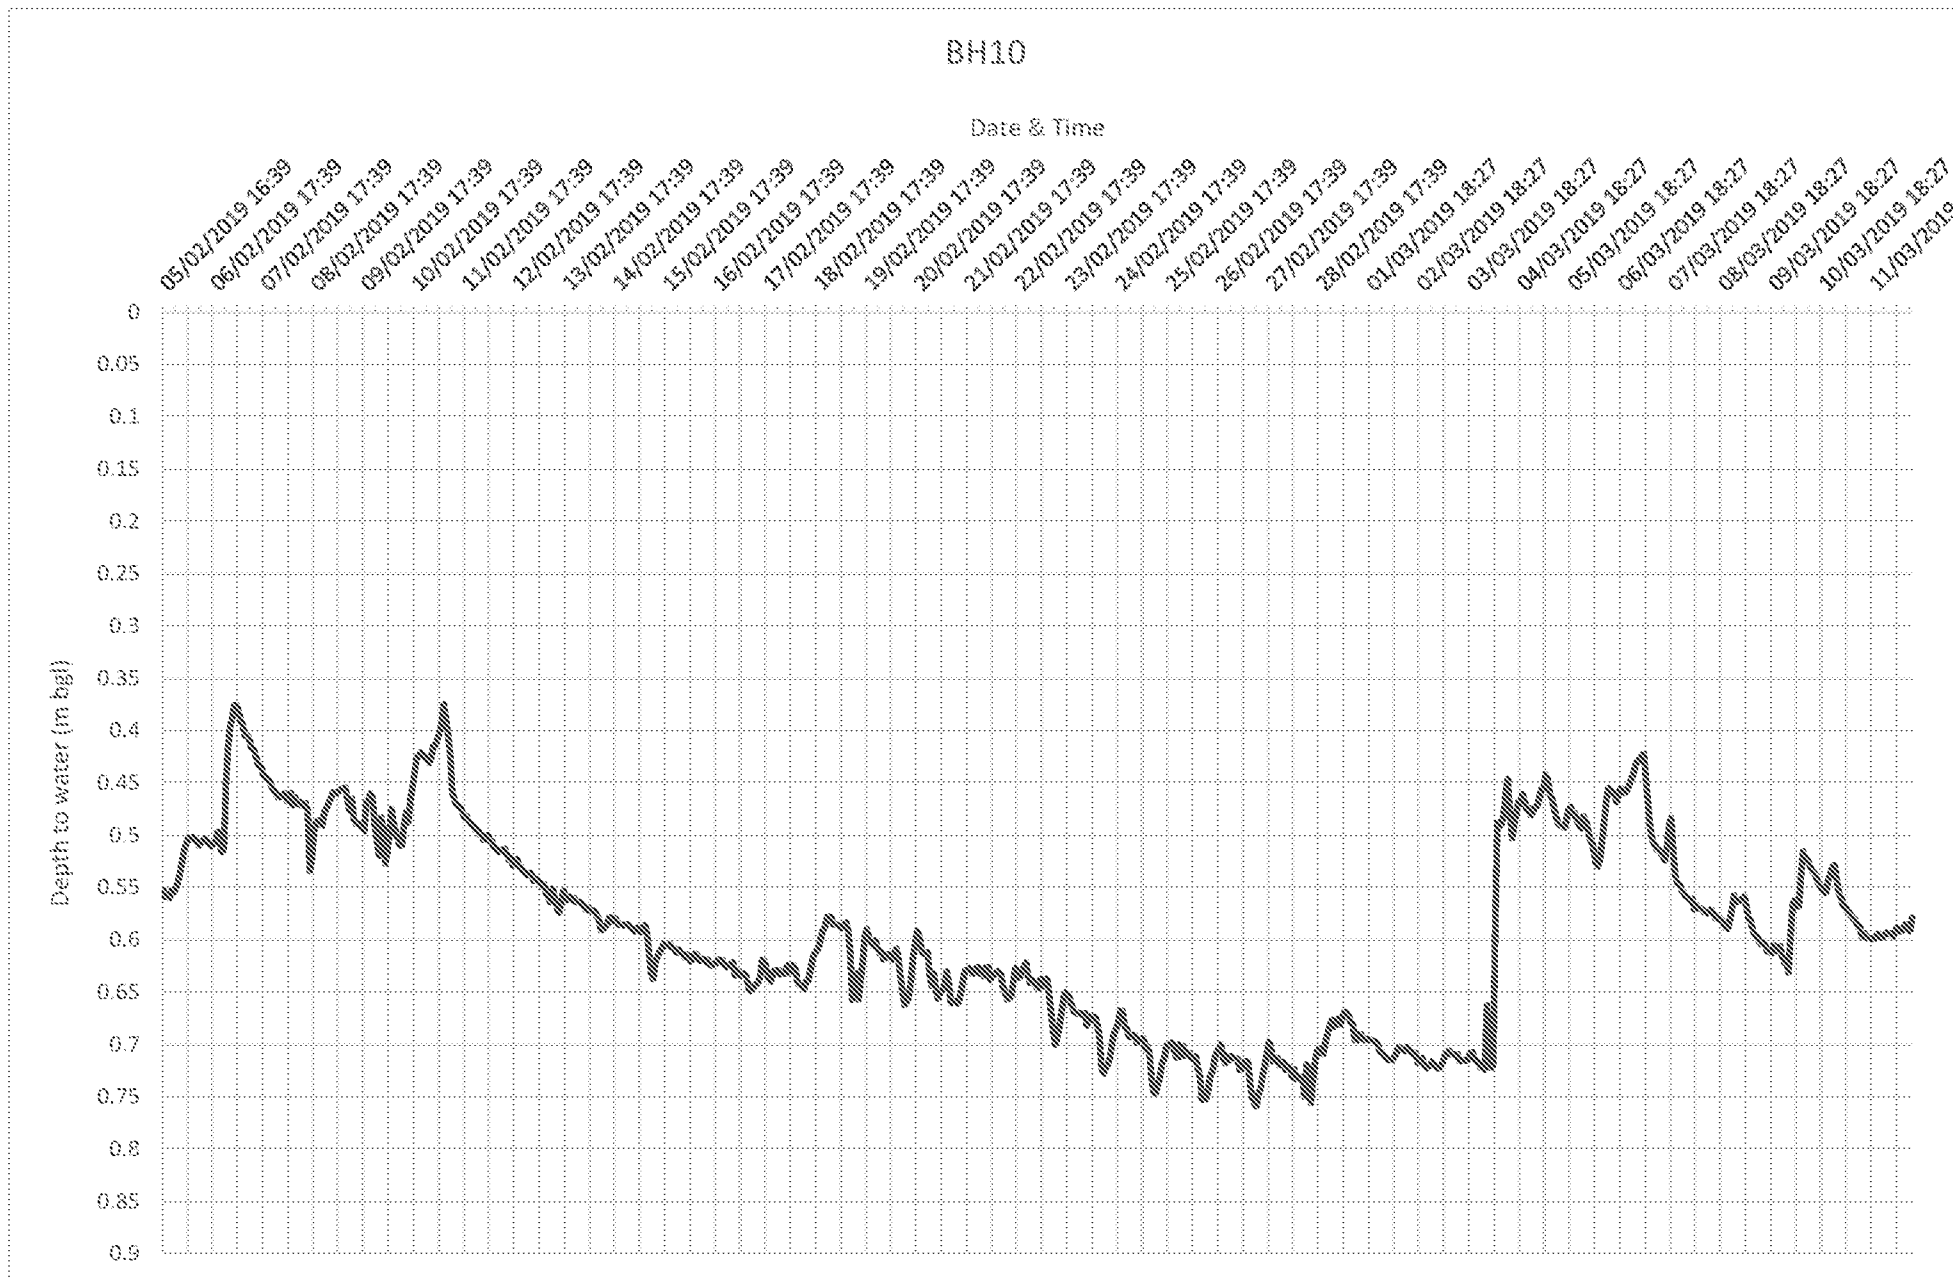
BH03

### **Continuous Groundwater Monitoring Results**

Winter groundwater monitoring indicates the presence of shallow groundwater parts of the site varying from 0.00mbgl to 1.81mbgl. Winter infiltration testing to BRE 365 was carried out and indicated permeability rates ranging from  $9.5 \times 10^{-7}$  to  $1.1 \times 10^{-5}$  m/s.

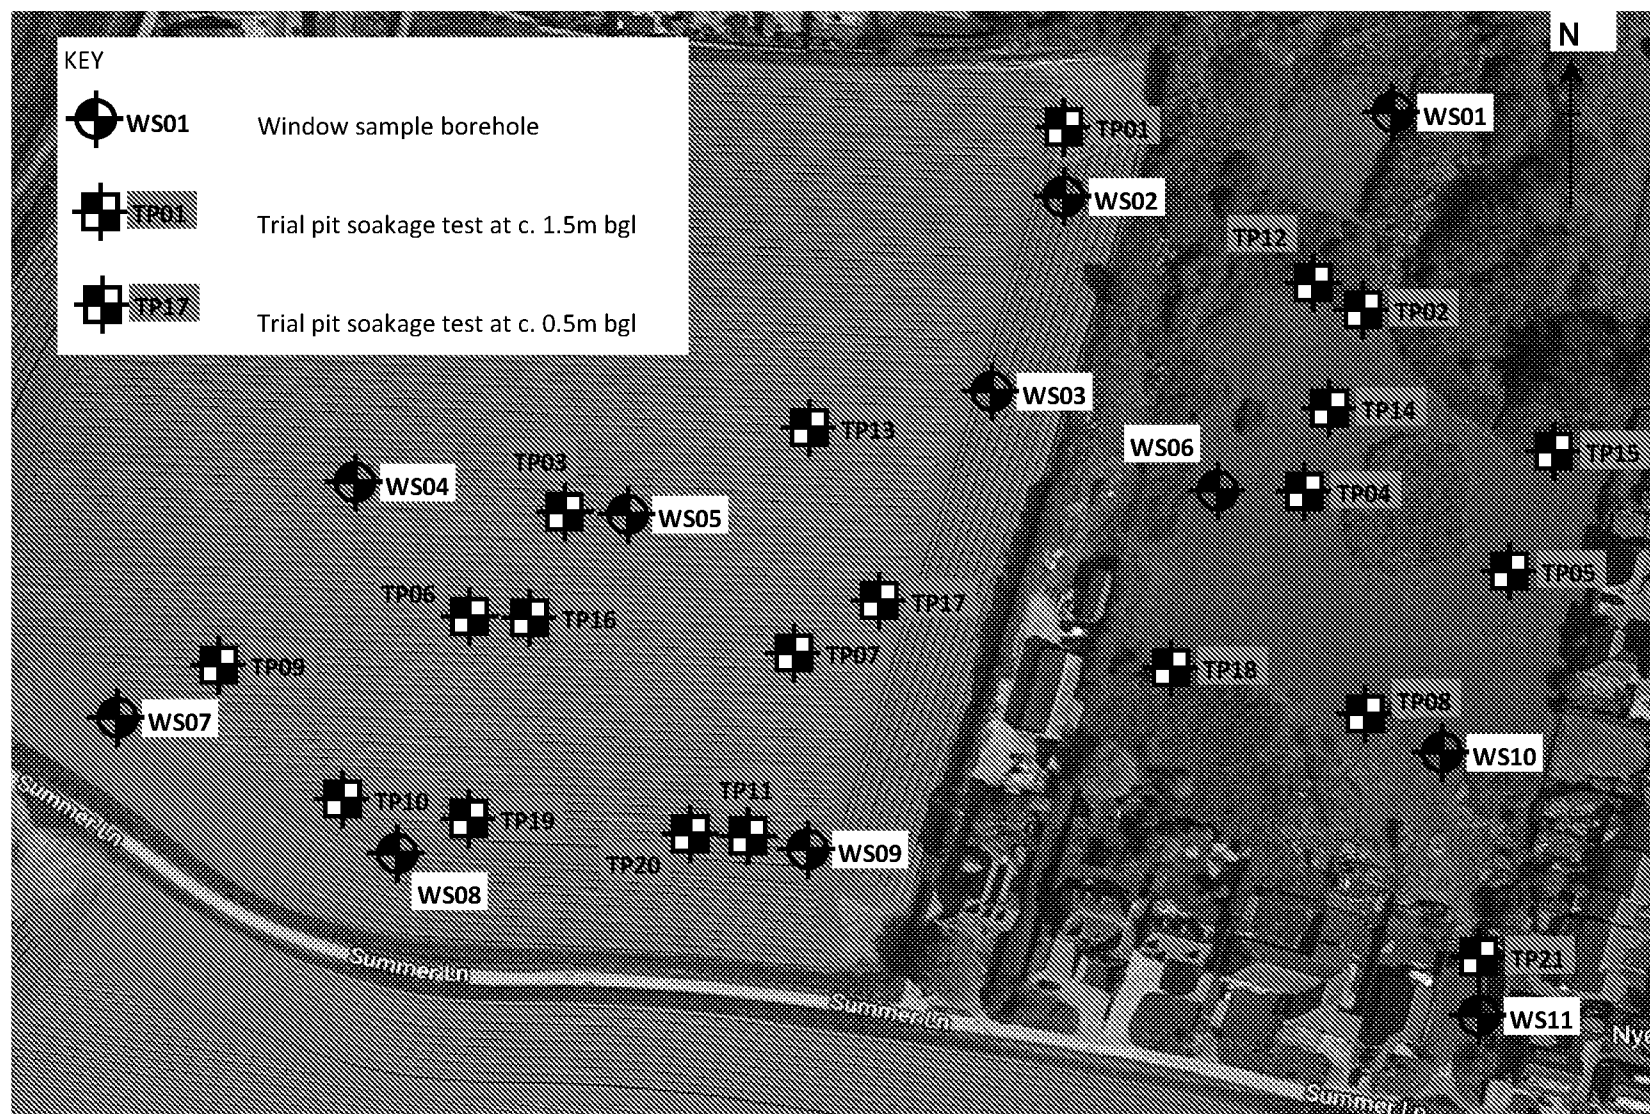
| Project: | Summer Lane, Pagham, Bongor Regis, PO21 4NQ | | | Title | Exploratory Hole Location Plan | |
