**REPORT TITLE:** **PHASE I REVIEW &  
PHASE II  
GEO-ENVIRONMENTAL  
ASSESSMENT**

Lane West of Hook Lane  
Pagham  
West Sussex  
PO21 3PD

GEG-19-623

GEG-19-623/PI\_PII

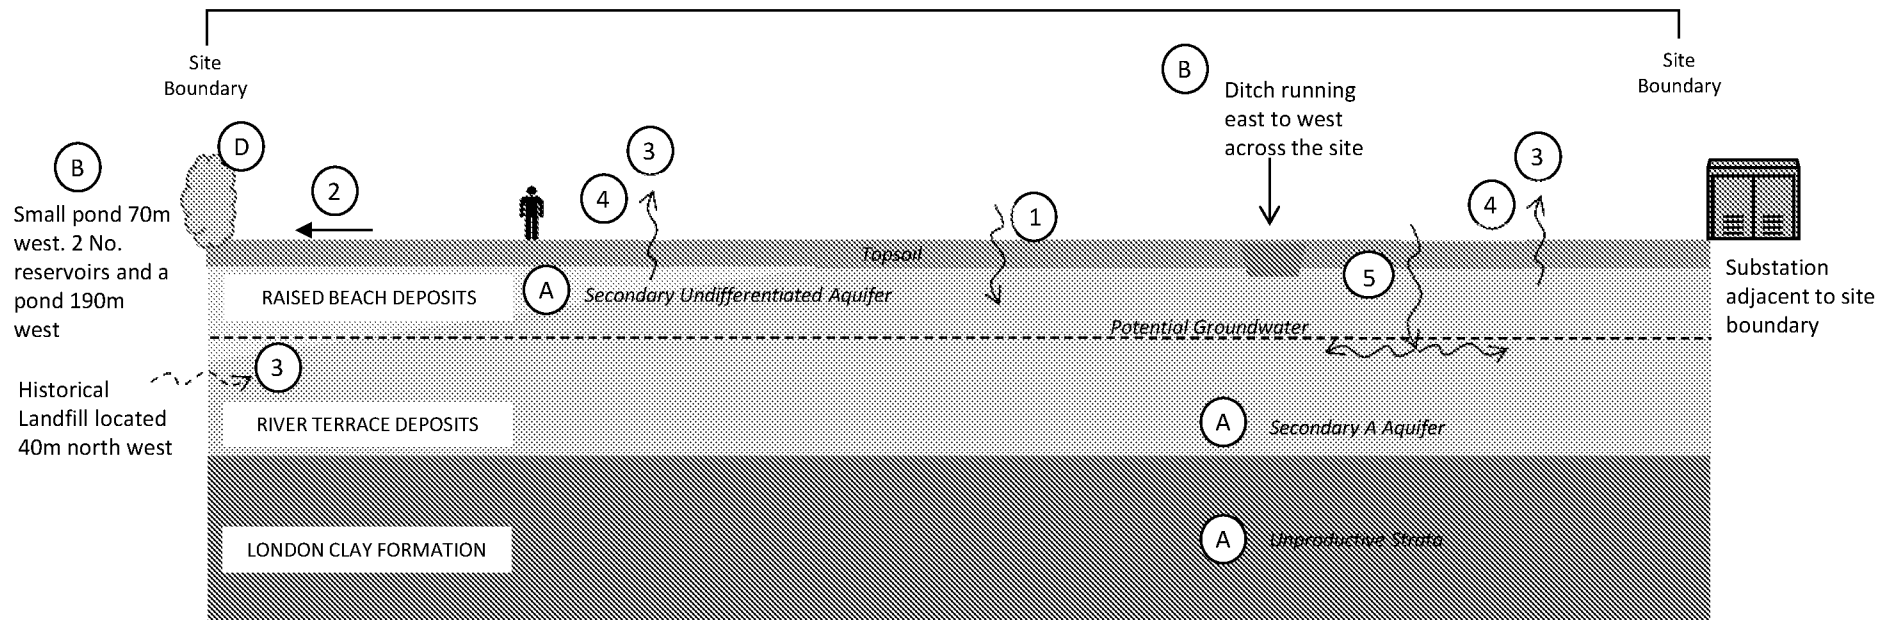
- 1 Infiltration of precipitation
- 2 Surface water run off
- 3 Migration of ground gases (methane and carbon dioxide)
- 4 Potential dermal contact, ingestion of contaminated soil and/or dust and inhalation of gases/vapours
- 5 Potential leaching/mobilisation of contaminants and lateral and vertical migration

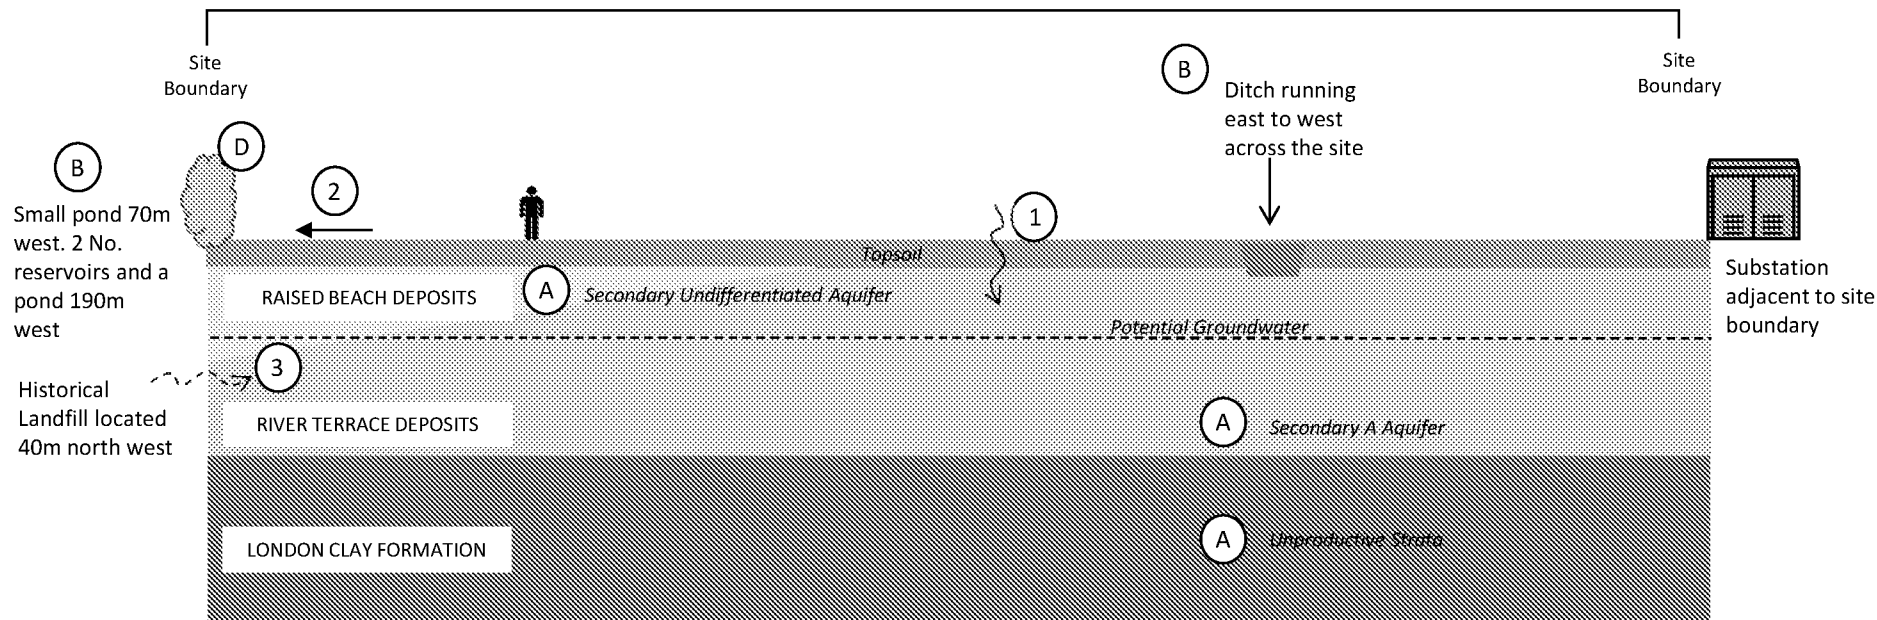
- ① Infiltration of precipitation
- ② Surface water run off
- ③ Migration of ground gases (methane and carbon dioxide)
- ④ Potential dermal contact, ingestion of contaminated soil and/or dust and inhalation of gases/vapours
- ⑤ Potential leaching/mobilisation of contaminants and lateral and vertical migration

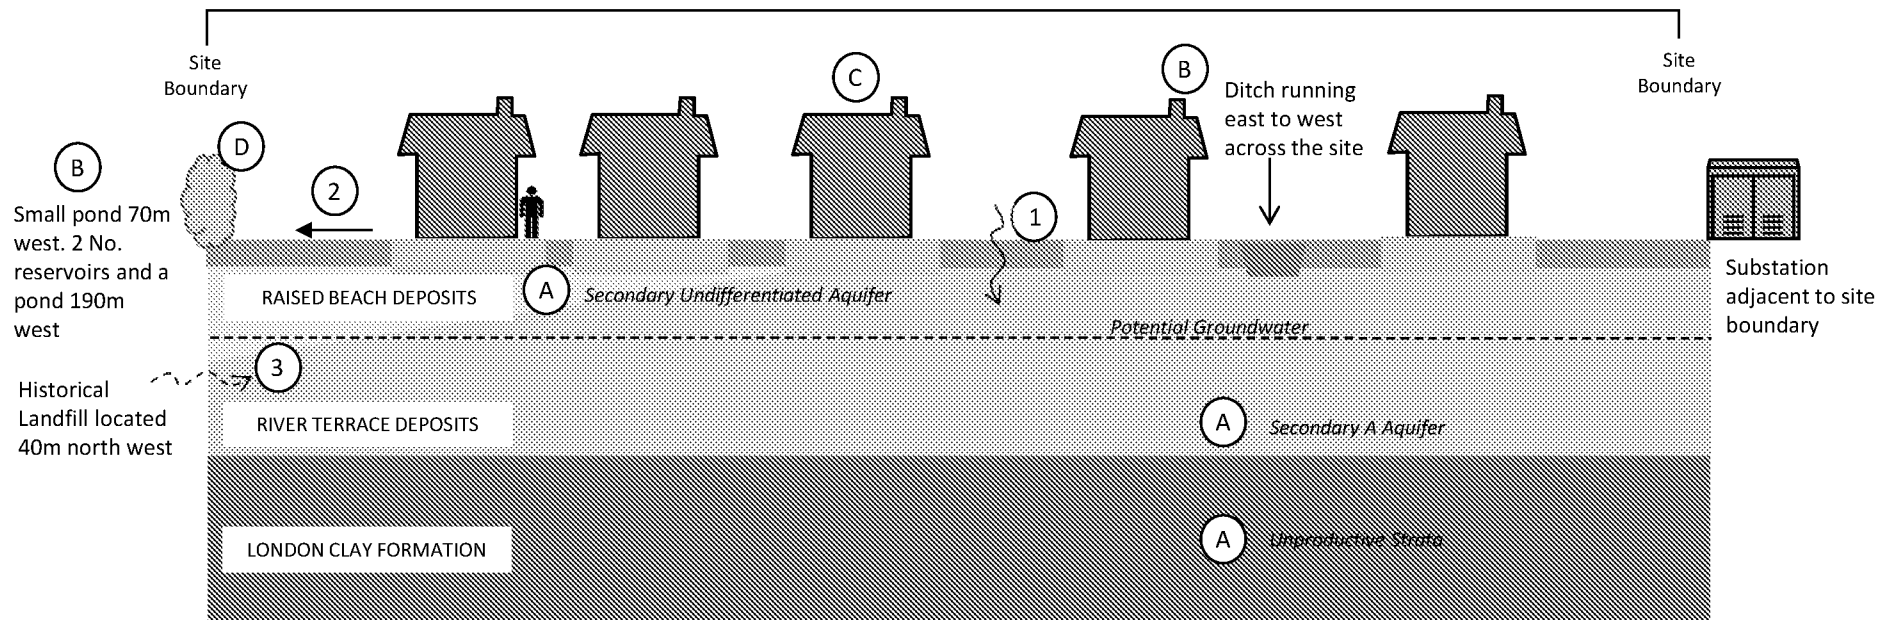
- ① Infiltration of precipitation
- ② Surface water run off
- ③ Migration of ground gases (methane and carbon dioxide)
- ④ Potential dermal contact, ingestion of contaminated soil and/or dust and inhalation of gases/vapours
- ⑤ Potential leaching/mobilisation of contaminants and lateral and vertical migration
