# Tree survey & report

Inglenook Residential Phase  
2, 253-255 Pagham Road,  
Bognor Regis PO21 3QB

February 2025

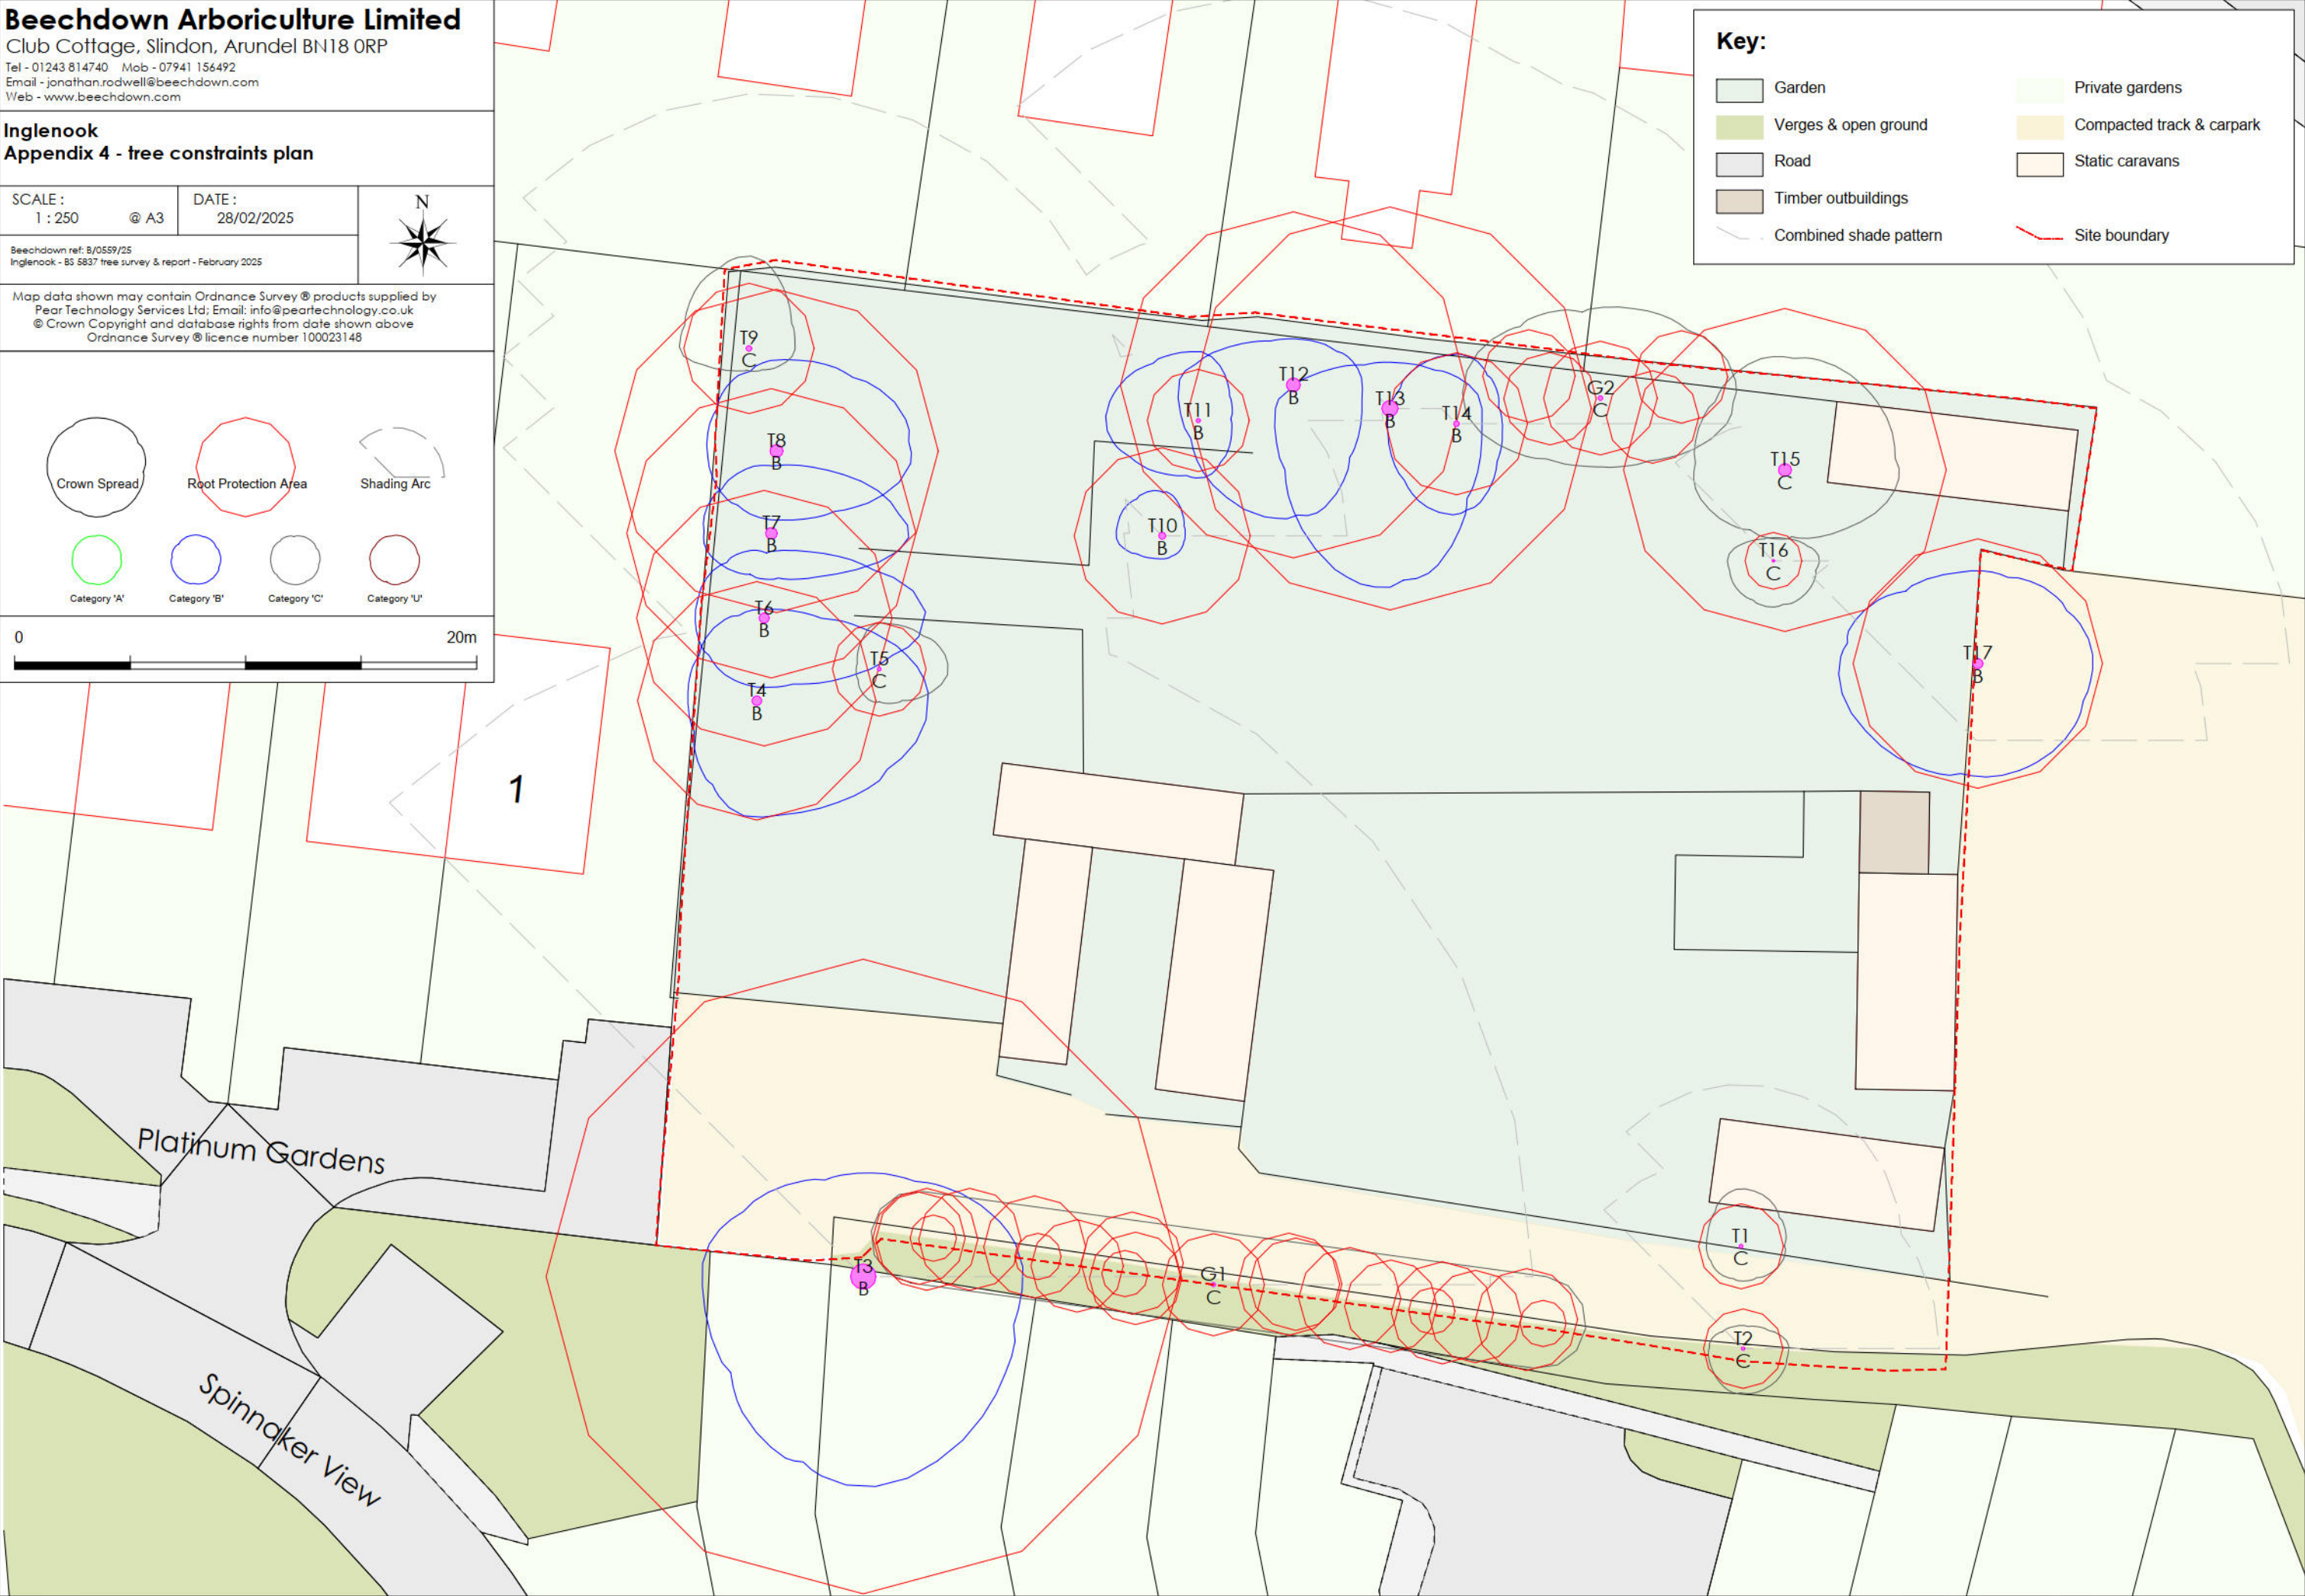
shadow pattern through the main part of the day is indicated on the 1:250 @ A3 tree constraints plan (Appendix 4).

- 3.2 The tree identification numbers used are for the purpose of this report and may not reflect numbering used in previous surveys or inspections.
- 3.3 Data was recorded digitally, the individual trees plotted via GPS and their positions marked on the 1:250 @ A3 tree constraints plan (Appendix 4).

- 10.2 The RPA calculations have been produced using the information gathered from the tree survey and section 4.6.1 of BS 5837:2012. This indicates the RPA in m<sup>2</sup> and the minimum required all round radial distances for rooting zone protection and allows a view to be taken as to whether the trees can be retained safely without undue damage to their root systems. The RPA calculations are detailed in the appended tree survey and the initial dimensions marked on the 1:250@ A3 tree constraints plan (Appendix 4).

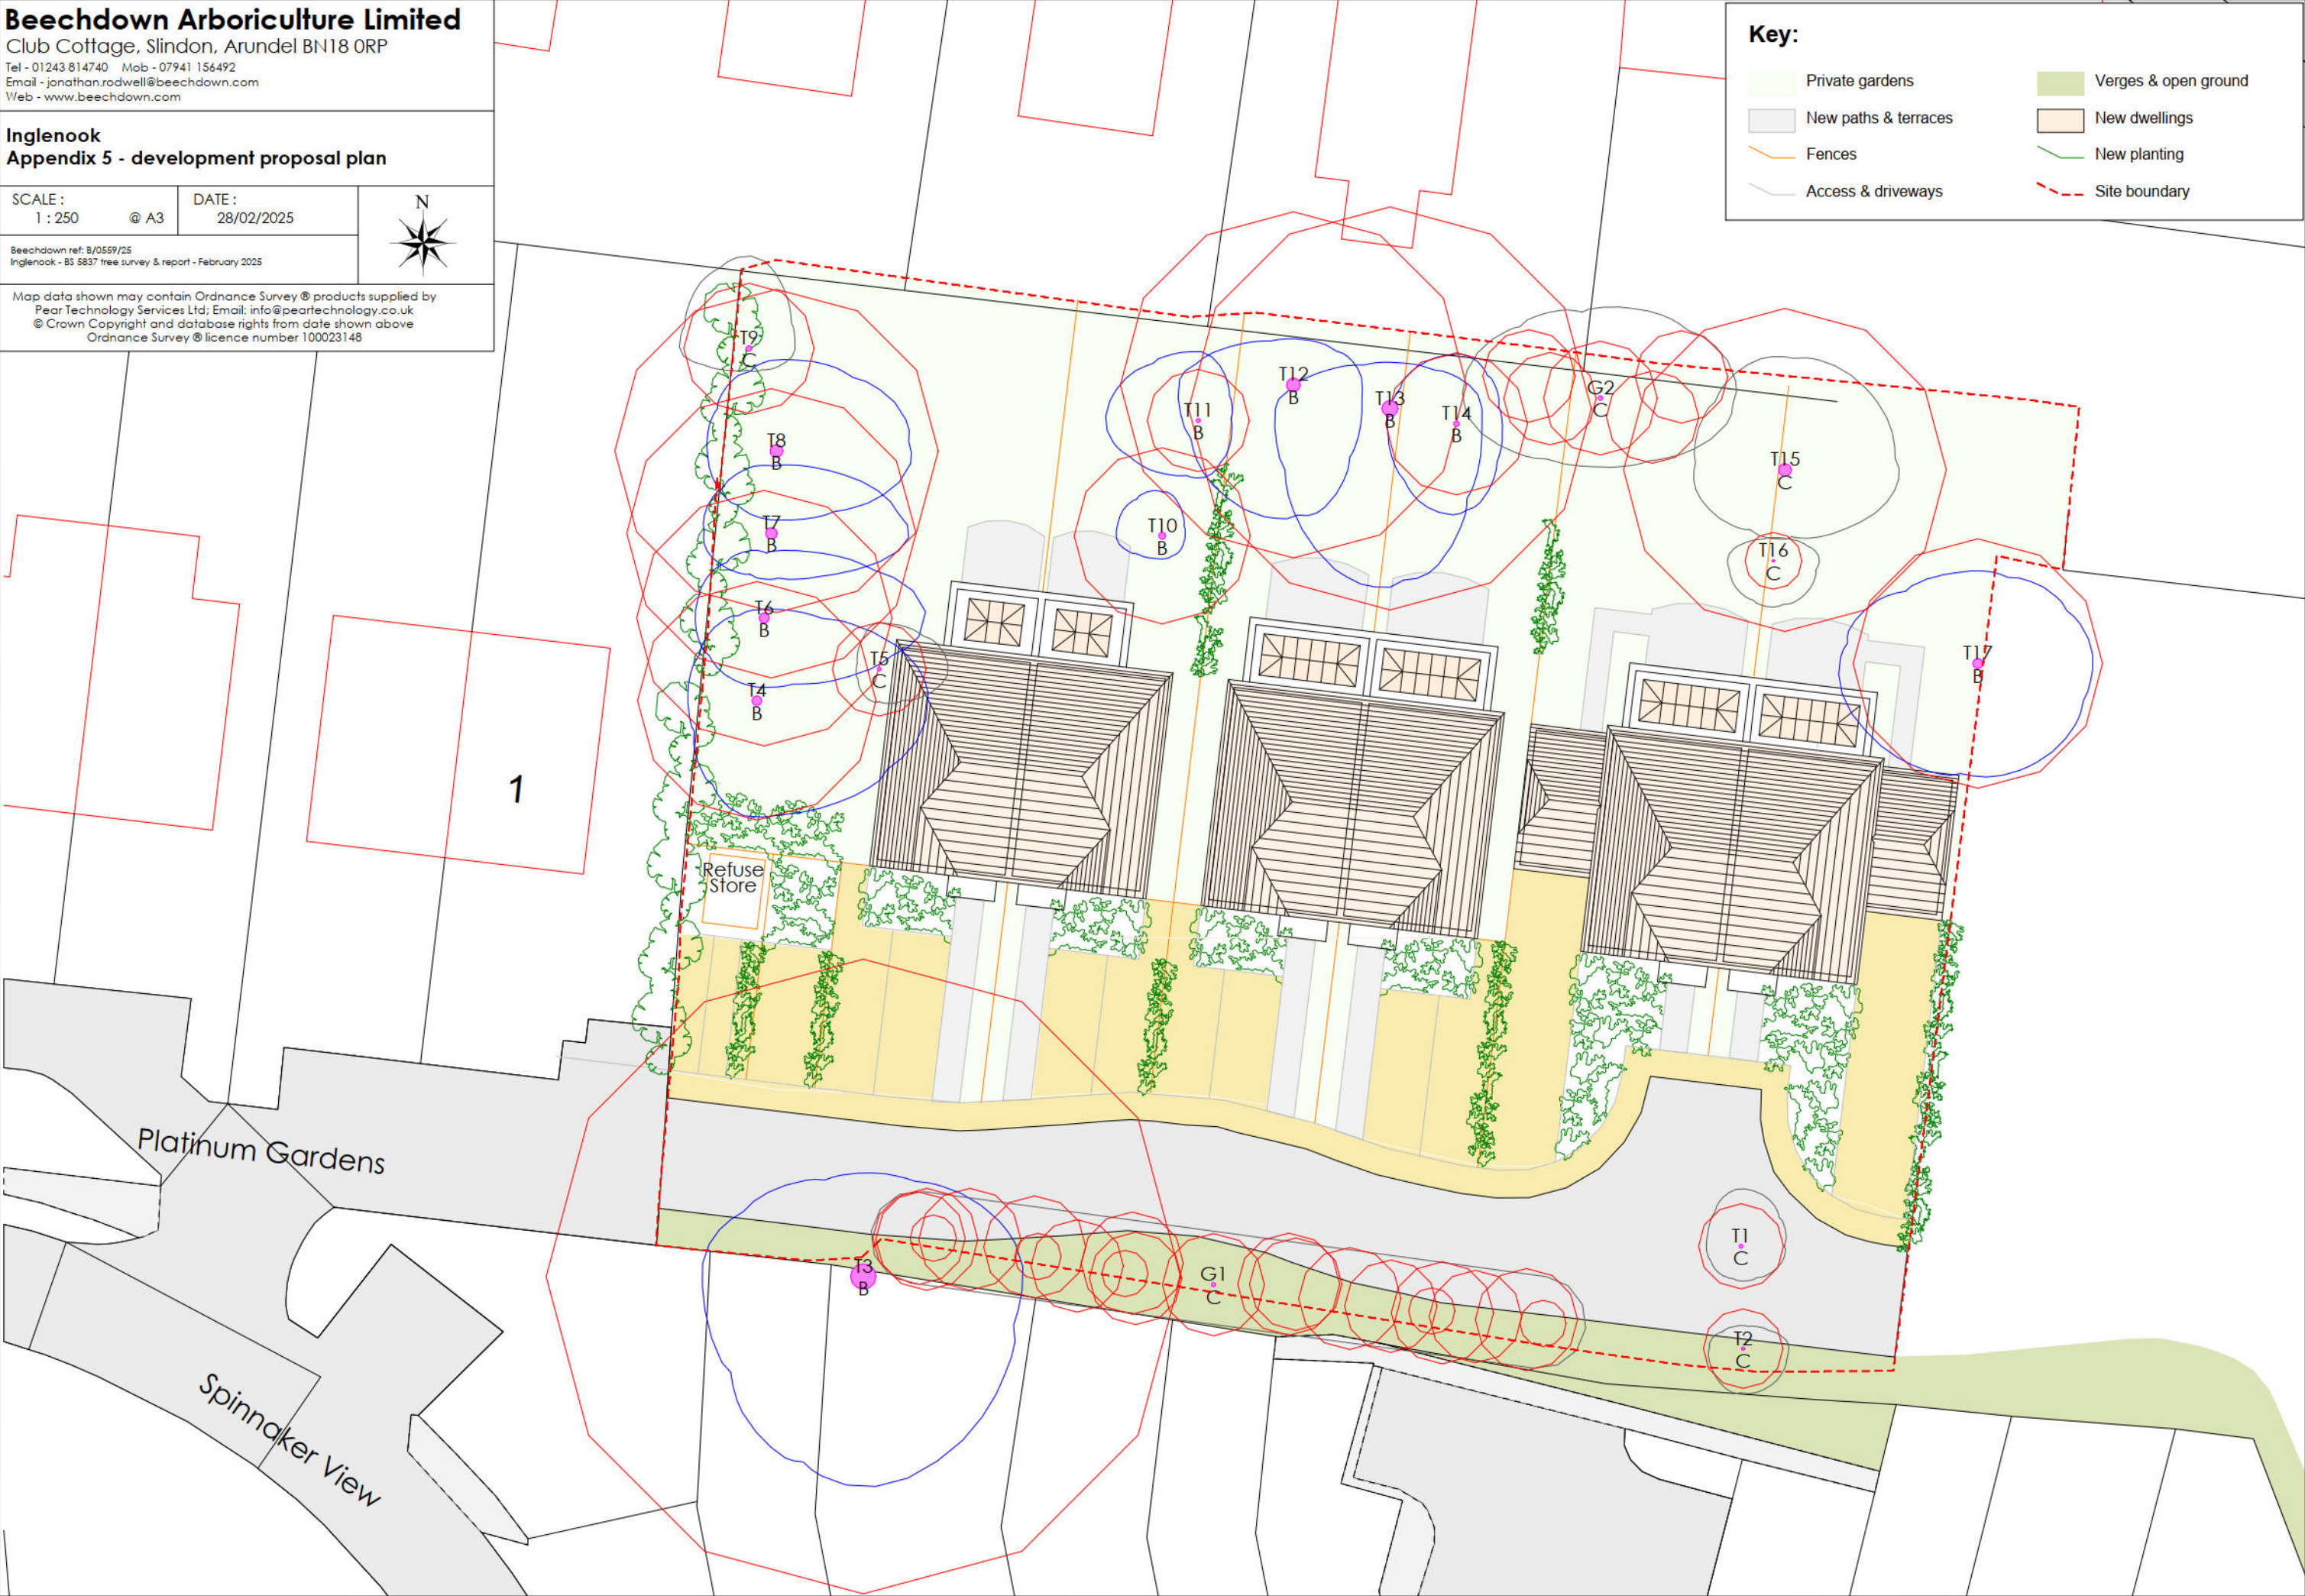
- 12.1 The 1:250 @A3 development proposal plan (Appendix 5) shows that construction of the new access road will require the removal of the Category C mountain ash (T1) while a second Category C mountain ash (T5) has a suppressed form, leans to the east and cannot realistically be retained. The sycamore (T15) is showing signs of decline and while it is largely beyond influence it may be sensible to remove it before the properties are occupied.

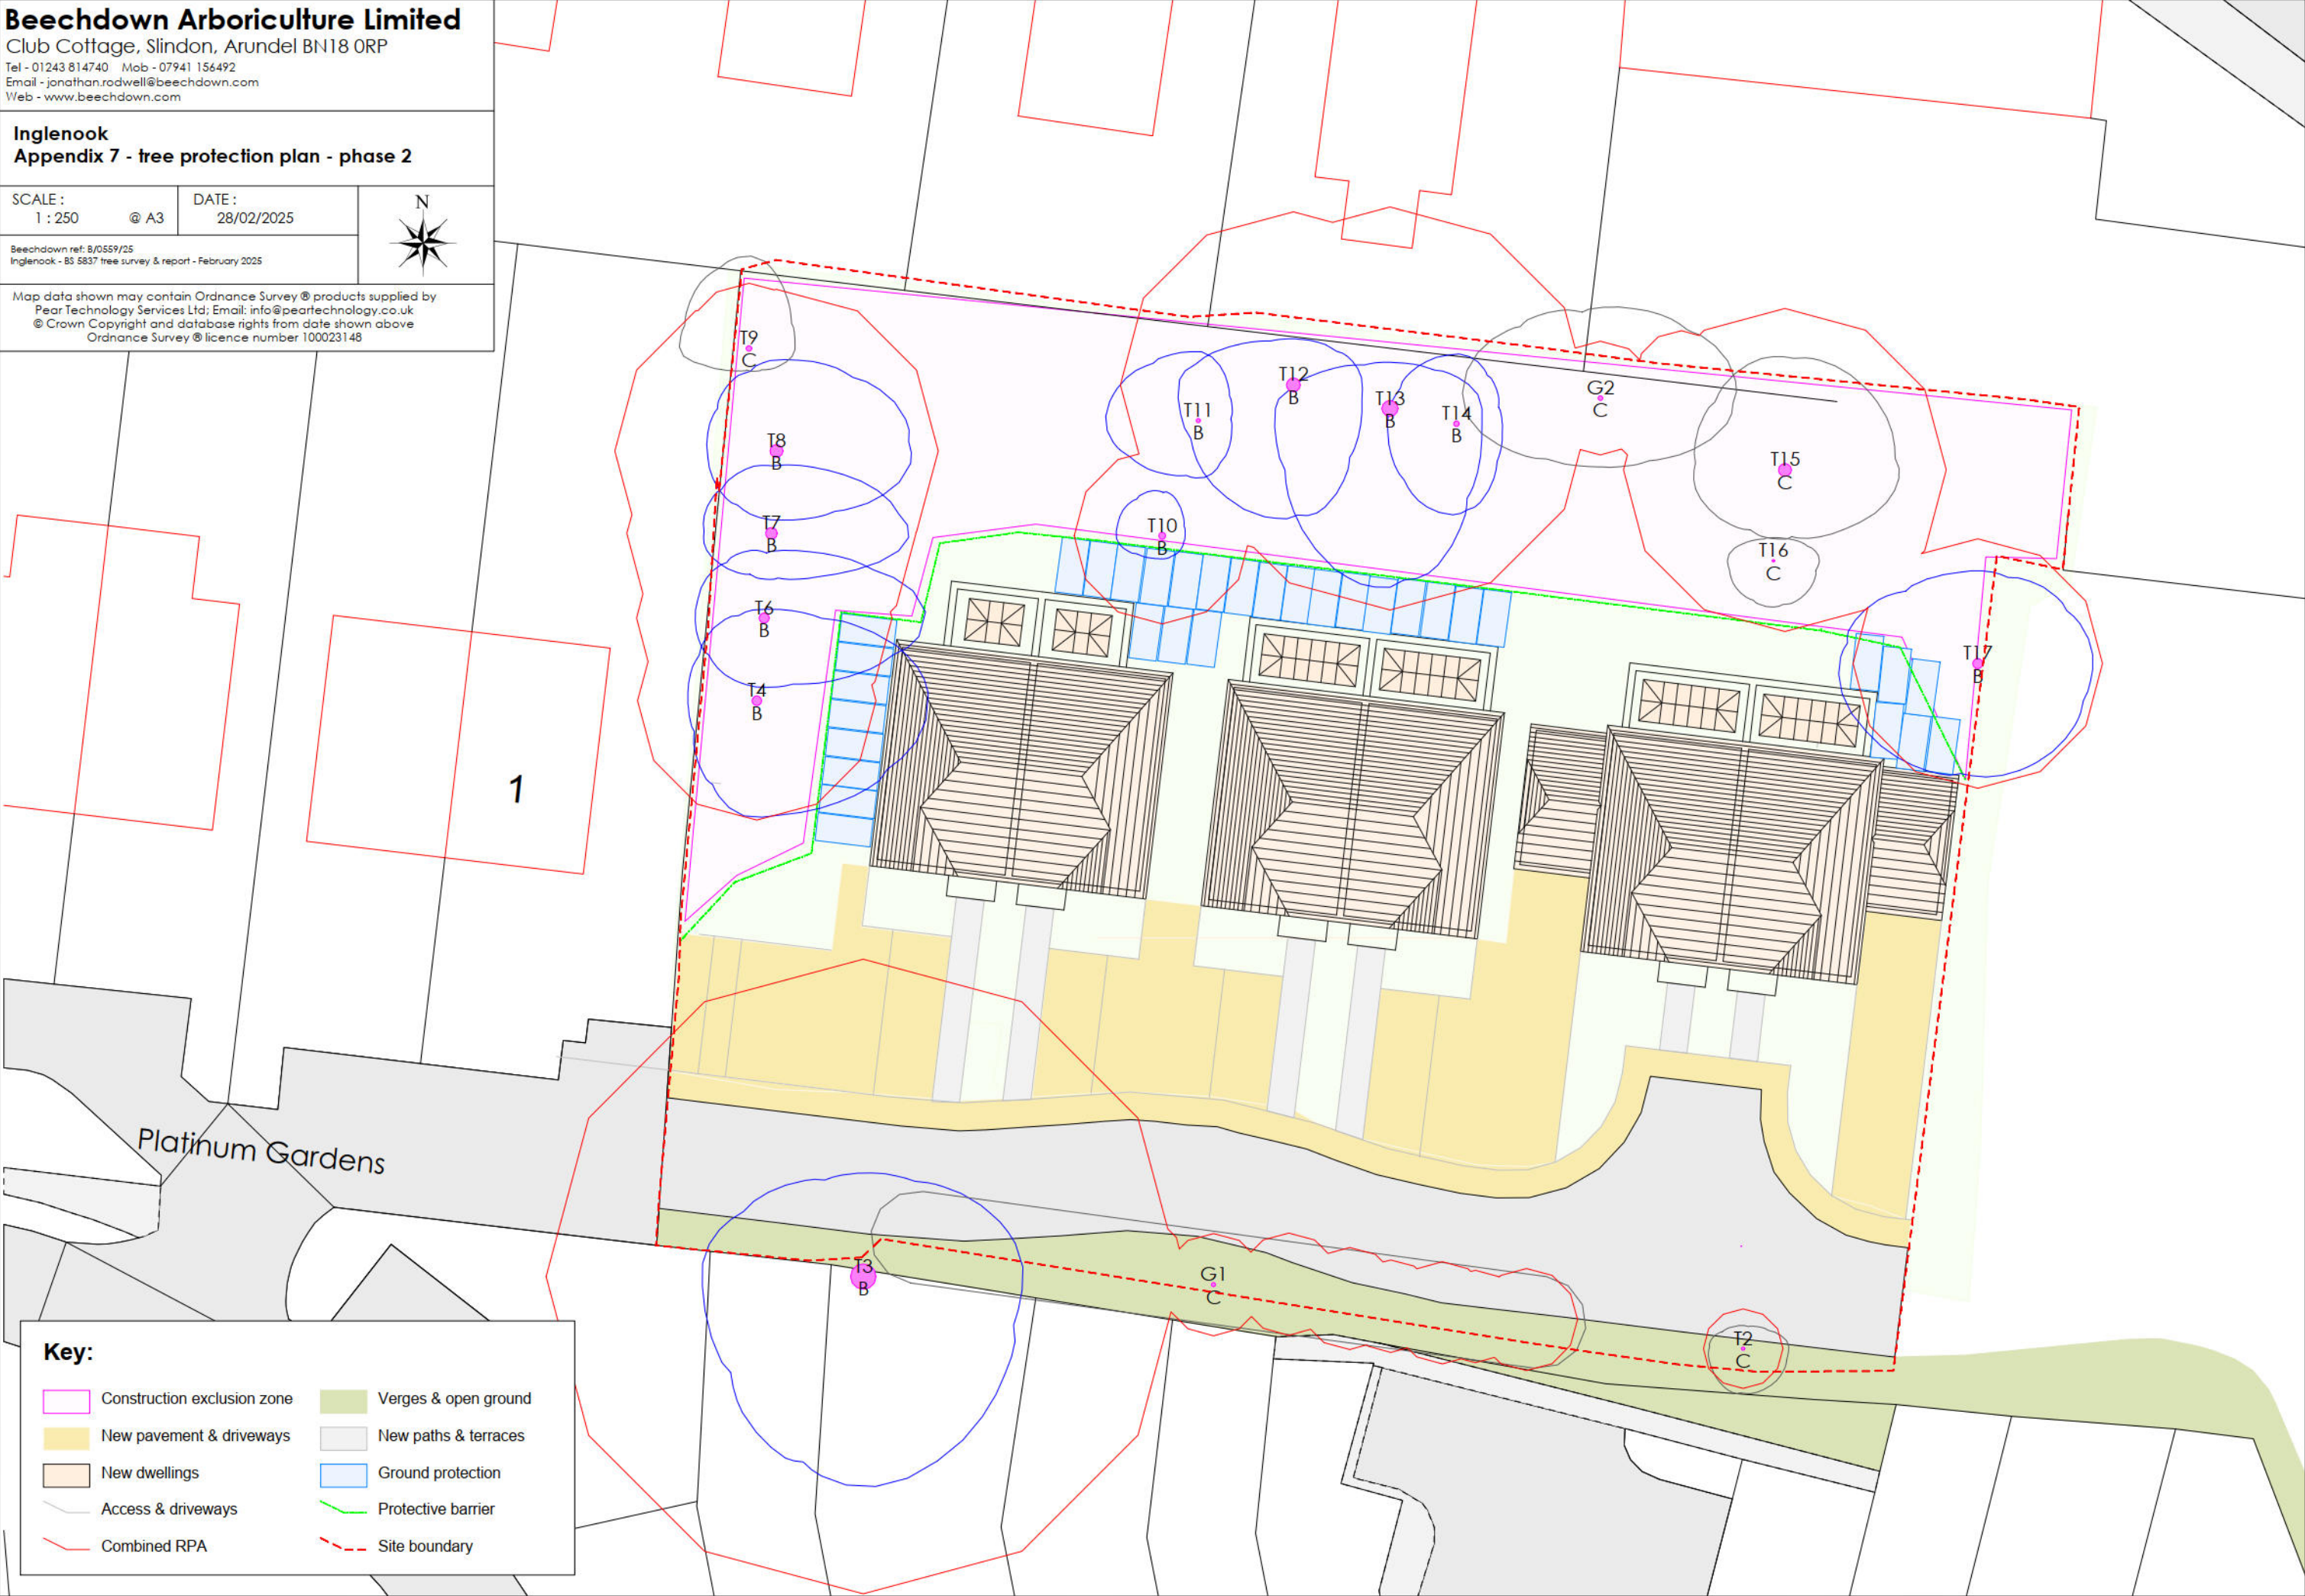
- 16.1 Prior to the commencement of construction work and before any machinery or materials are brought onto the site, protective barriers, marked as **a green broken line** on the tree protection plan (Appendix 6), must be erected, around the vulnerable Root Protection Area (RPA) to create a construction exclusion zone beyond the working area.

- 16.2 The construction exclusion zone, shown as **light purple shading** on the tree protection plan, will be afforded protection at all times during the development process; strictly no access, excavation, changes in soil levels, construction activities, mixing materials or storage will be allowed.

- 16.5 The protective barriers should be repositioned for the different stages of the development process as per appendices 7 & 8.
- **Construction exclusion zone Phase 1 – new surfacing & groundworks** – formed of 16 weld mesh panels positioned between the western boundary fence and the fence between the application site and the carpark to the east.

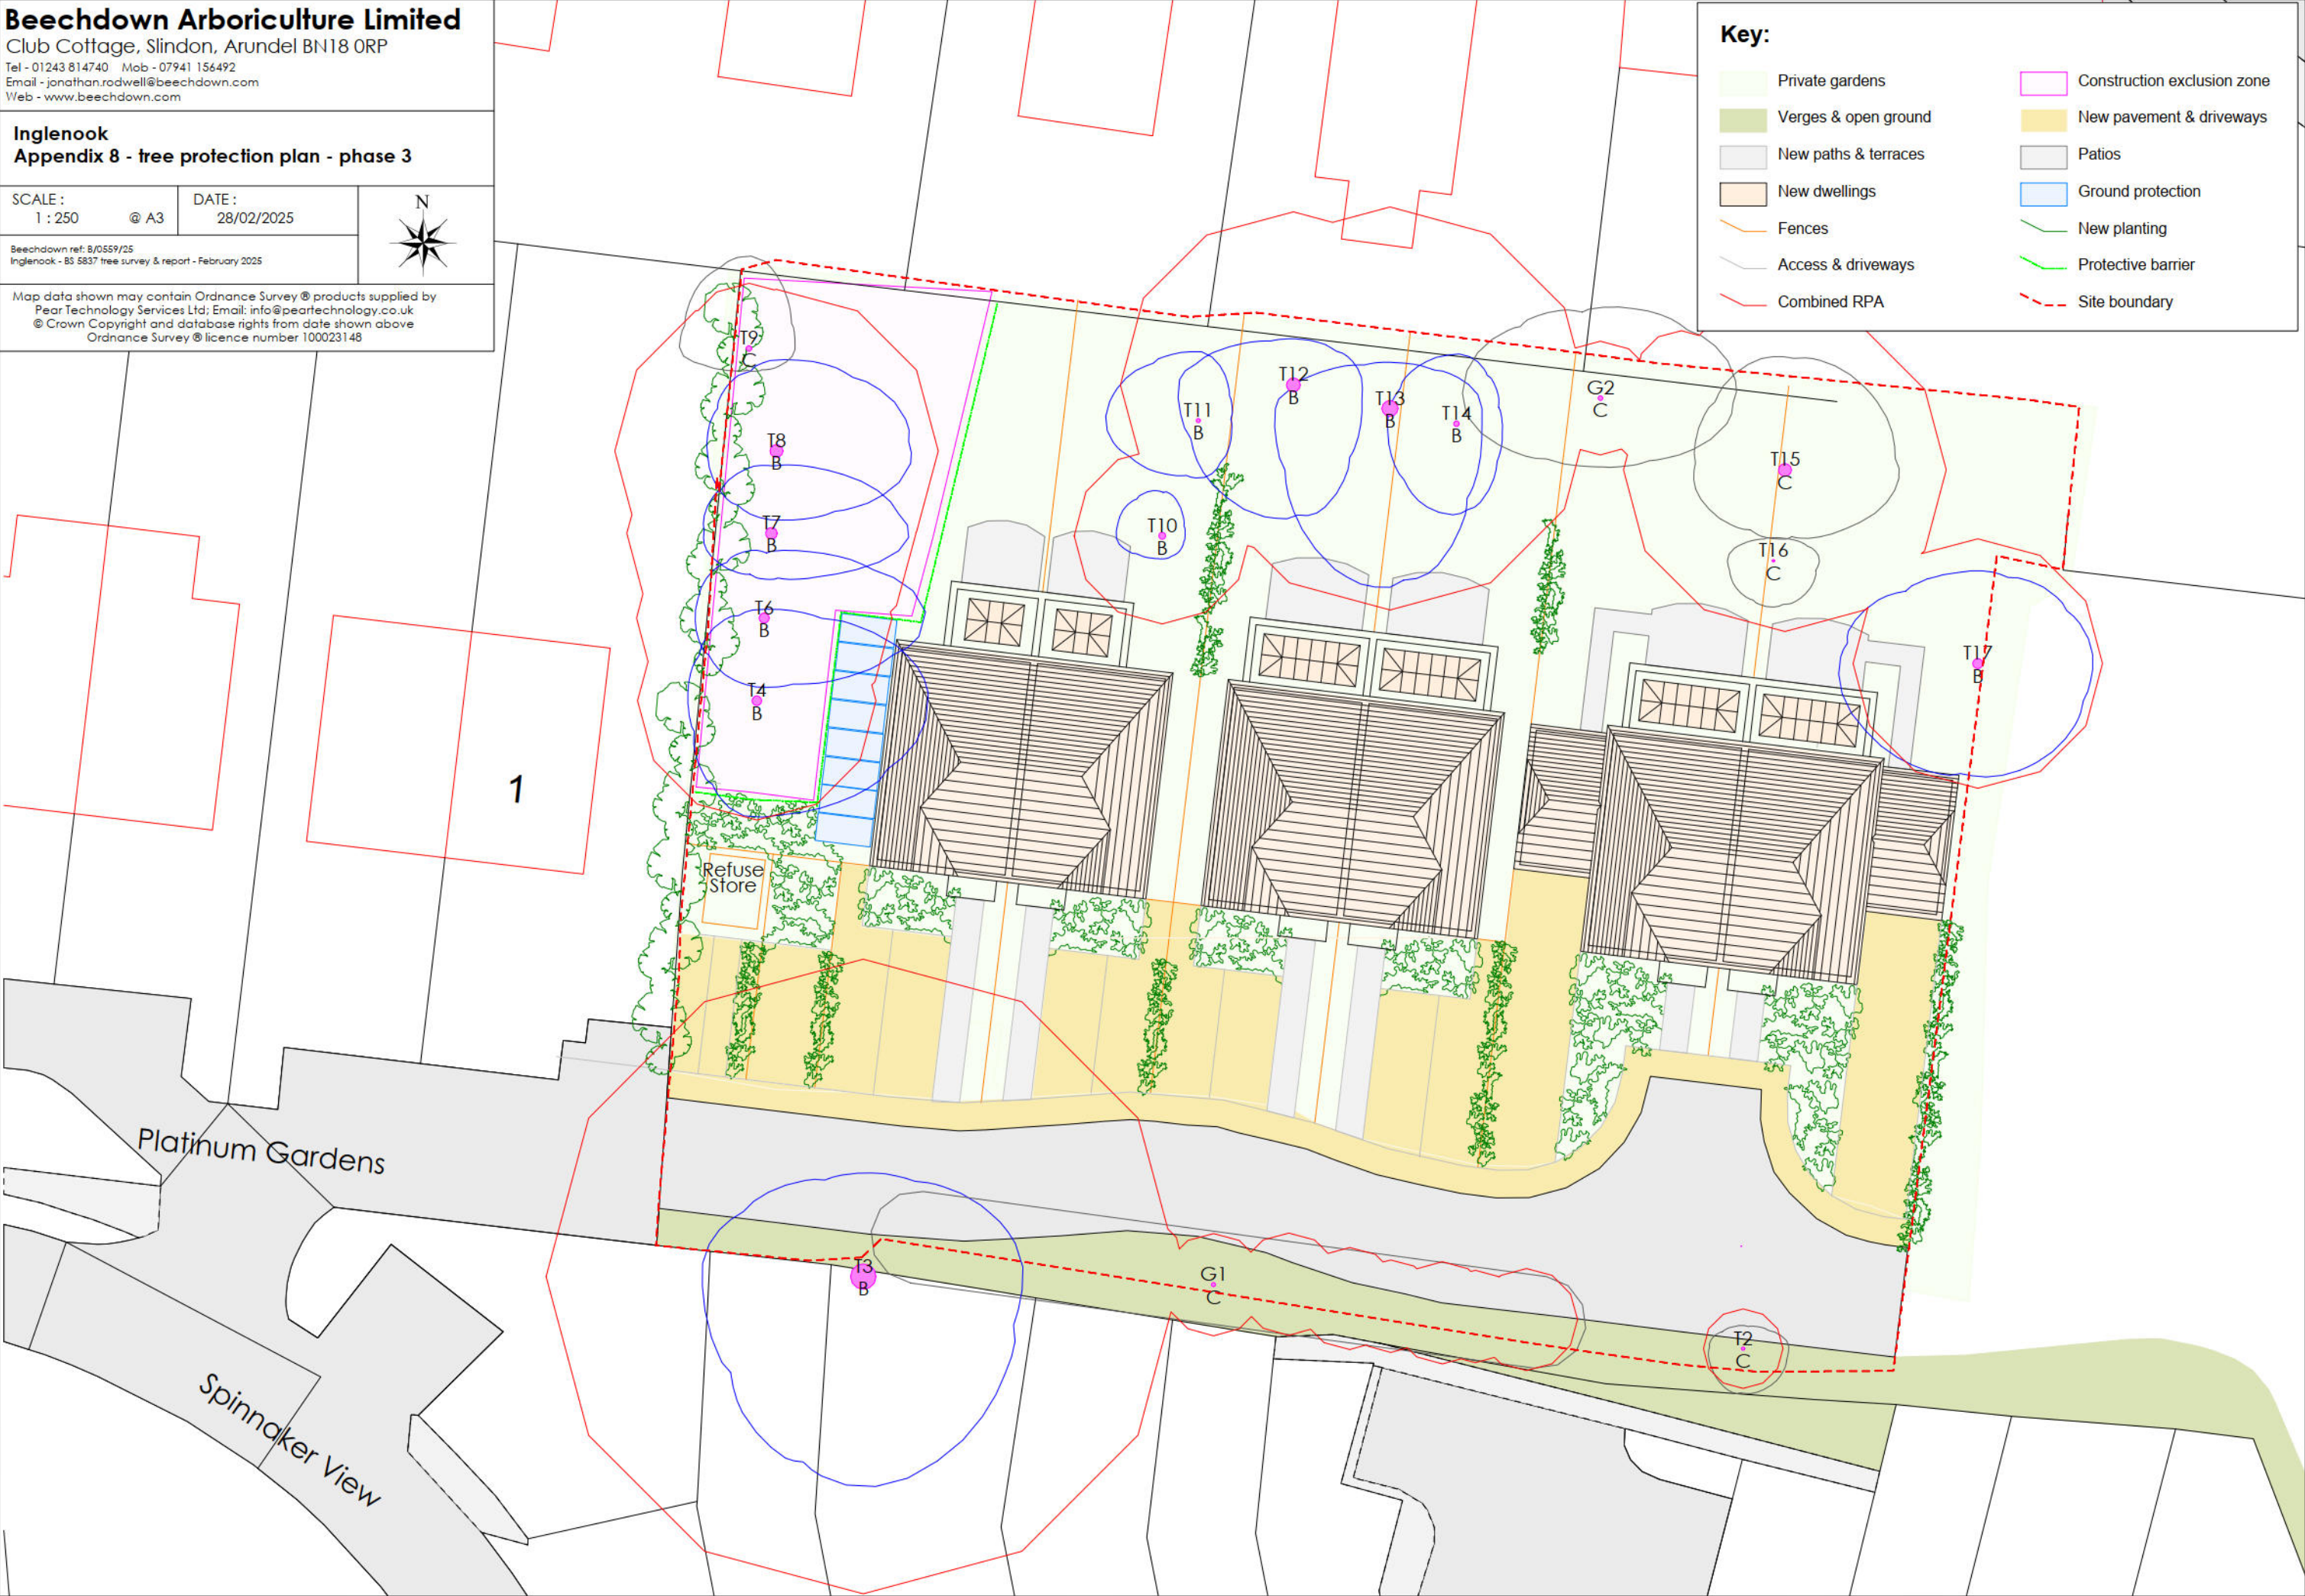
| Access & driveways | Protective barrier |
| Combined RPA | Site boundary |

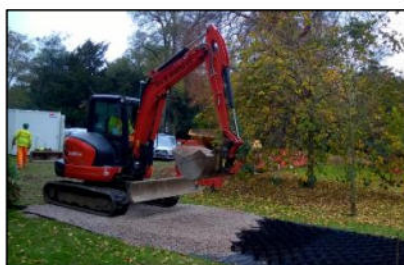
4. **Connection of the panels to create one single mattress**
  - All panels must be adjoined to one another both side by side and end to end
  - Simply connect the Geoweb with the supplied ATRA® keys, through the aligned slots

- Extend the width of the Geoweb to 2.6m wide, and secure each corner
  - Ensure the panel is secured at 6.6m x 2.6m, as this will achieve the 259mm by 224mm cell diameter required.
