# ARBO RIC ULTURAL REPO RT

Ingle nook Hotel, 253-255  
Pagham Road, Bognor Regis  
PO21 3QB

Jonathan Rodwell Cert Arb L4(ABC), Tech Arbor

August 2019

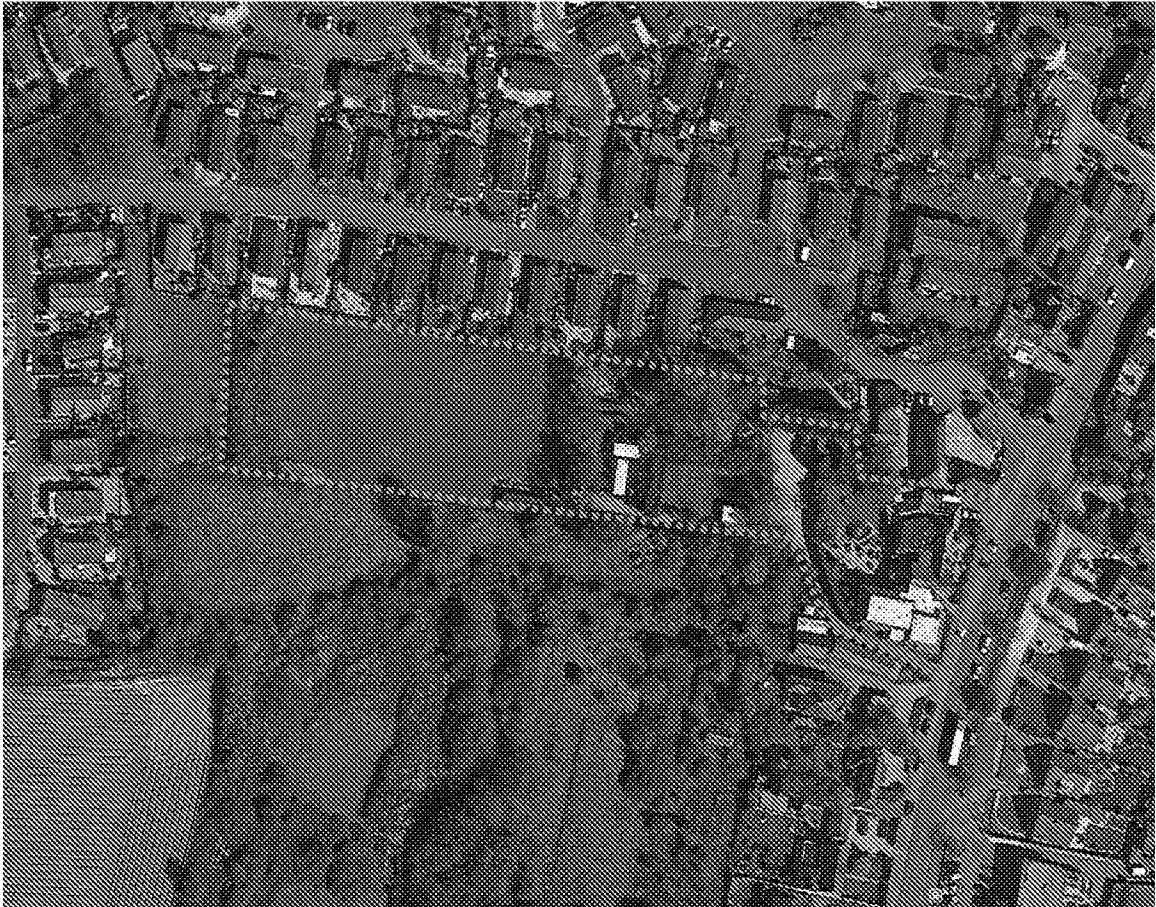
Fig. 1

- 7.1 The Inglebrook Hotel is set in broadly level grounds of a little under 1 hectare (Fig.1), while the area outlined for potential development covers a round 0.4 hectares (Fig.2).

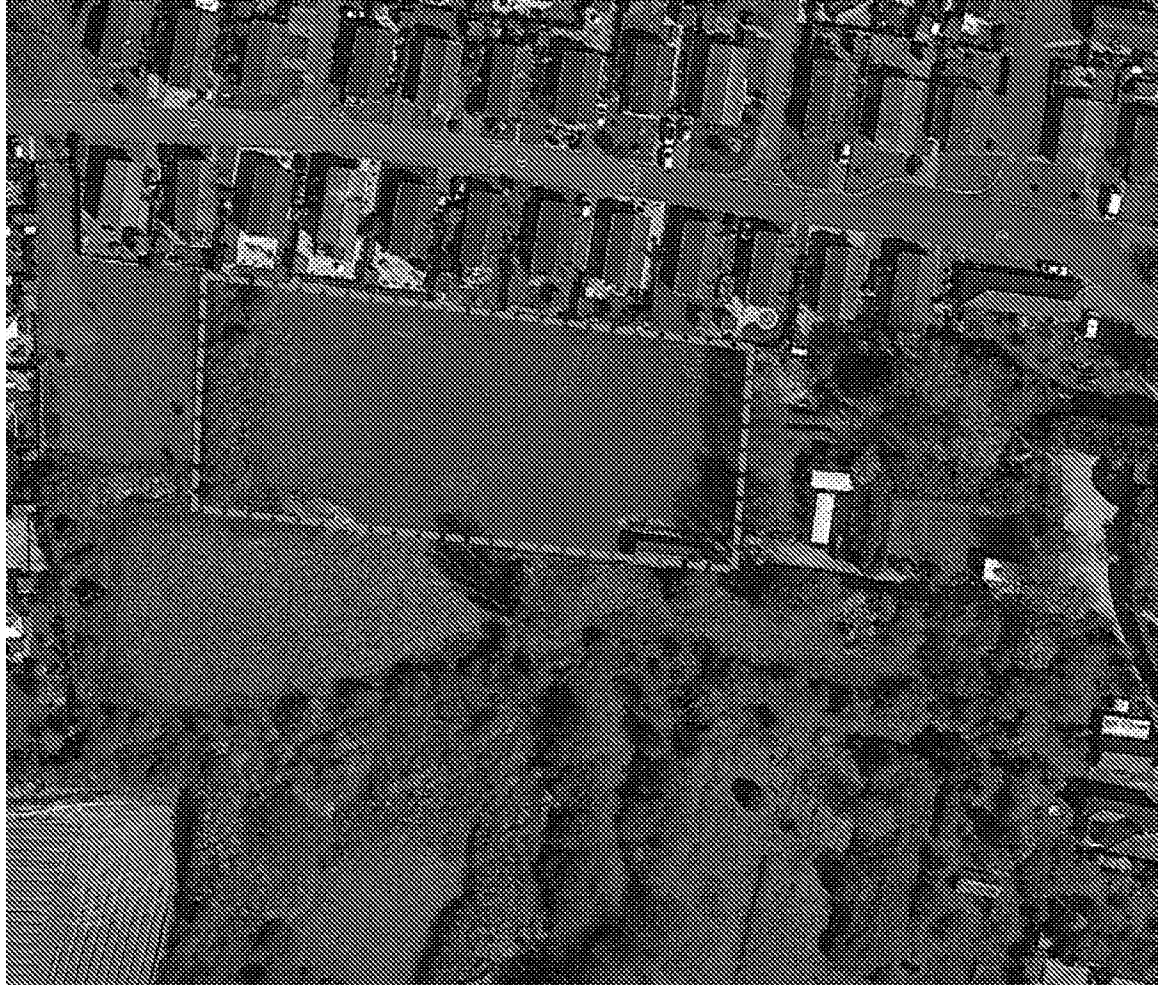
Fig. 2

Access to the site is via a tarmac driveway from Pagham Road that runs parallel to the southern boundary before opening into a small car-park behind the hotel. The area for proposed development, a field at the western end of the site, is just beyond four static caravans and various outbuildings in a landscaped area of formal planting, ornamental trees and clipped hedges. Current use of the field is for stabling and grazing horses. A 1.2m high post and rail fence extends along the north and east boundaries of the field with partially collapsed post and rail fences along the south and west boundaries.
