# PHOTOGRAPHIC SCHEDULE

REPLACEMENT OF CONSERVATORY WITH NEW FRONT PORCH, SINGLE STOREY REAR EXTENSION AND DORMER WINDOWS. EXTENSION OF EXISTING GARAGE AND STORE AND PART CONVERSION TO TOURIST ACCOMODATION.

GREY BARN, CHURCH LANE, PAGHAM, BOGNOR REGIS, WEST SUSSEX. PO21 4NX

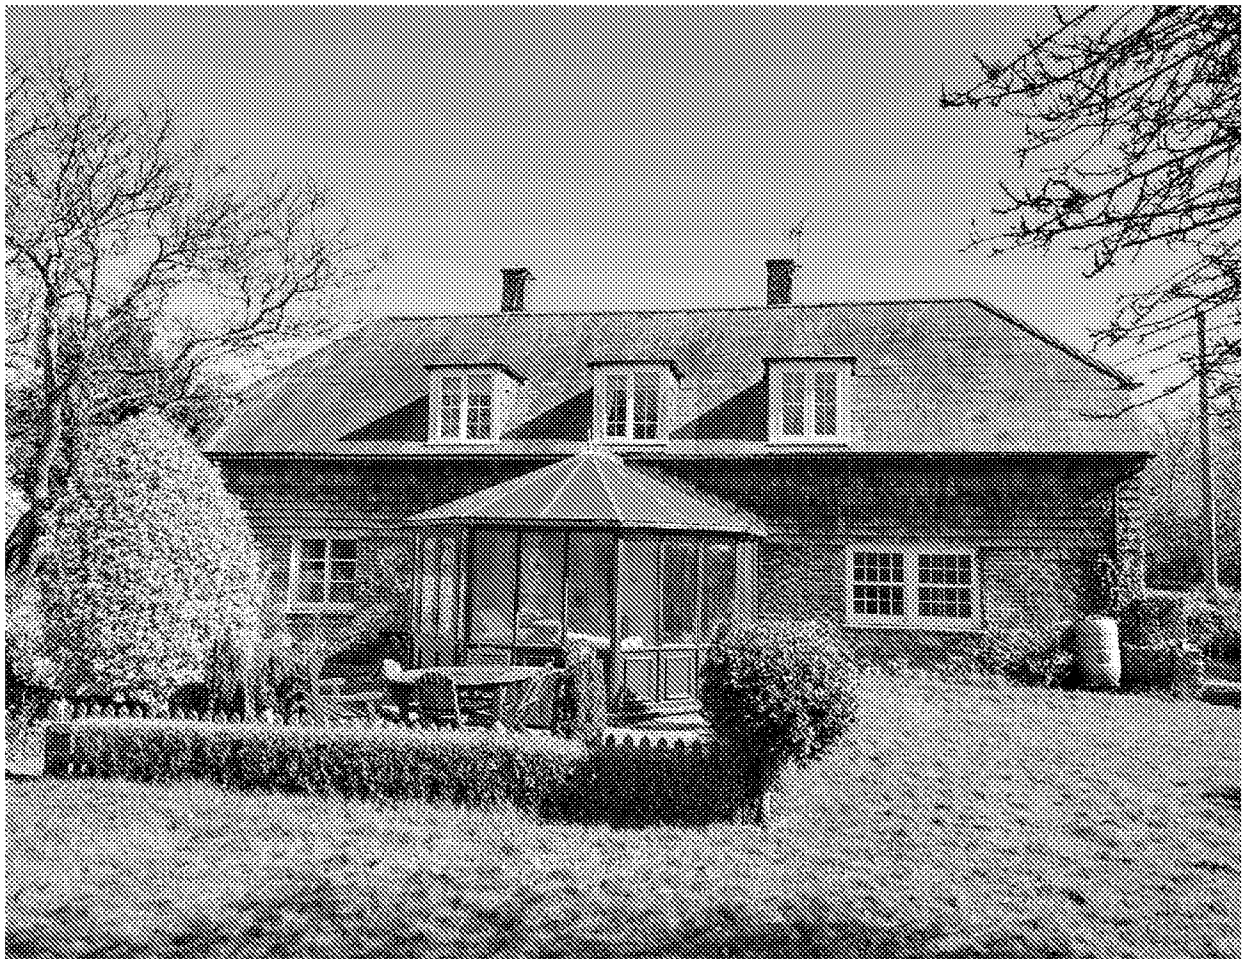
Plate I : The West Elevation of Grey Barn with PVCu Conservatory at odds with the style of the traditional barn form of the building.

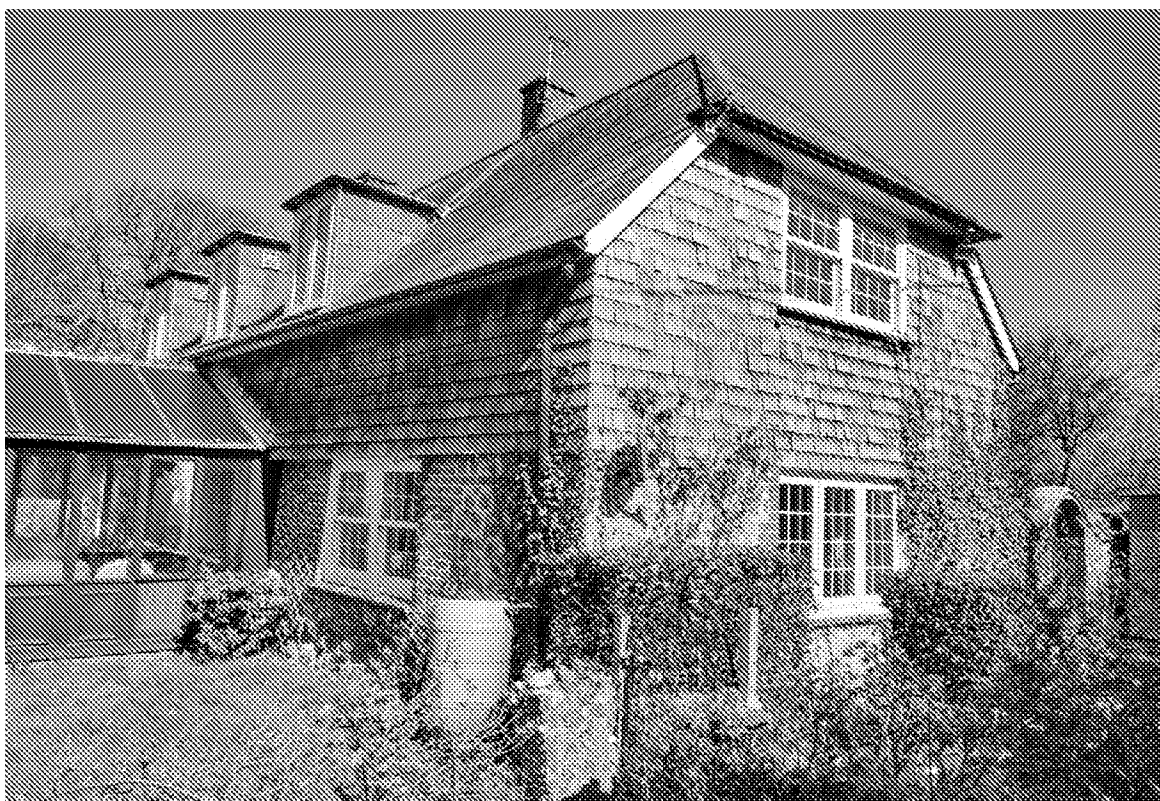
Plate II : Grey Barn – South-west perspective. The white PVCu windows at odds with the muted, natural tones of the shingles and roof slates.

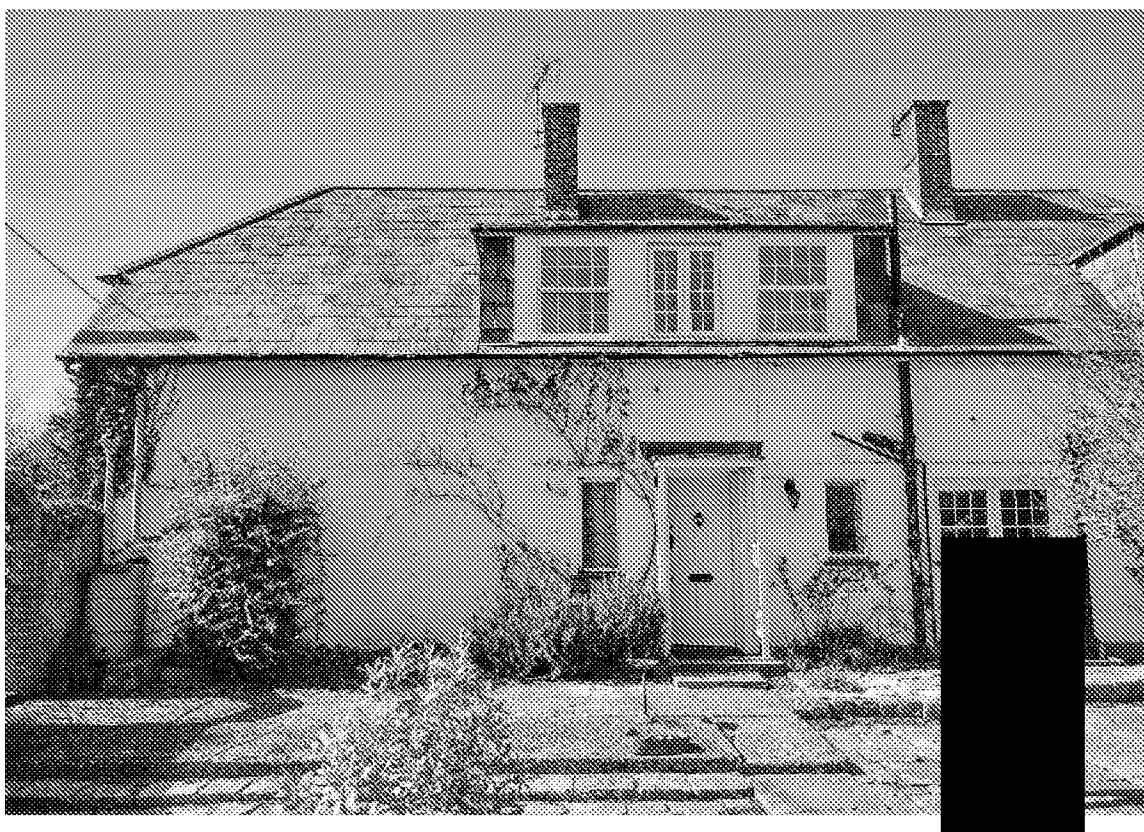
Plate IV : Grey Barn – Part East Elevation with concrete paved courtyard.

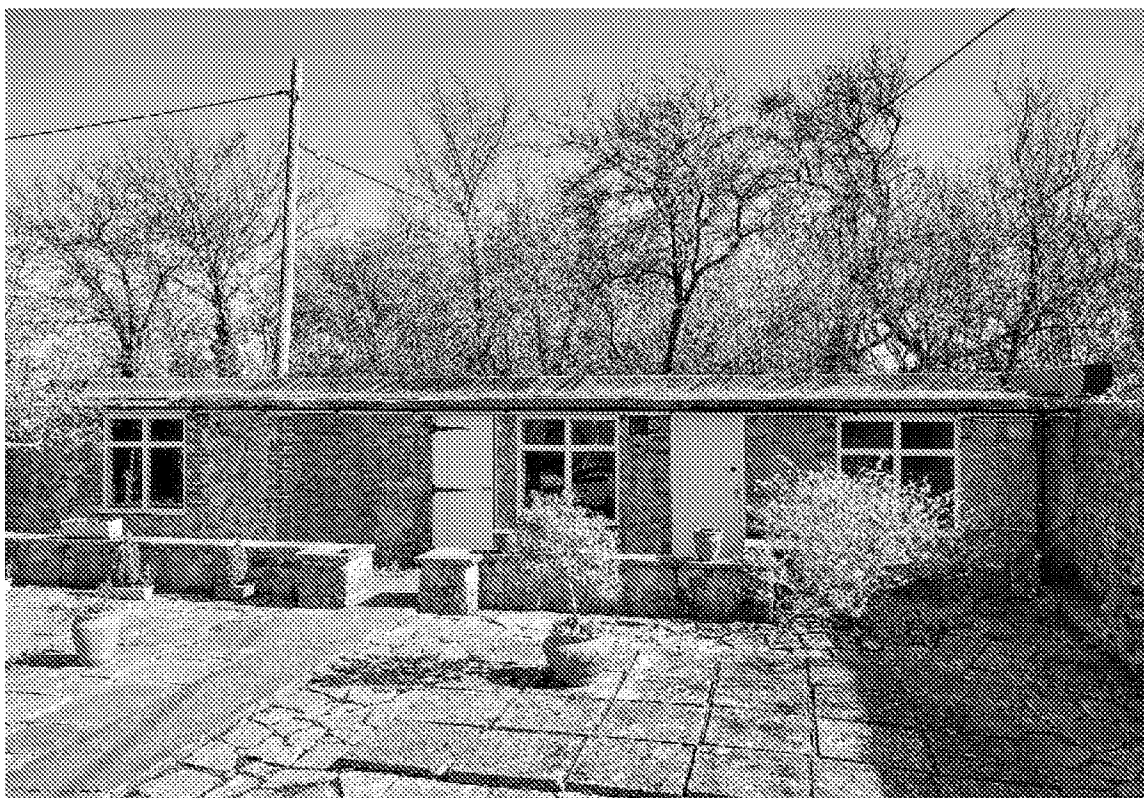
Plate V : Grey Barn Garage and ancillary store – West Elevation into concrete covered courtyard.

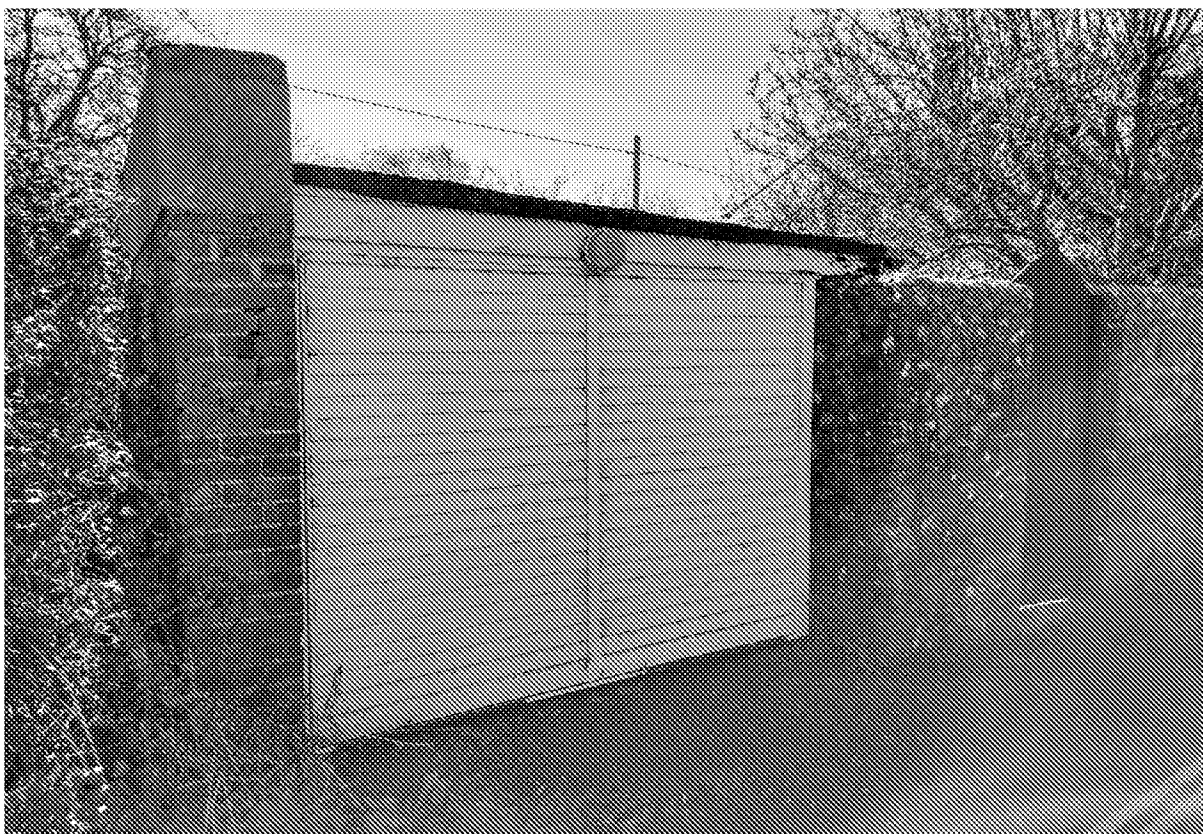
Plate VI : Grey Barn Garage – North Elevation dominated by a modern painted metal door.

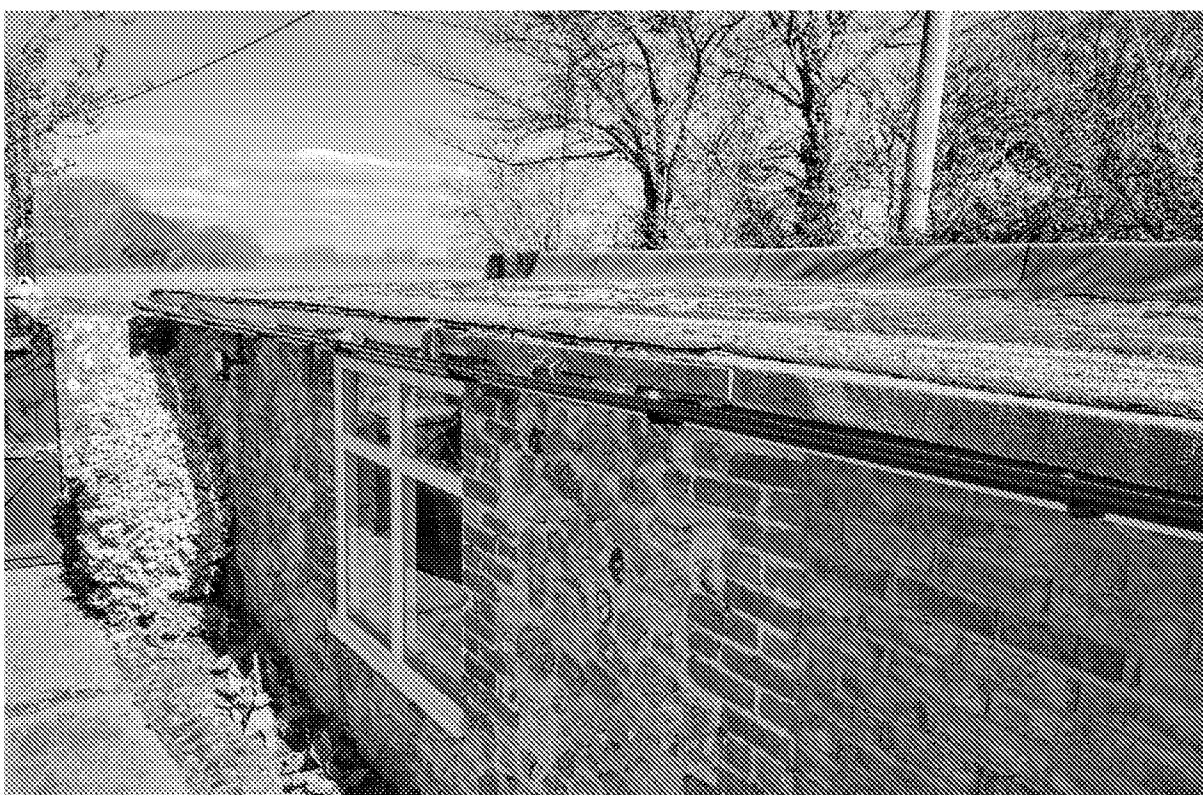
Plate VII : Grey Barn Garage – Roof in poor condition and suffering from water ingress

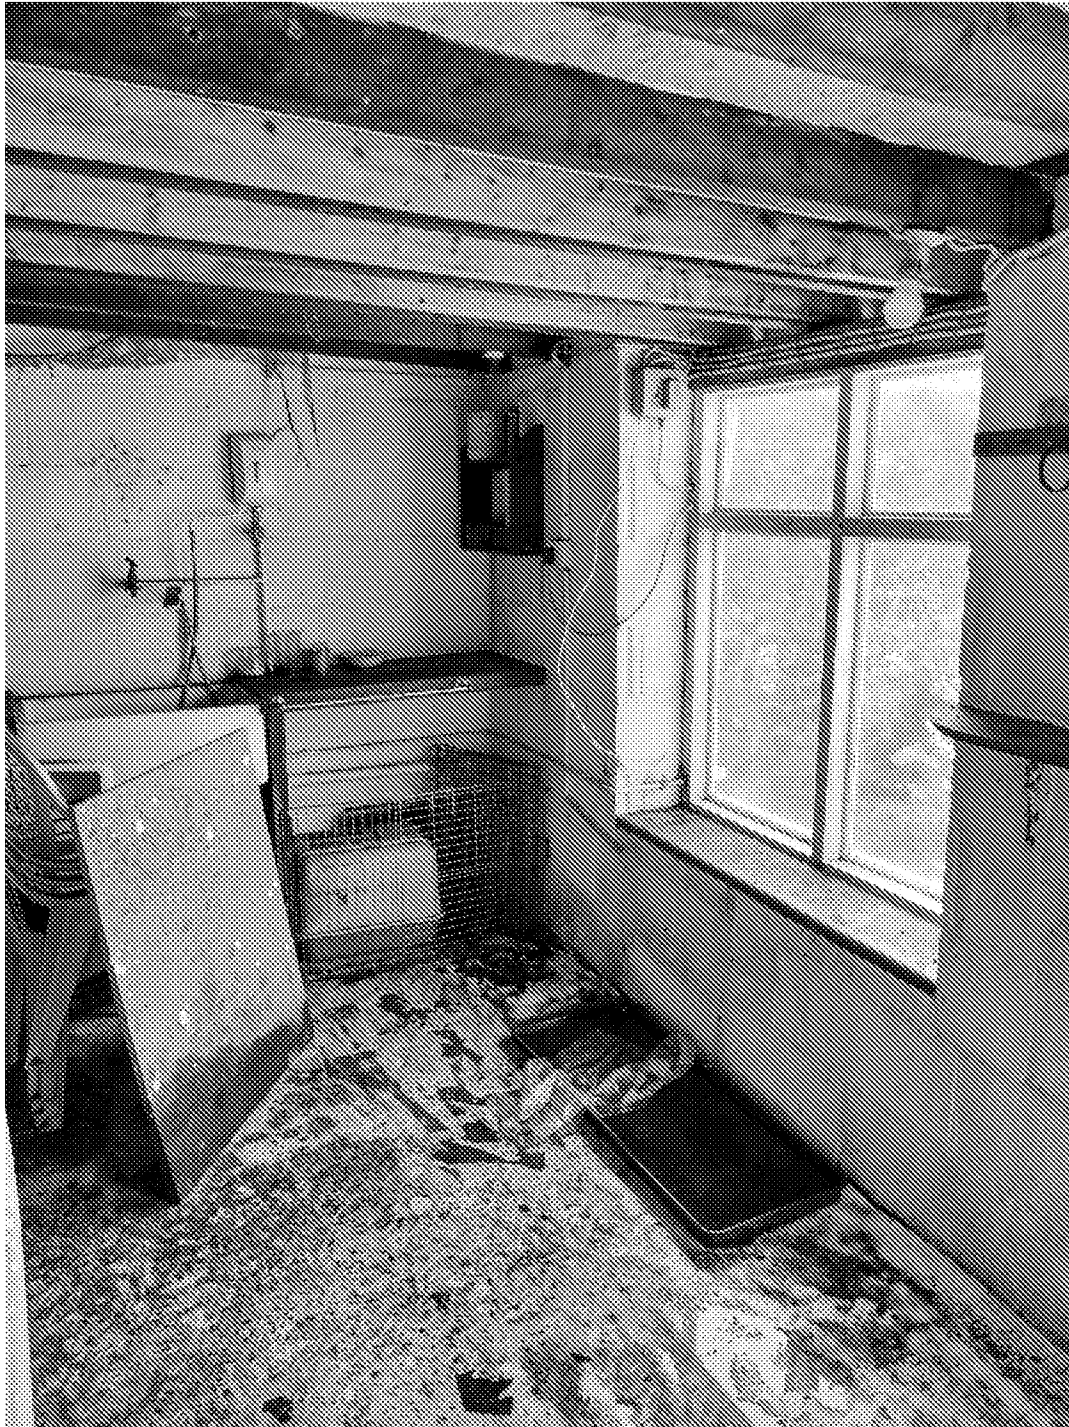
Plate VIII : Grey Barn Garage and ancillary store – Significant water ingress has lead to decay of the existing roof structure and significant issues related to dampness. Replacement of the roof will remediate these issues.
