# Groundwater Monitoring

## Land at Summer Lane Pagham Reserved Matters Application Planning Update

**RE: Summer Lane, Pagham, Bognor Regis, PO21 4NQ – Winter Groundwater Monitoring**

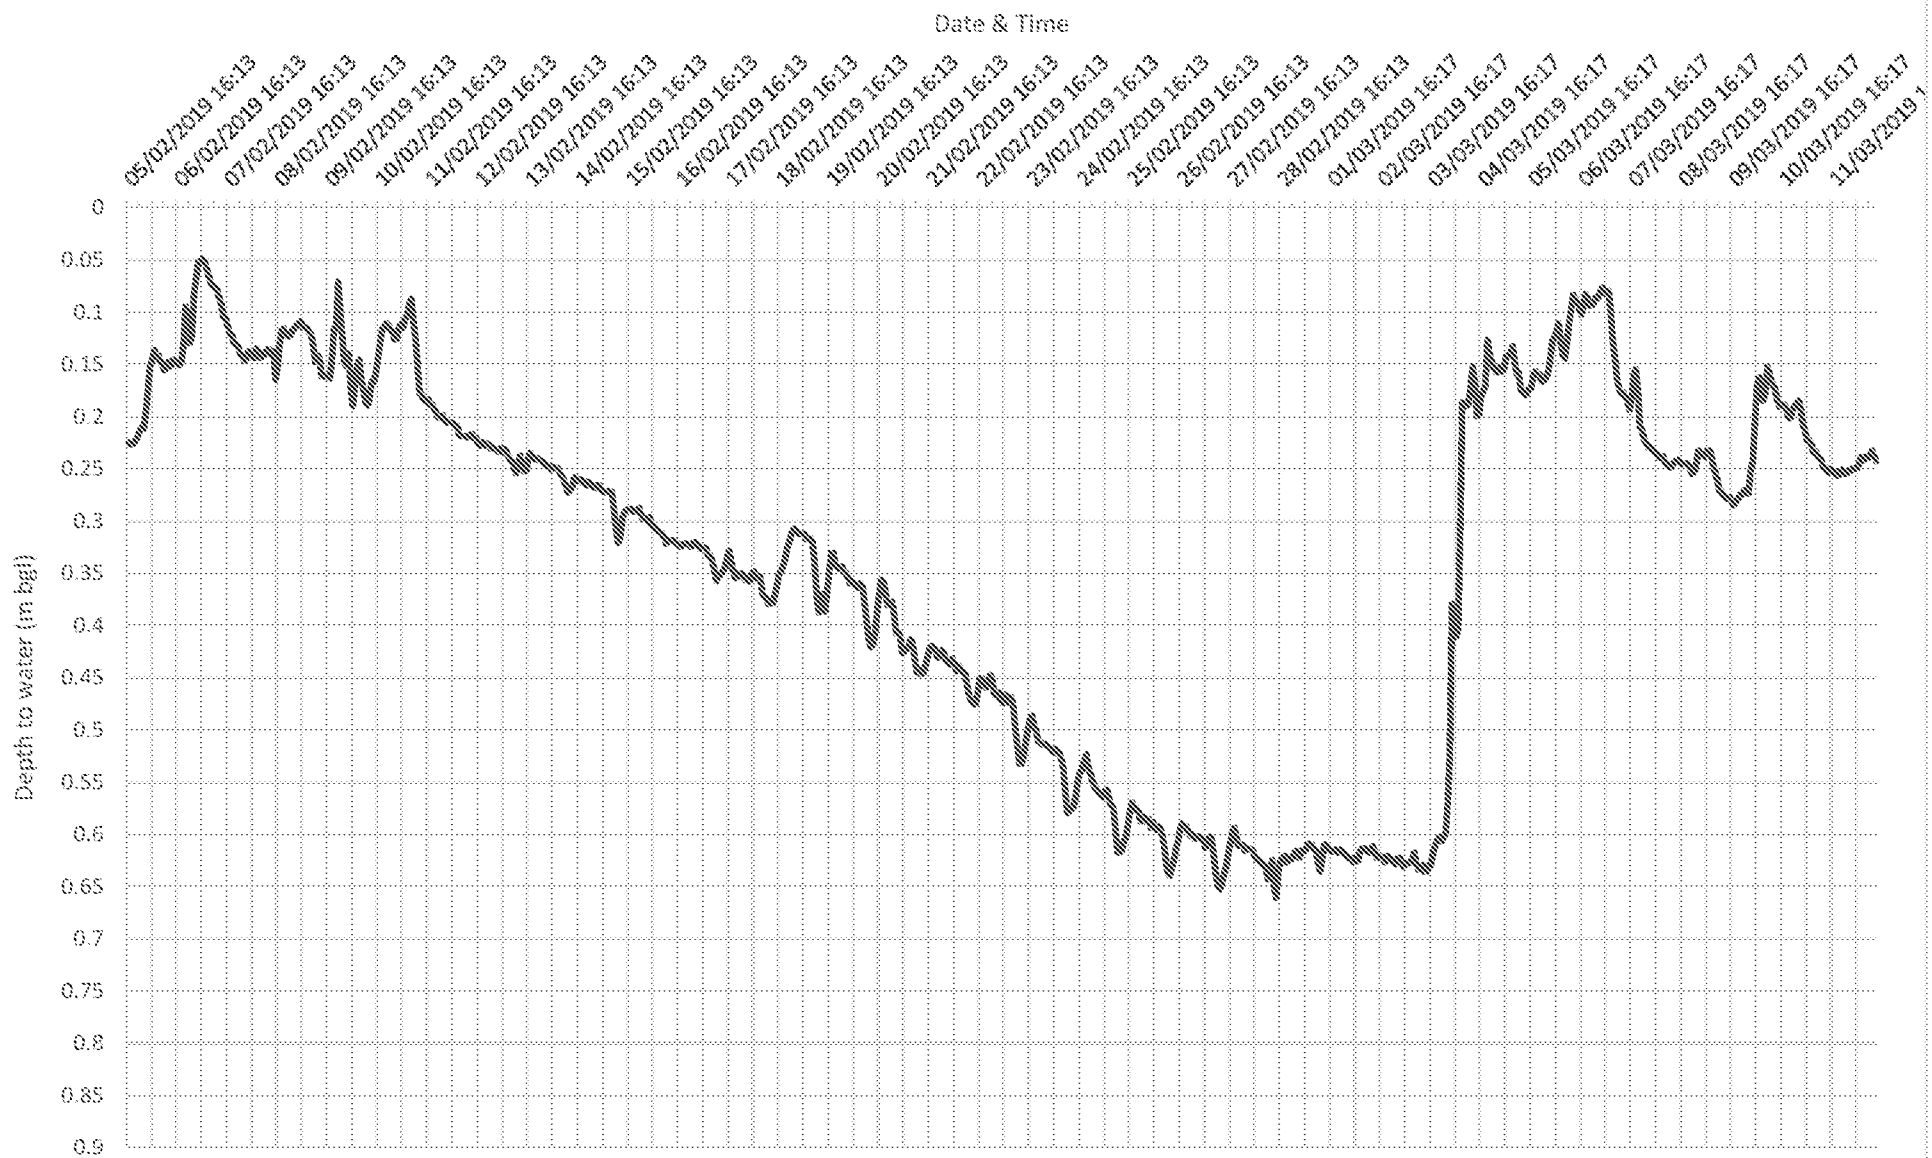
Continuous groundwater level dataloggers were installed within BH03, BH08 and BH10 from 5<sup>th</sup> February to 11<sup>th</sup> March 2019. The results are presented graphically in Appendix B.

The groundwater levels over the monitoring period show groundwater at a peak during the first rainfall event, then reducing to a relatively steady level before peaking in response to the second rainfall event.

The time taken for the groundwater level in BH03 to recover following the February rainfall event was approximately 14 days with an approximate decrease of 0.40m. The levels in BH08 took approximately 13 days, dropping approximately 0.25m. Within BH10 the fall in water level took approximately 15 days for an approximate 0.30m drop in water level. The response to the March rainfall event starting on 4<sup>th</sup> March appears to be less than 12 hours for all of the boreholes with increases in water level of approximately 0.50m, 0.25m and 0.25m for BH03, BH08 and BH10 respectively. The data also shows some evidence of the potential tidal effect on groundwater levels with daily variance in levels of up to 0.05m on some occasions.

The monitoring undertaken indicates that the winter groundwater levels at the site are likely to interfere with the effective performance of conventional stormwater soakaways. As a result, on-site storage and attenuation together with alternative storm water disposal options should be considered.
