# Drainage Strategy & SuDS Statement

## Land at Summer Lane

## Pagham

**Report Title** Drainage Strategy &  
SuDS Statement

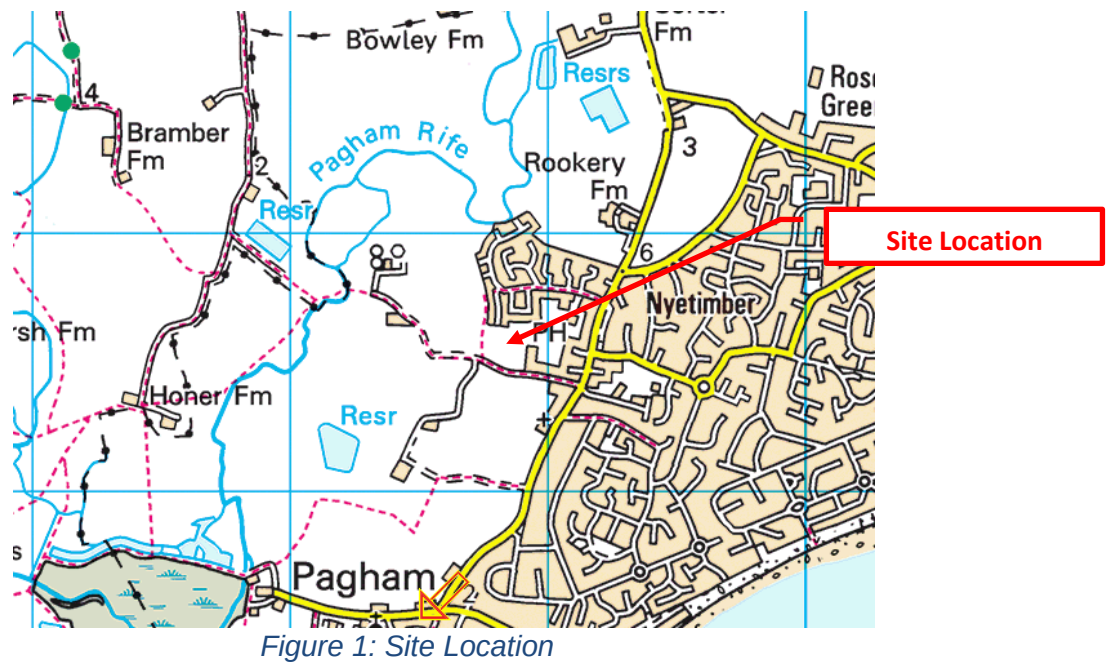
Figure 1: Site Location

The site is located north of Pagham, adjacent to Summer Lane (Refer to **Figure 1** below). The development is bounded to the north by an existing ditch and a new residential development, to the east and south by existing residential properties and to the west by existing farm lands

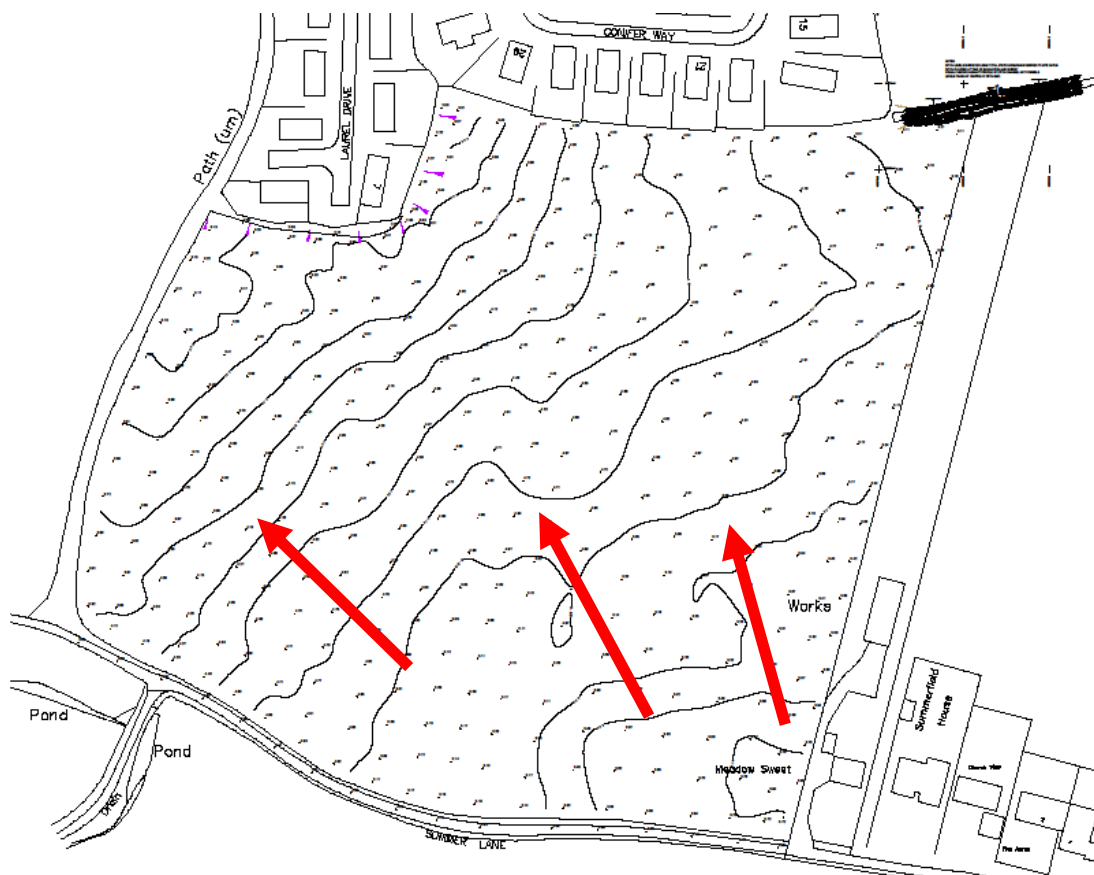
*Figure 2: Site Topography*

The application site generally falls in a westerly direction from the south eastern corner to the north west. An overview of the change in topography in this part of the wider site is presented as **Figure 2** overleaf. A copy of the topographical survey can be found in **Appendix A**.

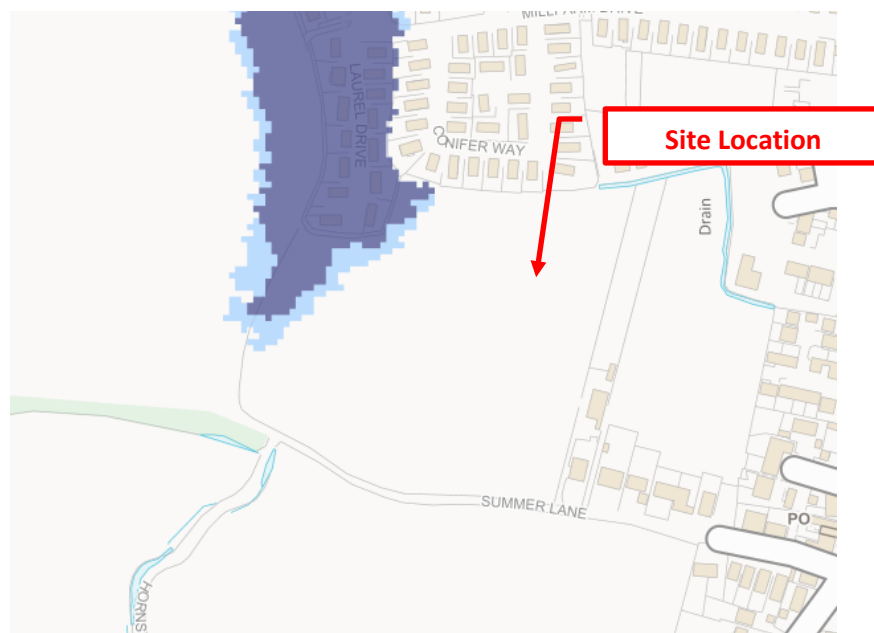
Figure 3: Extract of Flood Map from the EA's website

Based on a review of the EA's Flood Zone maps (see **Figure 3**), the development site appears to lie wholly within Flood Zone 1, considered to be at low risk from fluvial and tidal flooding.

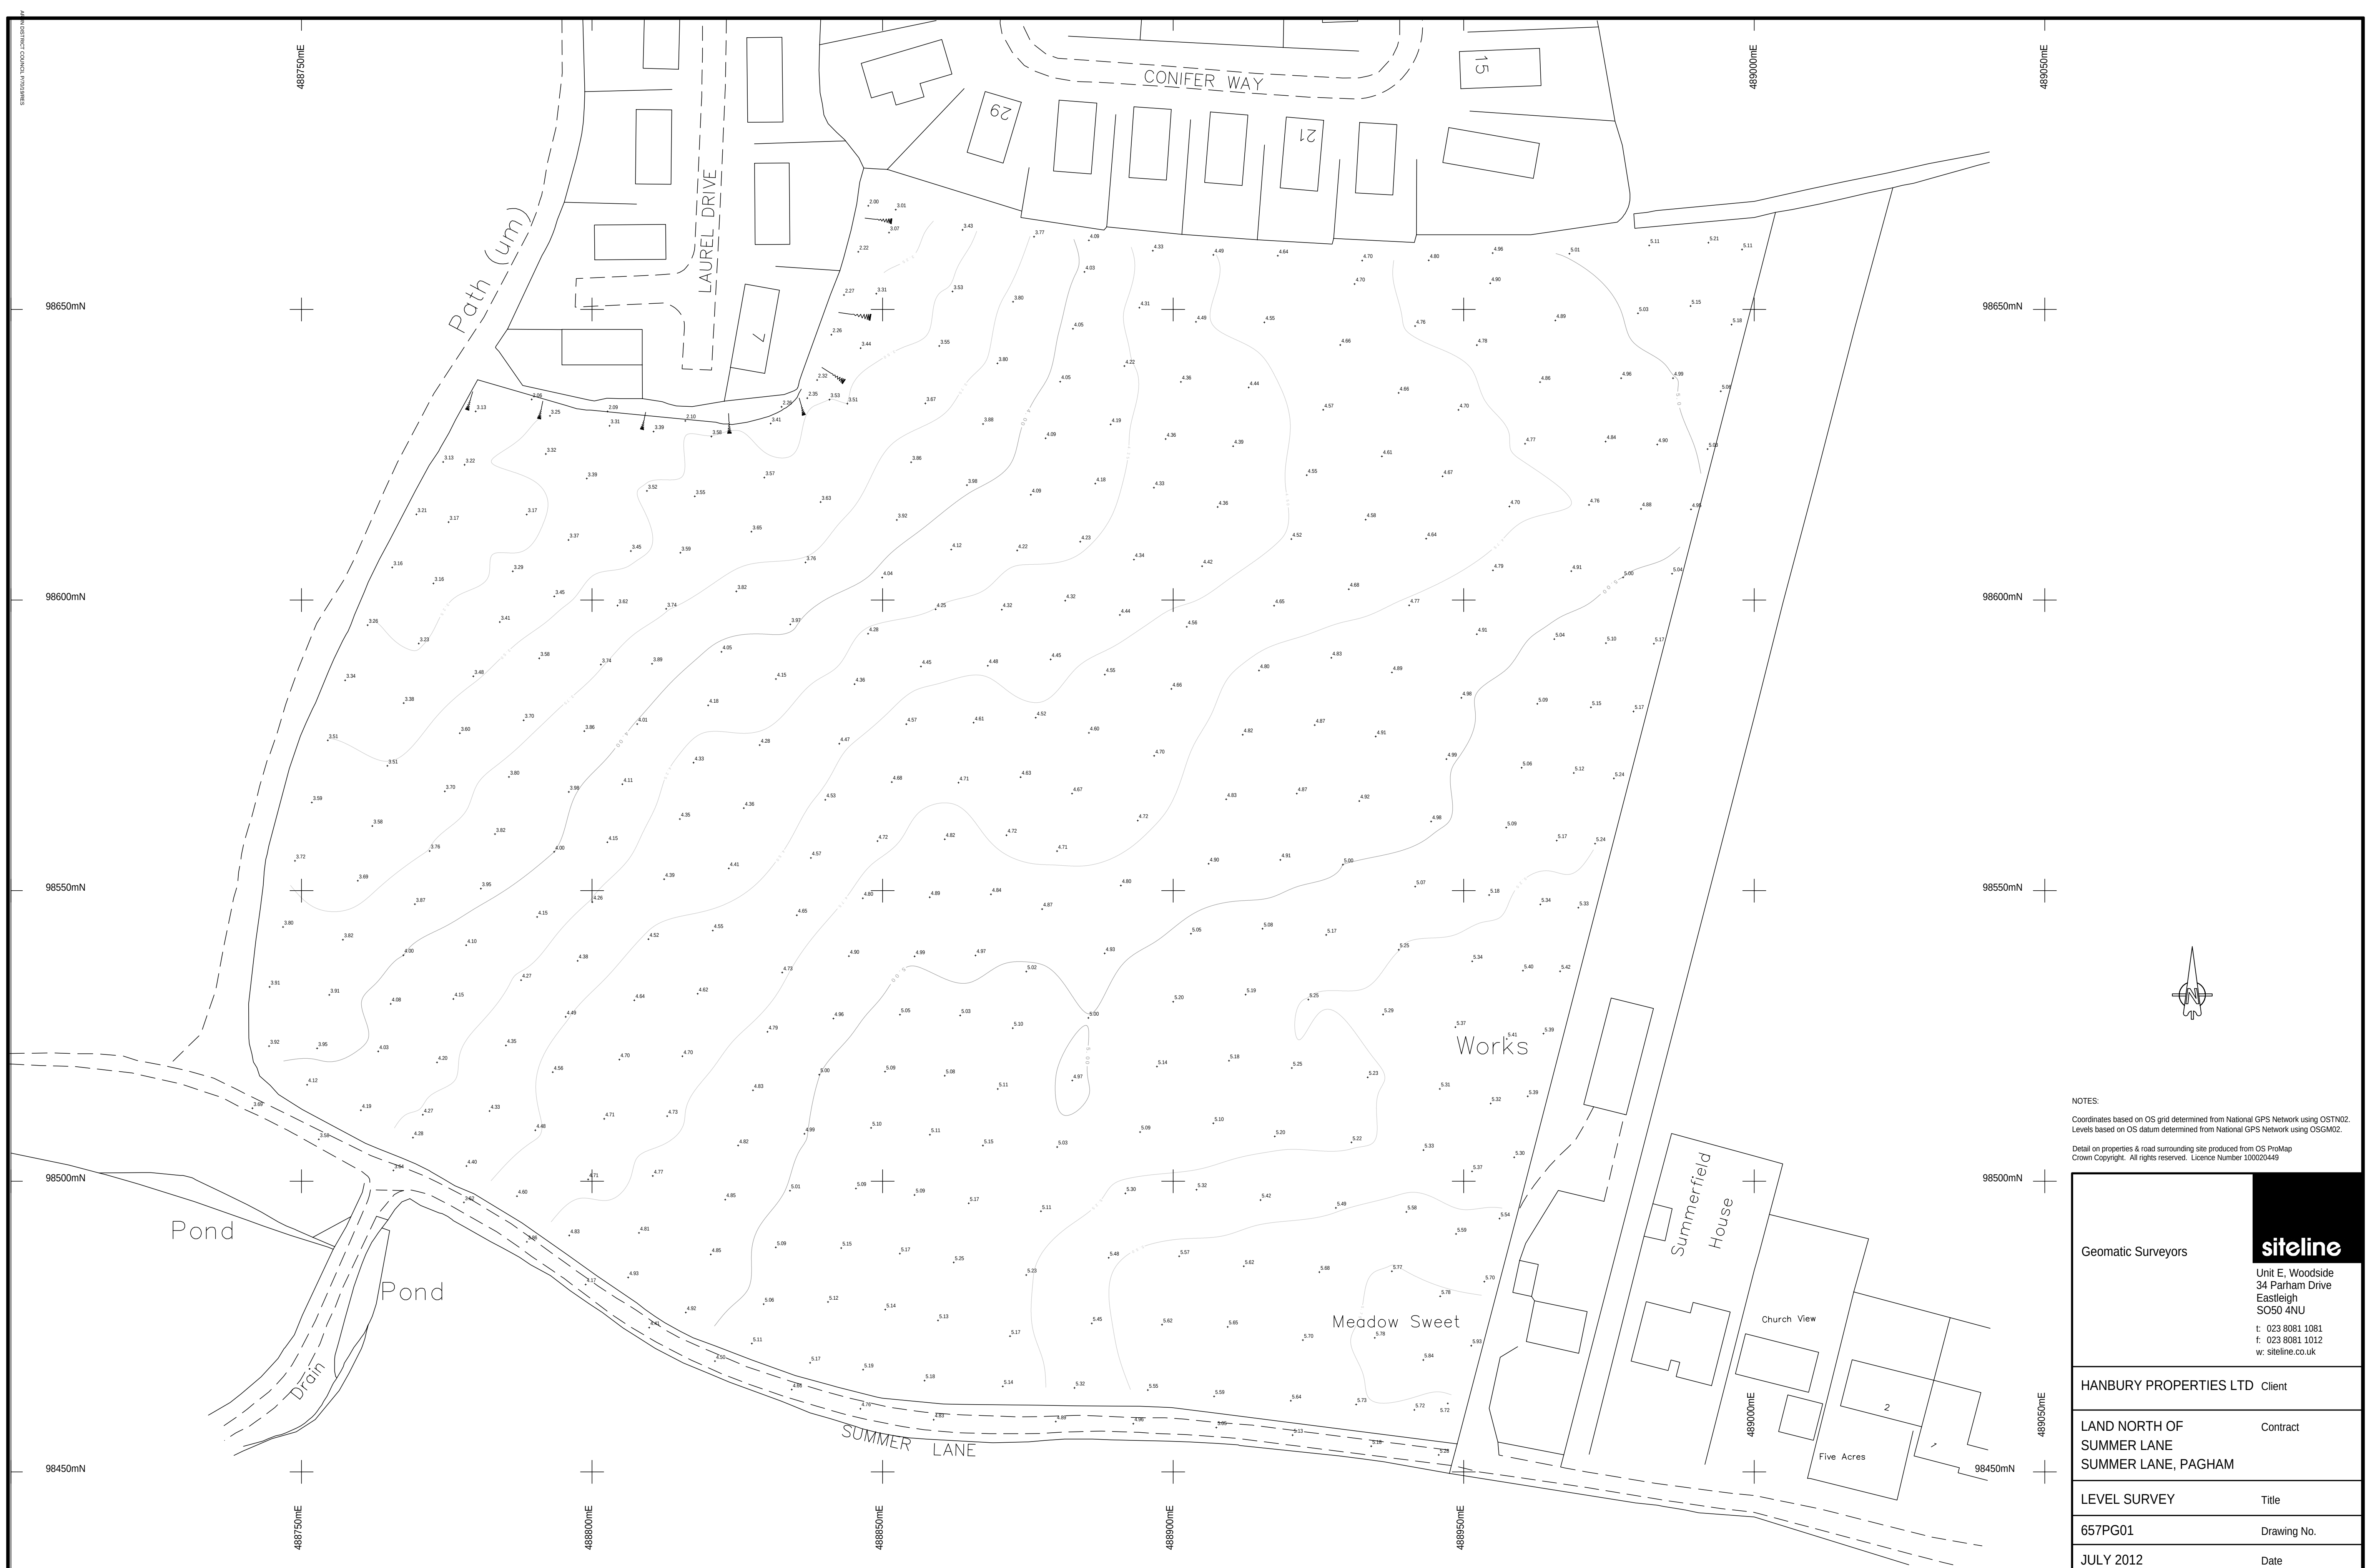
### **Topographic Survey**

NOTES:  
Coordinates based on OS grid determined from National GPS Network using OSTN02.  
Levels based on OS datum determined from National GPS Network using OSGM02.  
Detail on properties & road surrounding site produced from OS ProMap  
Crown Copyright. All rights reserved. Licence Number 100020449

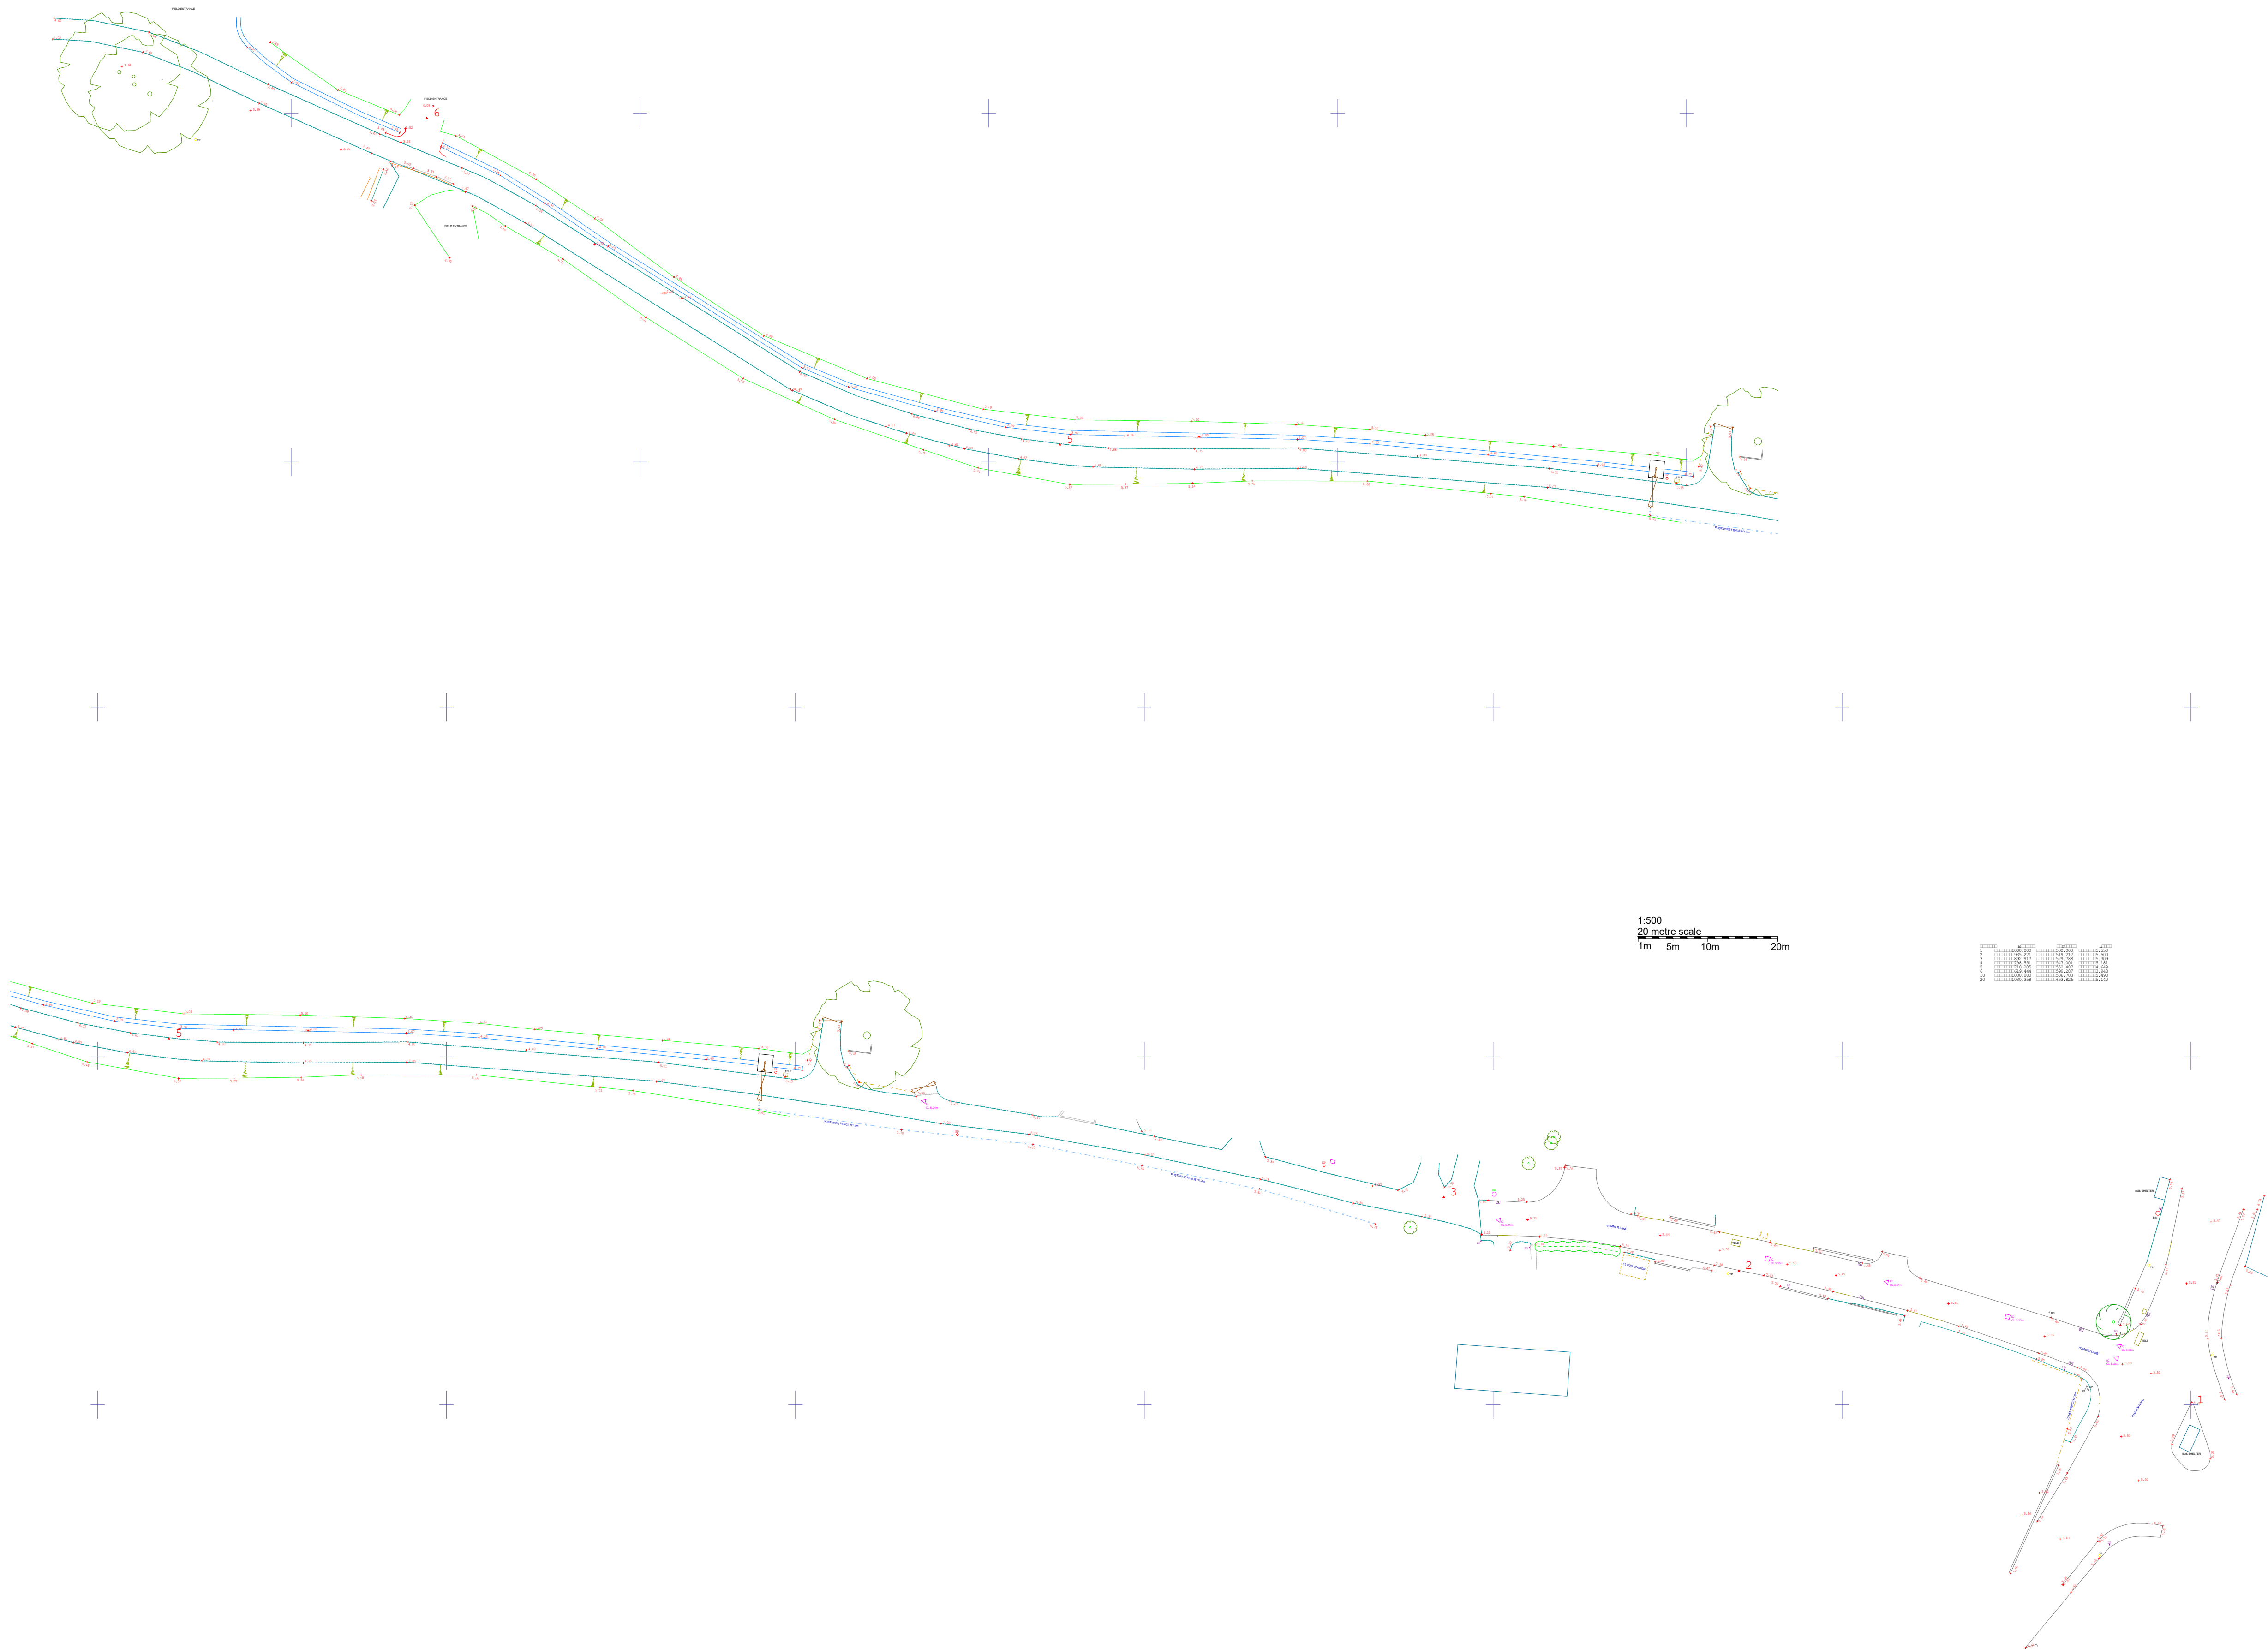
SUMMER LANE  
PAGHAM ROAD  
PAGHAM  
WEST SUSSEX
