56 East Front Road, Pagham, West Sussex

### Protected Species Assessment: Swallow and Starling

**September 2011 – Revision 00**

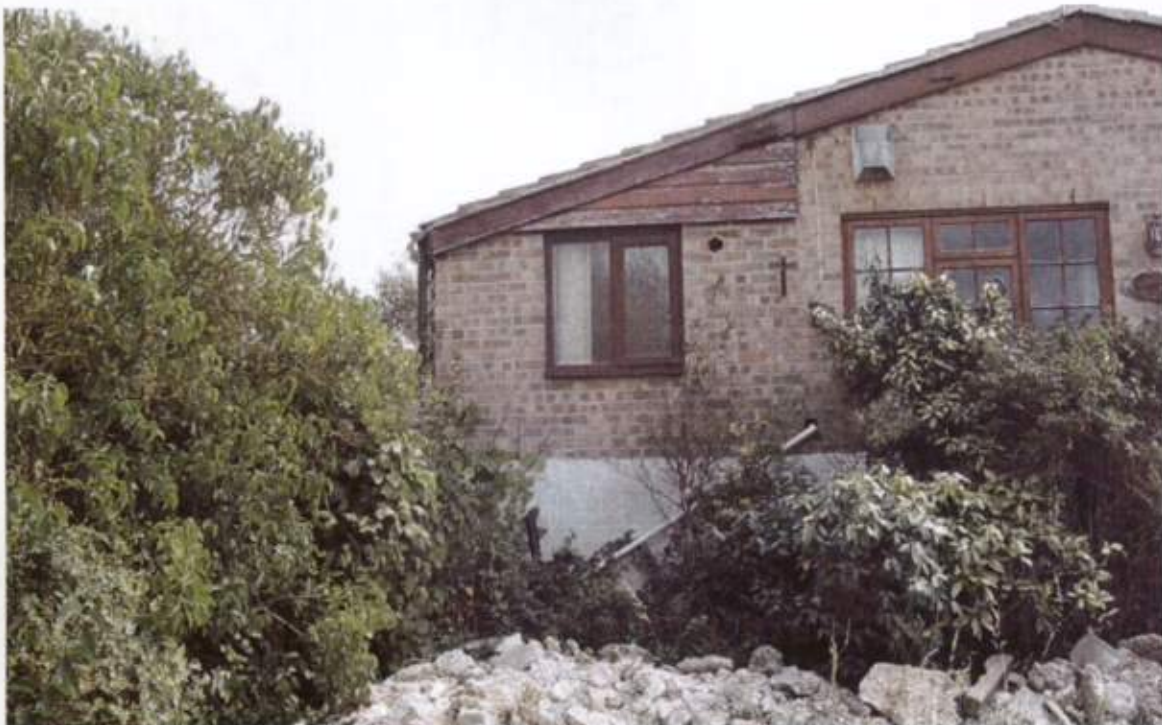
- 3.1 The Main Building on Site offered negligible nesting opportunities for each species respectively (*refer to Photographs No. 1-8; Appendix No. 1*). There were no holes in to which Starlings might access the potential nesting opportunities inside the house and minimal points on to which Swallows might construct a nest. The main building has been designated as having *negligible potential* for both species.

**Photograph No. 1 - North-Eastern Elevation of Main Building on Site. Negligible Nesting opportunities for Swallow or Starling respectively. Ventilation hole in centre of Photograph is closed.**

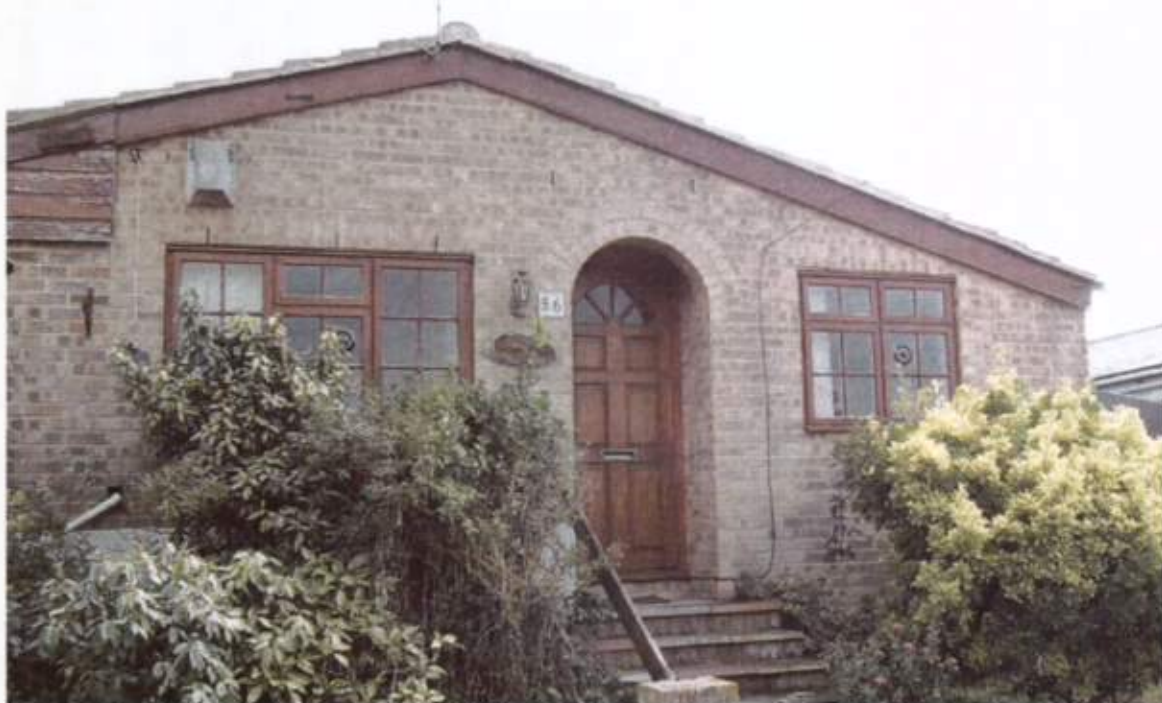
**Photograph No. 2 - North-Eastern Elevation of Main Building on Site. Negligible Nesting opportunities for Swallow or Starling respectively.**

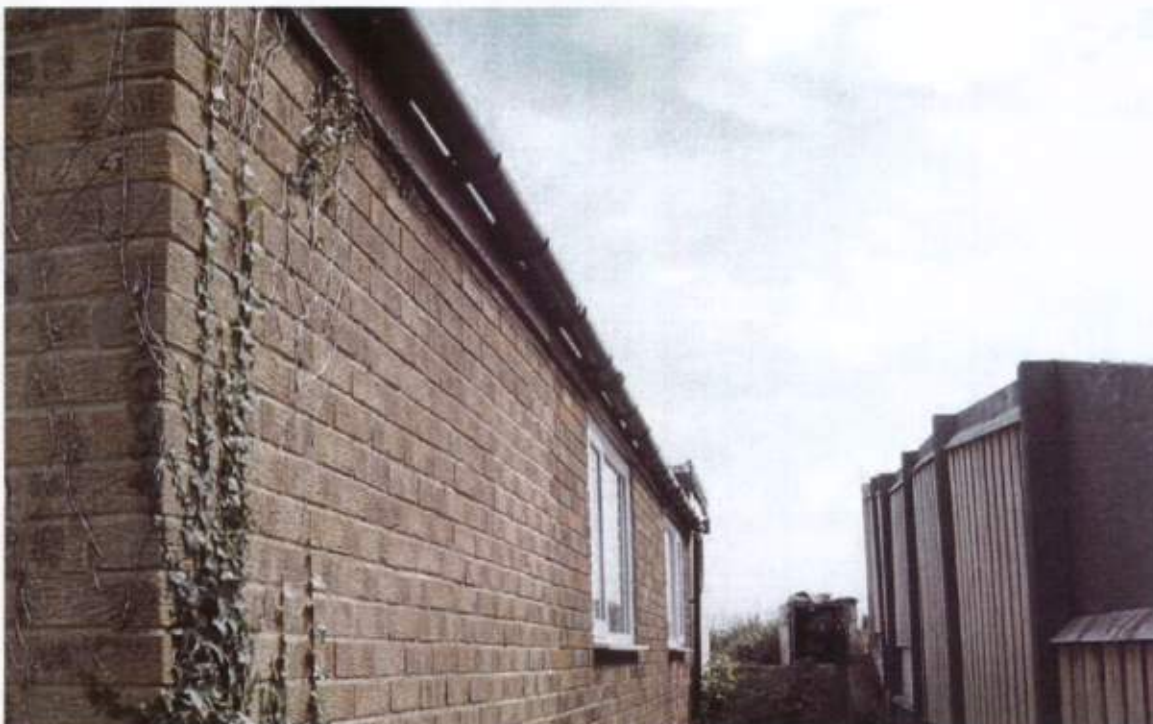
**Photograph No. 3 - South-Western Elevation of Main Building on Site.  
Negligible Nesting opportunities for Swallow or Starling respectively.**

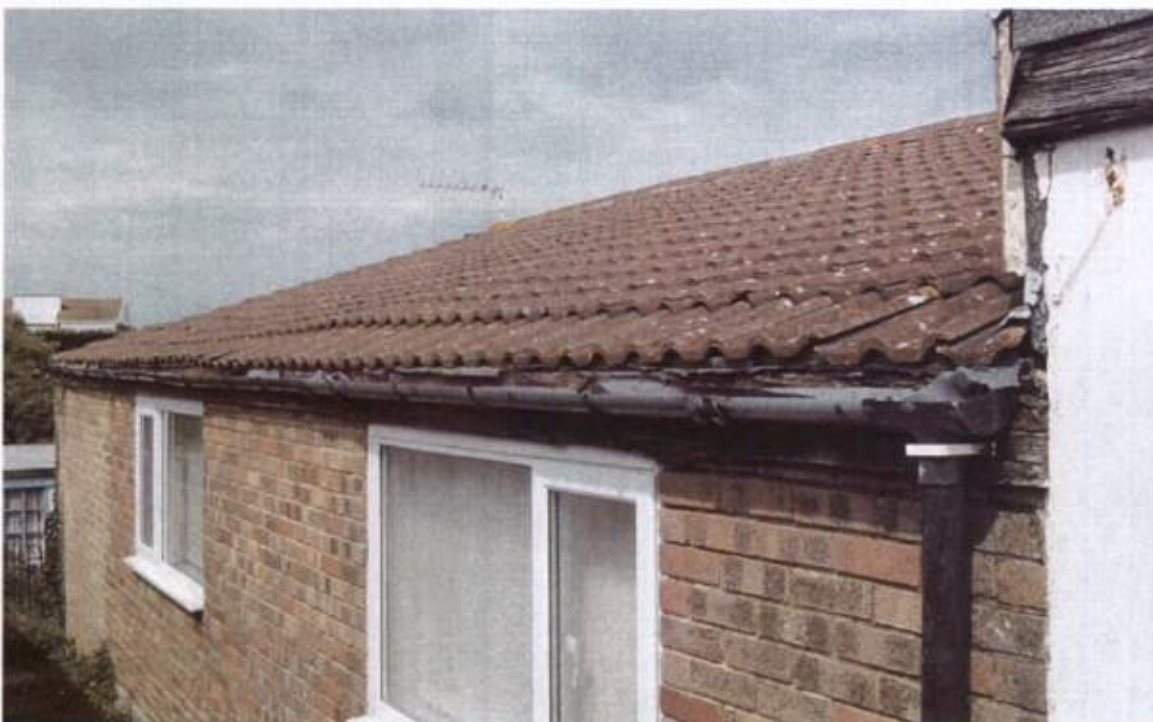
**Photograph No. 4 - South-Western Elevation and Roof of Main Building on Site.  
Negligible Nesting opportunities for Swallow or Starling respectively.**

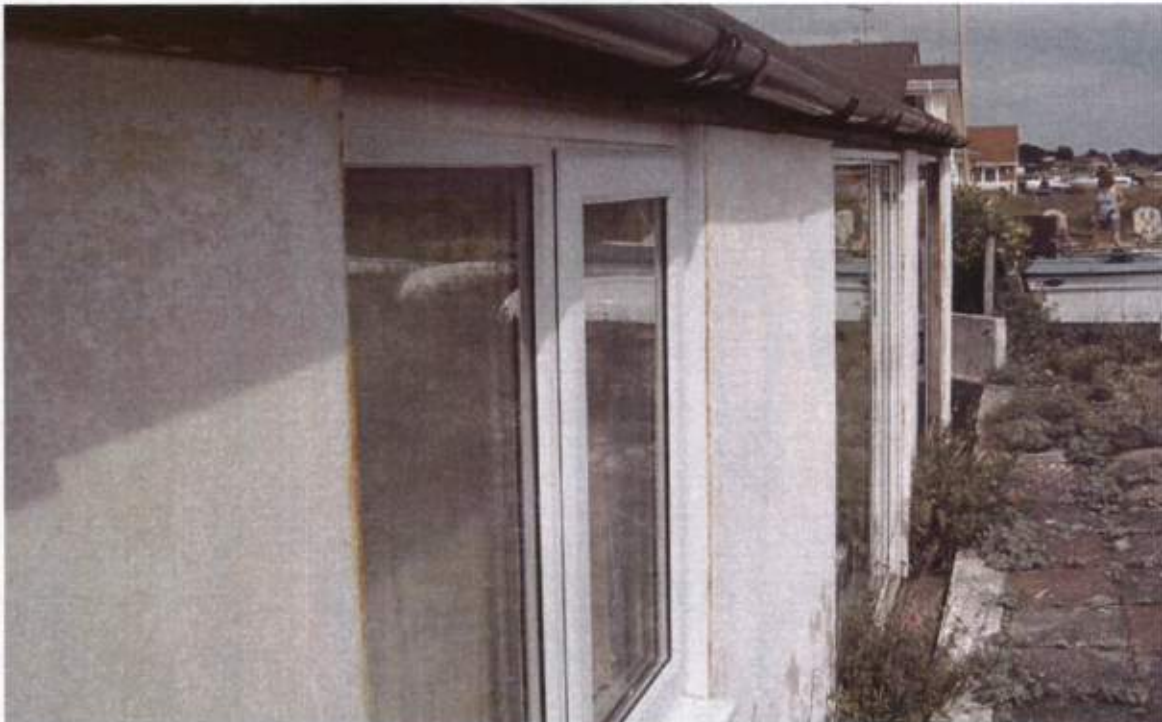
**Photograph No. 5 - South-Eastern Elevation of Main Building on Site. Negligible Nesting opportunities for Swallow or Starling respectively.**

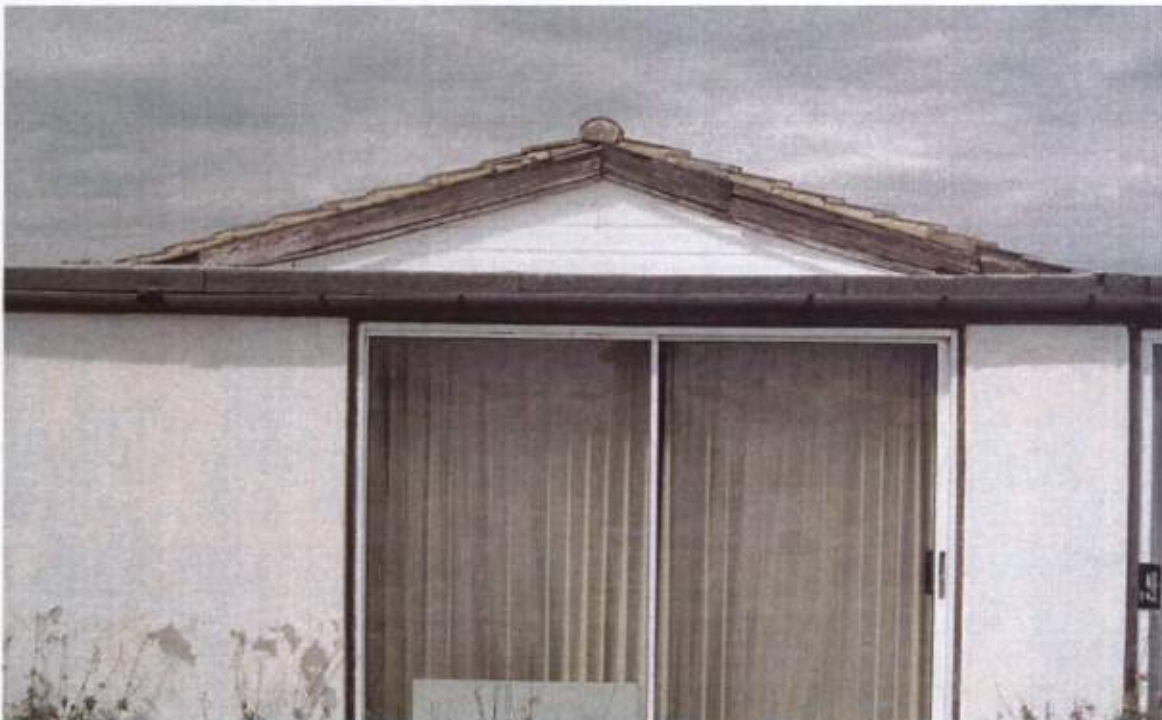
**Photograph No. 6 - South-Eastern Elevation and Roof of Main Building on Site. Negligible Nesting opportunities for Swallow or Starling respectively.**

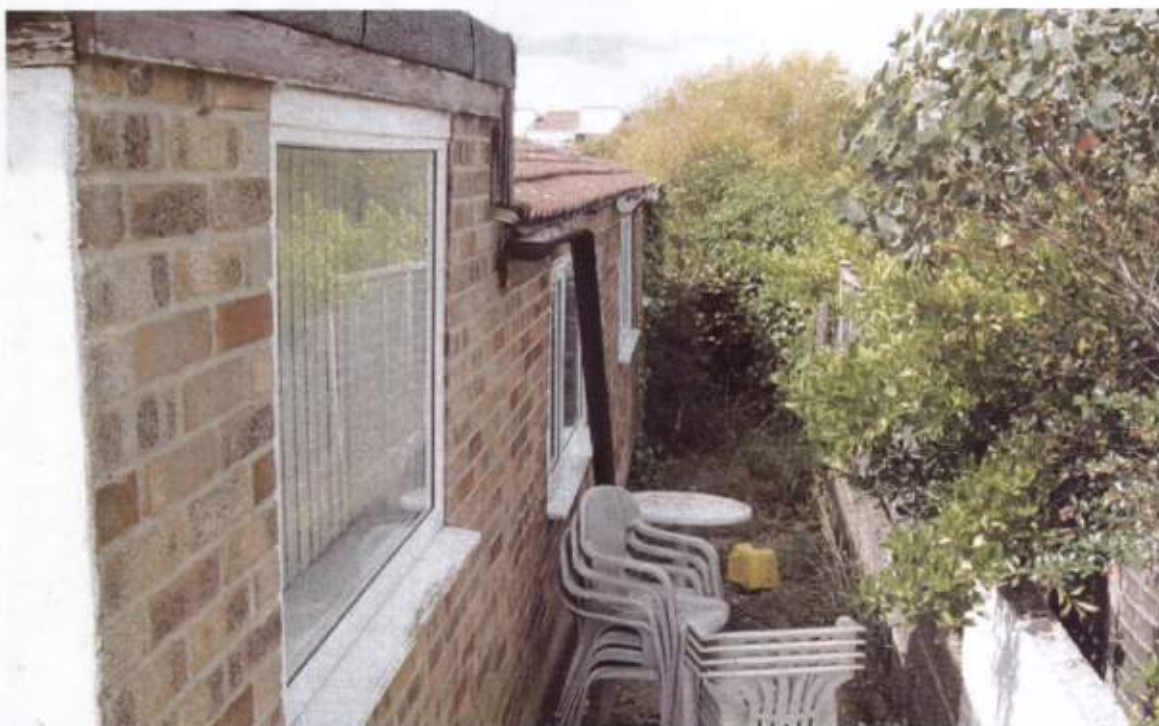
**Photograph No. 7 - North-Eastern Elevation of Main Building on Site. Negligible Nesting opportunities for Swallow or Starling respectively.**

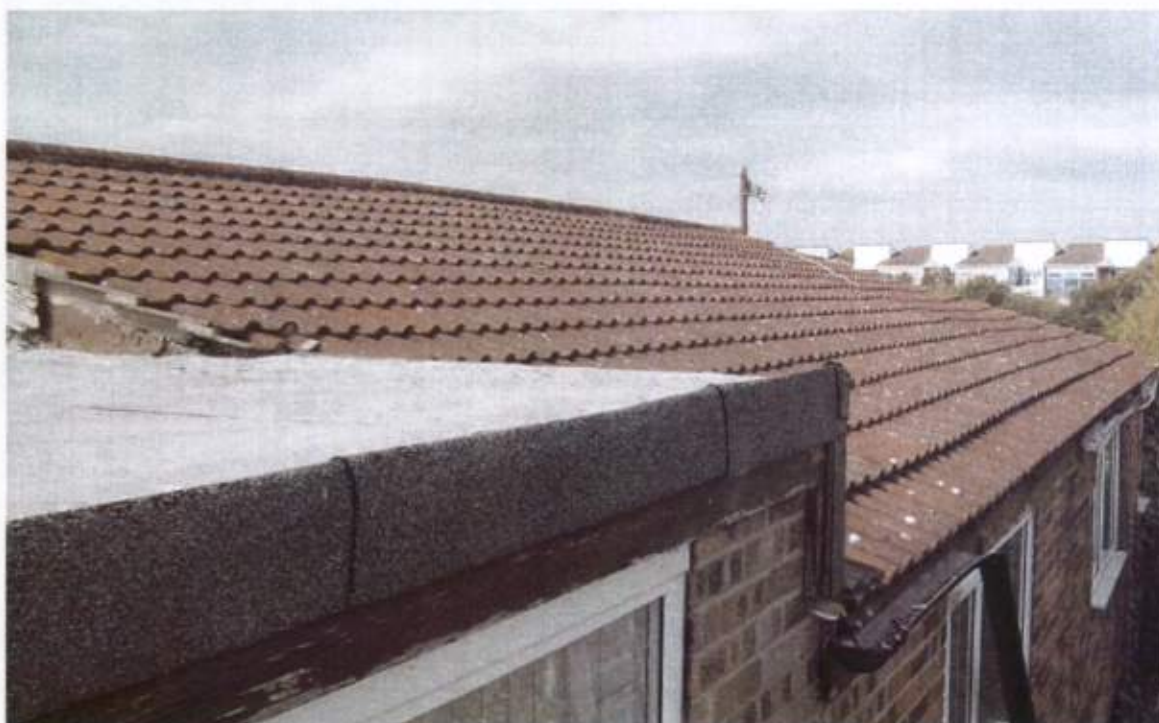
**Photograph No. 8 - North-Eastern Roof of Main Building on Site. Negligible Nesting opportunities for Swallow or Starling respectively.**

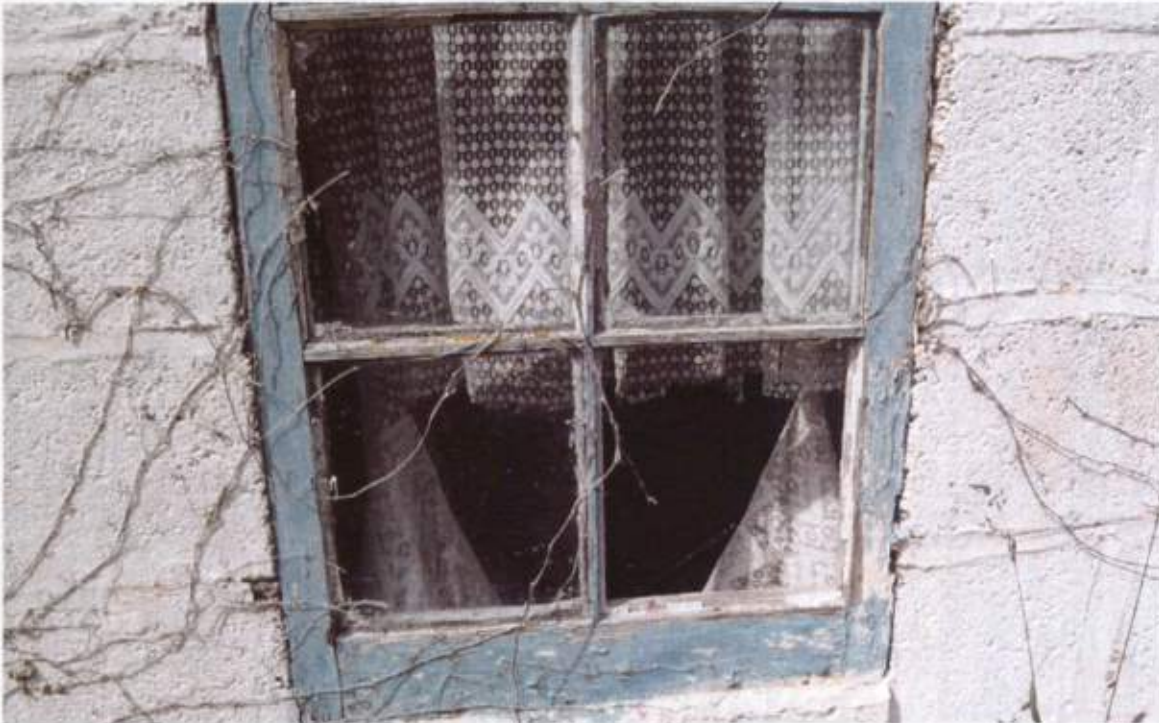
- 3.2 The Garage found to the northern extent of Site has a missing panel of glass on the southern elevation (*refer to Photograph No.9; Appendix No. 1*) that would allow access to the potential nesting opportunities inside. In addition there are sheltered ledges inside the garage on the eastern and western elevations that could be exploited for Nesting by Swallows and Starlings (*refer to Photograph No. 9-10; Appendix No. 1*). The Garage was inaccessible at the time of survey and a detailed inspection was unobtainable however no large accumulations of faeces were seen from the vantage point of the missing panel.

- 3.4 The garage has been designated as having high potential to provide nesting opportunities for Swallows as light levels were low; access was possible and suitable ledges were available.

**Photograph No. 9 - Broken panel allowing access to Nesting space within the Garage on Site. Opening is of a suitable size to allow Birds of either species to enter and exit.**

To create nesting opportunities in a garage or outhouse it is recommended:

- Create a small opening (*min. 50 mm high & 70 mm wide*) under the eaves.
- Fix a nest platform where you would like them to nest, high in the building, out of the reach of cats. Swallow nests can be purchased from the Royal Society for the Protection of Birds (*RSPB*).

- Place a plastic bag below the nest to catch droppings and block off sites where you don't want nesting to occur, for example by attaching polythene to a beam, then to the roof and back to the beam again

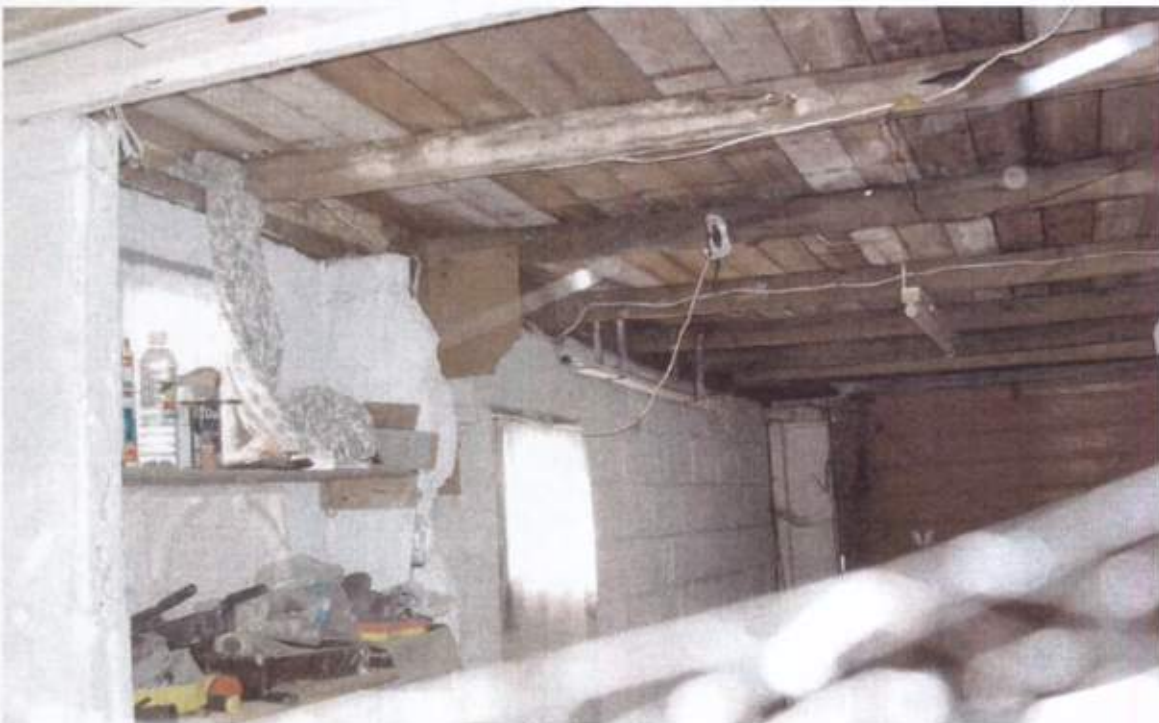
- 3.3 These conditions may be appealing to Swallows however the behaviour of Starlings negates much of the potential observed. Starlings form large roosts at

night (*Holden and Cleeves 2006*) and the amount of space and lack of significant faecal deposits suggests this is not used as such.

**Photograph No. 10 - Potential space for Nesting Swallows found at juncture of Wall and Roof in Garage on Site. Potential space for Nesting Starlings on ledges found to the Northern end of Garage found on Site.**

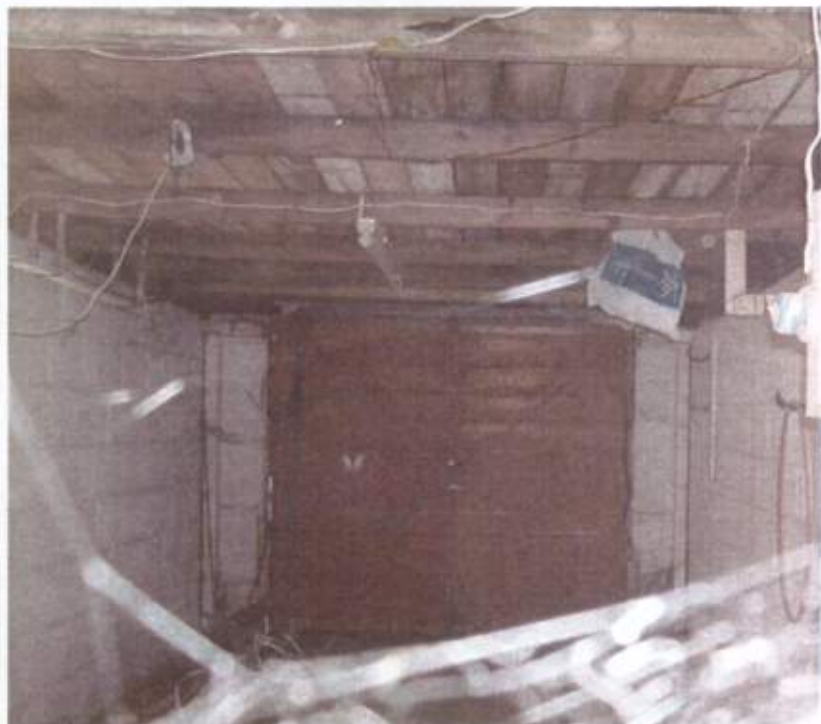
**Photograph No. 11 - Potential space for Nesting Swallows found at juncture of Wall and Roof in Garage on Site. Potential space for Nesting Starlings on ledges found to the Northern end of Garage found on Site.**

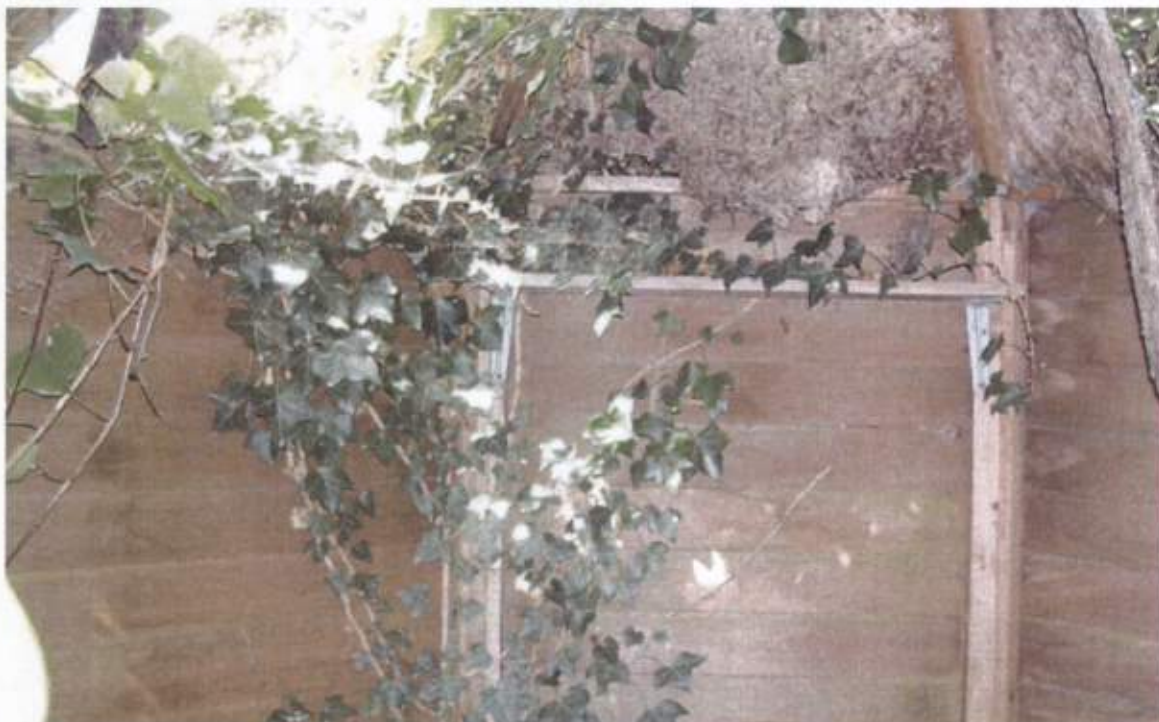
- 3.6 There were numerous opportunities for Swallows to construct a nest in the octagonal shed found at the northern end of Site (*refer to Photographs 12-14*). Access to the structure was limited at the time of survey although a partial view was possible. No direct evidence such as old nests or eggs were seen in the structure. The nesting potential has been designated as having *medium potential*.

**Photograph No. 12 - Potential Nesting Space for Swallows at juncture of Wall and Roof in Octagonal Shed found at Northern End of Site.**

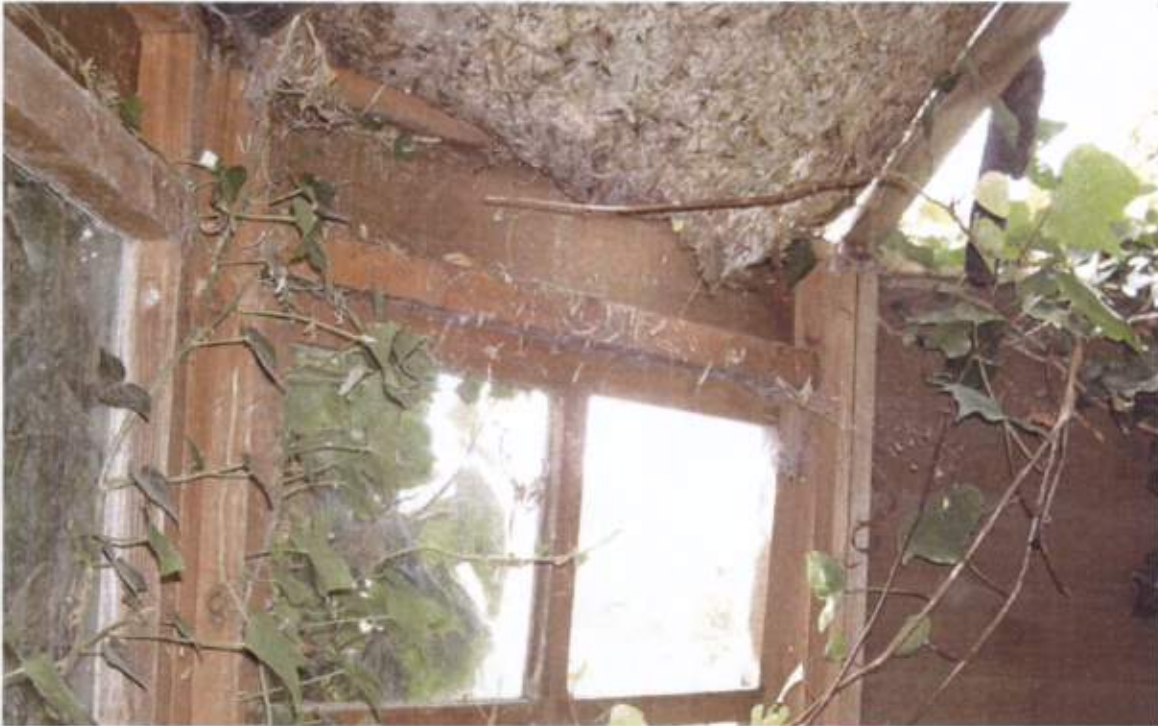
**Photograph No. 13 - Potential Nesting Space for Swallows at juncture of Wall and Roof in Octagonal Shed found at Northern End of Site.**

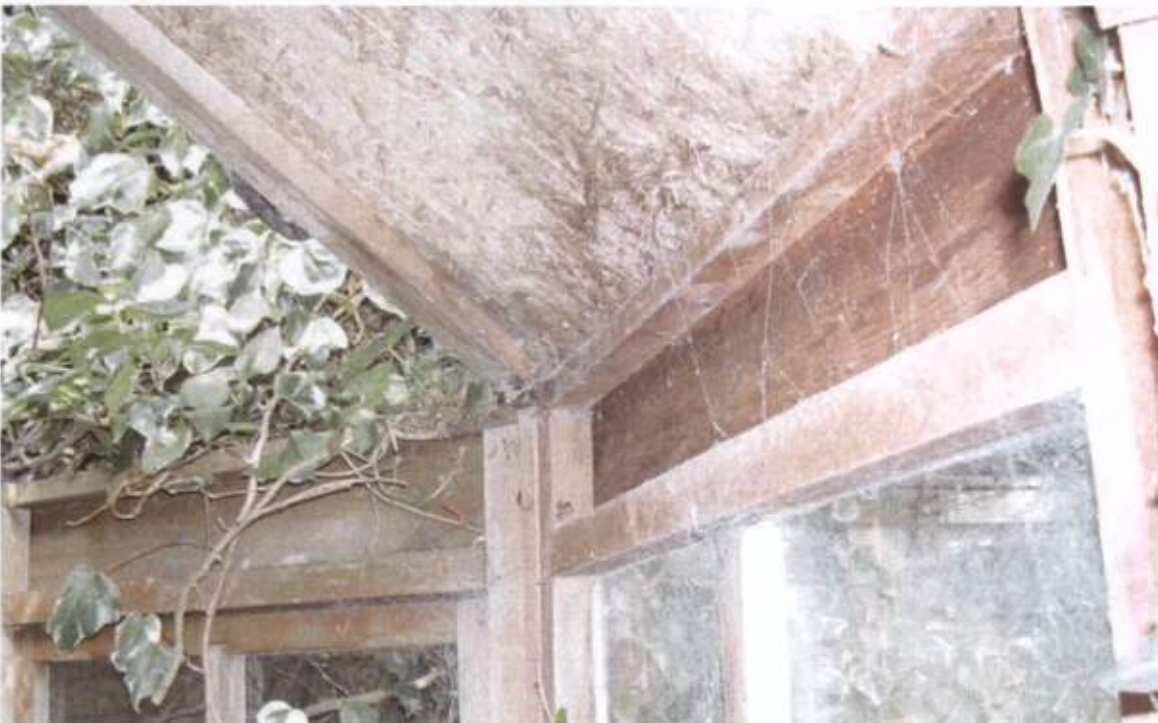
**Photograph No. 14 - Potential Nesting Space for Swallows at juncture of Wall and Roof in Octagonal Shed found at Northern End of Site.**
