## Church Farm, Pagham – Supply new & re-locate Show Bar AHU (PLAN VIEW)

## Church Farm, Pagham – Supply new & re-locate Show Bar AHU (ELEVATION 1 of 2)

## Church Farm, Pagham – Supply new & re-locate Show Bar AHU (ELEVATION 2 of 2)

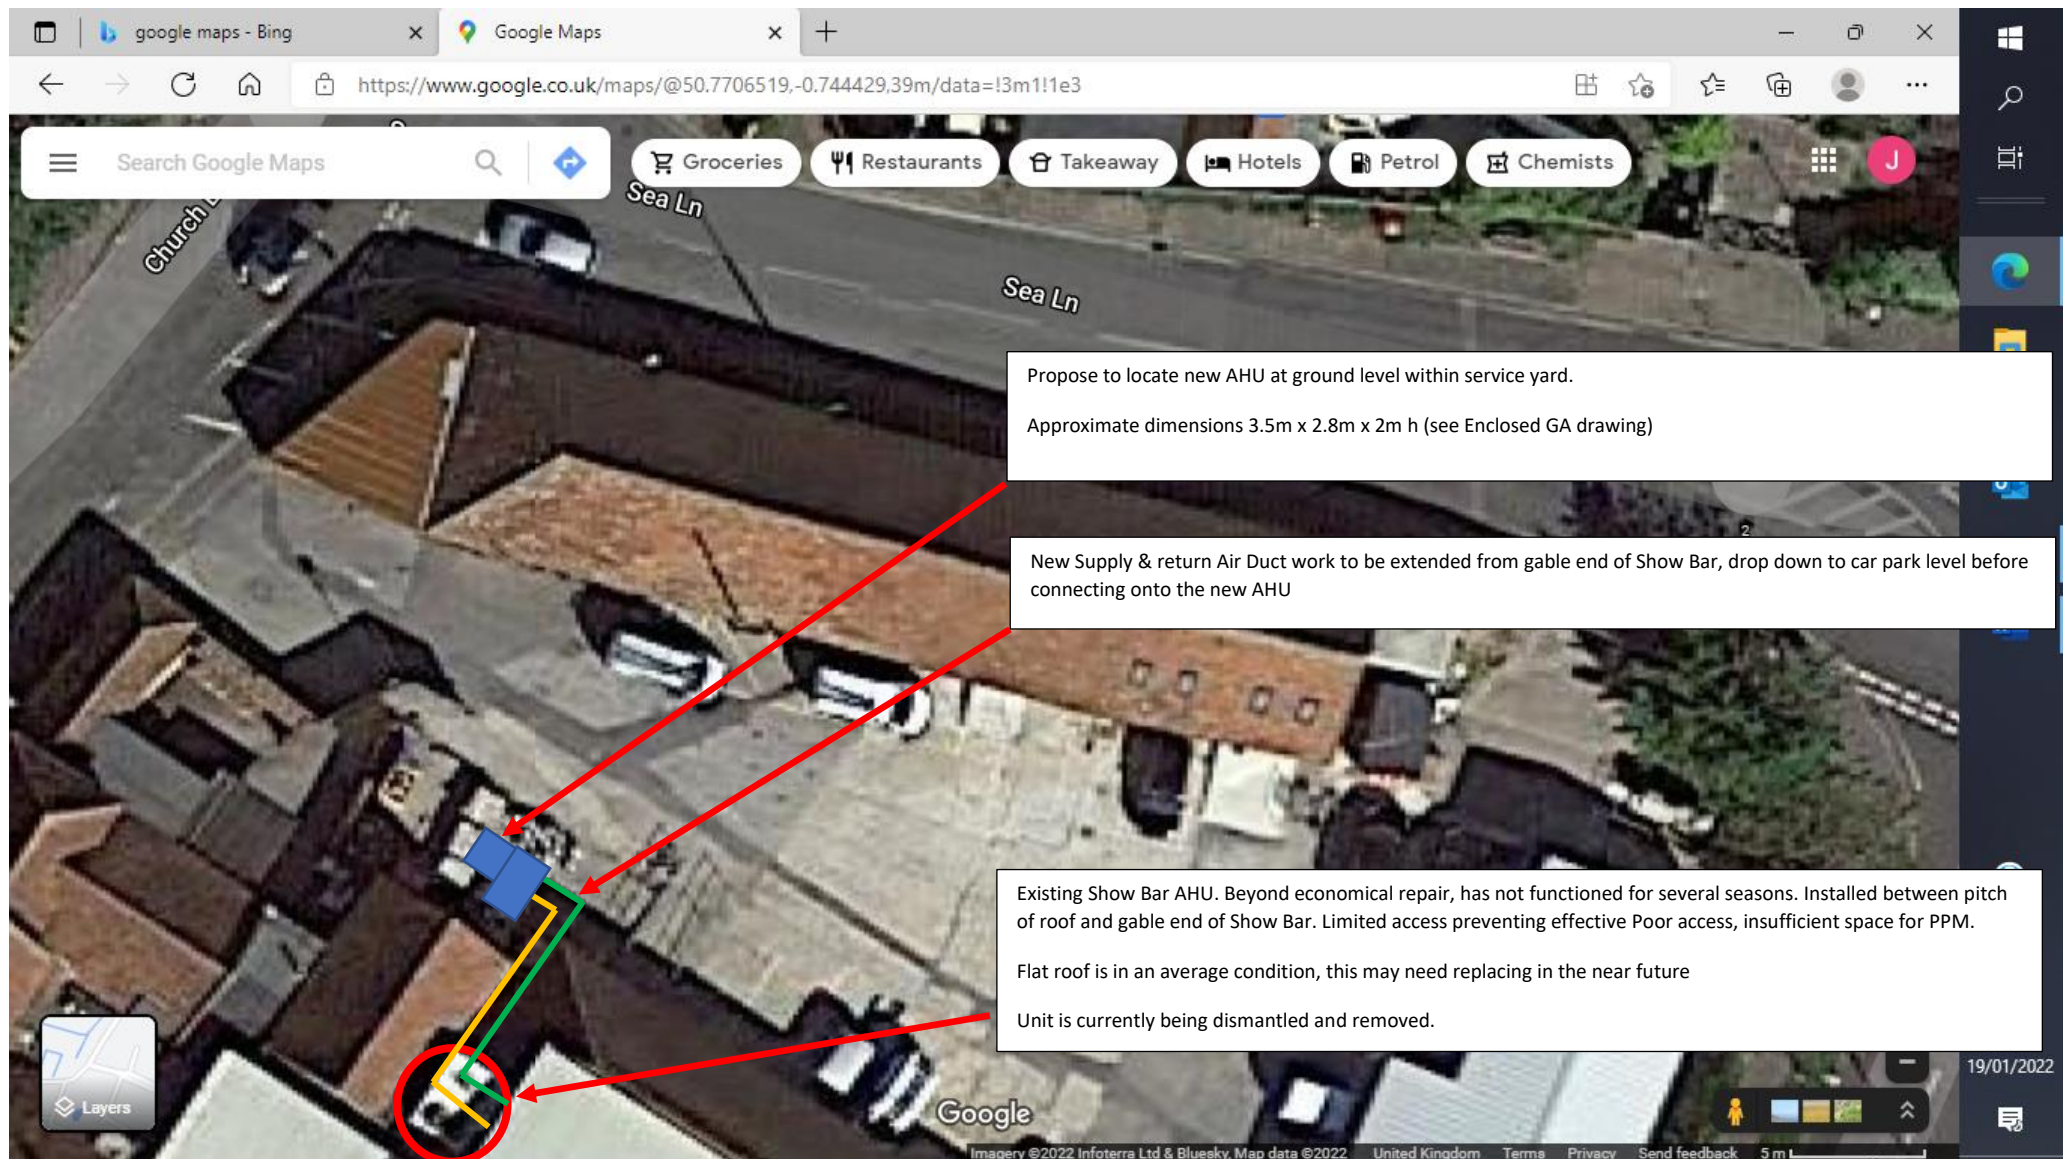
Propose to locate new AHU at ground level within service yard.

Approximate dimensions 3.5m x 2.8m x 2m h (see Enclosed GA drawing)

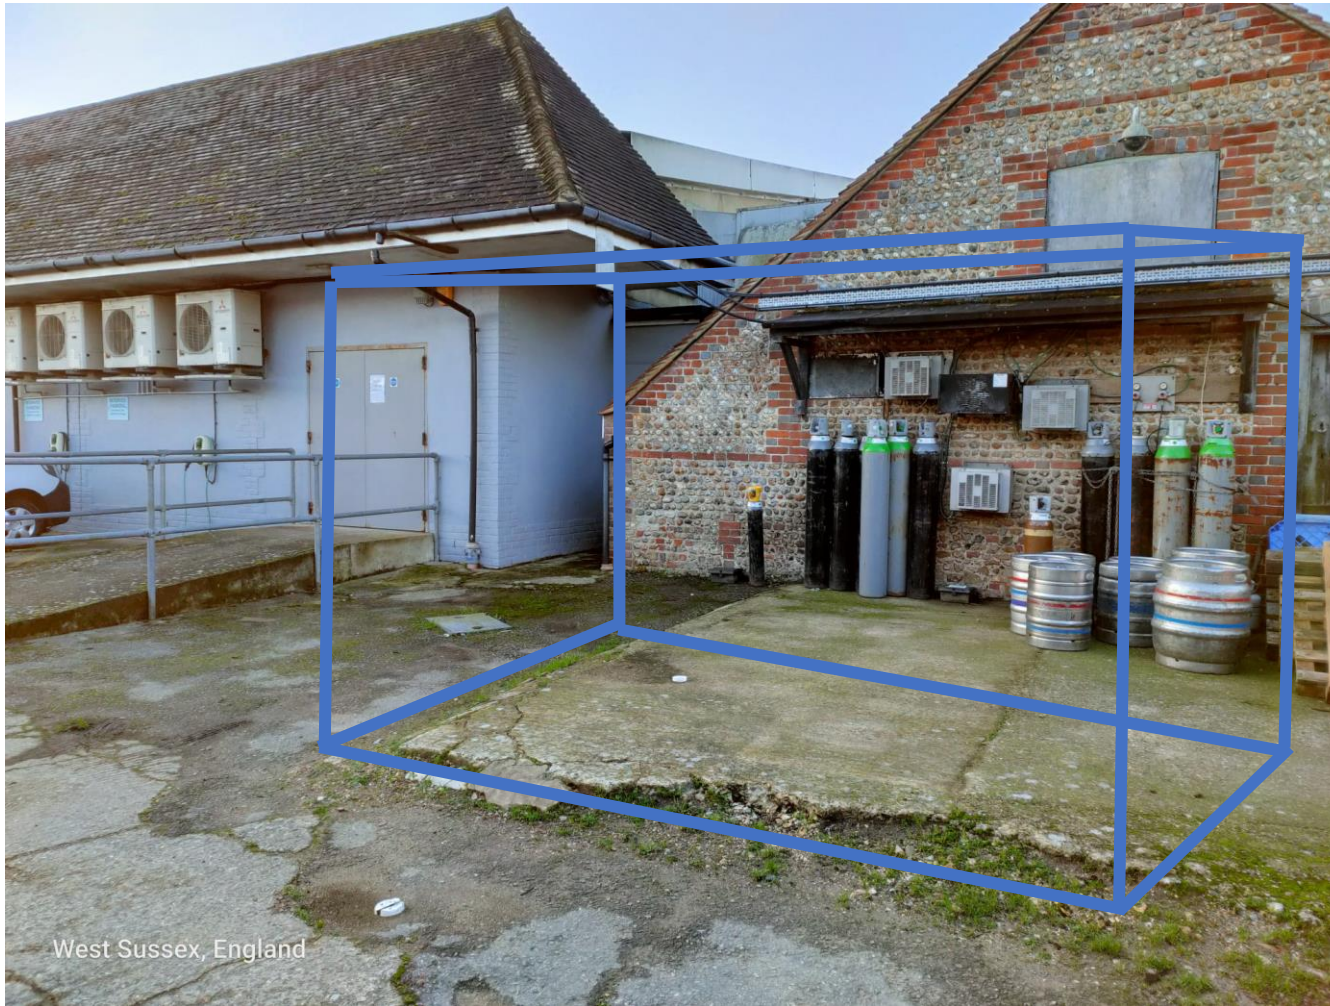
Illustration – to provide idea and approximate location and visualisation of proposed unit

New Base to be constructed to provide level surface for AHU to be sat upon

New Supply & return Air Duct work to be extended from gable end of Show Bar, drop down to car park level before connecting onto the new AHU

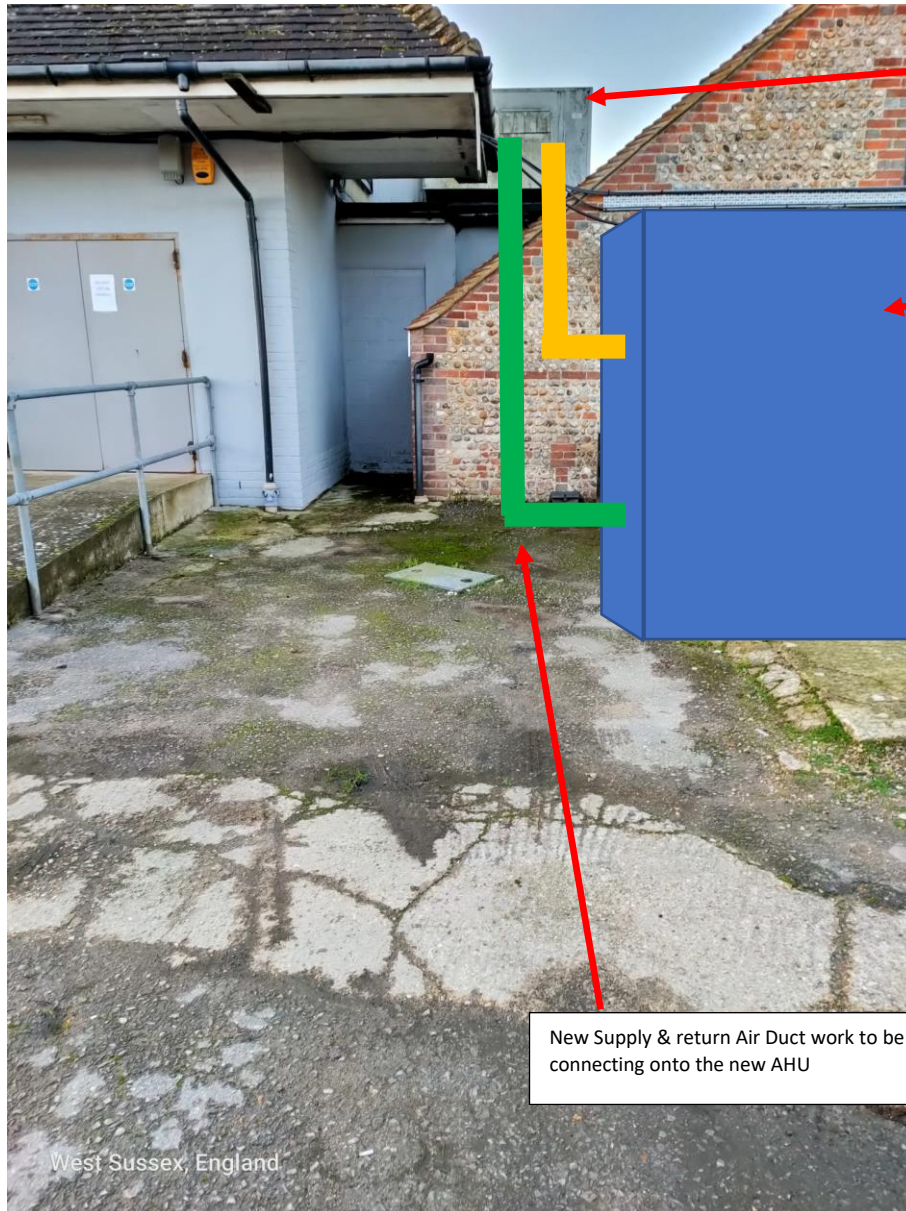
Existing Show Bar AHU. Beyond economical repair, has not functioned for several seasons. Installed between pitch of roof and gable end of Show Bar. Limited access preventing effective Poor access, insufficient space for PPM.

Flat roof is in an average condition, this may need replacing in the near future

Unit is currently being dismantled and removed.
