Our Ref: 305035 L01 (01)

16<sup>th</sup> July 2019

**RE: SEFTER ROAD, BOGNOR REGIS, PO21 3EE  
SUPPLEMENTARY HYDROGEOLOGICAL SITE ASSESSMENT**

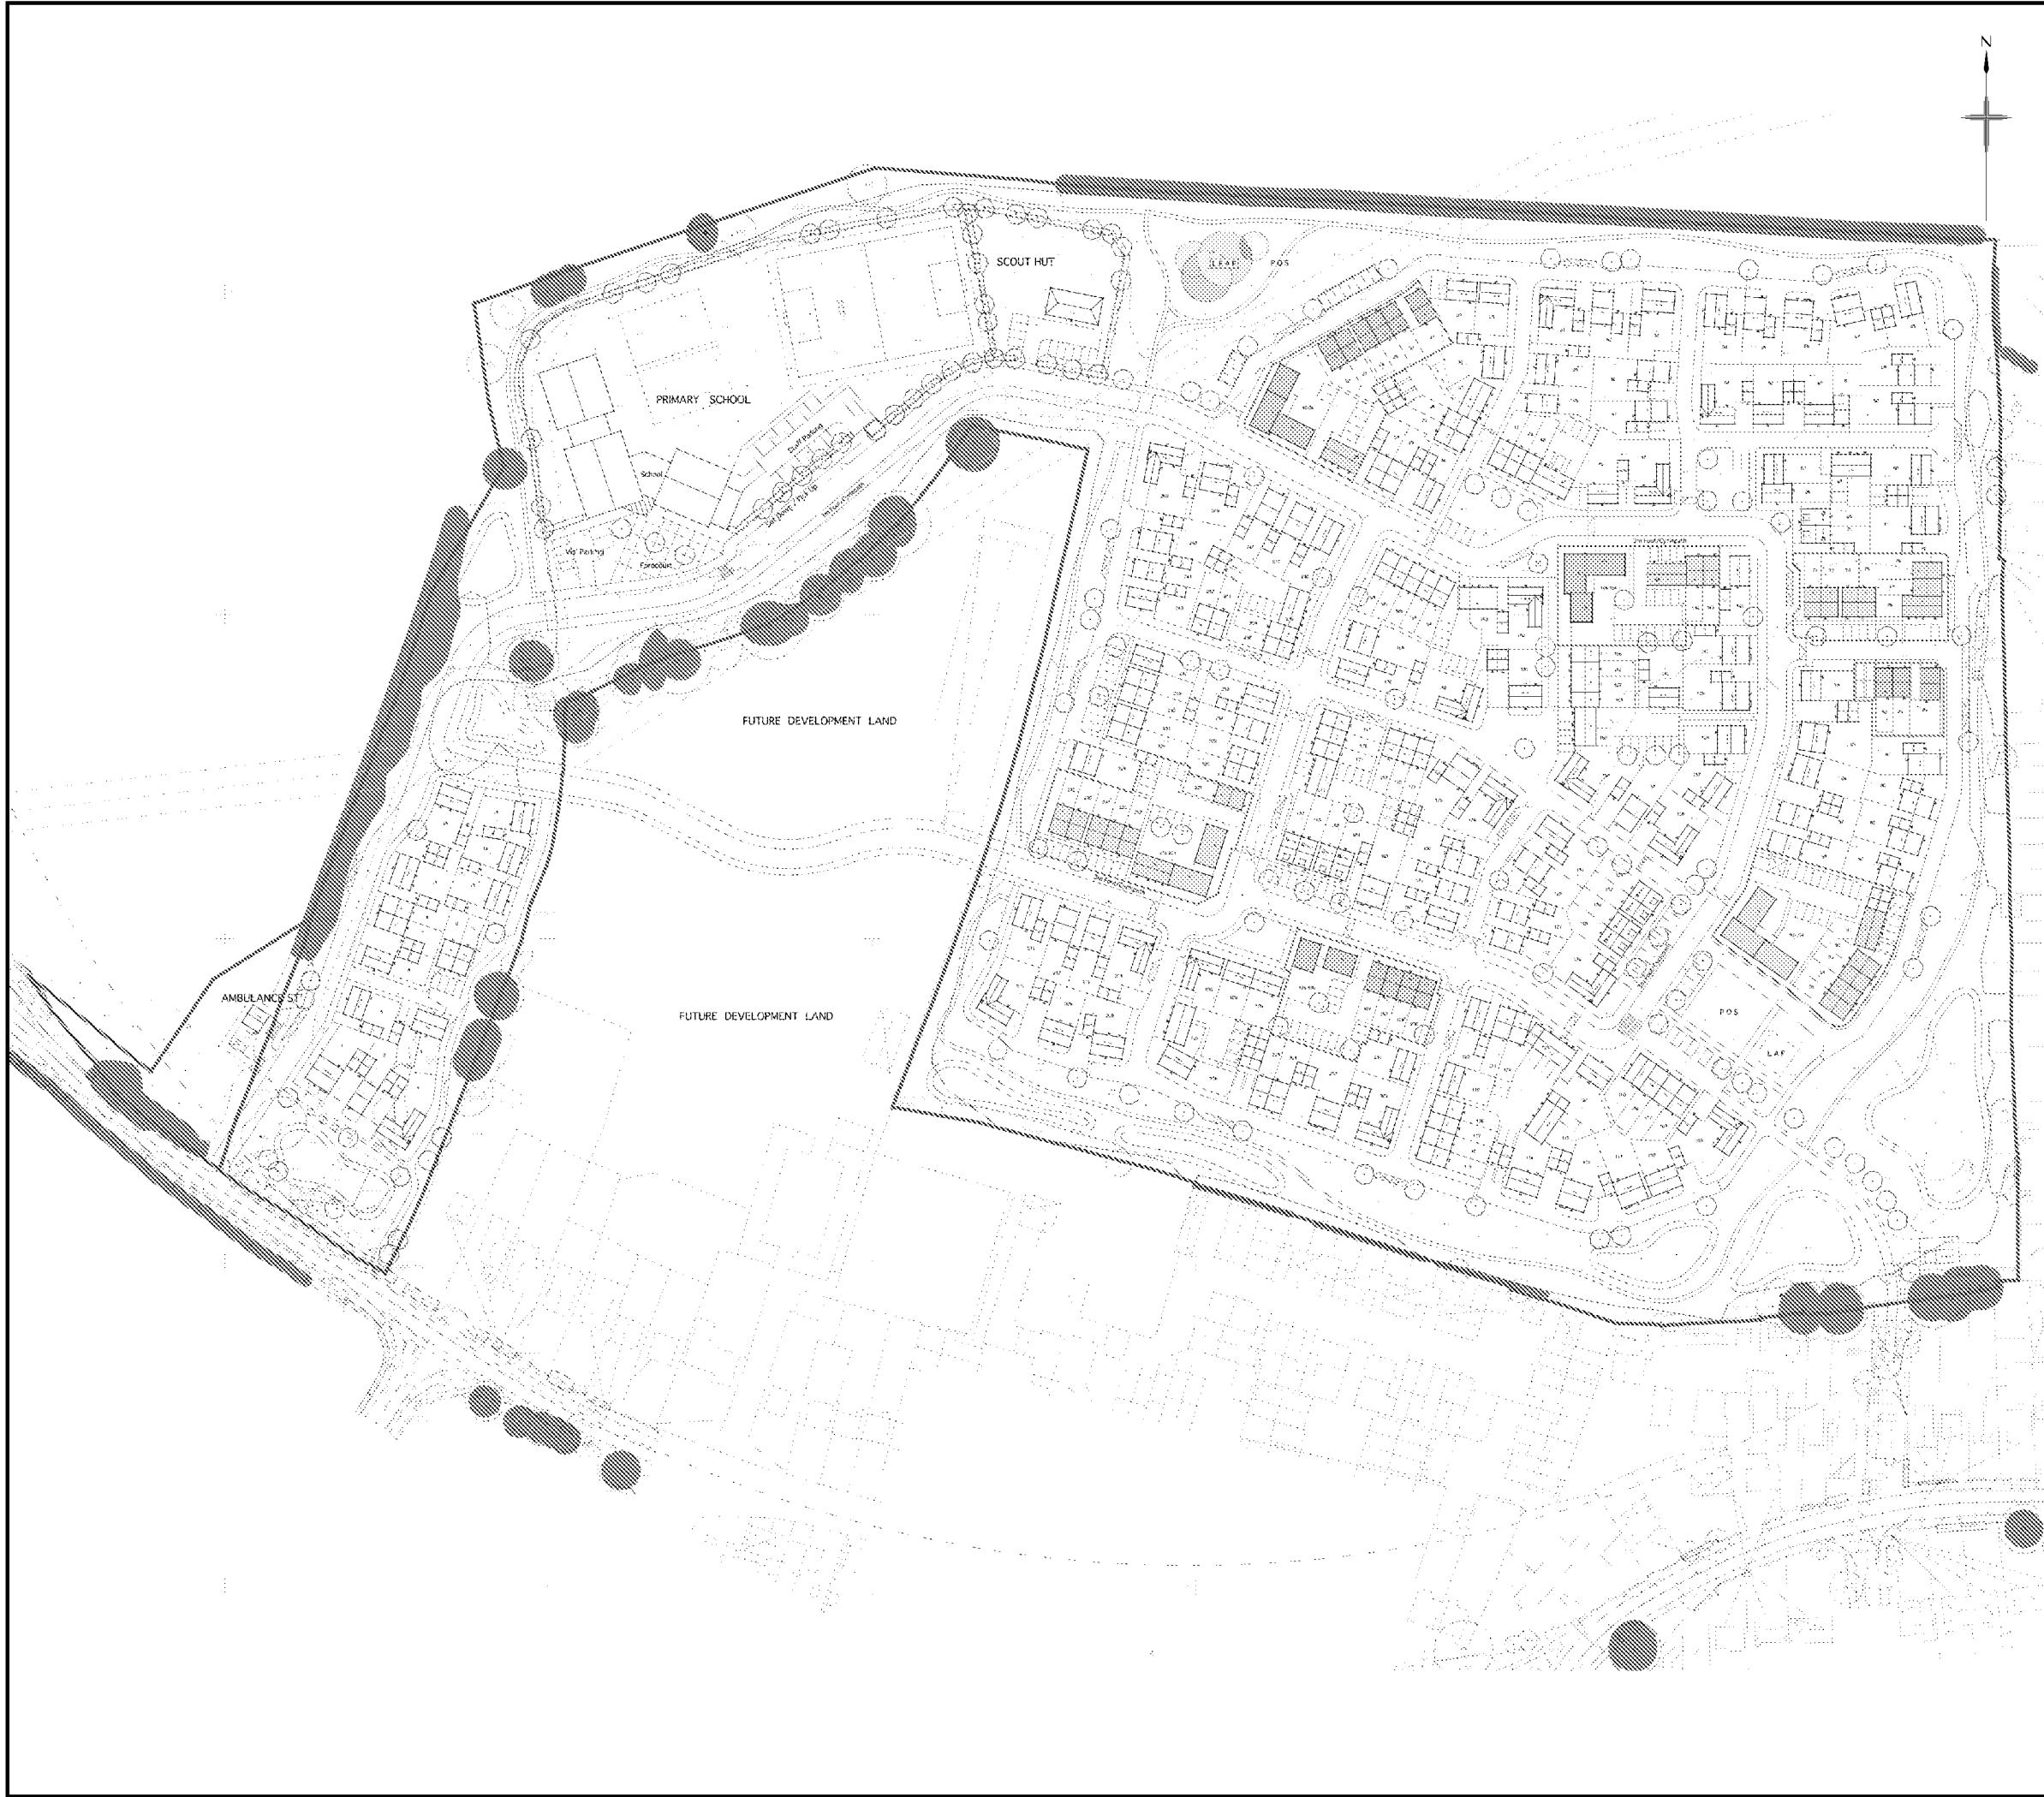
| FIGURE 2 | P1 |

It is understood that Arun District Council (ADC) requested further information relating to the potential for infiltration drainage to be utilised as far as possible in the proposed development strategy. Rogers Cory Partnership Ltd (RCP) – on behalf of Taylor Wimpey – scoped an additional intrusive ground investigation comprising a further 23 trial pit soakaway tests and 11 groundwater monitoring well installations, followed by twice-monthly groundwater monitoring visits from completion of the site works until the end of April. Of the 23 trial pit soakaway tests, it was initially proposed that 15 locations were to be to c. 1.5 mbgl (or groundwater level if shallower) and 8 locations were to be to c. 0.5 mbgl, however due to shallow groundwater conditions, only 11 locations could be completed to c. 1.5 mbgl, with 12 locations completed to c. 0.5 mbgl, as detailed in **Section 3**. The positions of all new locations in addition to those from previous investigations are given in **Figure 2**. All new locations were surveyed to Ordnance Datum by GPS, with this data shown in **Appendix B**.

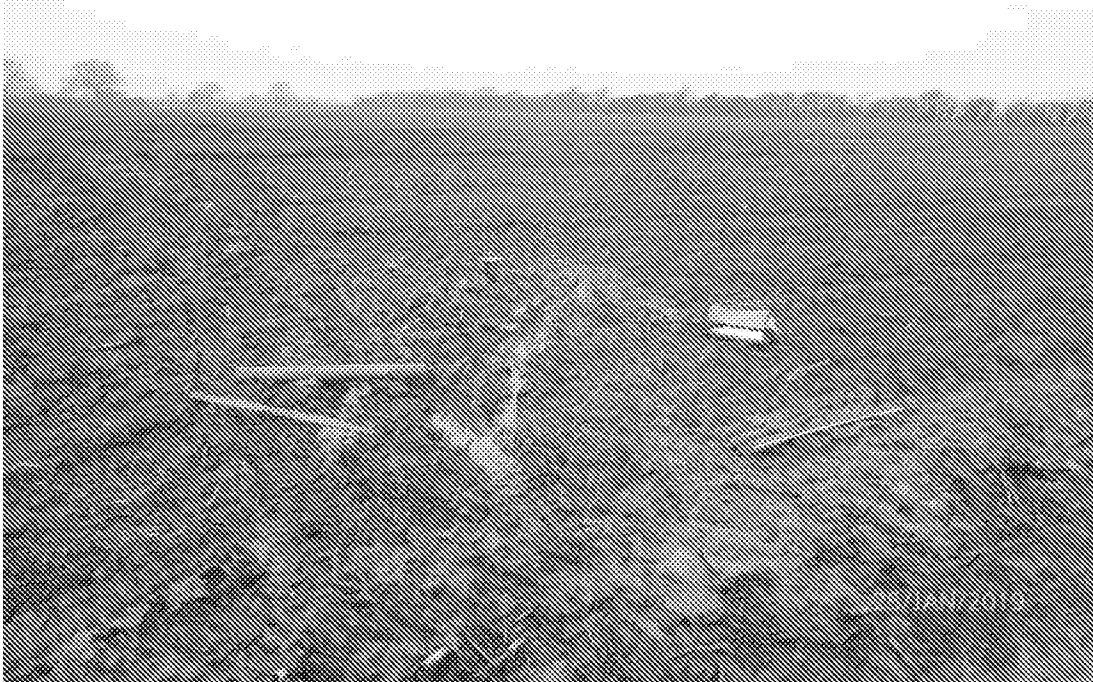
| PHOTOGRAPHIC LOG | | 305035 L01 (00) |
|---|---|---|
| <b>Photo No.</b><br>1 | | |

| PHOTOGRAPHIC LOG | | 305035 L01 (00) |
|---|---|---|
| Facing northwest, overview of BH206 | | |

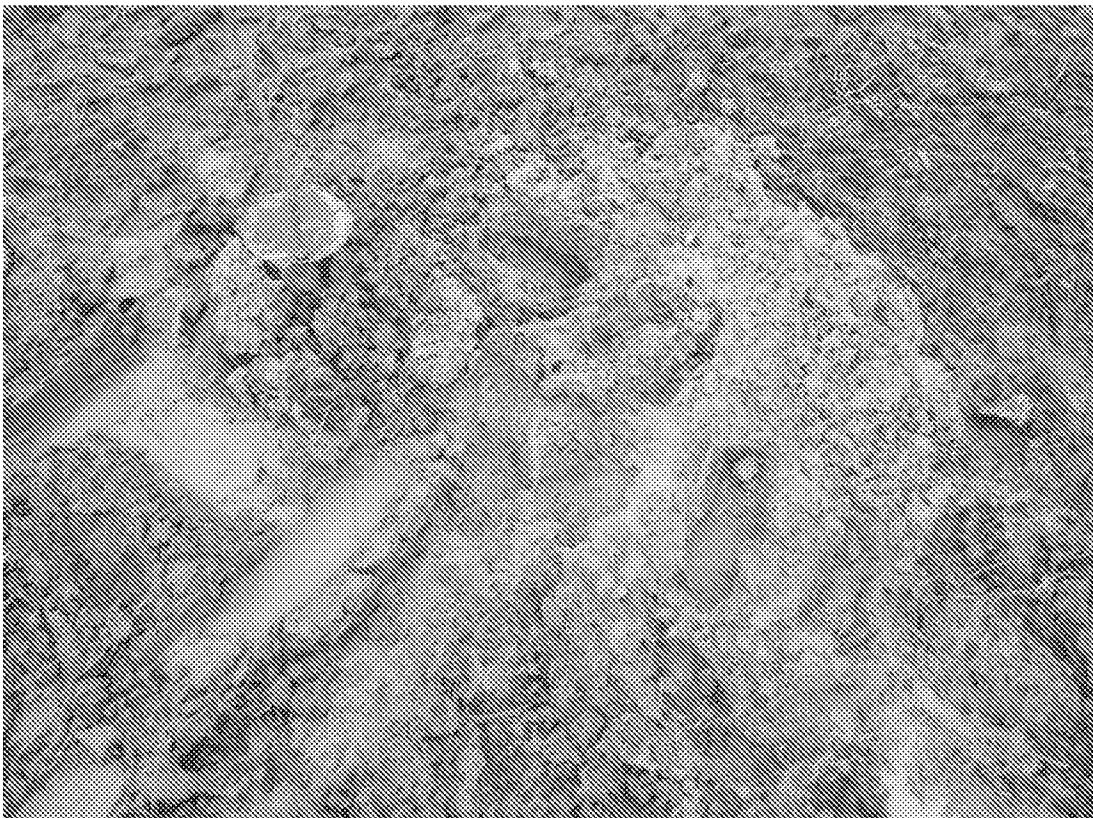
| PHOTOGRAPHIC LOG | | 305035 L01 (00) |
|---|---|---|
| <b>Photo No.</b><br>2 | | |

| PHOTOGRAPHIC LOG | | 305035 L01 (00) |
|---|---|---|
| BH206 hand pit arisings | | |

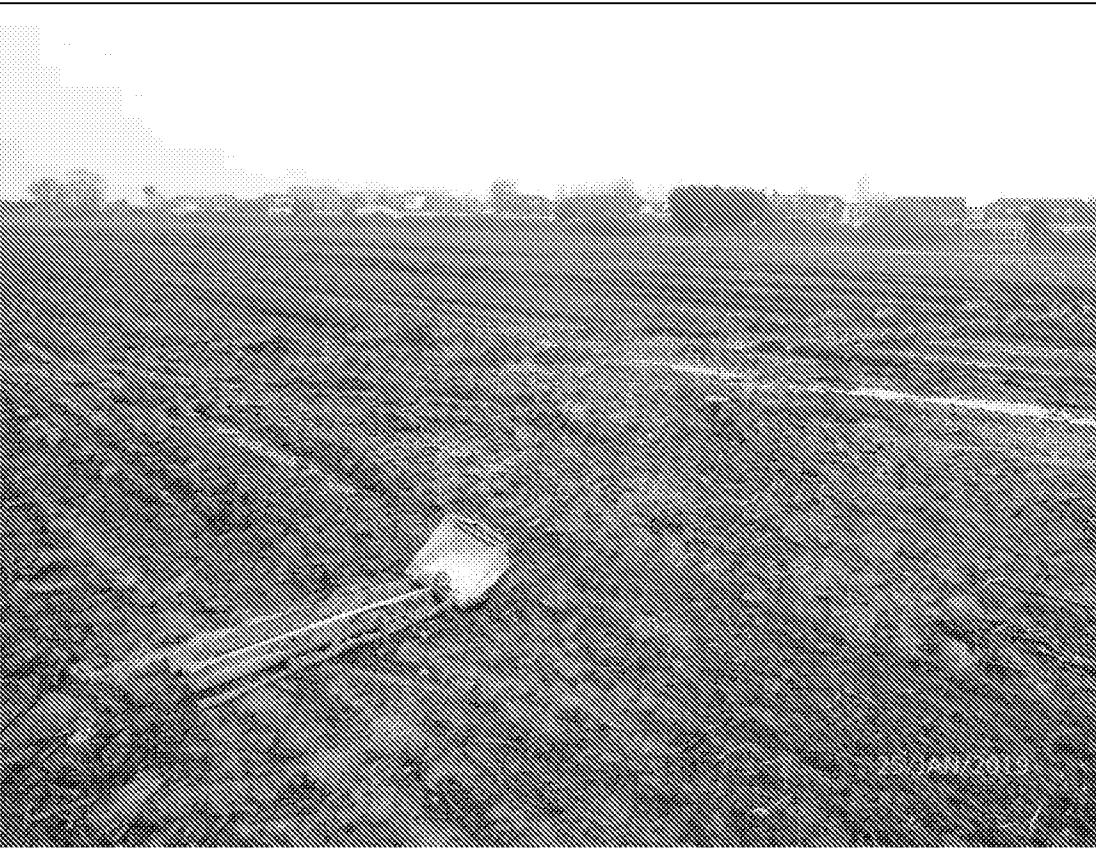
| PHOTOGRAPHIC LOG | | 305035 L01 (00) |
|---|---|---|
| <b>Photo No.</b><br>4 | | |

| PHOTOGRAPHIC LOG | | 305035 L01 (00) |
|---|---|---|
| Facing<br>northeast,<br>overview of<br>BH207 | | |

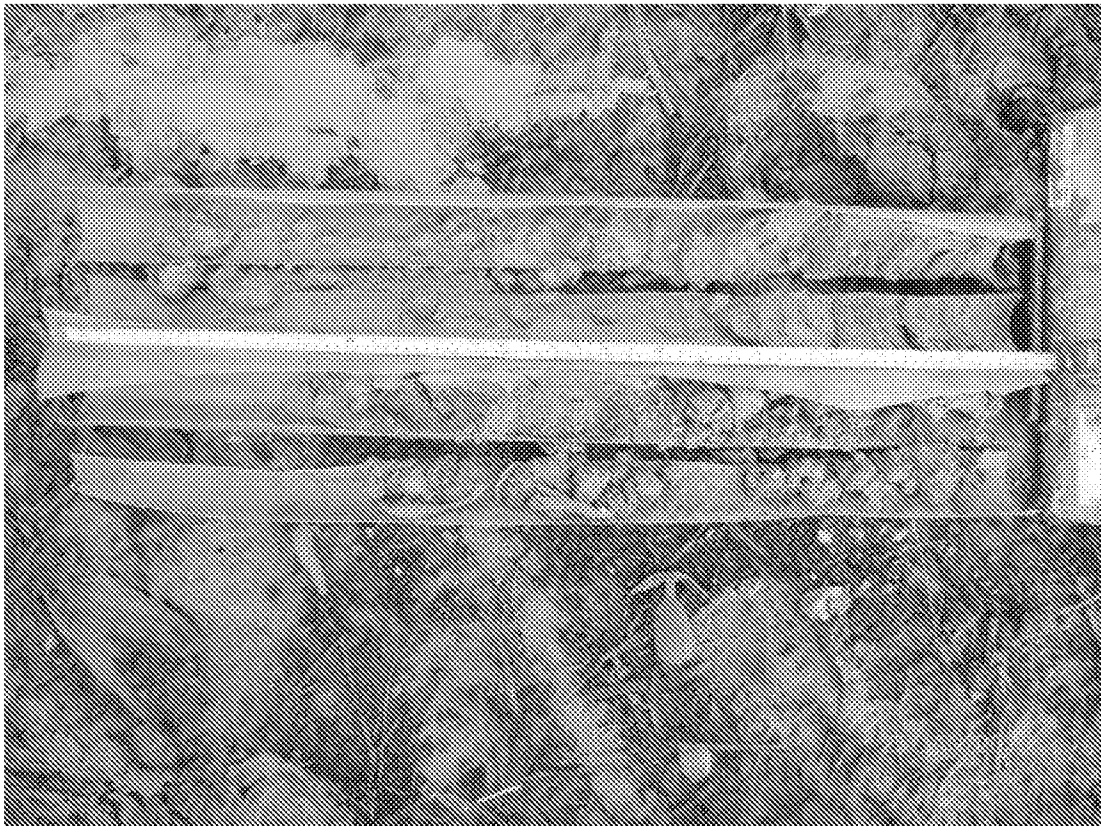
| PHOTOGRAPHIC LOG | | 305035 L01 (00) |
|---|---|---|
| <b>Photo No.</b><br>5 | | |

| PHOTOGRAPHIC LOG | | 305035 L01 (00) |
|---|---|---|
| BH207 core<br>soils recovery:<br>1. 2-3 m (L-R)<br>2. 1-2 m (L-R) | | |

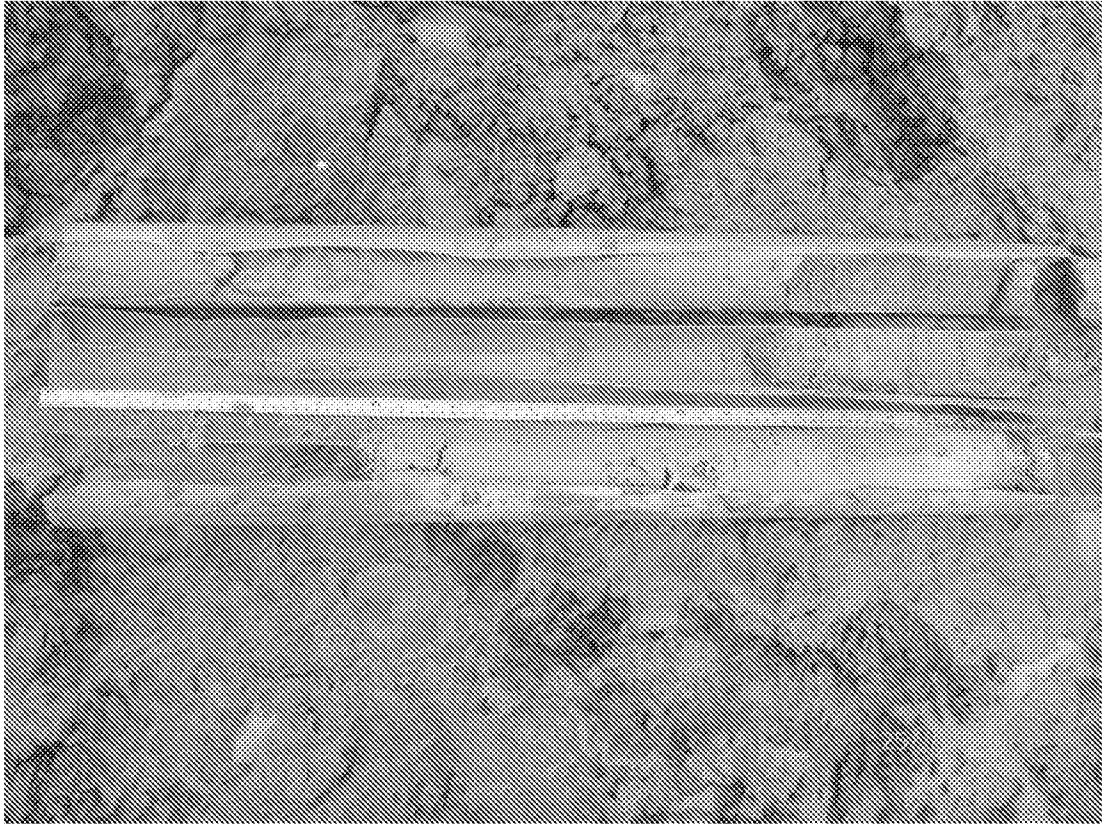
| PHOTOGRAPHIC LOG | | 305035 L01 (00) |
|---|---|---|
| <b>Photo No.</b><br>7 | | |

| PHOTOGRAPHIC LOG | | 305035 L01 (00) |
|---|---|---|
| BH208 core<br>soils recovery:<br>1. 2-3 m (L-R)<br>2. 1-2 m (L-R) | | |

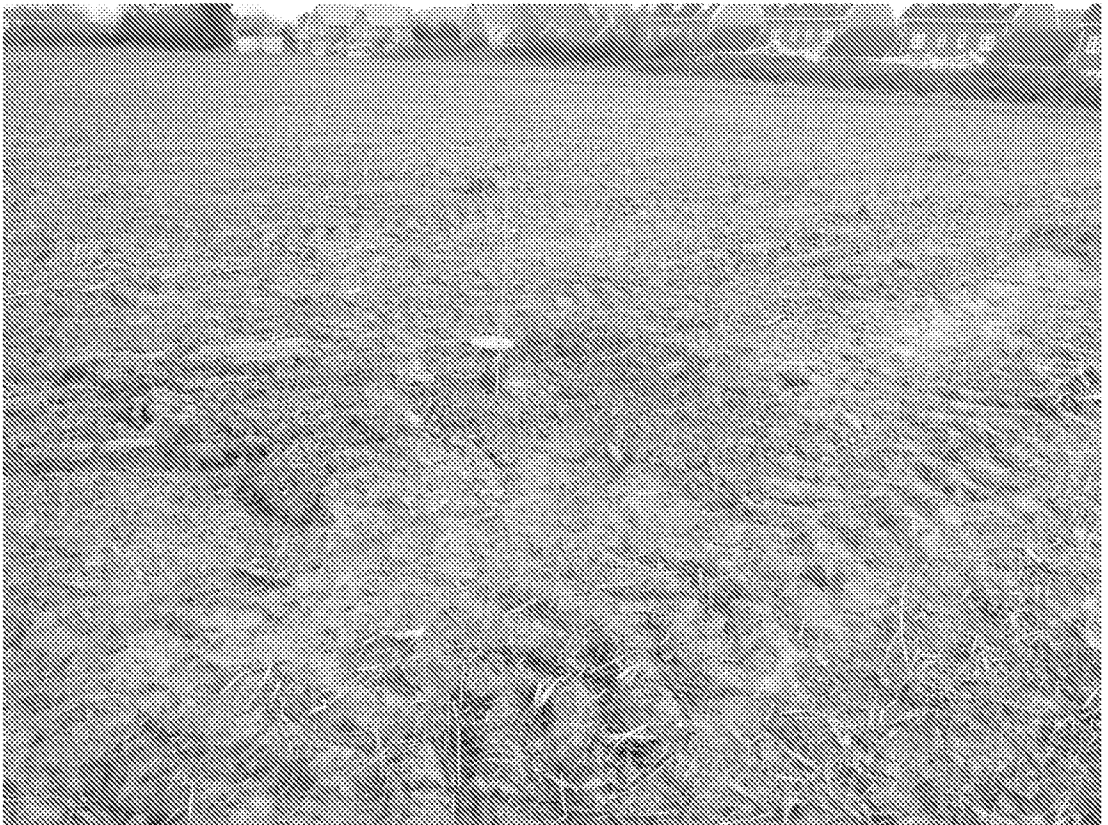
| PHOTOGRAPHIC LOG | | 305035 L01 (00) |
|---|---|---|
| <b>Photo No.</b><br>8 | | |

| PHOTOGRAPHIC LOG | | 305035 L01 (00) |
|---|---|---|
| Facing<br>northeast,<br>overview of<br>BH209 | | |

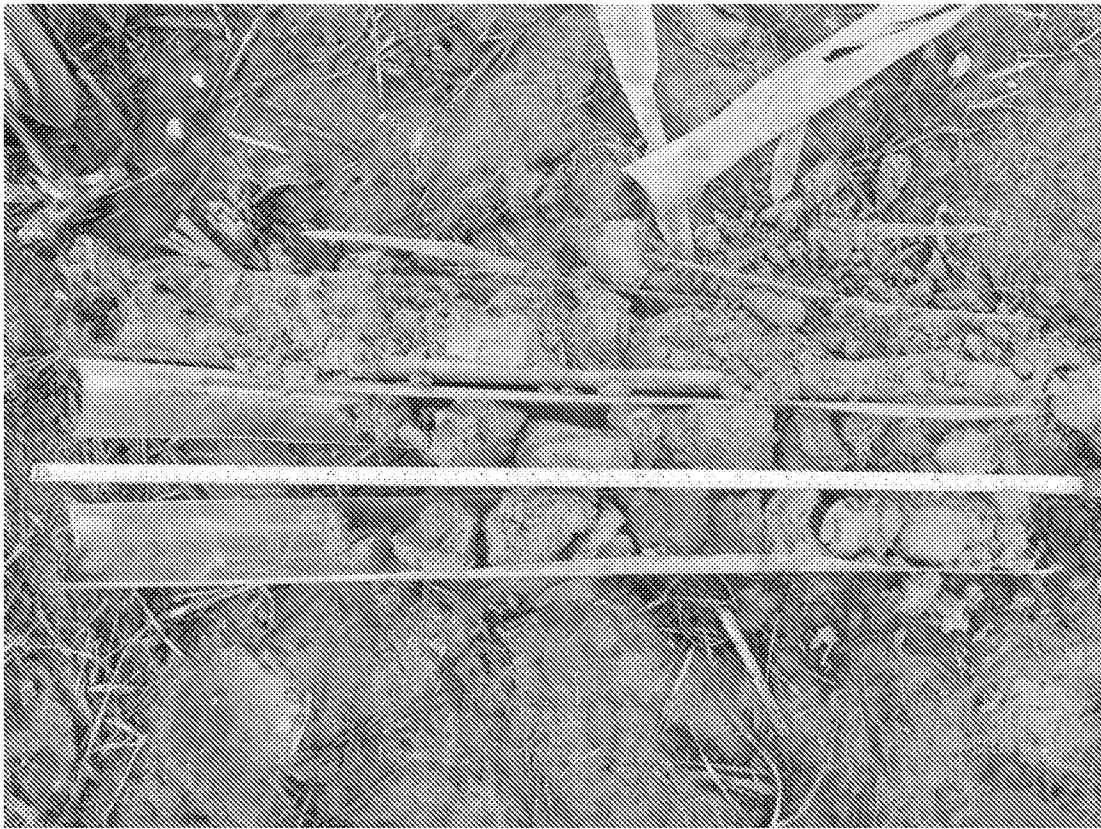
| PHOTOGRAPHIC LOG | | 305035 L01 (00) |
|---|---|---|
| <b>Photo No.</b><br>9 | | |

| PHOTOGRAPHIC LOG | | 305035 L01 (00) |
|---|---|---|
| BH209 core<br>soils recovery:<br>1. 2-3 m (L-R)<br>2. 1-2 m (L-R) | | |

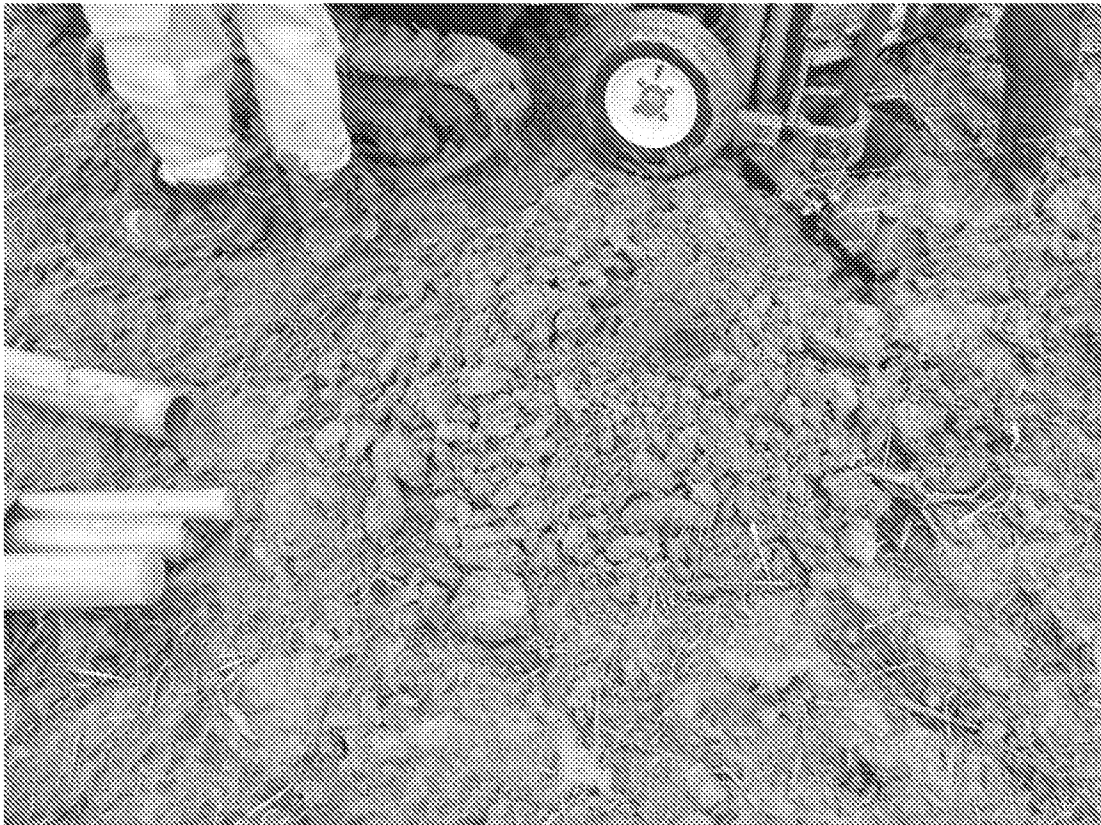
| PHOTOGRAPHIC LOG | | 305035 L01 (00) |
|---|---|---|
| <b>Photo No.</b><br>10 | | |

| PHOTOGRAPHIC LOG | | 305035 L01 (00) |
|---|---|---|
| BH210 handpit<br>arisings | | |

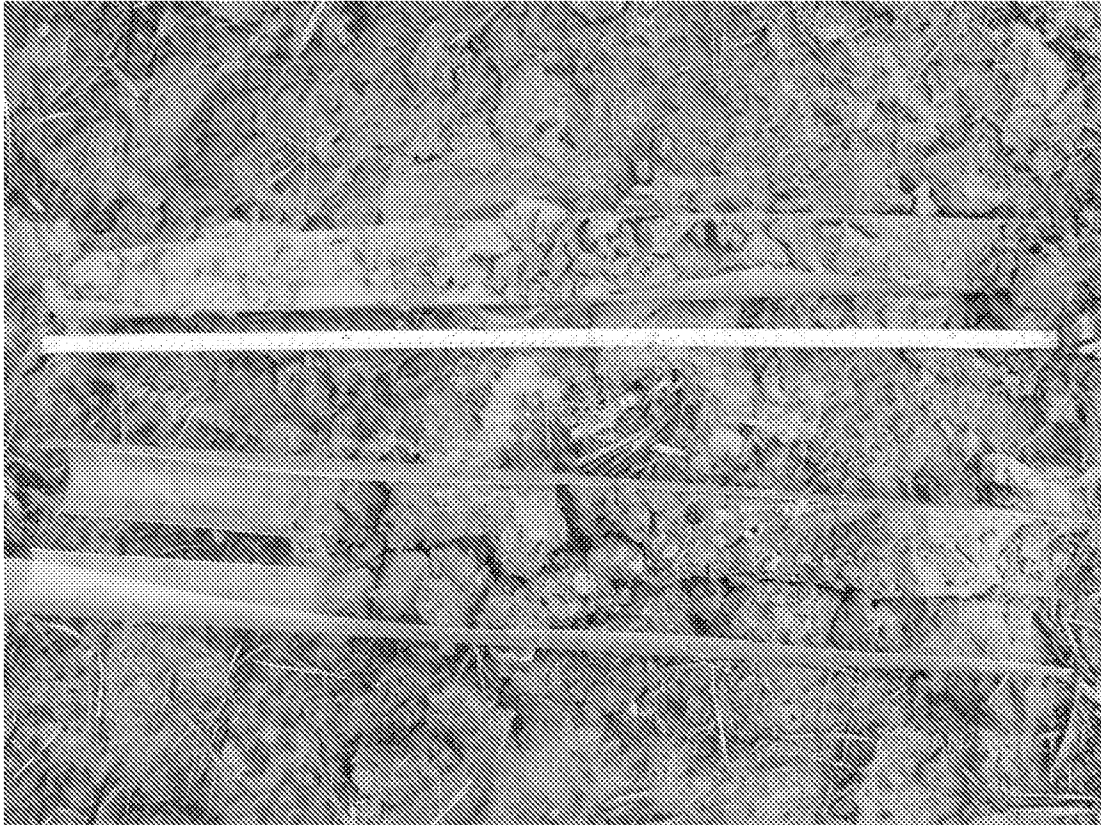
| PHOTOGRAPHIC LOG | | 305035 L01 (00) |
|---|---|---|
| <b>Photo No.</b><br>11 | | |

| PHOTOGRAPHIC LOG | | 305035 L01 (00) |
|---|---|---|
| BH210 core<br>soils recovery:<br>1. 2-3 m (L-R)<br>2. 1-2 m (L-R) | | |

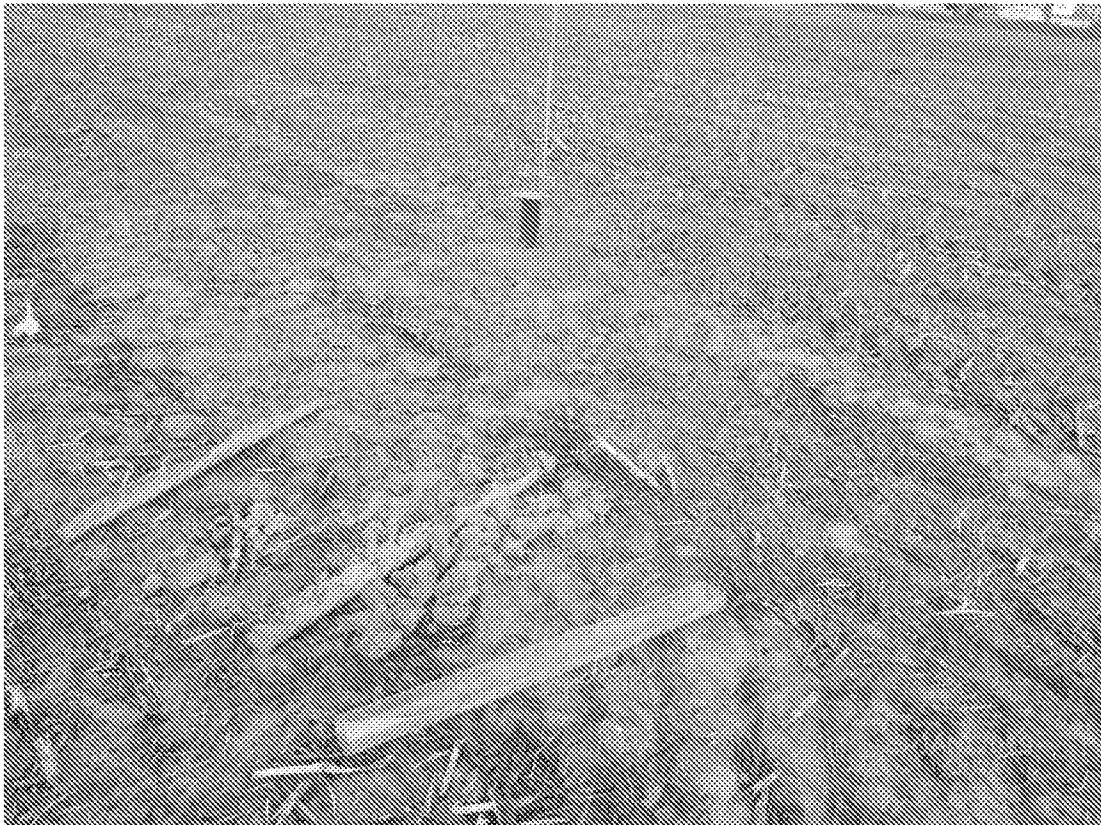
| PHOTOGRAPHIC LOG | | 305035 L01 (00) |
|---|---|---|
| <b>Photo No.</b><br>12 | | |

| PHOTOGRAPHIC LOG | | 305035 L01 (00) |
|---|---|---|
| Facing<br>northwest,<br>overview of<br>BH211 | | |

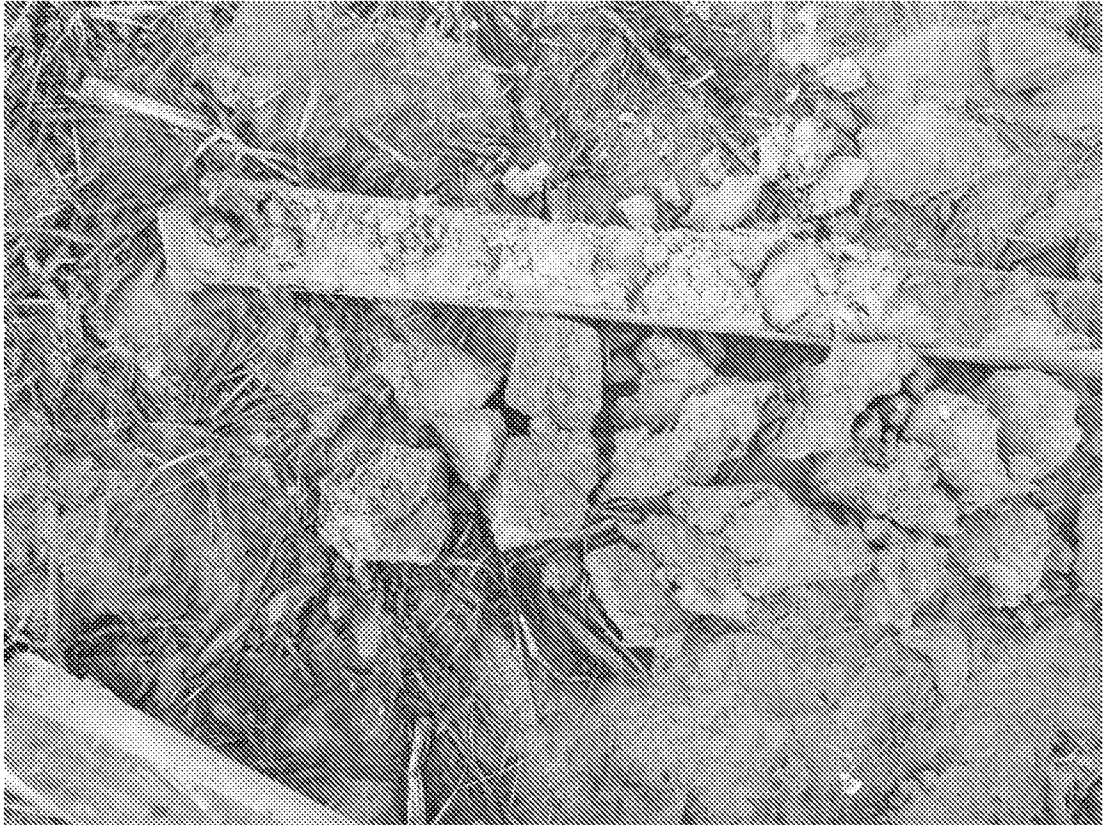
| PHOTOGRAPHIC LOG | | 305035 L01 (00) |
|---|---|---|
| <b>Photo No.</b><br>13 | | |

| PHOTOGRAPHIC LOG | | 305035 L01 (00) |
|---|---|---|
| BH211 core<br>soils recovery:<br>1. 2-3 m (L-R)<br>2. 1-2 m (L-R) | | |

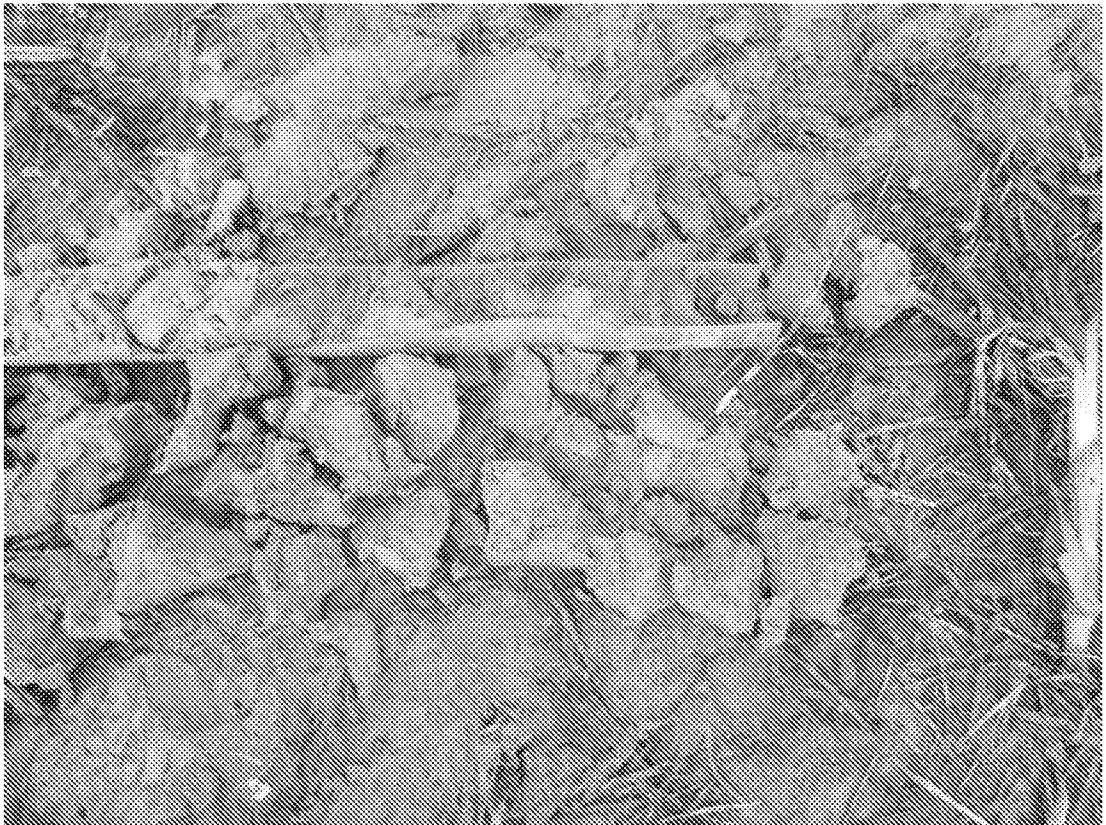
| PHOTOGRAPHIC LOG | | 305035 L01 (00) |
|---|---|---|
| <b>Photo No.</b><br>14 | | |

| PHOTOGRAPHIC LOG | | 305035 L01 (00) |
|---|---|---|
| BH211 core<br>soils recovery:<br>1. 2-3 m (L-R)<br>2. 1-2 m (L-R) | | |

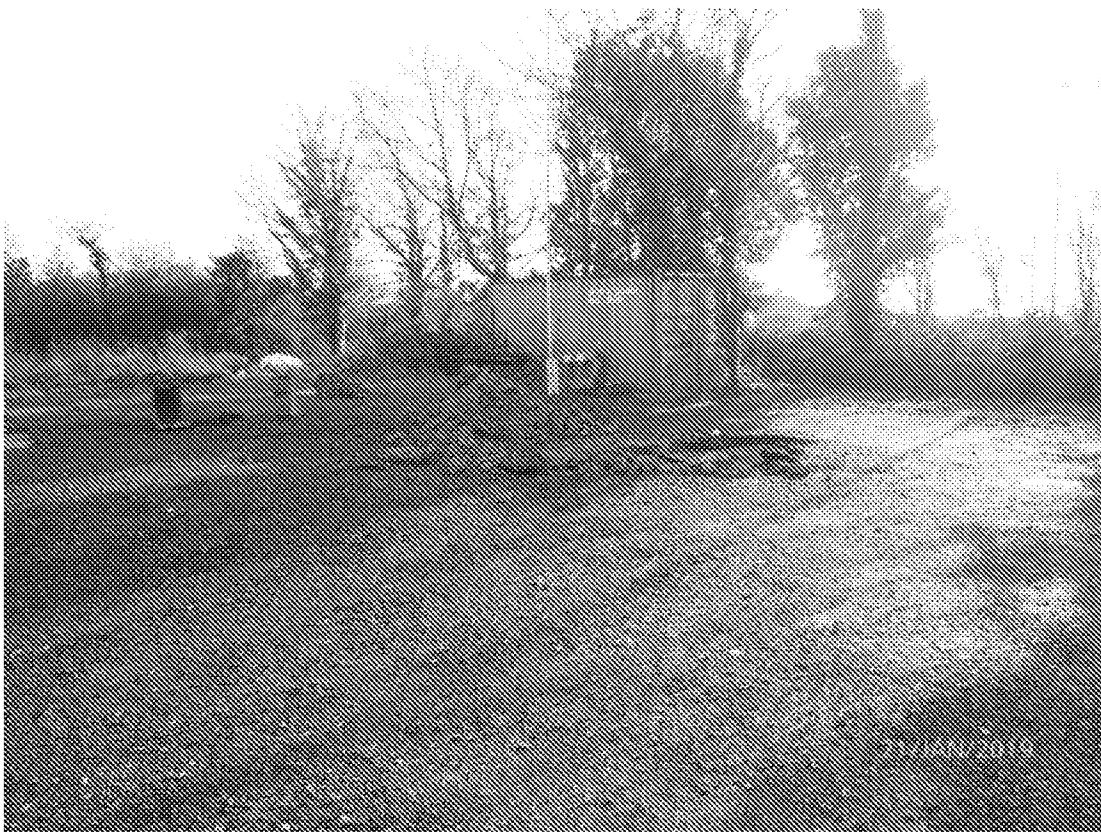
| PHOTOGRAPHIC LOG | | 305035 L01 (00) |
|---|---|---|
| <b>Photo No.</b><br>15 | | |

| Trial pit (test no.) | Base depth (mbgl) | Effective depth (m) | Test duration (hours) | Time to pass between 75 % and 25 % effective depth (seconds) | Infiltration rate (m/s) |
|---|---|---|---|---|---|
| TP201 | 1.80 | 1.00 | 23 | - | Test fail |

| PHOTOGRAPHIC LOG | | 305035 L01 (00) |
|---|---|---|
| Facing southeast, overview of TP201 | | |

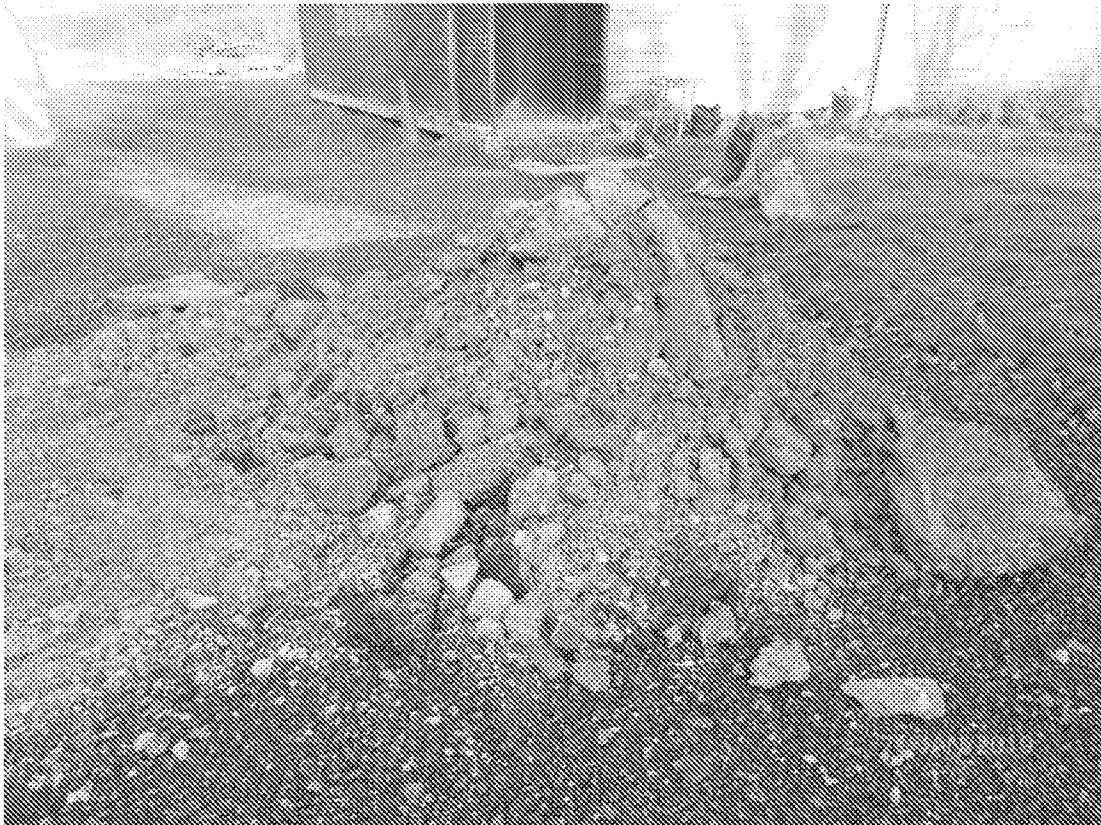
| PHOTOGRAPHIC LOG | | 305035 L01 (00) |
|---|---|---|
| <b>Photo No.</b><br>16 | | |

| PHOTOGRAPHIC LOG | | 305035 L01 (00) |
|---|---|---|
| Arisings from TP201 | | |

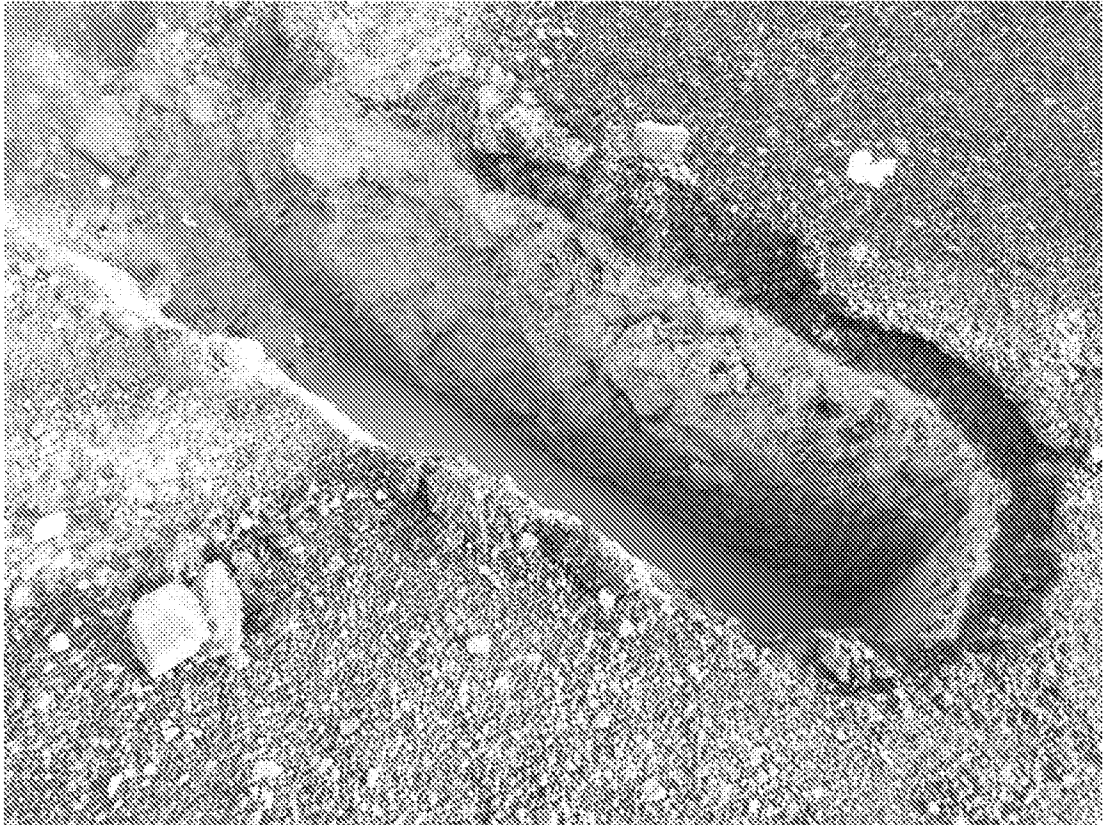
| PHOTOGRAPHIC LOG | | 305035 L01 (00) |
|---|---|---|
| View downhole of TP201, during soakaway test | | |

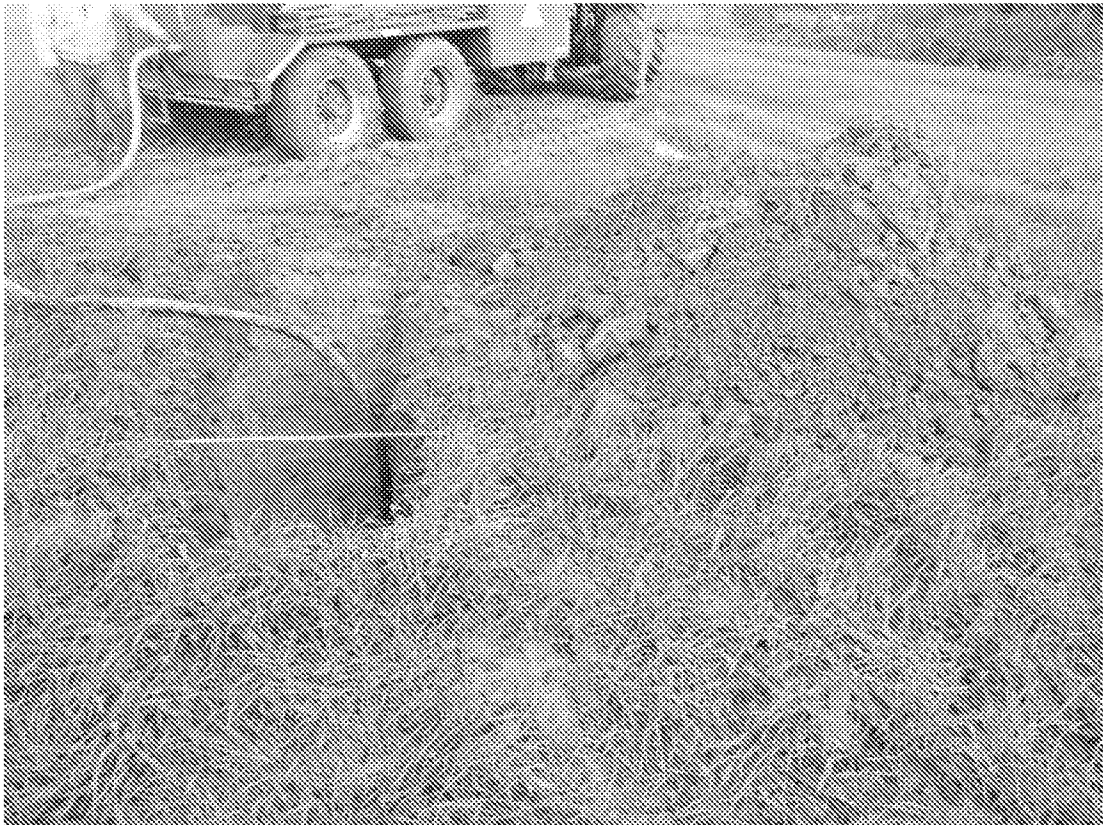
| PHOTOGRAPHIC LOG | | 305035 L01 (00) |
|---|---|---|
| <b>Photo No.</b><br>18 | | |

| Trial pit (test no.) | Base depth (mbgl) | Effective depth (m) | Test duration (hours) | Time to pass between 75 % and 25 % effective depth (seconds) | Infiltration rate (m/s) |
|---|---|---|---|---|---|
| TP202 | 1.48 | 0.88 | 24 | - | Test fail |

| PHOTOGRAPHIC LOG | | 305035 L01 (00) |
|---|---|---|
| Facing east, overview of TP202 and arisings | | |

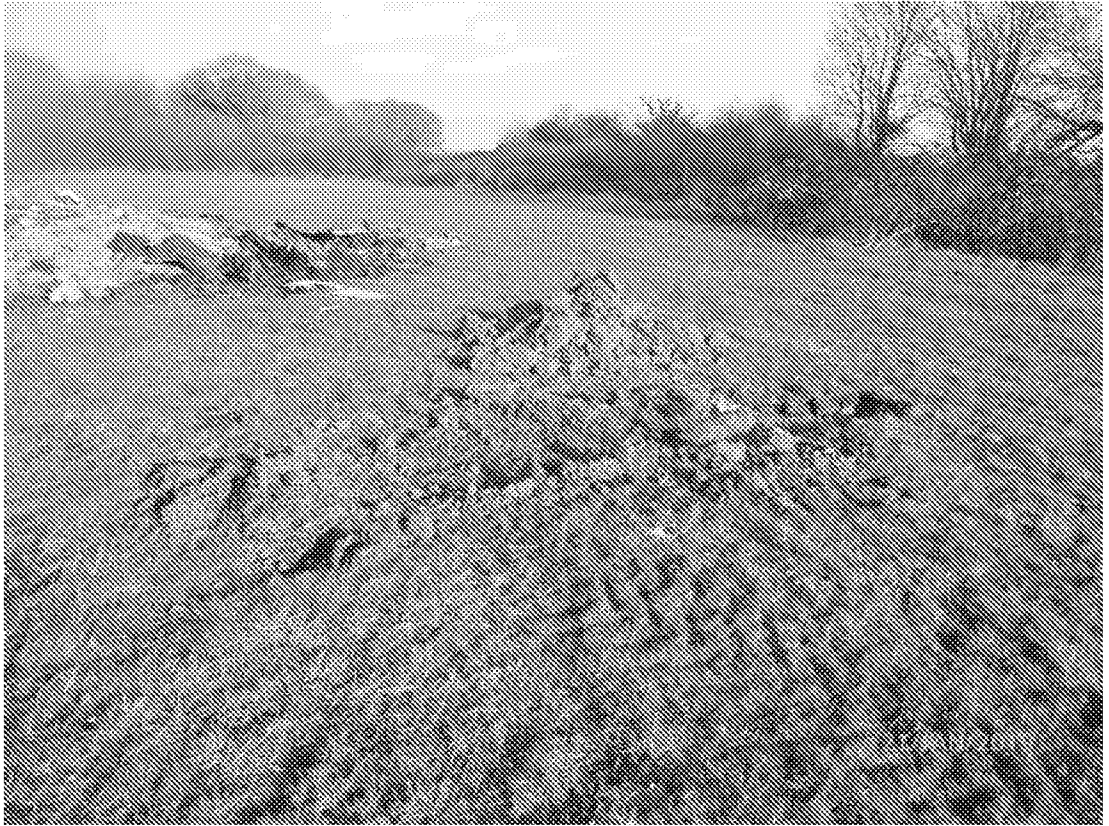
| PHOTOGRAPHIC LOG | | 305035 L01 (00) |
|---|---|---|
| <b>Photo No.</b><br>19 | | |

As shown in **Table 5**, falling water levels the majority of the trial pits did not cross the 75 % / 25 % fill level thresholds as required by BRE 365. Only in TP203 in the west of the site and in TP223 in the centre of the main field did any reportable infiltration occur. It is considered that this is due to localised variations in geology allowing extremely limited capacity for small-scale infiltration. It is furthermore worth noting that both of these locations were shallow 0.50 m trial pit soakaway tests, and therefore would not be suitable locations for development-scale soakaway features.

| PHOTOGRAPHIC LOG | | 305035 L01 (00) |
|---|---|---|
| Facing<br>northeast, view<br>of TP203 and<br>arisings | | |

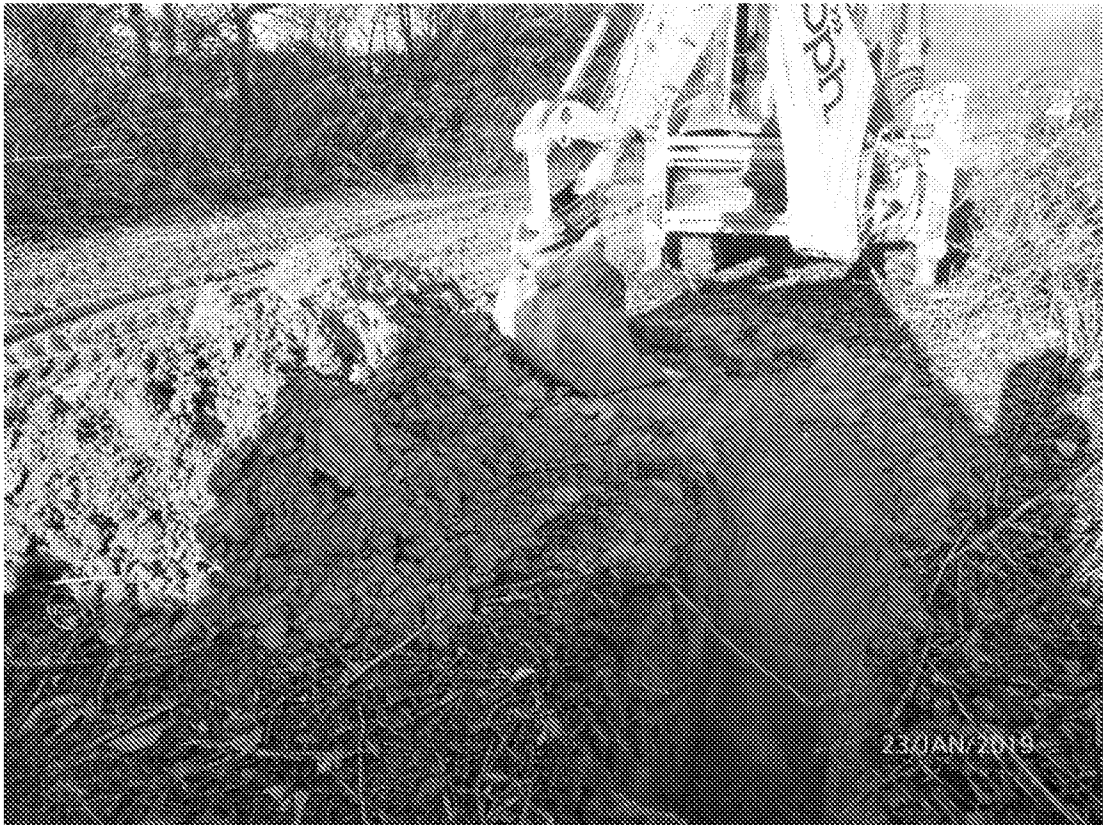
| PHOTOGRAPHIC LOG | | 305035 L01 (00) |
|---|---|---|
| <b>Photo No.</b><br>20 | | |

| Trial pit (test no.) | Base depth (mbgl) | Effective depth (m) | Test duration (hours) | Time to pass between 75 % and 25 % effective depth (seconds) | Infiltration rate (m/s) |
|---|---|---|---|---|---|
| TP204 | 1.50 | 0.85 | 24 | - | Test fail |

| PHOTOGRAPHIC LOG | | 305035 L01 (00) |
|---|---|---|
| Facing north,<br>view of TP204<br>and arisings | | |

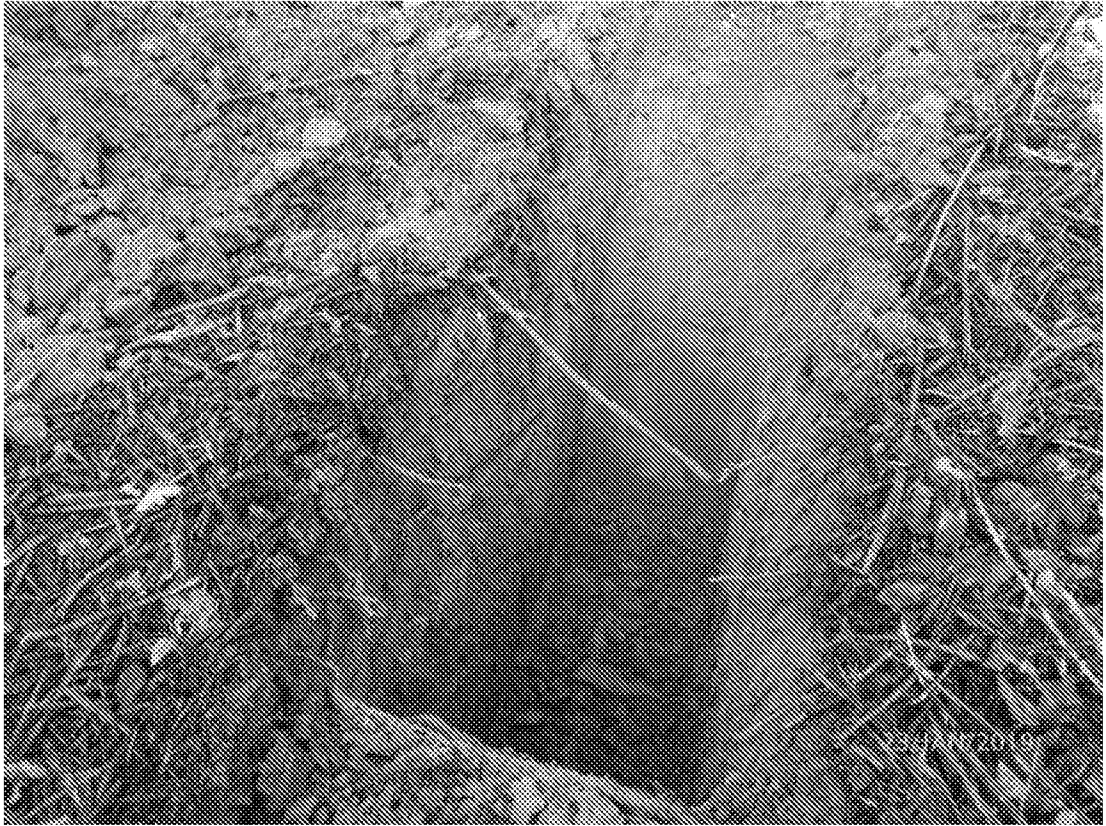
| PHOTOGRAPHIC LOG | | 305035 L01 (00) |
|---|---|---|
| <b>Photo No.</b><br>21 | | |

| PHOTOGRAPHIC LOG | | 305035 L01 (00) |
|---|---|---|
| Downhole view of TP204 | | |
