Our Ref: 305035 L01 (01)

16<sup>th</sup> July 2019

**RE: SEFTER ROAD, BOGNOR REGIS, PO21 3EE  
SUPPLEMENTARY HYDROGEOLOGICAL SITE ASSESSMENT**

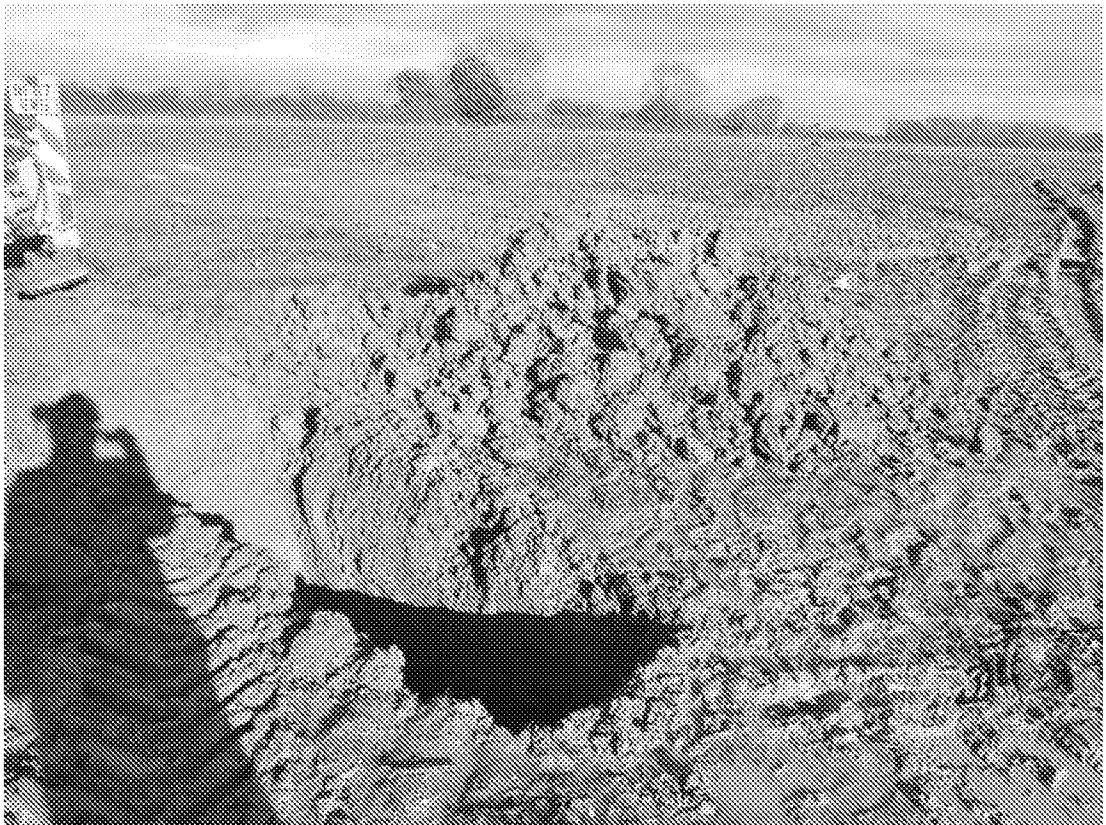
| PHOTOGRAPHIC LOG | | 305035 L01 (00) |
|---|---|---|
| <b>Photo No.</b><br>22 | | |

| Trial pit (test no.) | Base depth (mbgl) | Effective depth (m) | Test duration (hours) | Time to pass between 75 % and 25 % effective depth (seconds) | Infiltration rate (m/s) |
|---|---|---|---|---|---|
| TP205 | 1.50 | 0.97 | 26 | - | Test fail |

| PHOTOGRAPHIC LOG | | 305035 L01 (00) |
|---|---|---|
| Facing northeast, view of TP205 and arisings | | |

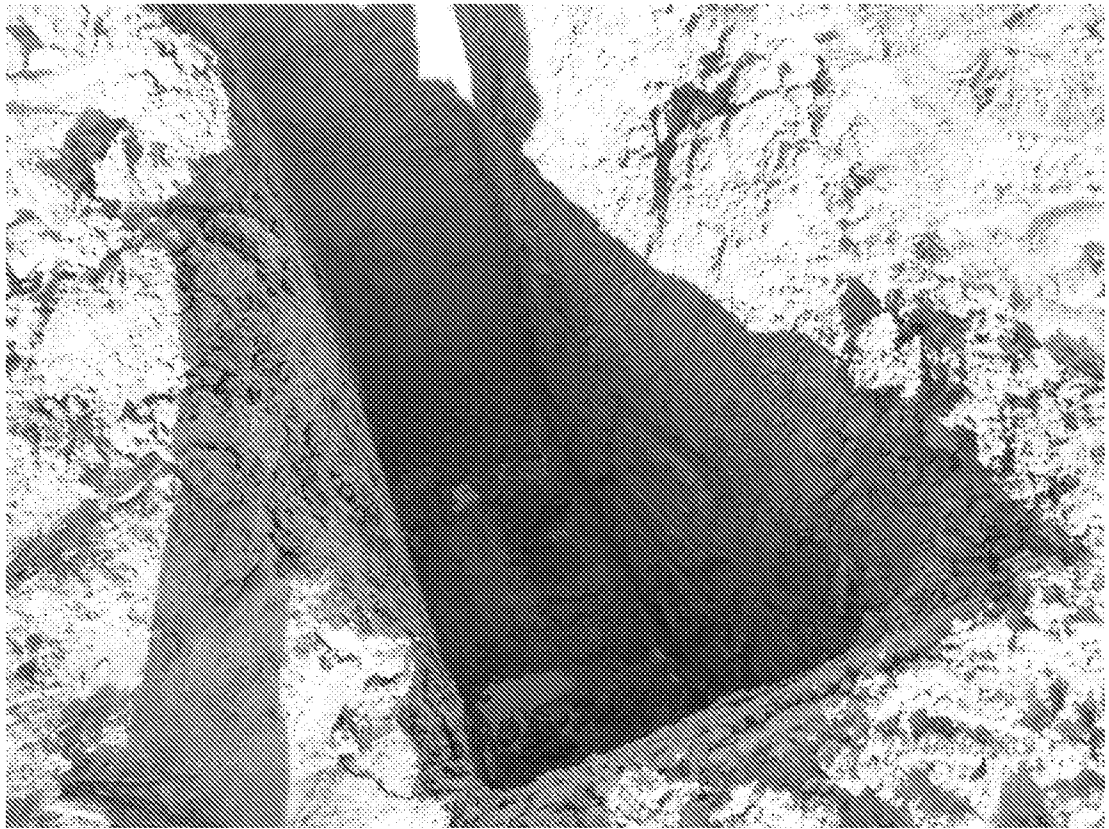
| PHOTOGRAPHIC LOG | | 305035 L01 (00) |
|---|---|---|
| Photo No.<br>23 | | |

| PHOTOGRAPHIC LOG | | 305035 L01 (00) |
|---|---|---|
| Downhole view of TP205 | | |

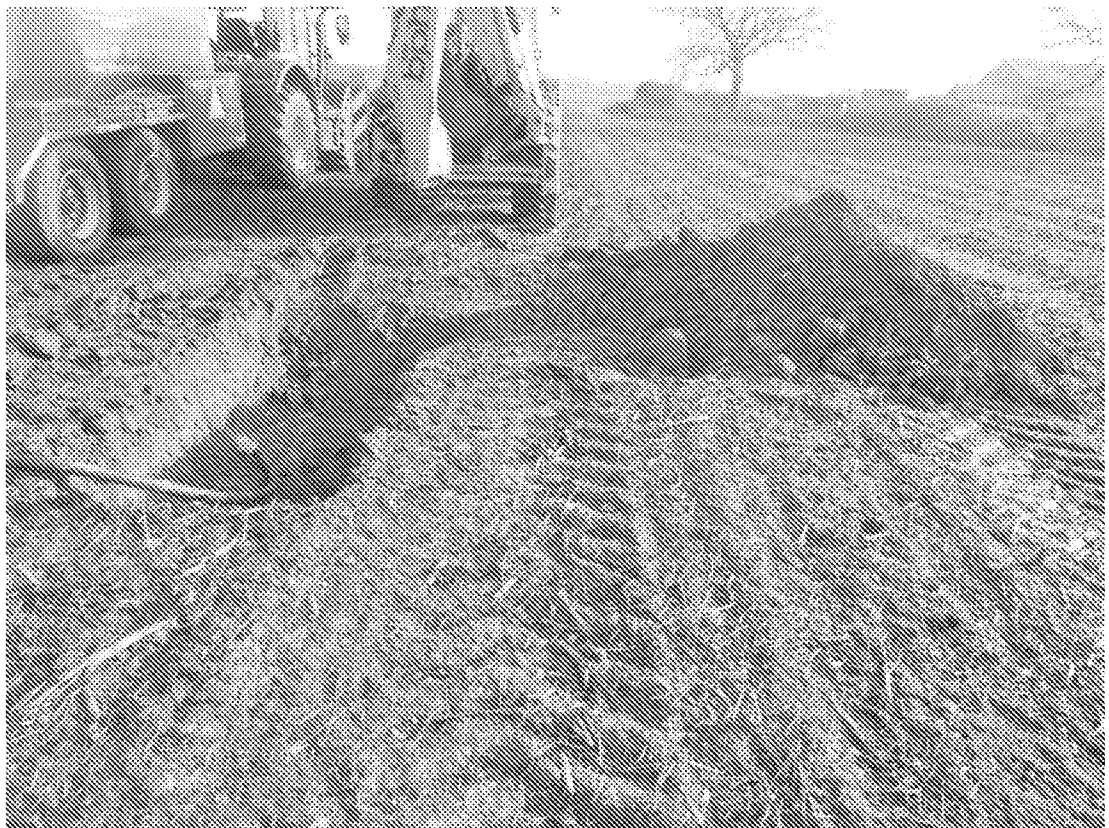
| PHOTOGRAPHIC LOG | | 305035 L01 (00) |
|---|---|---|
| Photo No.<br>24 | | |

| Trial pit (test no.) | Base depth (mbgl) | Effective depth (m) | Test duration (hours) | Time to pass between 75 % and 25 % effective depth (seconds) | Infiltration rate (m/s) |
|---|---|---|---|---|---|
| TP206 | 0.70 | 0.45 | 54 | - | Test fail |

| PHOTOGRAPHIC LOG | | 305035 L01 (00) |
|---|---|---|
| Facing east, view of TP206 and arisings | | |

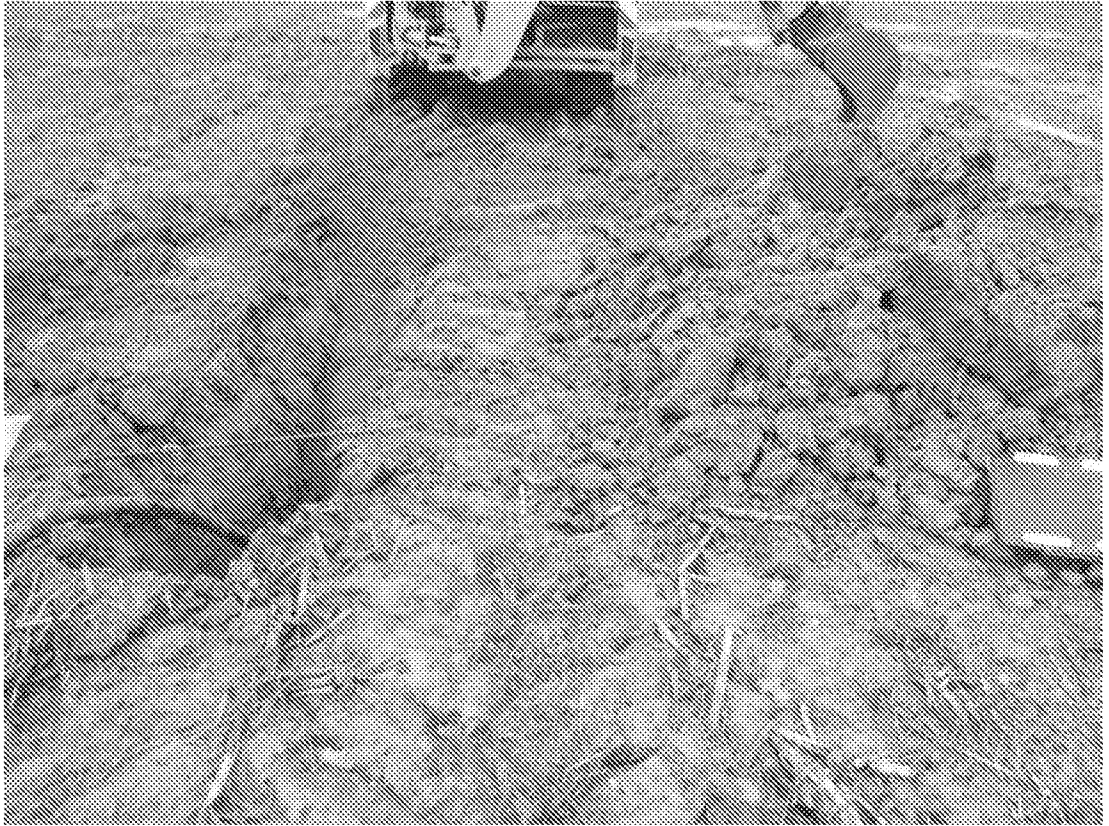
| PHOTOGRAPHIC LOG | | 305035 L01 (00) |
|---|---|---|
| <b>Photo No.</b><br>25 | | |

| Trial pit (test no.) | Base depth (mbgl) | Effective depth (m) | Test duration (hours) | Time to pass between 75 % and 25 % effective depth (seconds) | Infiltration rate (m/s) |
|---|---|---|---|---|---|
| TP207 | 1.60 | 0.66 | 26 | - | Test fail |

| PHOTOGRAPHIC LOG | | 305035 L01 (00) |
|---|---|---|
| Facing east,<br>view of TP207 | | |

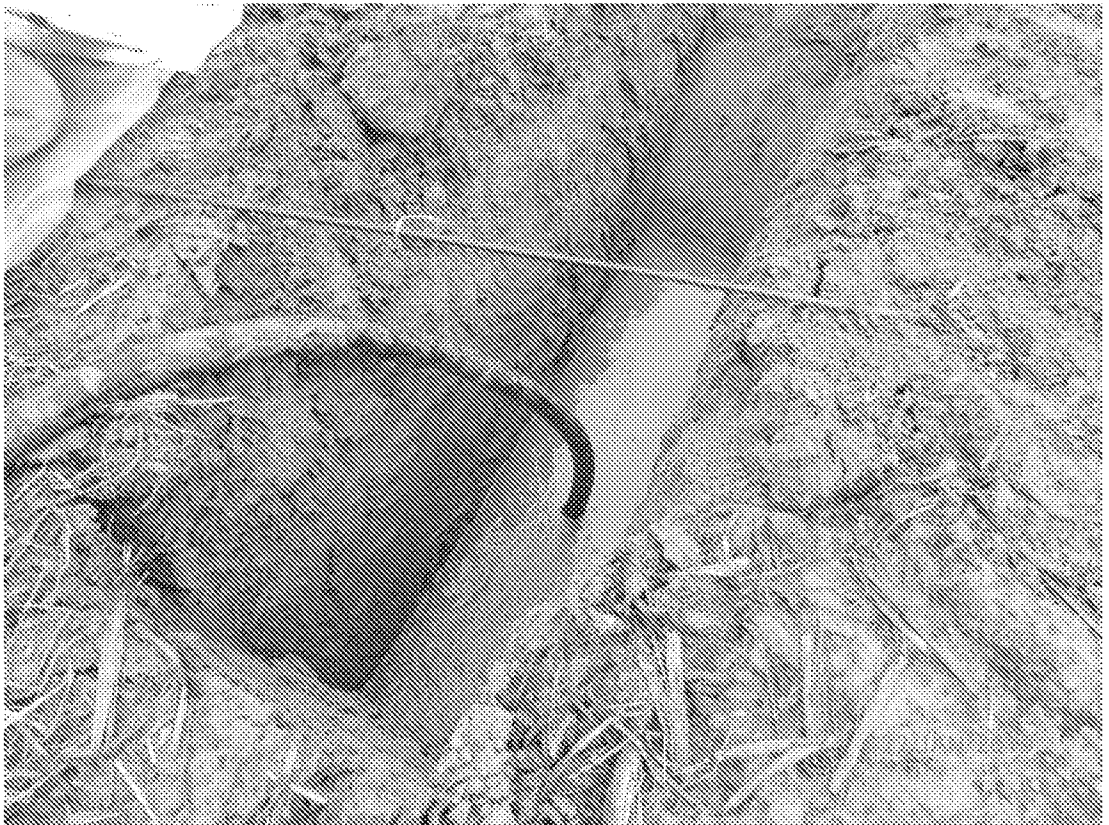
| PHOTOGRAPHIC LOG | | 305035 L01 (00) |
|---|---|---|
| <b>Photo No.</b><br>26 | | |

| PHOTOGRAPHIC LOG | | 305035 L01 (00) |
|---|---|---|
| Downhole view<br>of TP207 | | |

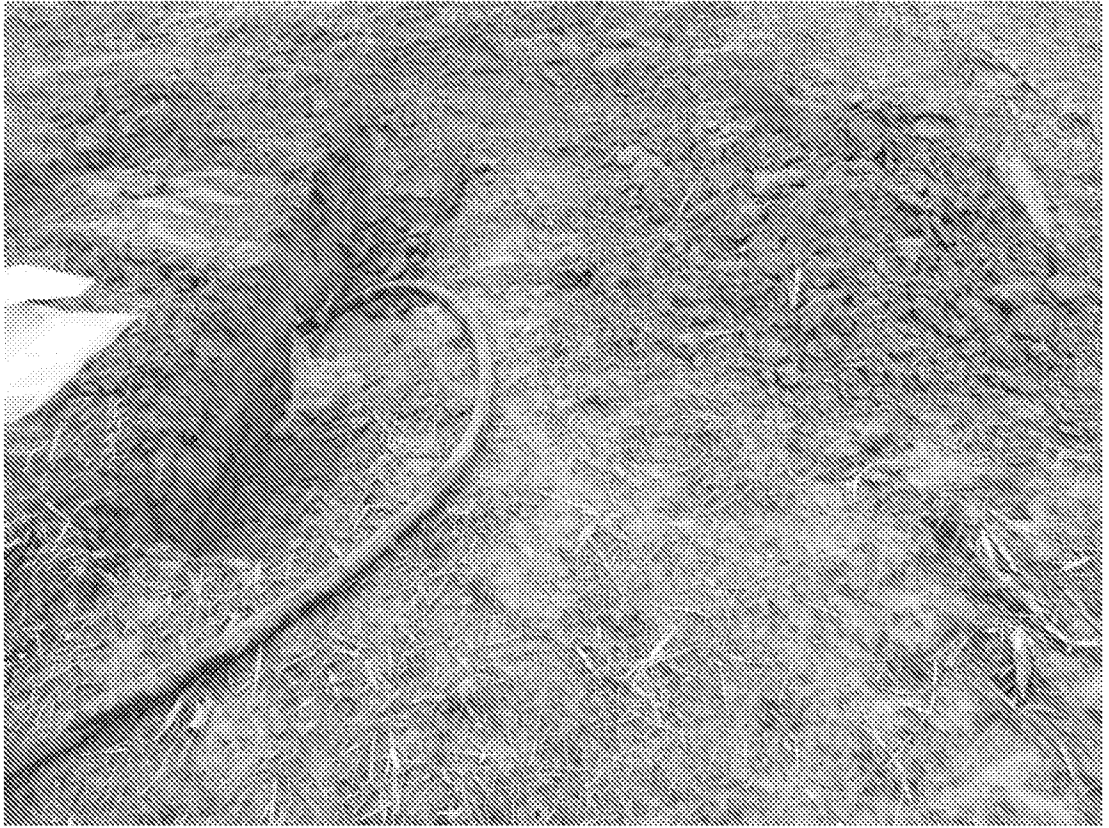
| PHOTOGRAPHIC LOG | | 305035 L01 (00) |
|---|---|---|
| <b>Photo No.</b><br>27 | | |

| Trial pit (test no.) | Base depth (mbgl) | Effective depth (m) | Test duration (hours) | Time to pass between 75 % and 25 % effective depth (seconds) | Infiltration rate (m/s) |
|---|---|---|---|---|---|
| TP208 | 0.50 | 0.31 | 26 | - | Test fail |

| PHOTOGRAPHIC LOG | | 305035 L01 (00) |
|---|---|---|
| Facing<br>northeast, view<br>of TP208 | | |

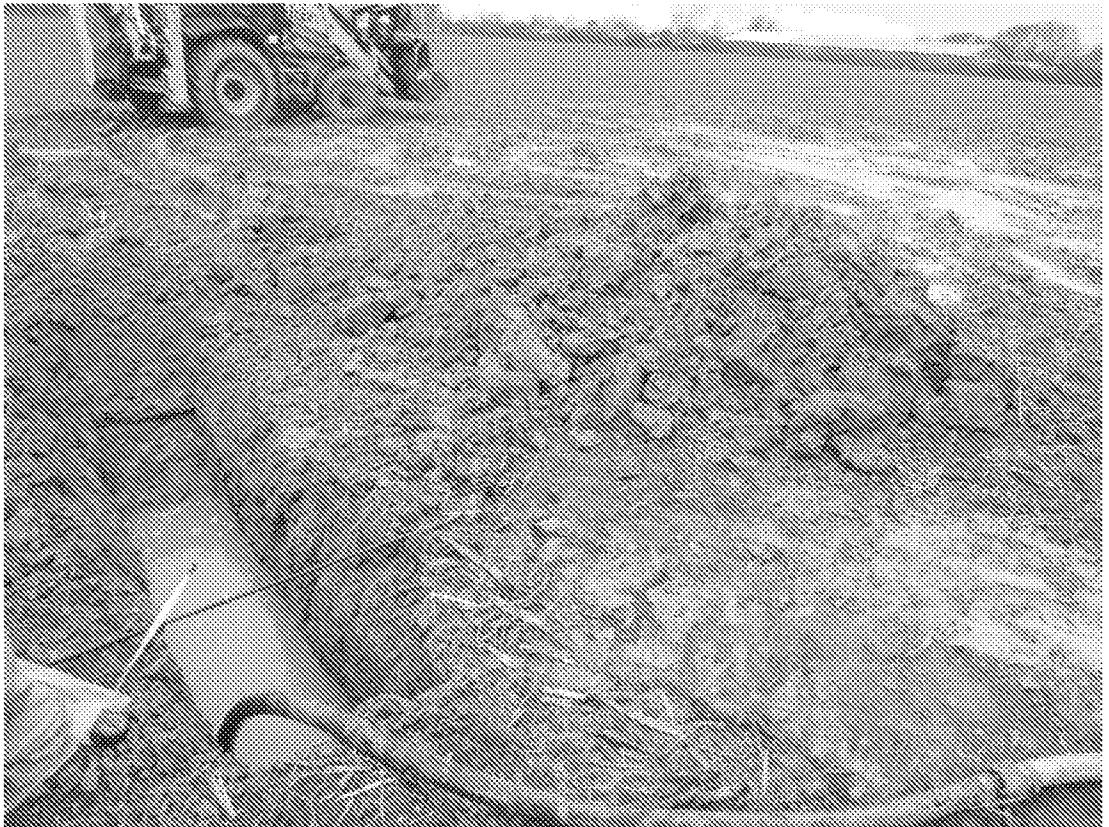
| PHOTOGRAPHIC LOG | | 305035 L01 (00) |
|---|---|---|
| <b>Photo No.</b><br>28 | | |

| Trial pit (test no.) | Base depth (mbgl) | Effective depth (m) | Test duration (hours) | Time to pass between 75 % and 25 % effective depth (seconds) | Infiltration rate (m/s) |
|---|---|---|---|---|---|
| TP209 | 1.50 | 0.95 | 26 | - | Test fail |

| PHOTOGRAPHIC LOG | | 305035 L01 (00) |
|---|---|---|
| Facing<br>southwest,<br>view of TP209 | | |

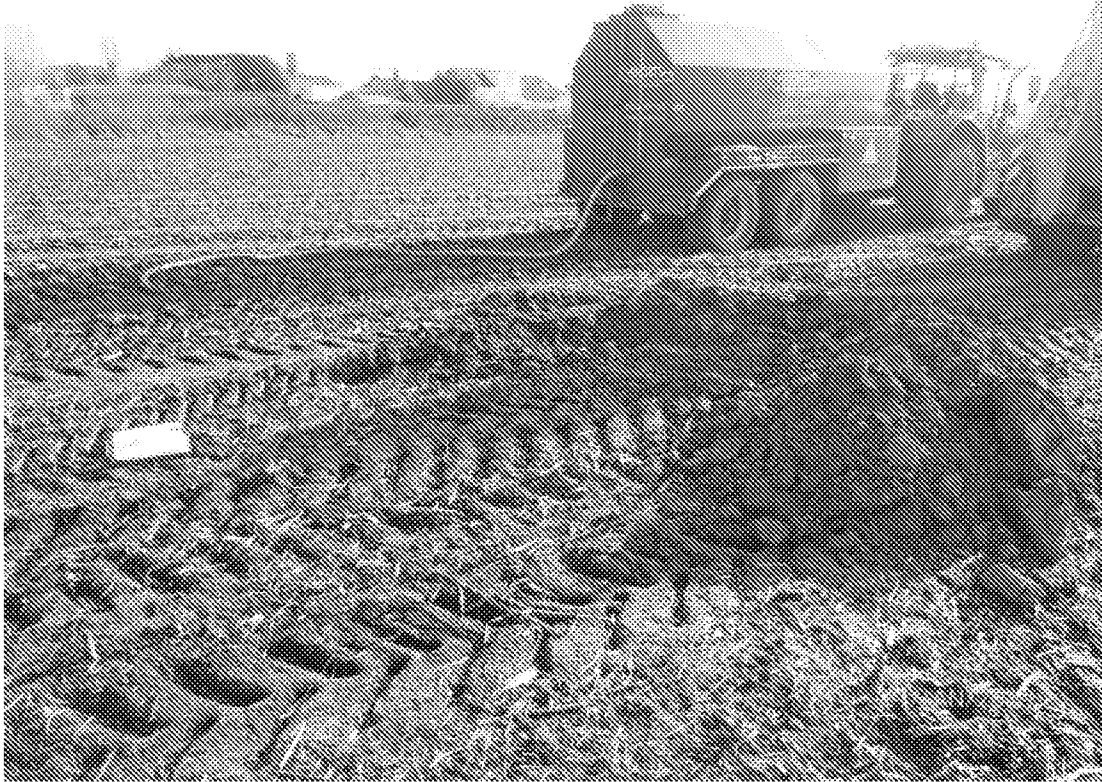
| PHOTOGRAPHIC LOG | | 305035 L01 (00) |
|---|---|---|
| <b>Photo No.</b><br>29 | | |

| Trial pit (test no.) | Base depth (mbgl) | Effective depth (m) | Test duration (hours) | Time to pass between 75 % and 25 % effective depth (seconds) | Infiltration rate (m/s) |
|---|---|---|---|---|---|
| TP210 | 0.42 | 0.27 | 26 | - | Test fail |

| PHOTOGRAPHIC LOG | | 305035 L01 (00) |
|---|---|---|
| Facing southeast, overview of TP210 and arisings | | |

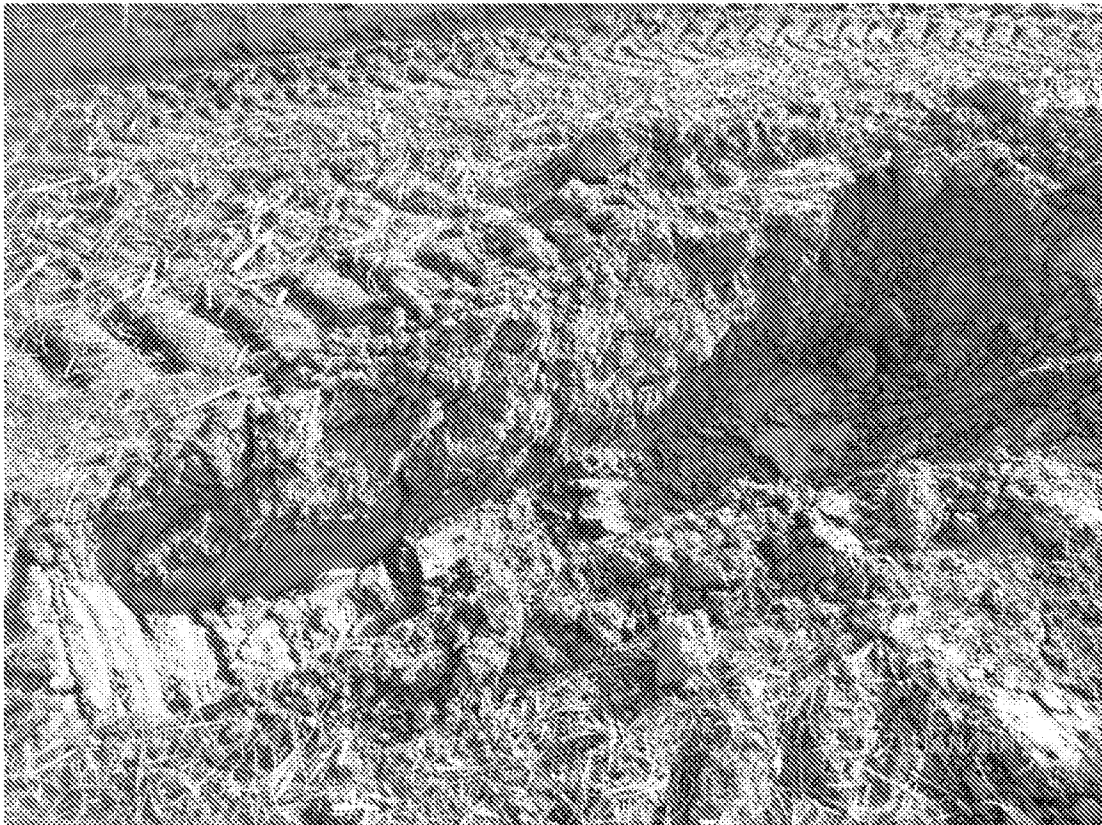
| PHOTOGRAPHIC LOG | | 305035 L01 (00) |
|---|---|---|
| <b>Photo No.</b><br>30 | | |

| PHOTOGRAPHIC LOG | | 305035 L01 (00) |
|---|---|---|
| Downhole view of TP210 | | |

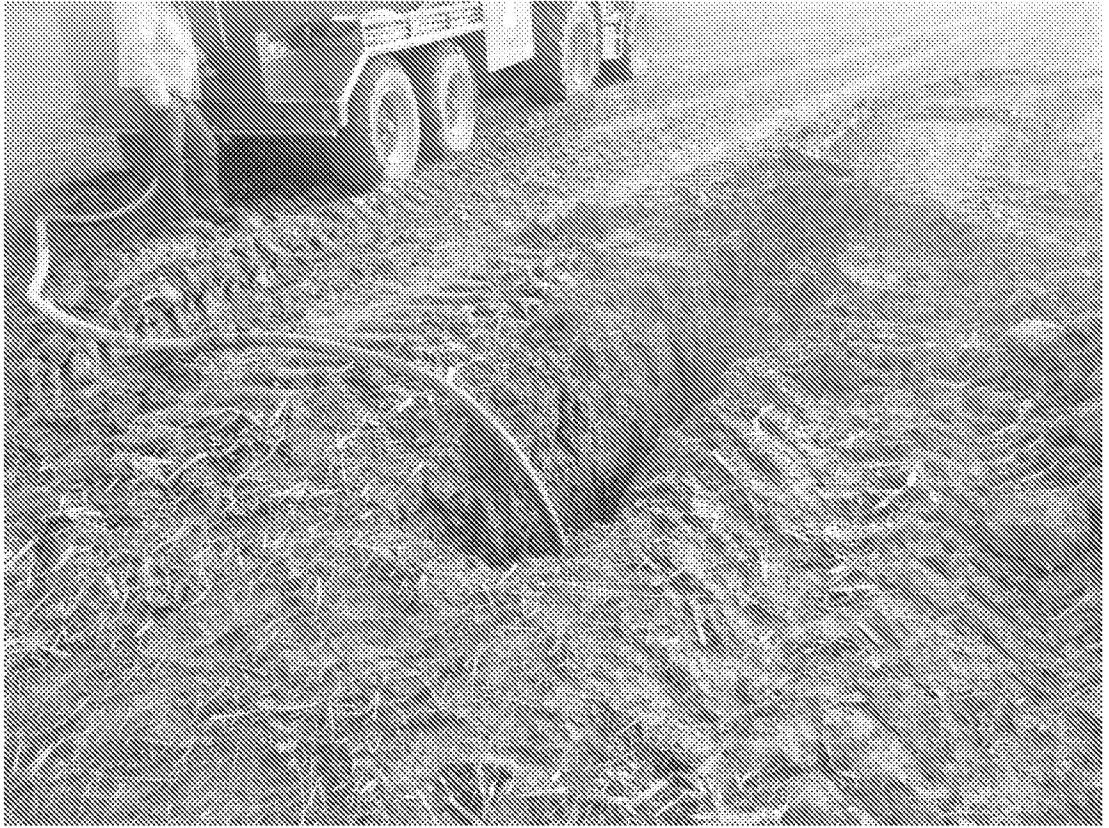
| PHOTOGRAPHIC LOG | | 305035 L01 (00) |
|---|---|---|
| <b>Photo No.</b><br>31 | | |

| Trial pit (test no.) | Base depth (mbgl) | Effective depth (m) | Test duration (hours) | Time to pass between 75 % and 25 % effective depth (seconds) | Infiltration rate (m/s) |
|---|---|---|---|---|---|
| TP211 | 1.50 | 1.00 | 24 | - | Test fail |

| PHOTOGRAPHIC LOG | | 305035 L01 (00) |
|---|---|---|
| Facing southwest,<br>view of TP211 | | |

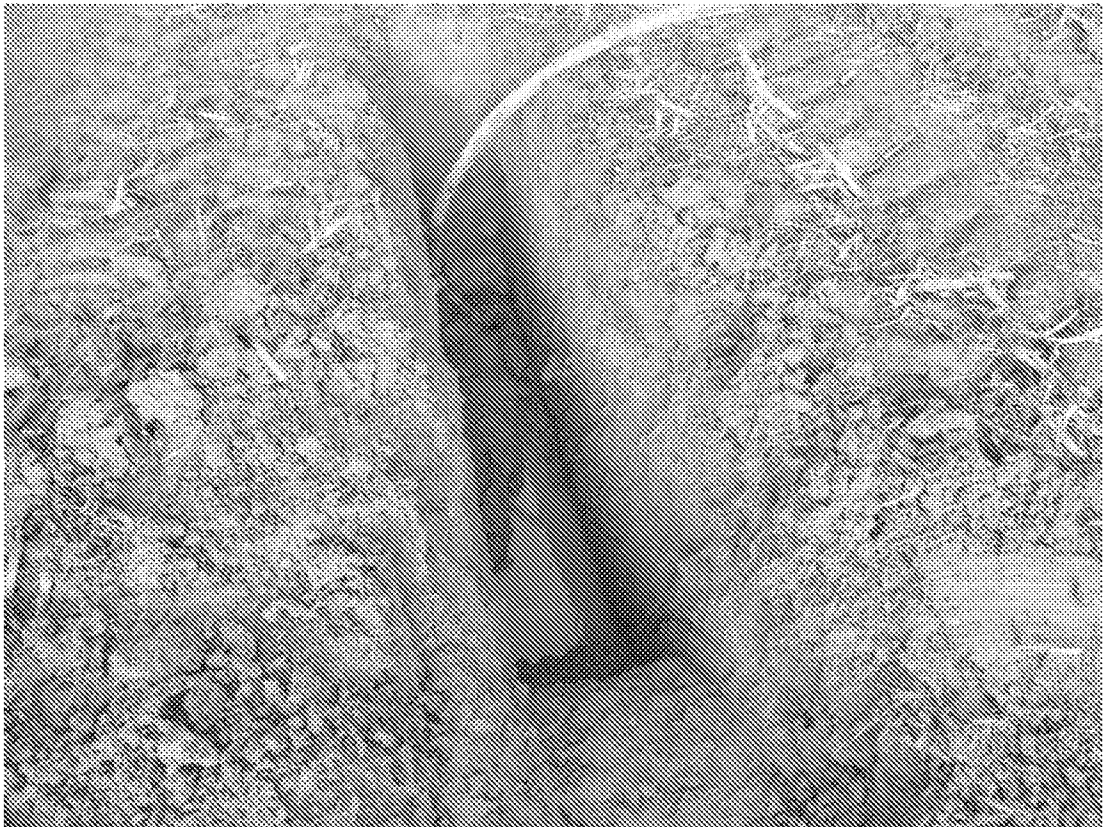
| PHOTOGRAPHIC LOG | | 305035 L01 (00) |
|---|---|---|
| <b>Photo No.</b><br>32 | | |

| PHOTOGRAPHIC LOG | | 305035 L01 (00) |
|---|---|---|
| Downhole view<br>of TP211 | | |

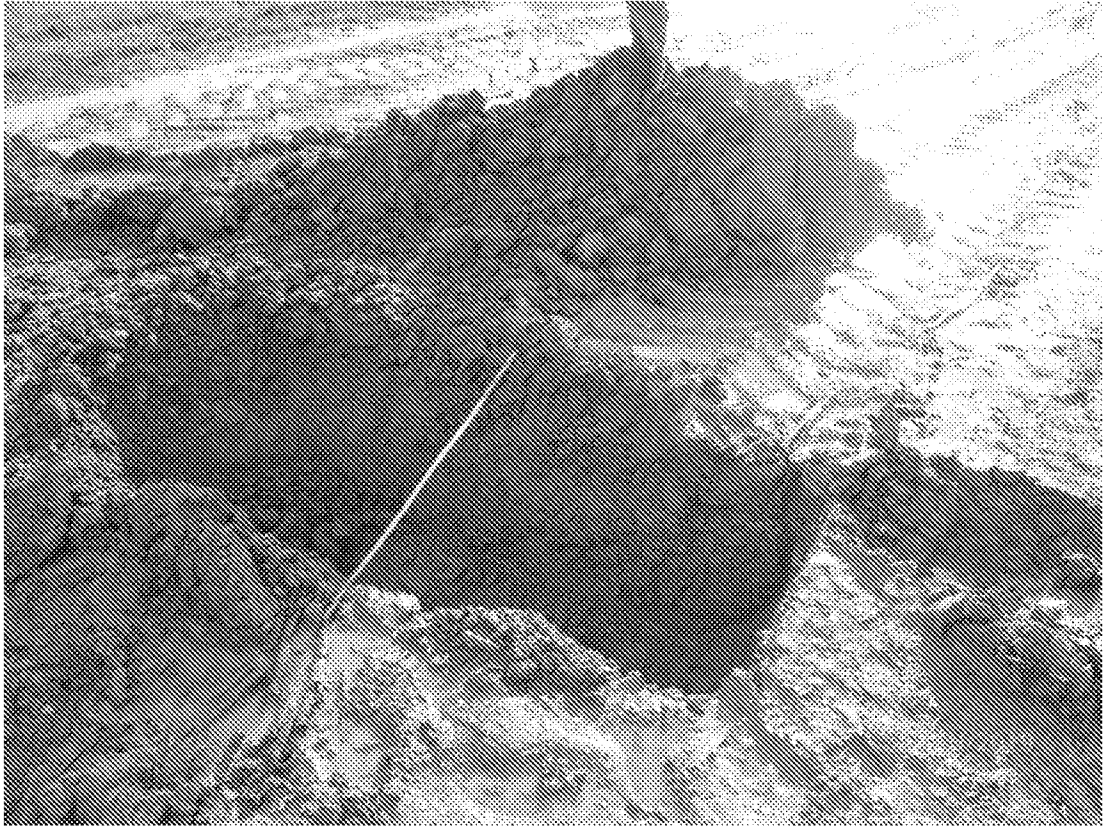
| PHOTOGRAPHIC LOG | | 305035 L01 (00) |
|---|---|---|
| <b>Photo No.</b><br>33 | | |

| PHOTOGRAPHIC LOG | | 305035 L01 (00) |
|---|---|---|
| Facing southwest,<br>view of TP212<br>and arisings | | |

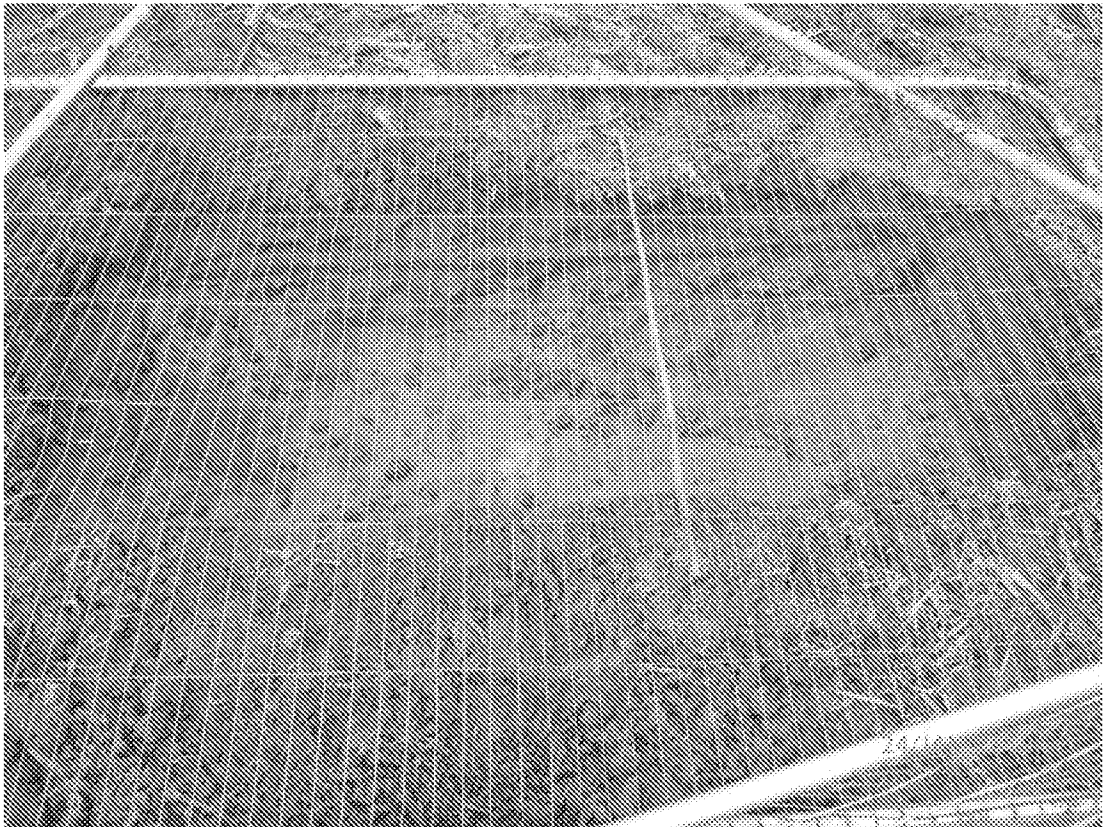
| PHOTOGRAPHIC LOG | | 305035 L01 (00) |
|---|---|---|
| <b>Photo No.</b><br>34 | | |

| PHOTOGRAPHIC LOG | | 305035 L01 (00) |
|---|---|---|
| View of<br>TP2123 | | |

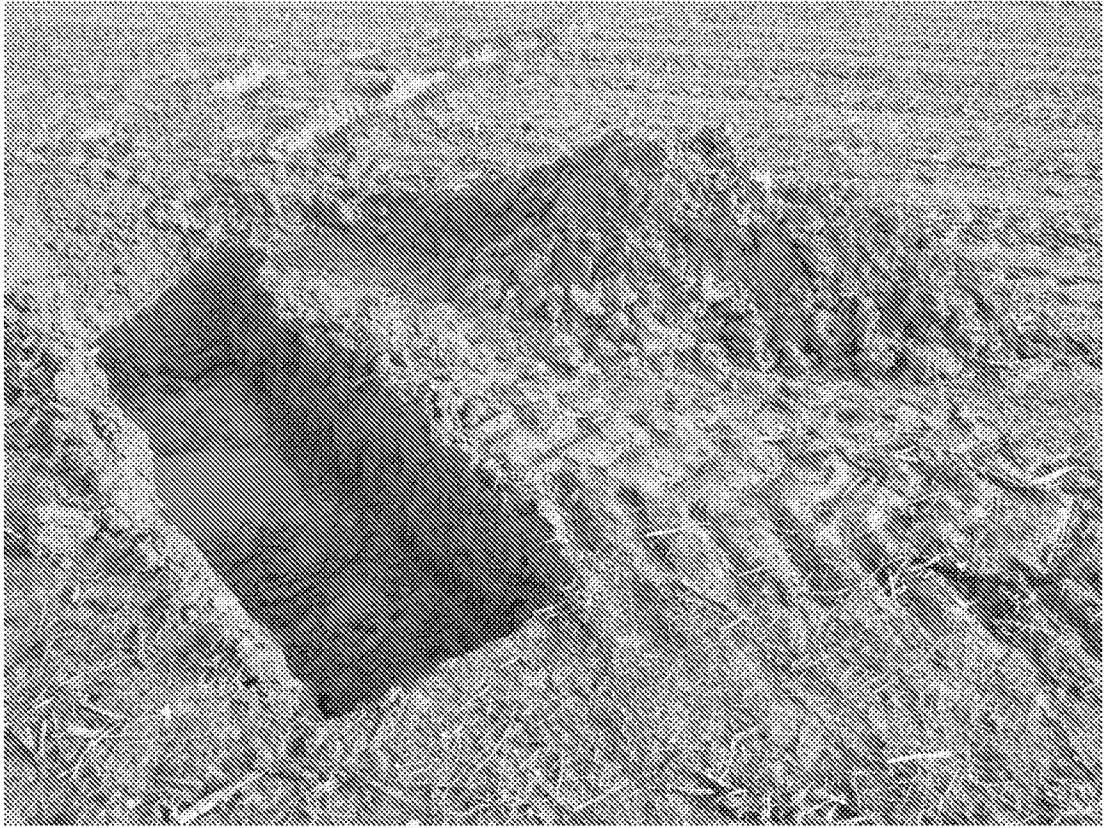
| PHOTOGRAPHIC LOG | | 305035 L01 (00) |
|---|---|---|
| <b>Photo No.</b><br>35 | | |

| Trial pit (test no.) | Base depth (mbgl) | Effective depth (m) | Test duration (hours) | Time to pass between 75 % and 25 % effective depth (seconds) | Infiltration rate (m/s) |
|---|---|---|---|---|---|
| TP214 | 0.65 | 0.55 | 27 | - | Test fail |

| PHOTOGRAPHIC LOG | | 305035 L01 (00) |
|---|---|---|
| Facing east,<br>view of TP214 | | |

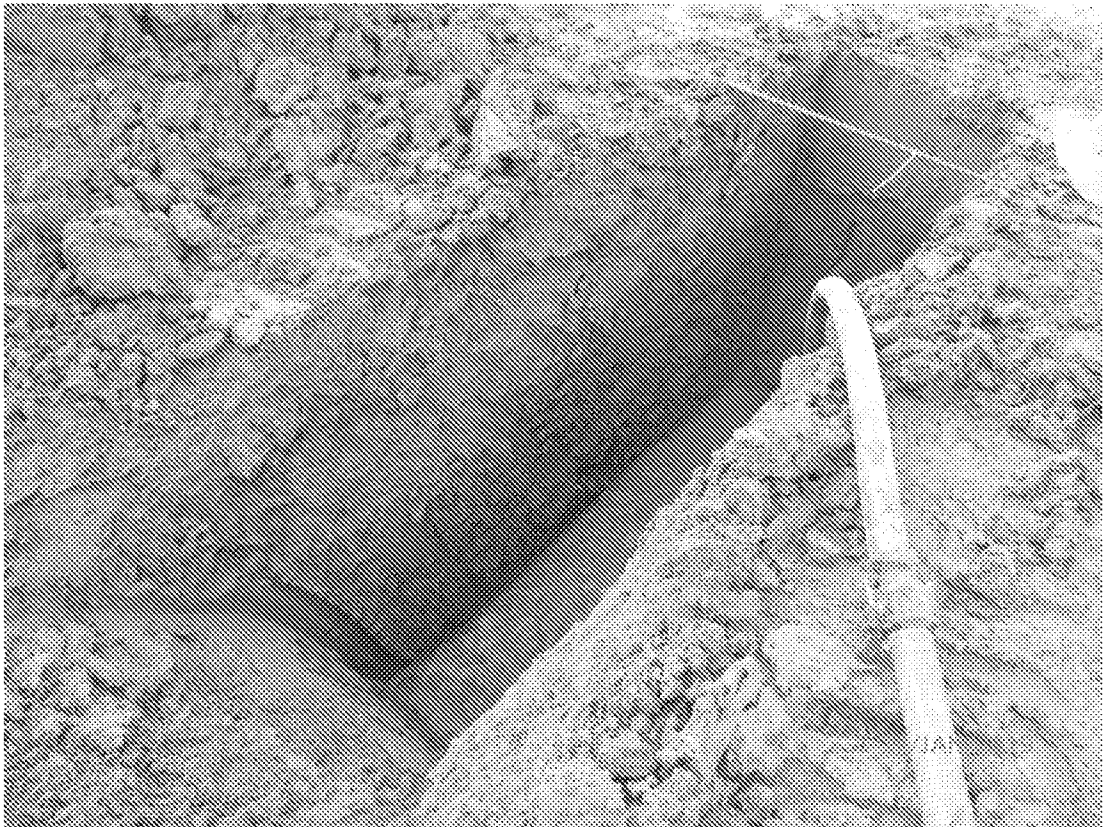
| PHOTOGRAPHIC LOG | | 305035 L01 (00) |
|---|---|---|
| <b>Photo No.</b><br>36 | | |

| Trial pit (test no.) | Base depth (mbgl) | Effective depth (m) | Test duration (hours) | Time to pass between 75 % and 25 % effective depth (seconds) | Infiltration rate (m/s) |
|---|---|---|---|---|---|
| TP215 | 1.60 | 0.99 | 25 | - | Test fail |

| PHOTOGRAPHIC LOG | | 305035 L01 (00) |
|---|---|---|
| Downhole view<br>of TP215 | | |

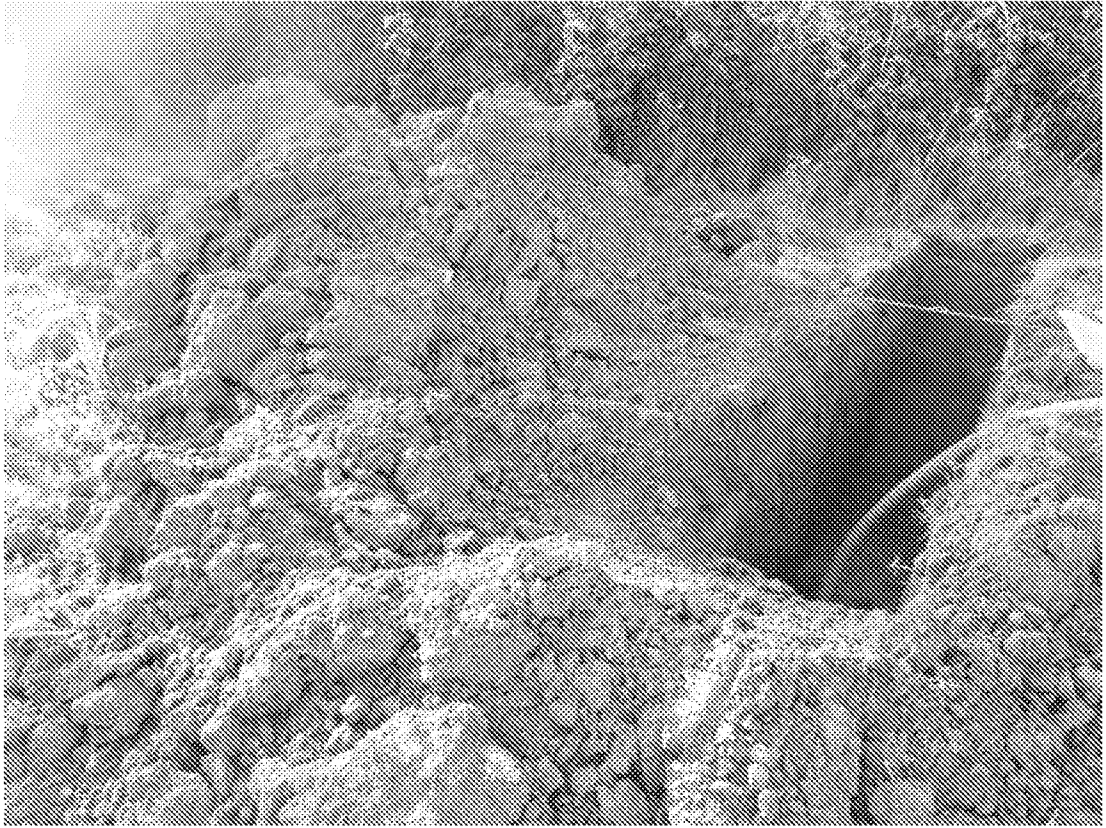
| PHOTOGRAPHIC LOG | | 305035 L01 (00) |
|---|---|---|
| <b>Photo No.</b><br>37 | | |

| Trial pit (test no.) | Base depth (mbgl) | Effective depth (m) | Test duration (hours) | Time to pass between 75 % and 25 % effective depth (seconds) | Infiltration rate (m/s) |
|---|---|---|---|---|---|
| TP216 | 1.50 | 1.00 | 25 | - | Test fail |

| PHOTOGRAPHIC LOG | | 305035 L01 (00) |
|---|---|---|
| Facing southwest,<br>view of TP216 | | |

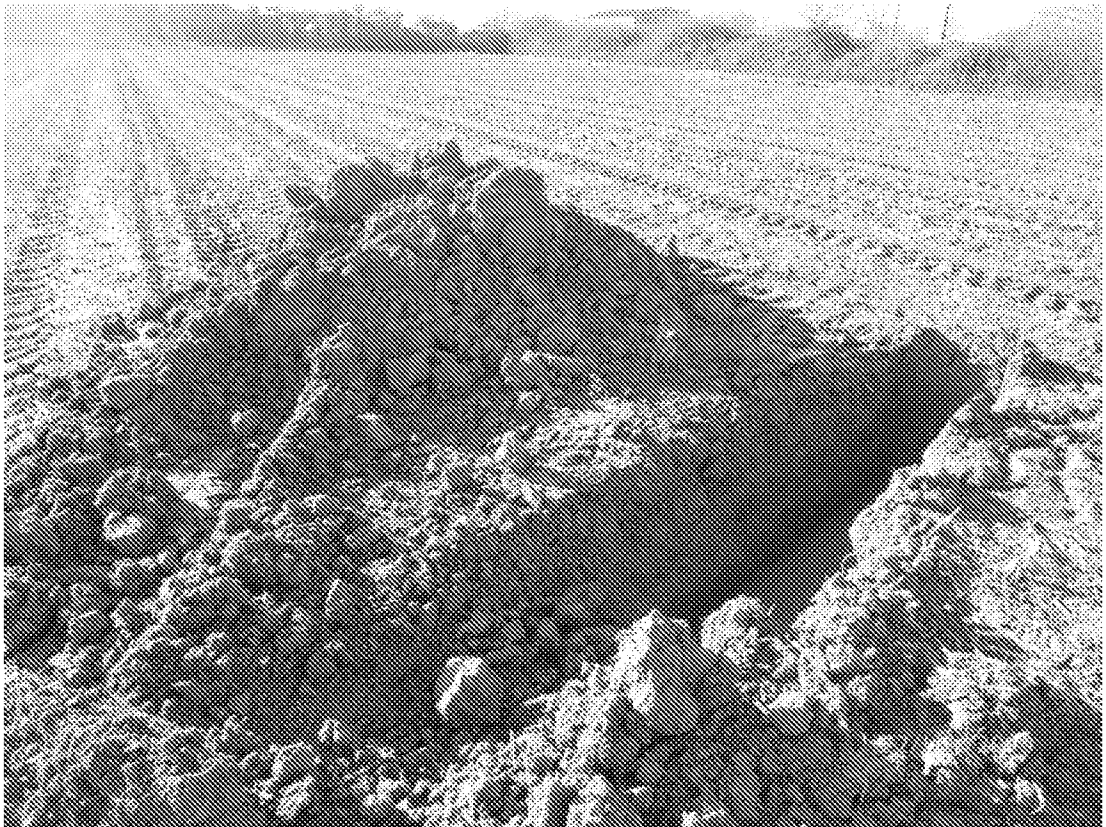
| PHOTOGRAPHIC LOG | | 305035 L01 (00) |
|---|---|---|
| <b>Photo No.</b><br>38 | | |

| Trial pit (test no.) | Base depth (mbgl) | Effective depth (m) | Test duration (hours) | Time to pass between 75 % and 25 % effective depth (seconds) | Infiltration rate (m/s) |
|---|---|---|---|---|---|
| TP218 | 1.50 | 1.00 | 50 | - | Test fail |

| PHOTOGRAPHIC LOG | | 305035 L01 (00) |
|---|---|---|
| Facing southwest,<br>view of TP218<br>and arisings | | |

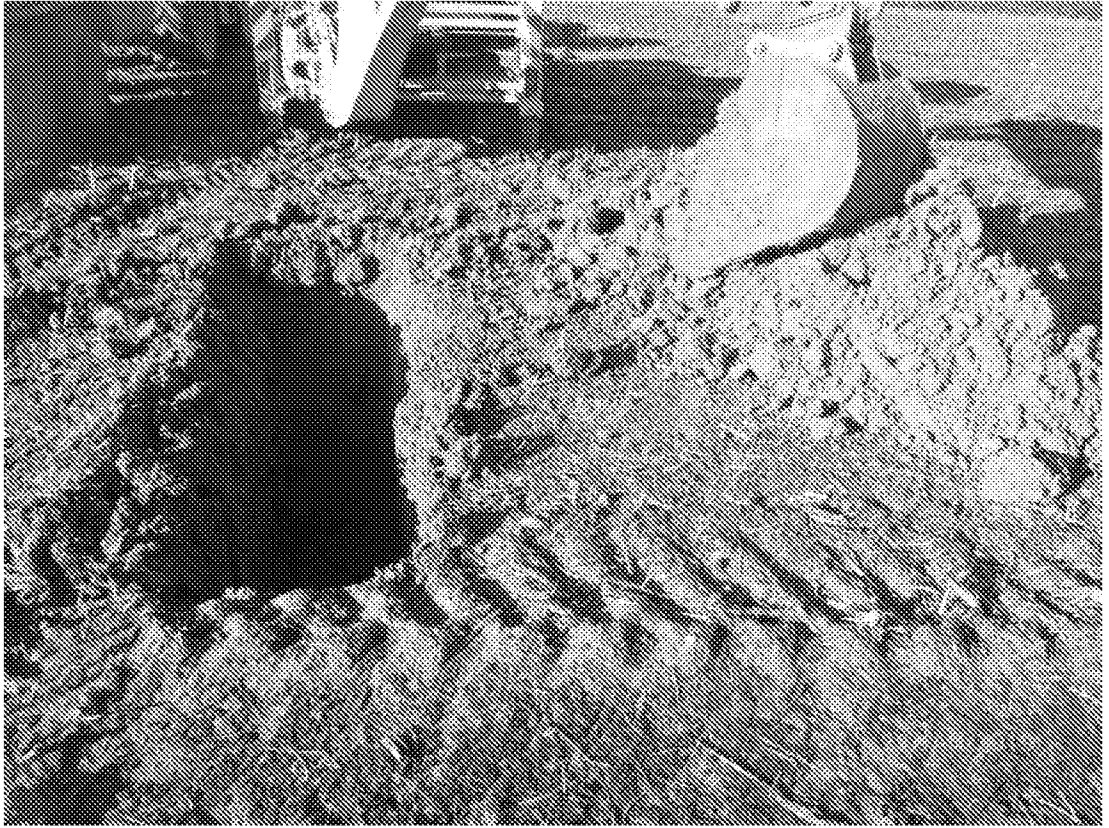
| PHOTOGRAPHIC LOG | | 305035 L01 (00) |
|---|---|---|
| <b>Photo No.</b><br>39 | | |

| Trial pit (test no.) | Base depth (mbgl) | Effective depth (m) | Test duration (hours) | Time to pass between 75 % and 25 % effective depth (seconds) | Infiltration rate (m/s) |
|---|---|---|---|---|---|
| TP219 | 1.50 | 1.00 | 30 | - | Test fail |

| PHOTOGRAPHIC LOG | | 305035 L01 (00) |
|---|---|---|
| Facing west,<br>view of TP219<br>and arisings | | |

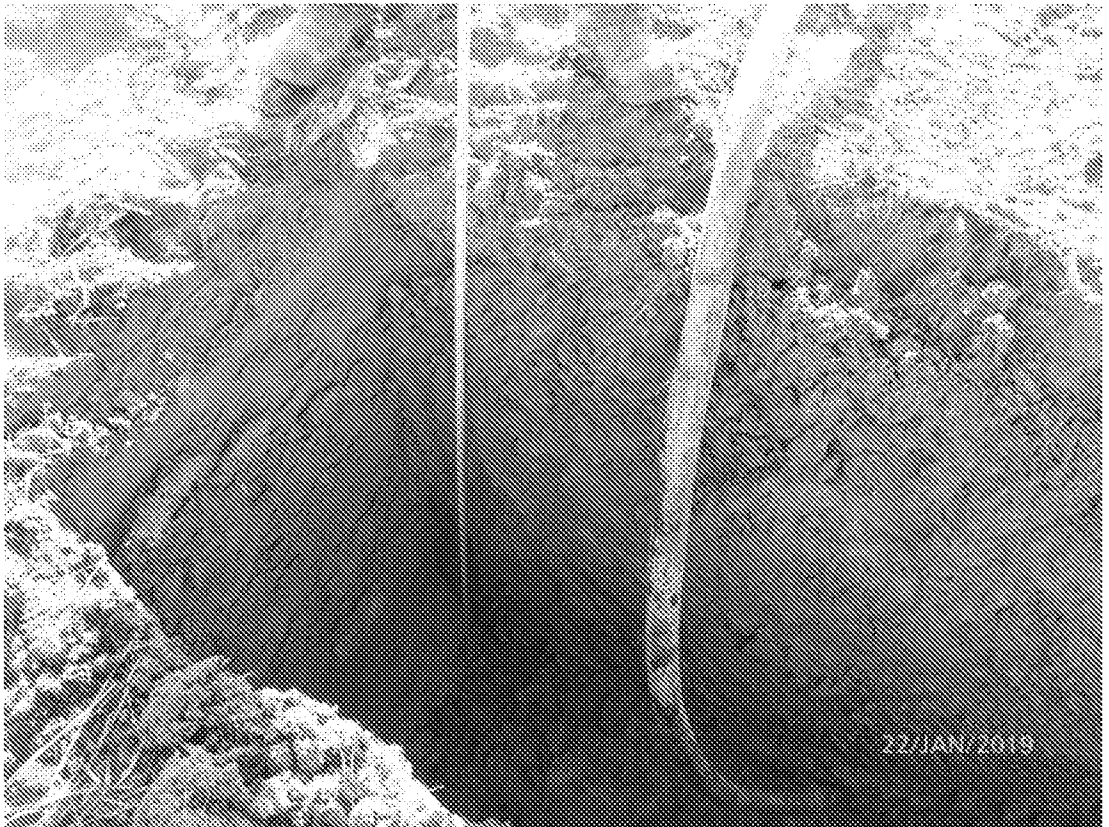
| PHOTOGRAPHIC LOG | | 305035 L01 (00) |
|---|---|---|
| <b>Photo No.</b><br>40 | | |

| PHOTOGRAPHIC LOG | | 305035 L01 (00) |
|---|---|---|
| Downhole view<br>of TP219 | | |

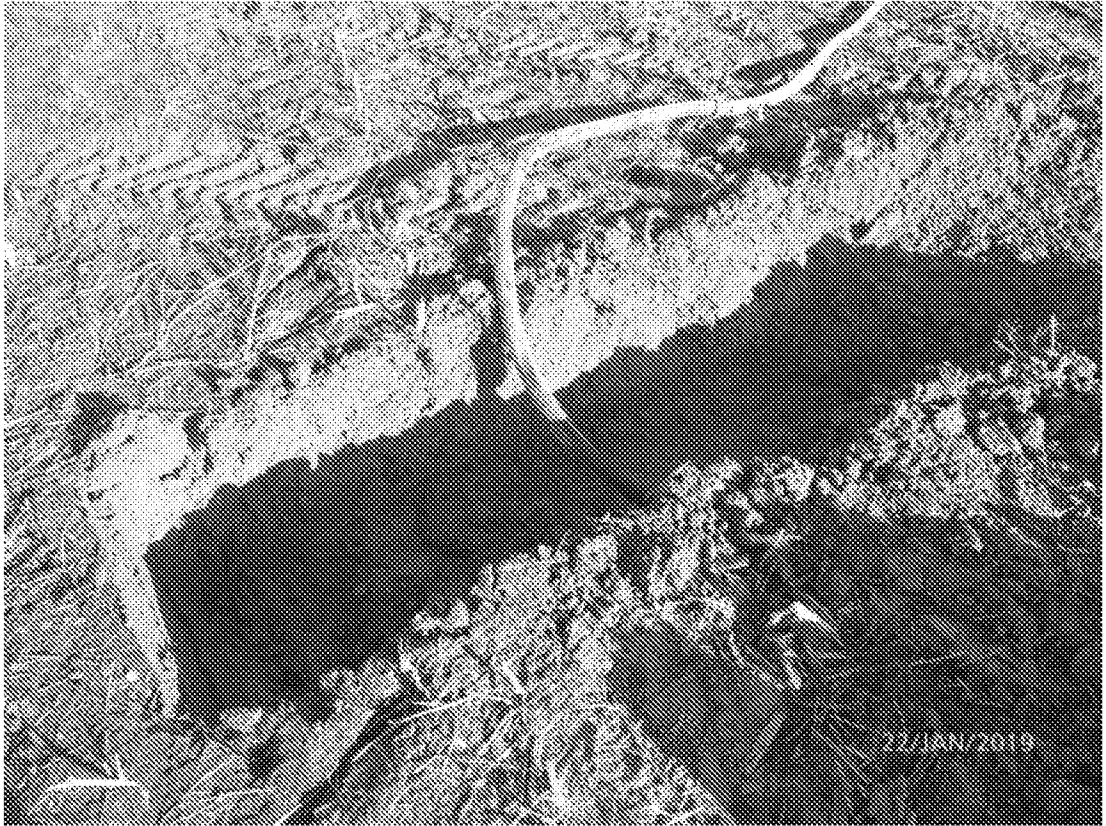
| PHOTOGRAPHIC LOG | | 305035 L01 (00) |
|---|---|---|
| Photo No.<br>41 | | |

| Trial pit (test no.) | Base depth (mbgl) | Effective depth (m) | Test duration (hours) | Time to pass between 75 % and 25 % effective depth (seconds) | Infiltration rate (m/s) |
|---|---|---|---|---|---|
| TP220 | 0.50 | 0.37 | 26 | - | Test fail |

| PHOTOGRAPHIC LOG | | 305035 L01 (00) |
|---|---|---|
| View of TP220 | | |

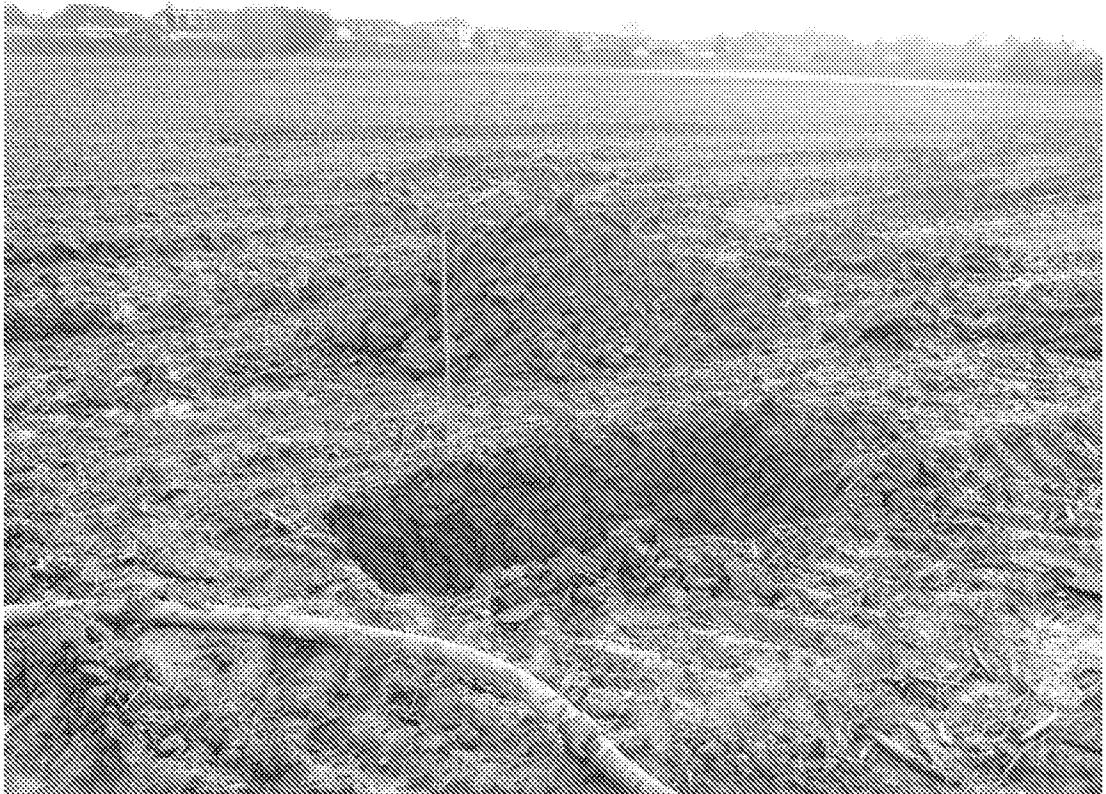
| PHOTOGRAPHIC LOG | | 305035 L01 (00) |
|---|---|---|
| Photo No.<br>42 | | |

| PHOTOGRAPHIC LOG | | 305035 L01 (00) |
|---|---|---|
| Facing east,<br>view of TP221<br>and arisings | | |

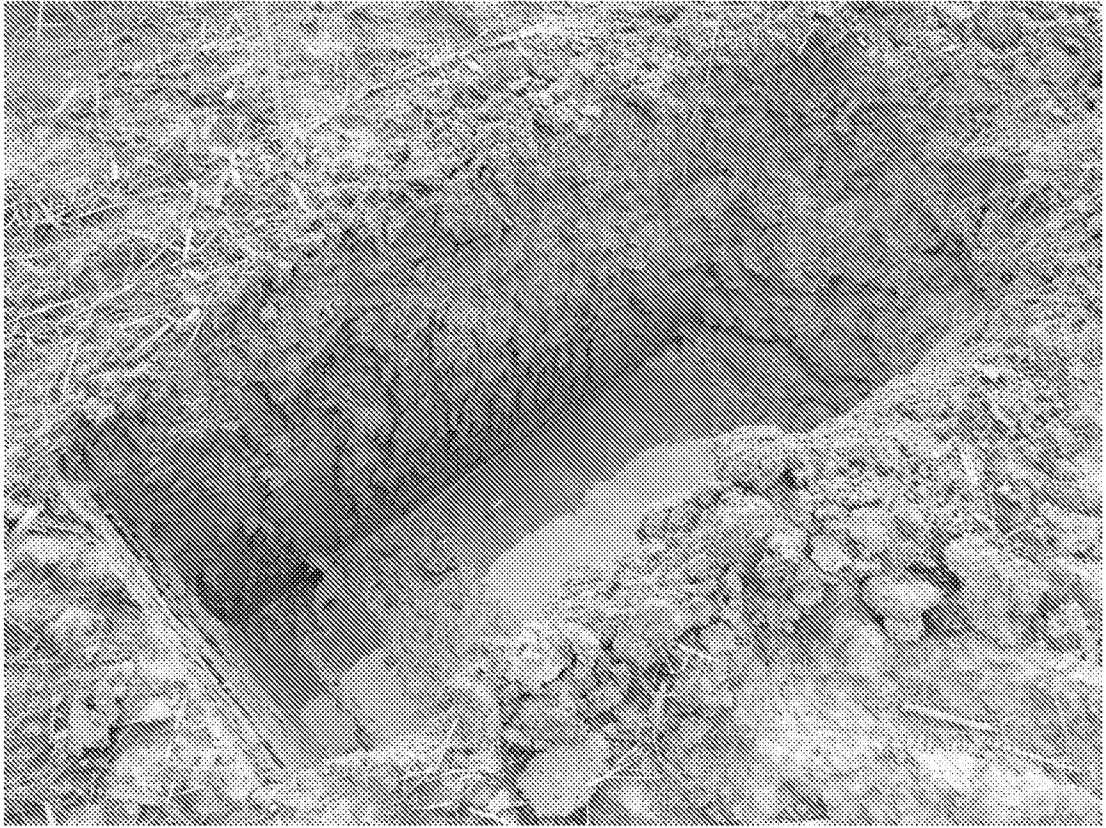
| PHOTOGRAPHIC LOG | | 305035 L01 (00) |
|---|---|---|
| Downhole view of TP221 during soakage test | | |

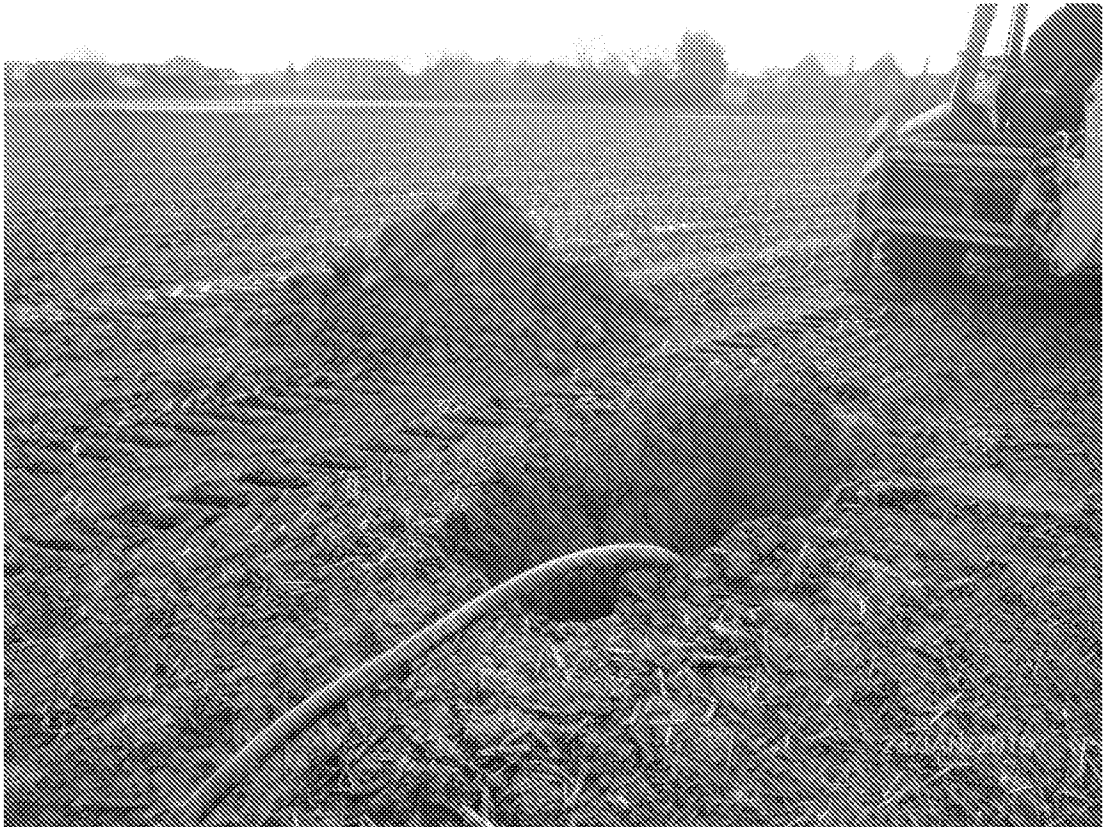
| PHOTOGRAPHIC LOG | | 305035 L01 (00) |
|---|---|---|
| <b>Photo No.</b><br>44 | | |

| PHOTOGRAPHIC LOG | | 305035 L01 (00) |
|---|---|---|
| Facing southeast, view of TP222 | | |
