Our Ref: 305035 L01 (01)

16<sup>th</sup> July 2019

**RE: SEFTER ROAD, BOGNOR REGIS, PO21 3EE  
SUPPLEMENTARY HYDROGEOLOGICAL SITE ASSESSMENT**

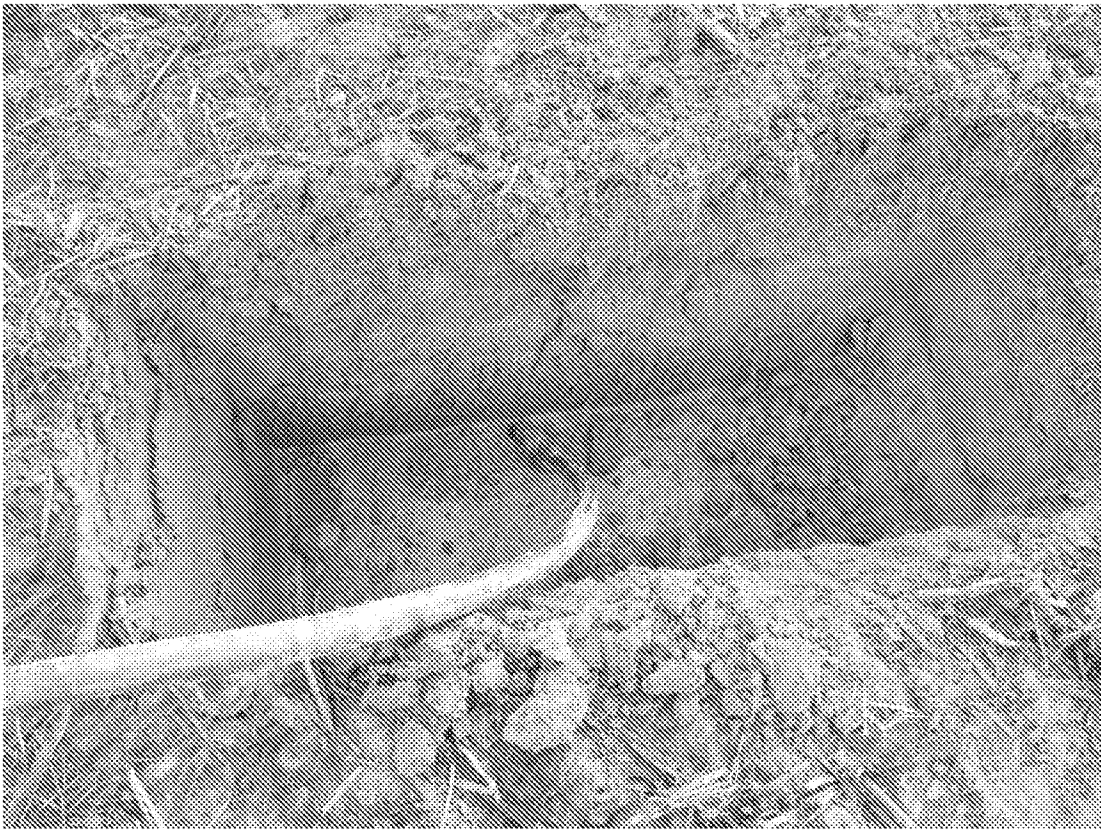
| PHOTOGRAPHIC LOG | | 305035 L01 (00) |
|---|---|---|
| Photo No.<br>45 | | |

| PHOTOGRAPHIC LOG | | 305035 L01 (00) |
|---|---|---|
| Downhole view<br>of TP222 | | |

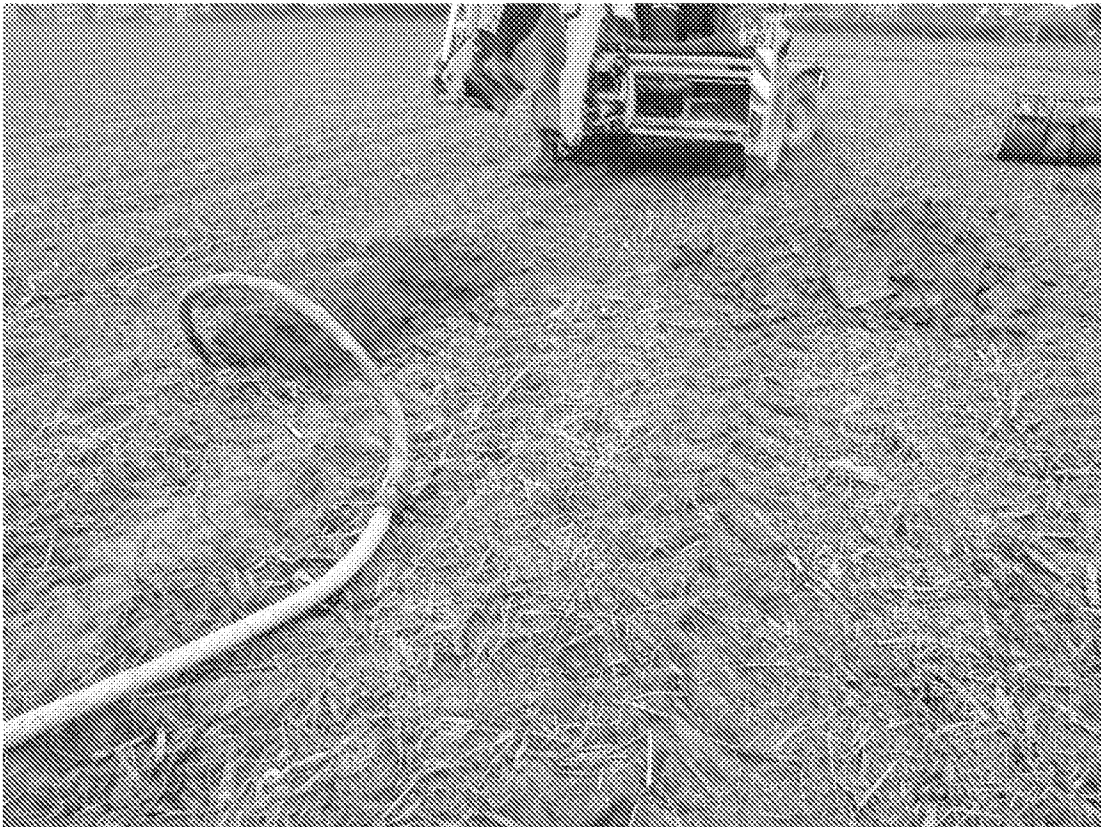
| PHOTOGRAPHIC LOG | | 305035 L01 (00) |
|---|---|---|
| Photo No.<br>46 | | |

| PHOTOGRAPHIC LOG | | 305035 L01 (00) |
|---|---|---|
| Facing south,<br>view of TP223 | | |

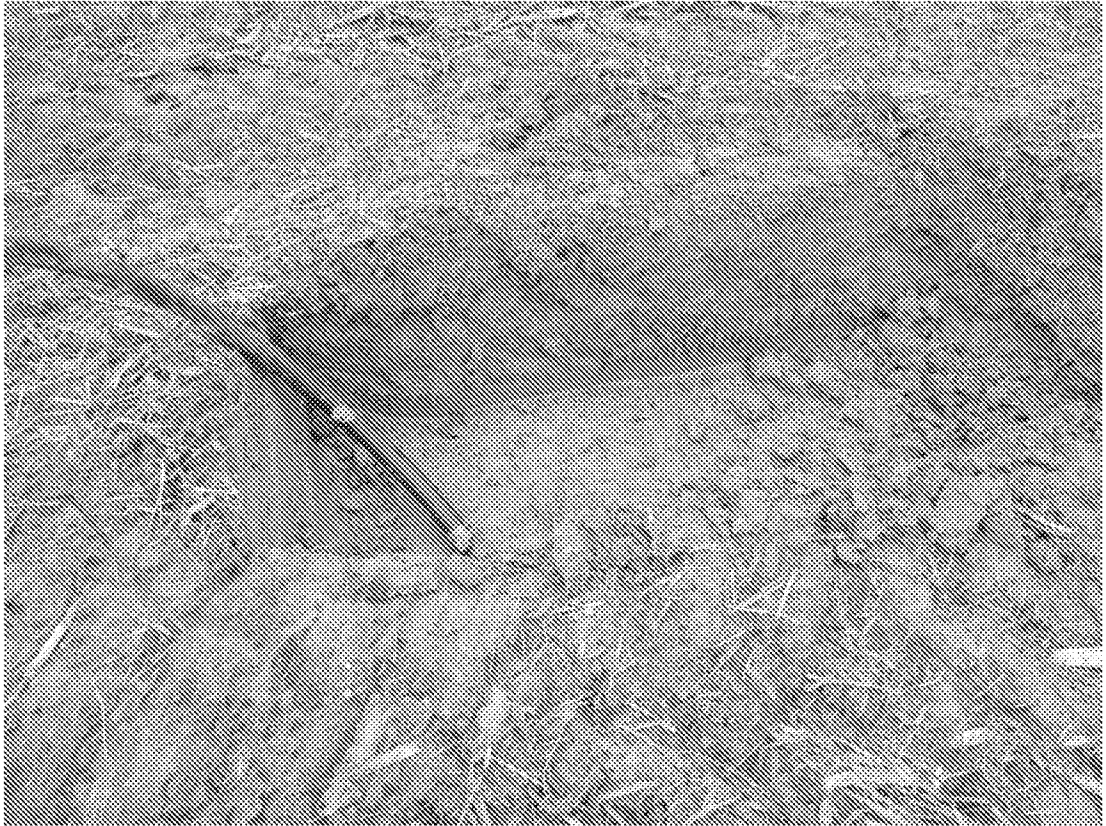
| PHOTOGRAPHIC LOG | | 305035 L01 (00) |
|---|---|---|
| Photo No.<br>47 | | |

| PHOTOGRAPHIC LOG | | 305035 L01 (00) |
|---|---|---|
| Downhole view<br>of TP223 | | |
