**Bat Survey  
Butterlees Farm  
Pagham Road  
Lagness  
Chichester**

**Stephanie Murphy  
August 2010**

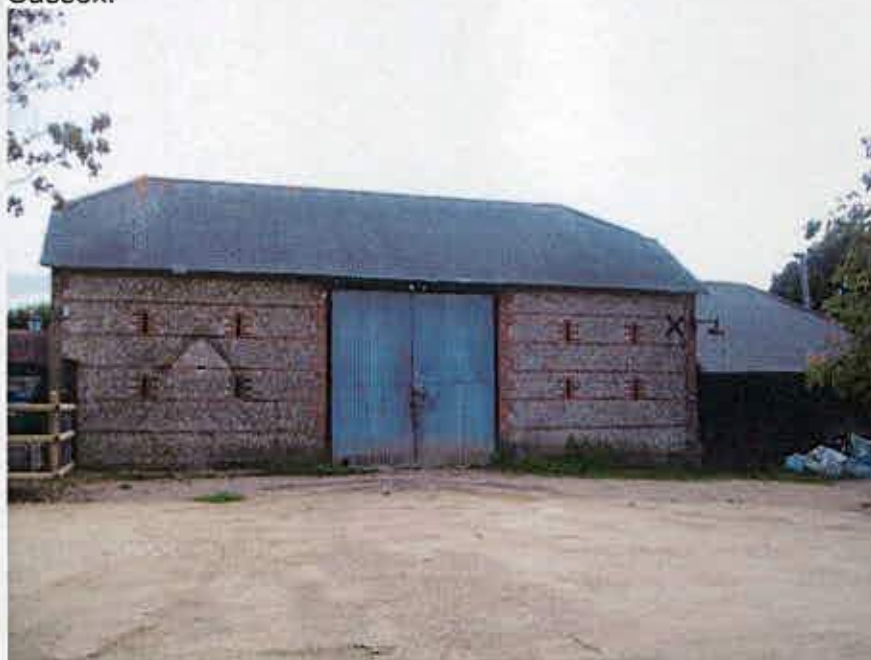
**Photograph 2.1:** Building 1 and 2, Butterlees Farm, Pagham Road, Lagness, West Sussex.

- 2.4 Building 2, also shown in Photograph 2.1, is single storey lean to, of brick, stone and flint construction, situated to the north-west of the main barn building. The building has wooden double doors comprising the north-east of the building, and a slate roof overlaid on the timber roof batons.
- 2.5 Building 3, shown in Photograph 2.3, historically was used as a cow shed but is now used for timber storage. The single storey building is of brick, stone and flint construction, with half of the roof comprised of slate tiles overlaid against the timber roof batons and the other half of the roof is comprised of asbestos sheeting. Lead flashing is present across the roof ridge. A small lean to, with wooden doors and flat plastic corrugated roofing is situated between the building and the main residential property (which is not within the proposed application).

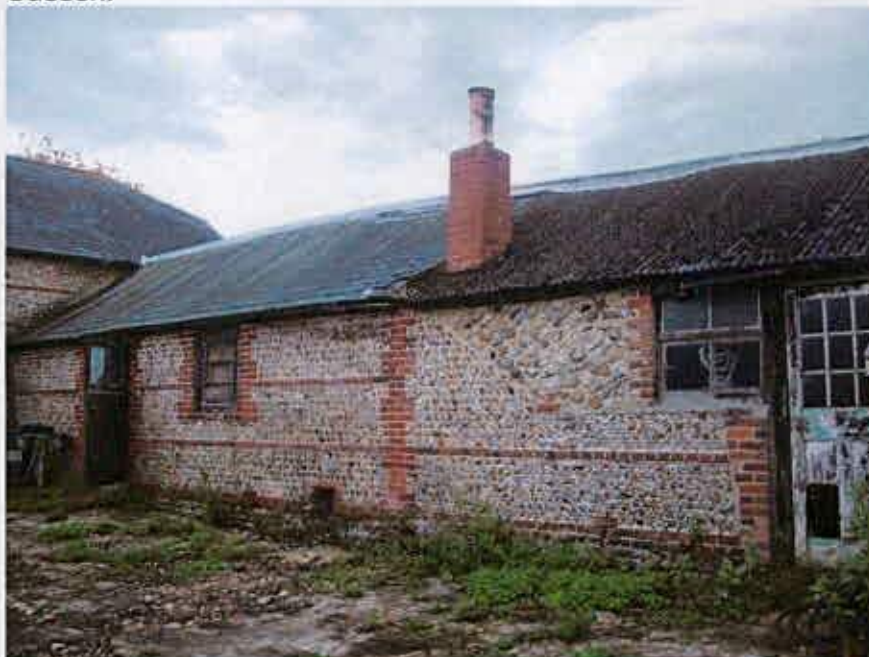
**Photograph 2.3:** Building 3, Butterlees Farm, Pagham Road, Lagness, West Sussex.

- 4.6 An exterior inspection of the building noted numerous bat access areas, including gaps under the eaves, gaps in lead flashing adjacent to brick chimney breast and gaps around the doors. All potential access points were examined but no evidence of bats was found to indicate a large roost site or maternity roost or main emergence point externally.

- 4.7 The interior of the old cow shed was examined using a high powered Cluson torch to look for any bats roosting in crevices. No bats were recorded roosting or any evidence of bats, such as droppings, was found present. The building is used as a timber storage area, and any bats droppings, if present, would have been evident on the stacked timber. The timbers in the roof space were heavily cobwebbed, which implies a lack of bat activity.

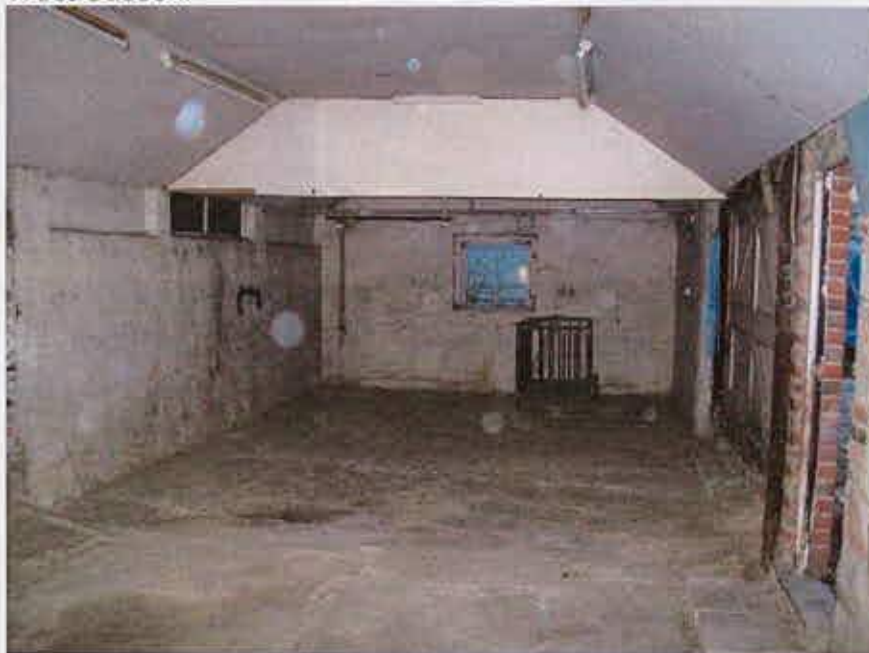
**Photograph 2.4:** Interior of Building 4, Butterlees Farm, Pagham Road, Lagness, West Sussex.

- 2.6 Building 4, previously used as a chicken shed, is now an unused building. The single storey building is of brick, stone and flint construction, with a pitched corrugated tin roof. The interior roof of the building, shown in Photograph 2.4, has been boarded throughout, creating a false flat ceiling.

- 4.10 The interior of the old chicken shed was examined using a high powered Cluson torch to look for any bats roosting in crevices. A false ceiling prevented a visual inspection of the roof space, but the loft area was accessed via a ladder and hatch. The roof is comprised of corrugated tin and limited bat roosting areas are present. No bats were recorded roosting or any evidence of bats, such as droppings, was found present. The roof area was heavily cobwebbed, which implies a lack of bat activity.

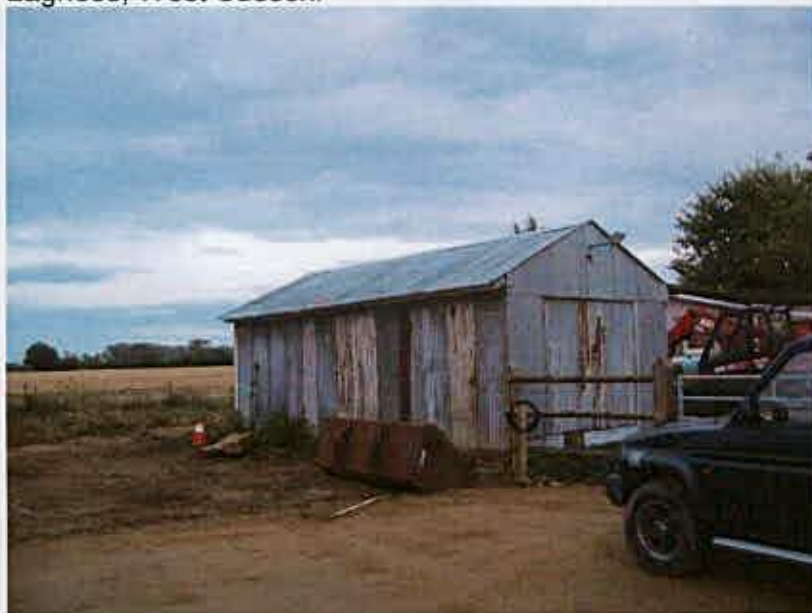
**Photograph 2.5:** Temporary storage unit, Butterlees Farm, Pagham Road, Lagness, West Sussex.

- 2.7 There are also two temporary buildings which have been constructed by the property owners as temporary accommodation and storage. These buildings are shown in Photograph 2.5 and 2.6 and not within the current application. However, it is likely that these buildings will be removed at a later stage.

- 4.11 The temporary buildings used for storage and accommodation, shown in Photograph 2.5 and 2.6, were considered unlikely to support roosting bats.

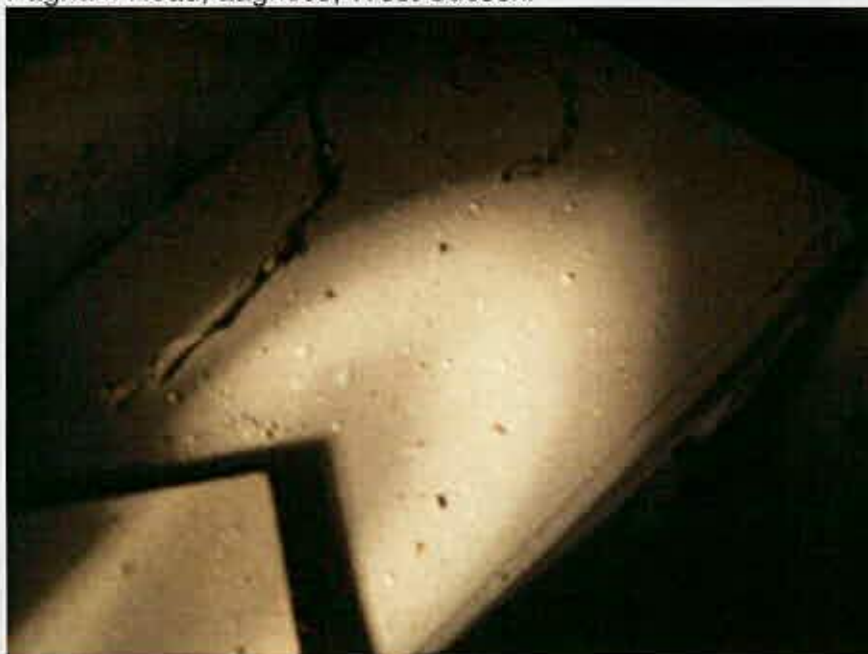
- 4.2 An exterior inspection of the building noted numerous bat access areas, including gaps under the eaves, ventilation gaps in the brickwork, gaps under the ridge tiles and gaps above both double barn doors. All potential access points were examined but no evidence of bats was found to indicate a large roost site or maternity roost or main emergence point externally.
- 4.3 The interior of the barn and timber frame structure was examined using a high powered Cluson torch to look for any bats roosting in crevices. No bats were recorded roosting but a few scattered bat droppings (approximately 10) were found on work surfaces and on some machinery, as shown in Photograph 4.1. The droppings were a mixture of old and fresh, and likely to be Common Pipistrelle (*Pipistrellus pipistrellus*) droppings.

**Photograph 4.1:** Scattered small bat droppings, Building 1, Butterlees Farm, Pagham Road, Lagness, West Sussex.

- 6.1 No fresh droppings or recent evidence of bats were identified examining around the exterior of the buildings and only low numbers of fresh droppings were identified inside Building 1. The small amount of droppings recorded present at Building 1, Butterlees Farm, is not typical of a main roost site. The numerous potential access areas in the barn, in conjunction with the low number of droppings, are more typical of a bat in flight or a night roost.

- 6.6 Bats are protected under the Wildlife and Countryside Act 1981 (as amended) and the Conservation contravening (Natural Habitats &c.) Regulations 1994, (which make it illegal to intentionally kill, injure or otherwise disturb bats, or to damage, destroy or obstruct access to a bat roost, whether bats are present or not). As there is a very low chance that individual roosting bats may be present at any time as a precaution potential roosting areas should be stripped by hand under supervision of a licensed bat worker, particularly the ridge board and slate tiles within the main barn, building 1.

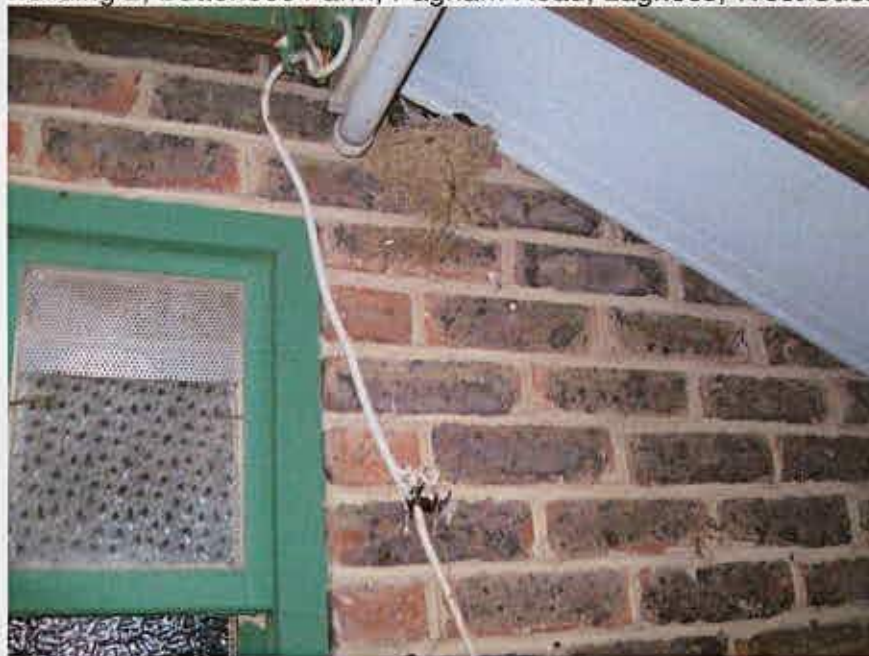
- 4.8 The lean two area between Building 2 and the residential property was examined. No bat roosting potential was noted but an active Swallow (*Hirundo rustica*) nest was noted built against the brick wall of the residential property, shown in Photograph 4.2.

**Photograph 4.2:** Active Swallow nest, located in the 'lean to' at the south-west of Building 2, Butterlees Farm, Pagham Road, Lagness, West Sussex.

- 6.7 Birds - There was evidence of nesting birds using the buildings on site. If any work involving clearance of vegetation or demolition of buildings were scheduled to take place between the beginning of March and the end of August, a survey to check for nesting birds would be required. This applies to trees and ground vegetation. No vegetation can be cleared whilst a nest is occupied.

- 6.10 Due to the presence of breeding Swallows on site, additional nesting sites could be provided by the provision of nesting boxes, such as the Schwegler No 10 Swallow Nest.
