**Appendix -** (for general location details shown in the photographs, refer to Figures 1 and 3)

## **Pagham Harbour Photographs 2001 to 2019**

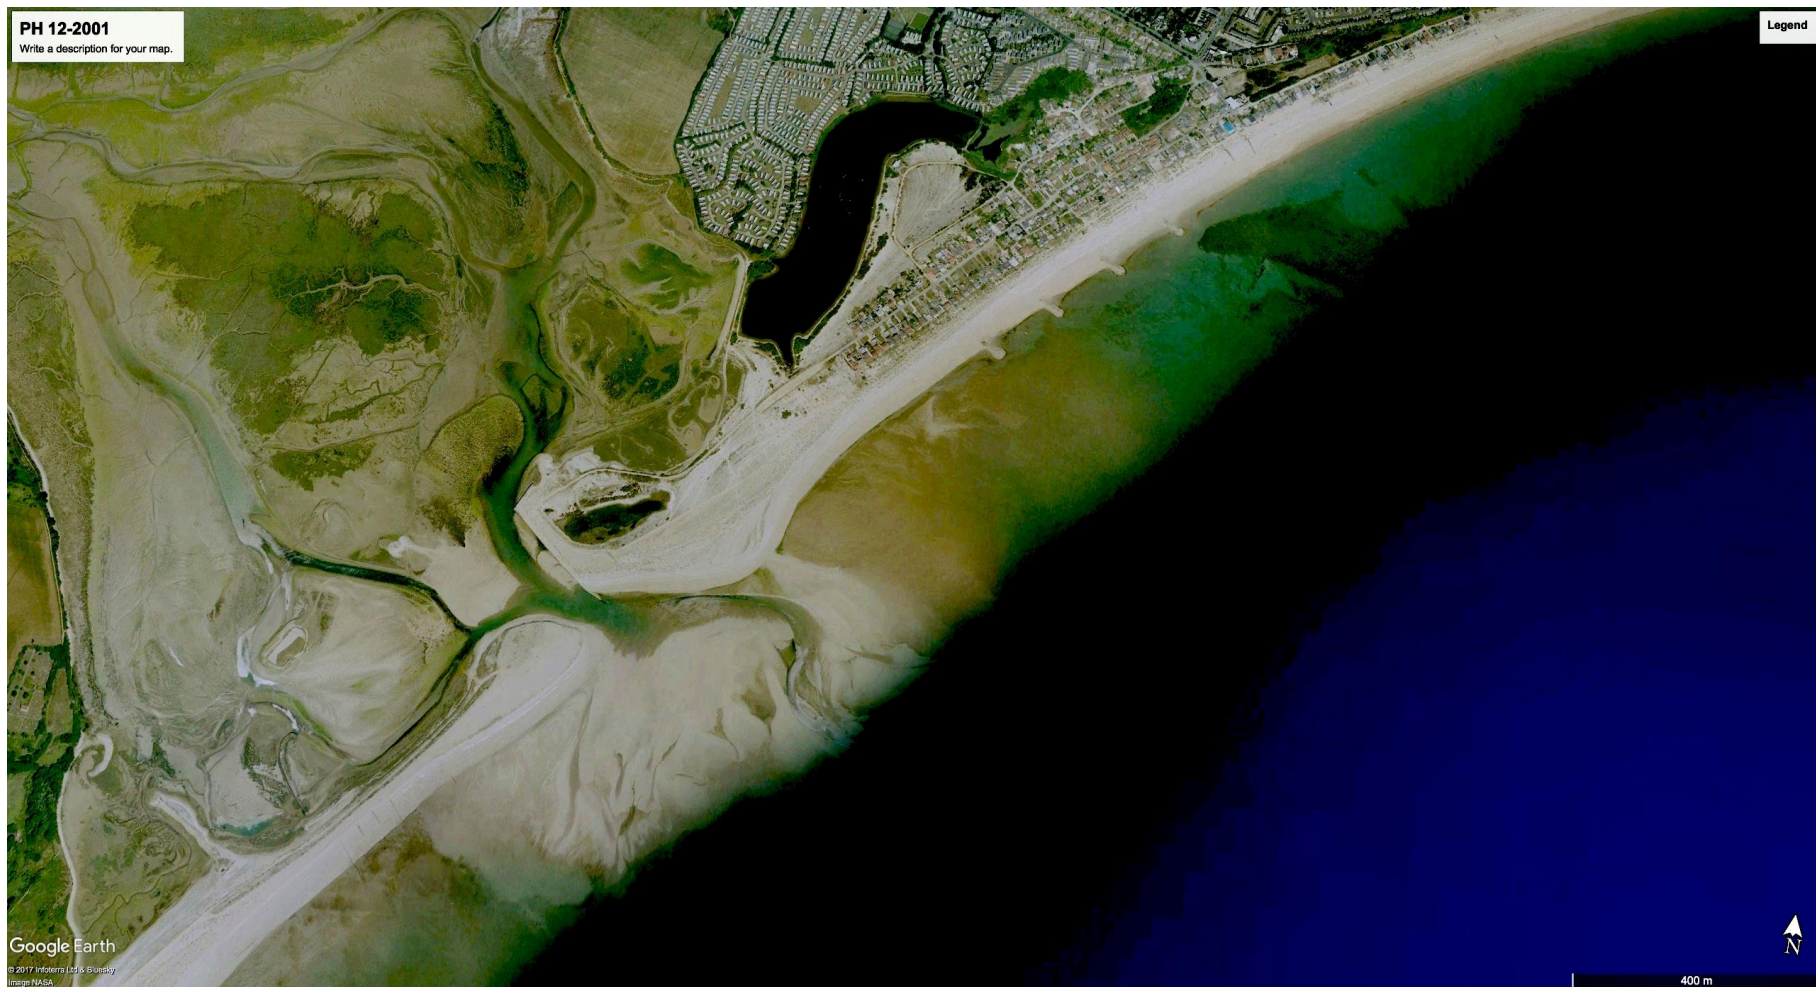
**Photograph 2** – taken December 2001

Training wall actively fixing channel at each end with evidence of flood flow along the steel pile wall with ebb flow curved off the wall – CN spit pushing outlet channel to north-east with delta channels oriented to the south. Delta area significantly larger south west of main outlet channel.

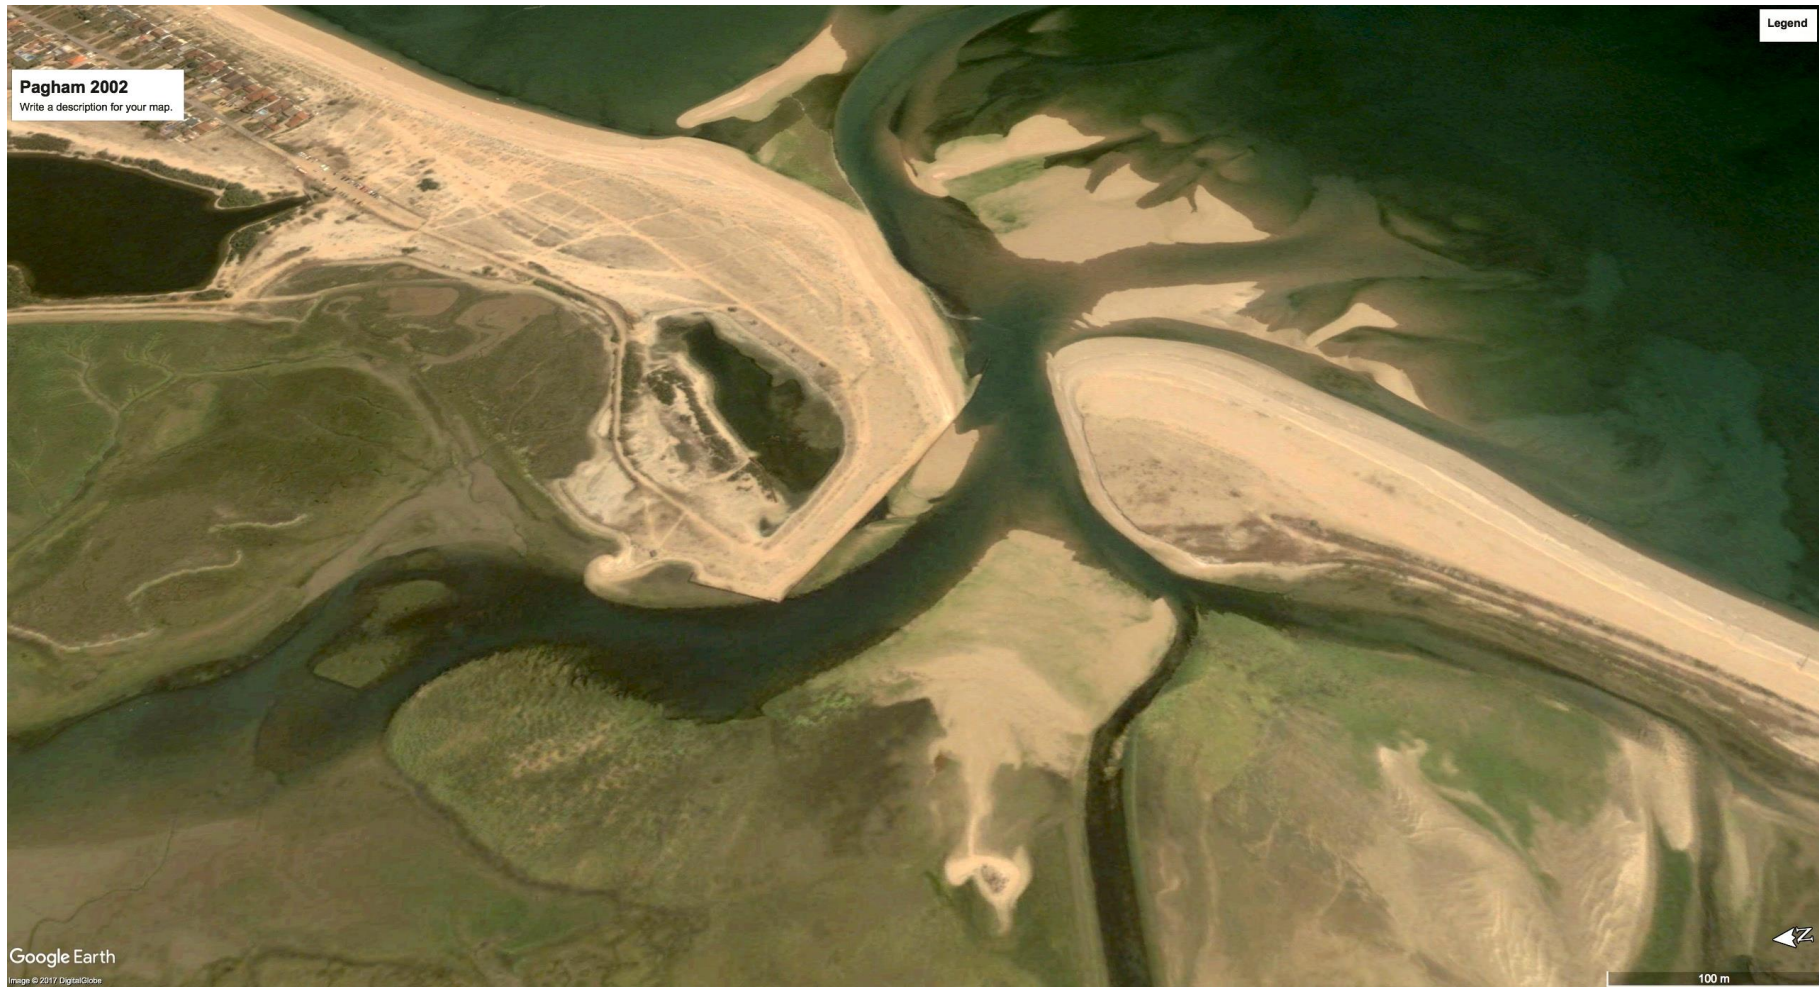
**Photograph 3** – taken August 2002

Training wall actively fixing channel at each end with evidence of flood flow along the steel pile wall with ebb flow curved off the wall – CN spit pushing outlet channel to north-east with delta channels oriented to the south. Delta area significantly larger south west of main outlet channel.

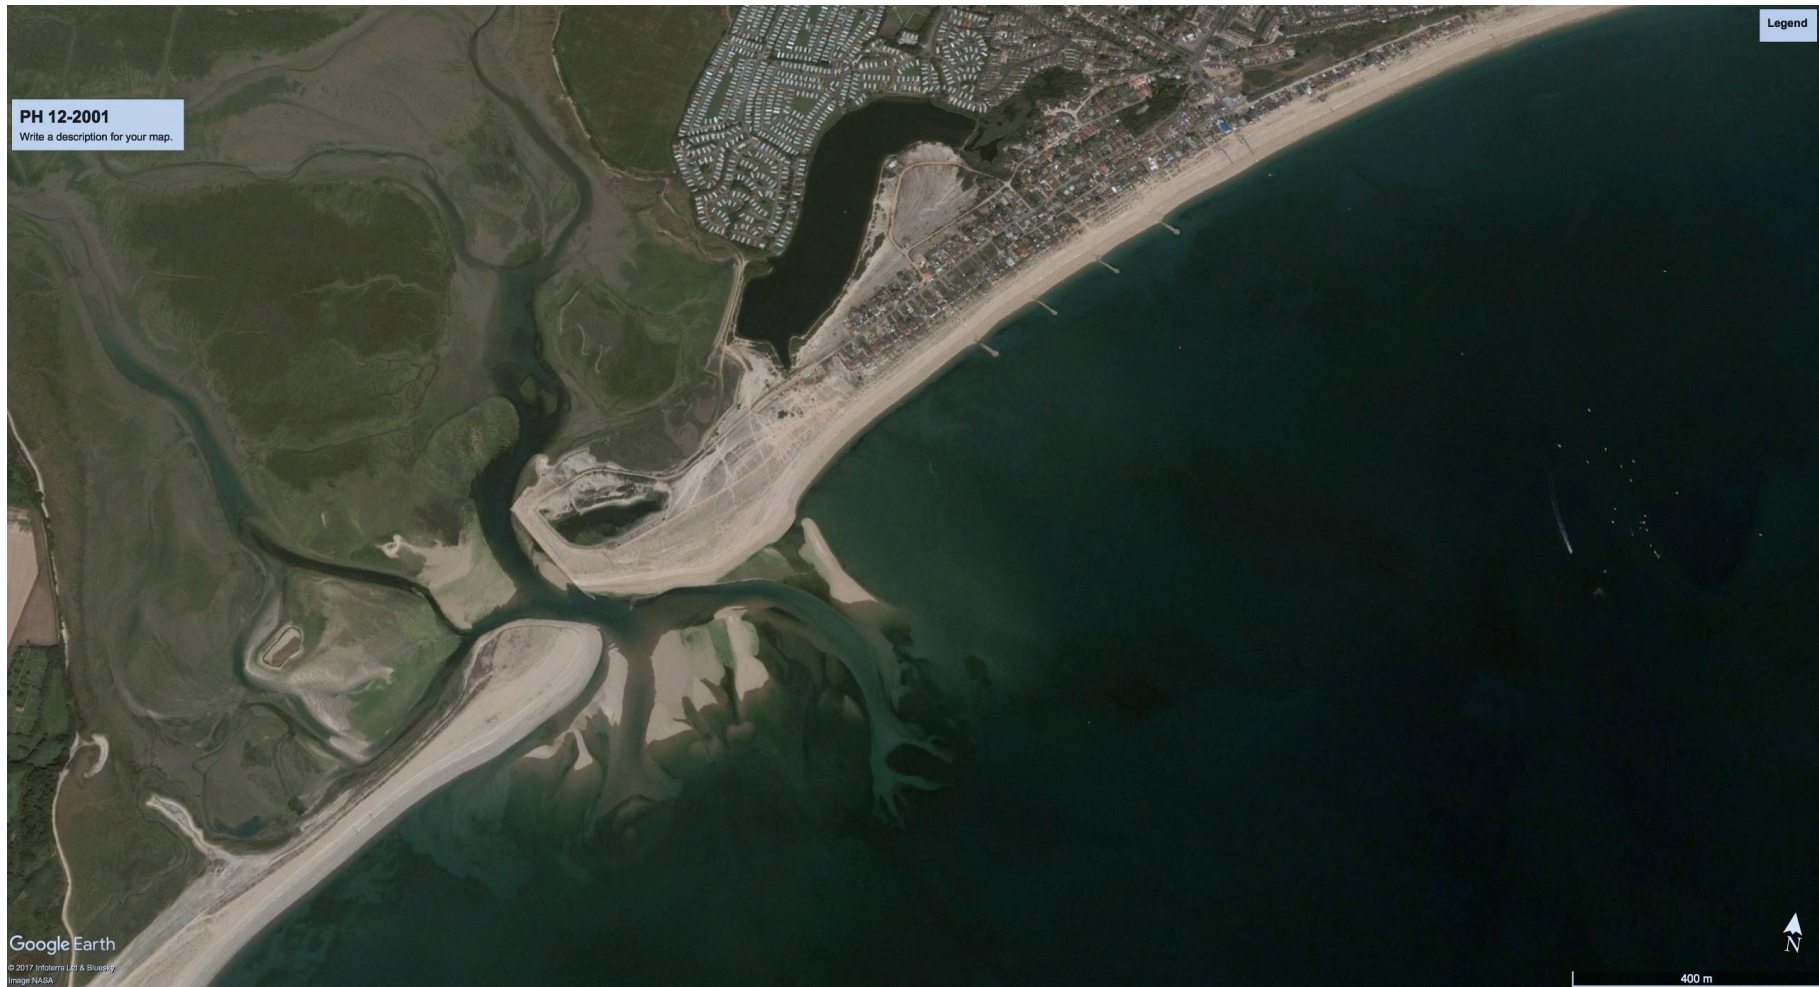
**Photograph 4** – taken August 2002

Training wall actively fixing channel at each end with evidence of flood flow along the steel pile wall with ebb flow curved off the wall – CN spit pushing outlet channel to north-east with delta channels oriented to the south. Delta area significantly larger south west of main outlet channel.

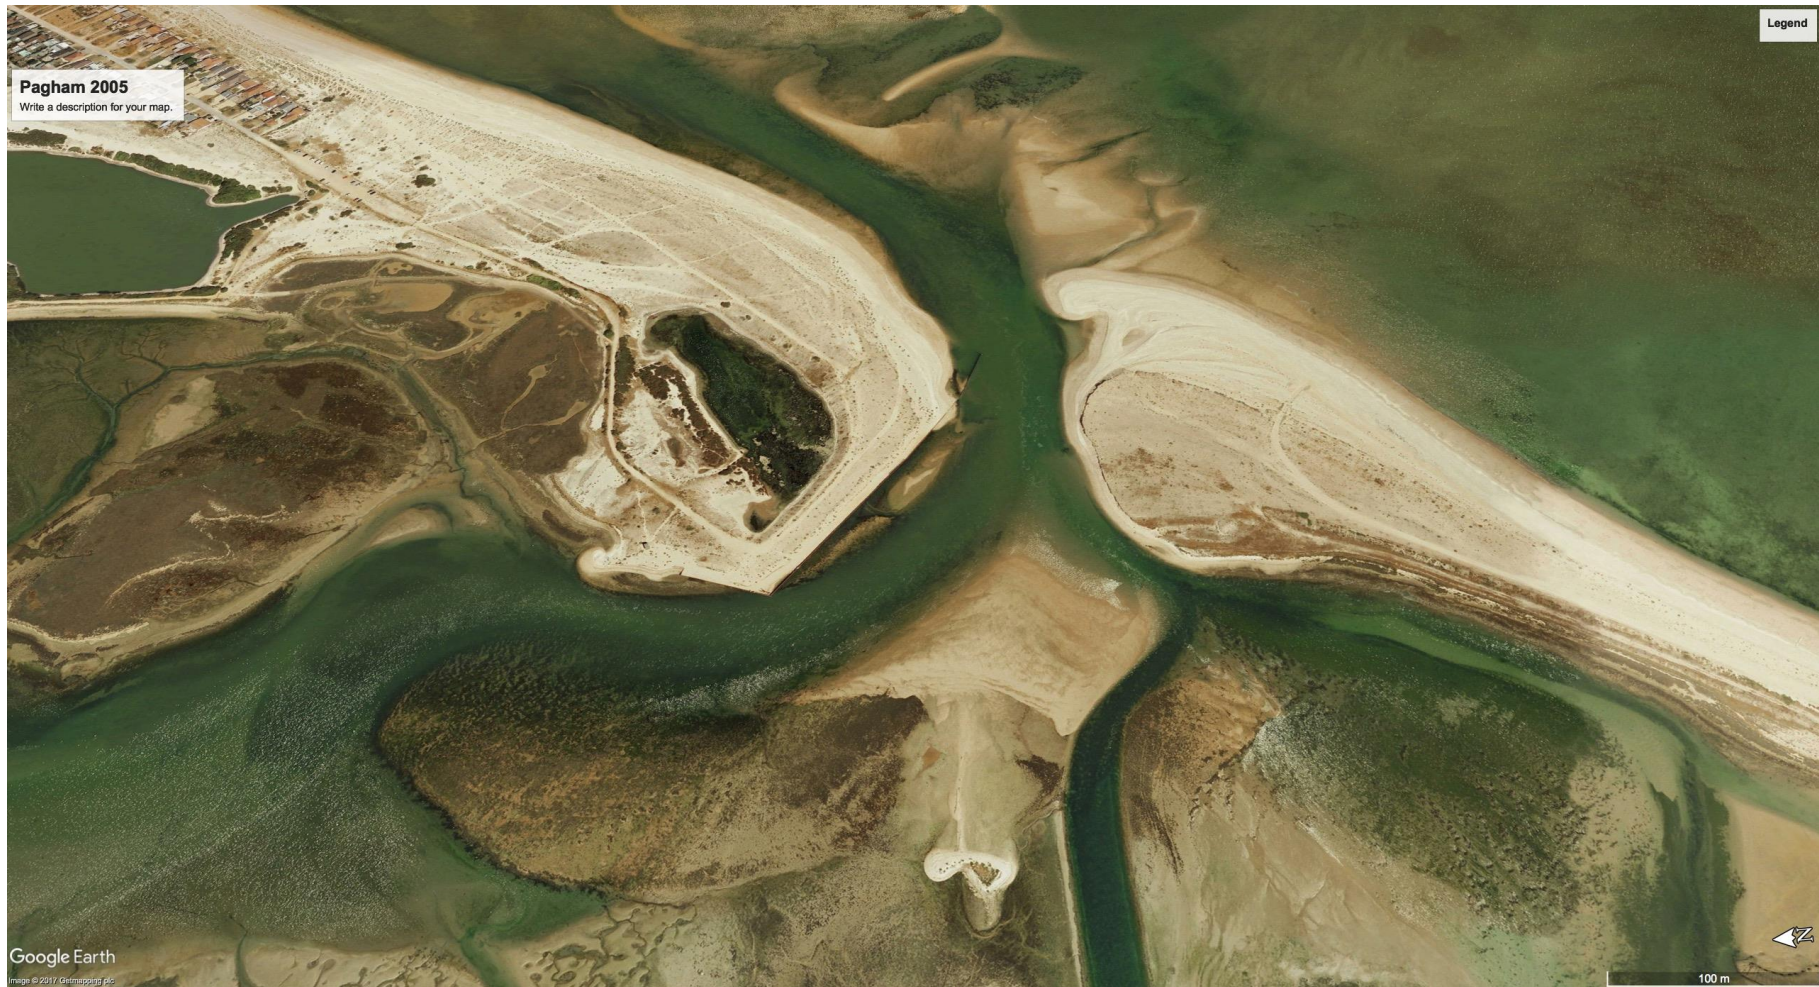
**Photograph 5** – taken December 2005

Shingle recycling from south-western side of outlet channel ceased in 2004 – note embryonic development of CN Spit to seaward of previous location due to mature delta area.

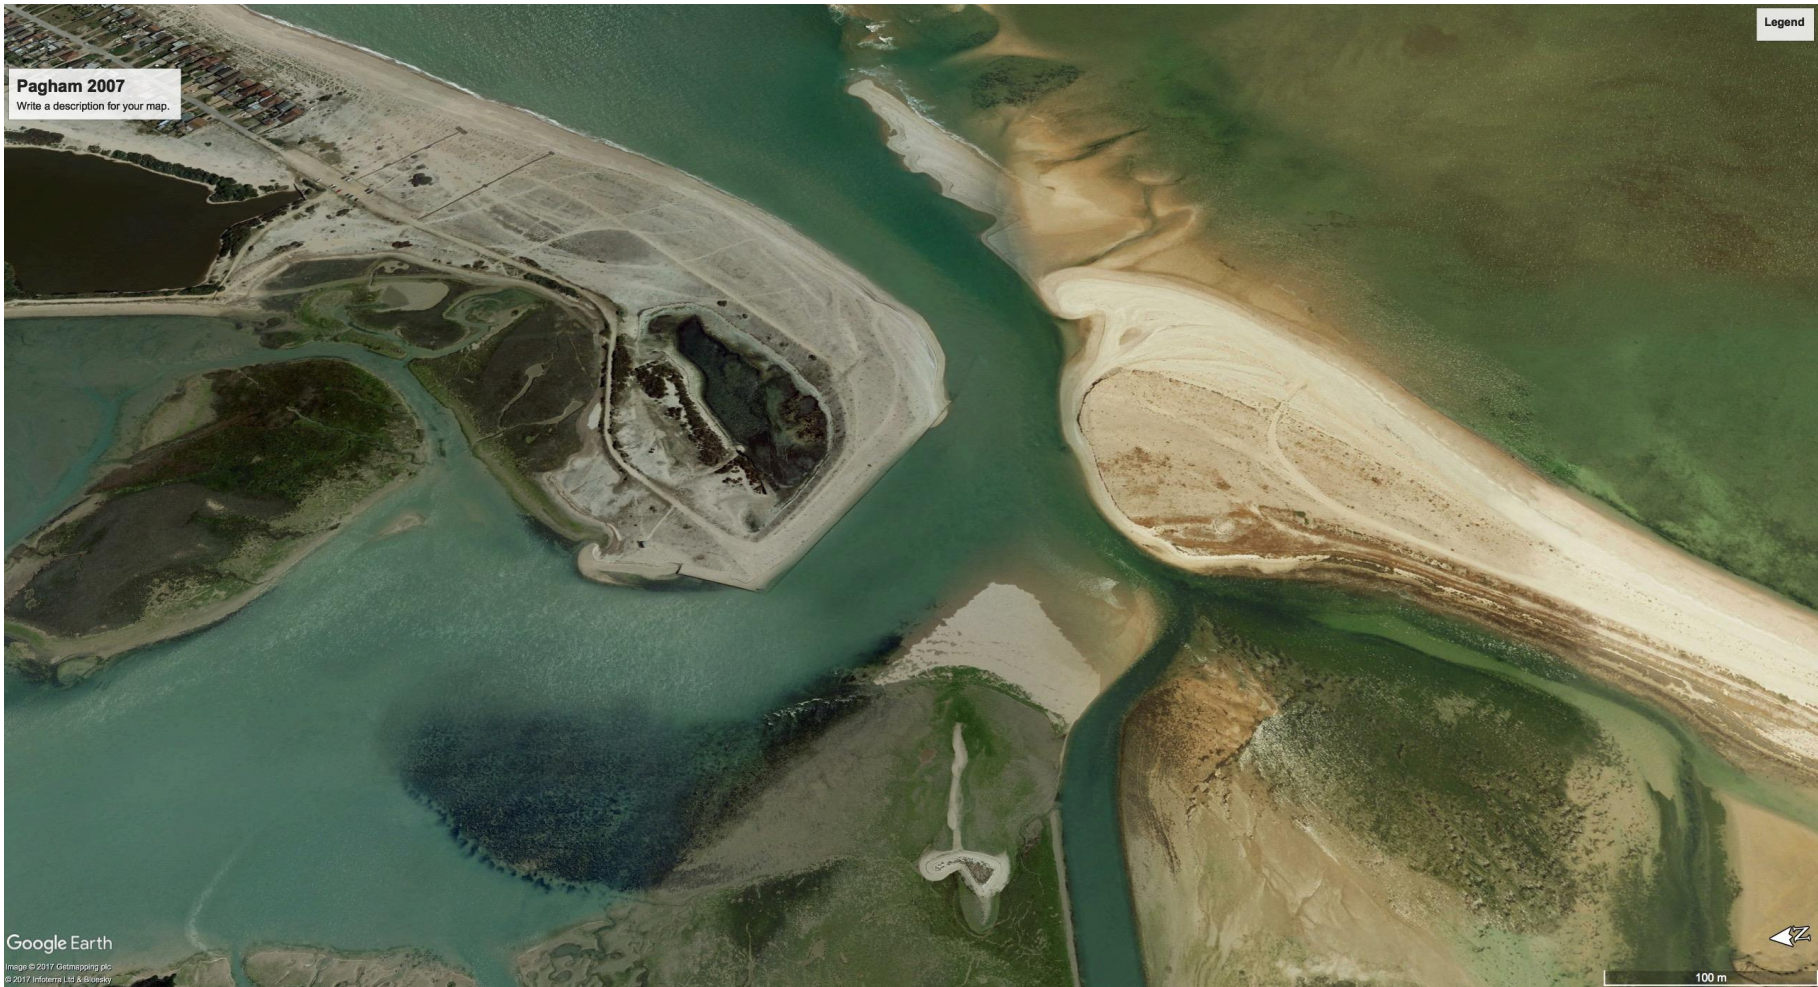
Photograph 7 – taken May 2007

Further spit development in evidence since 2005

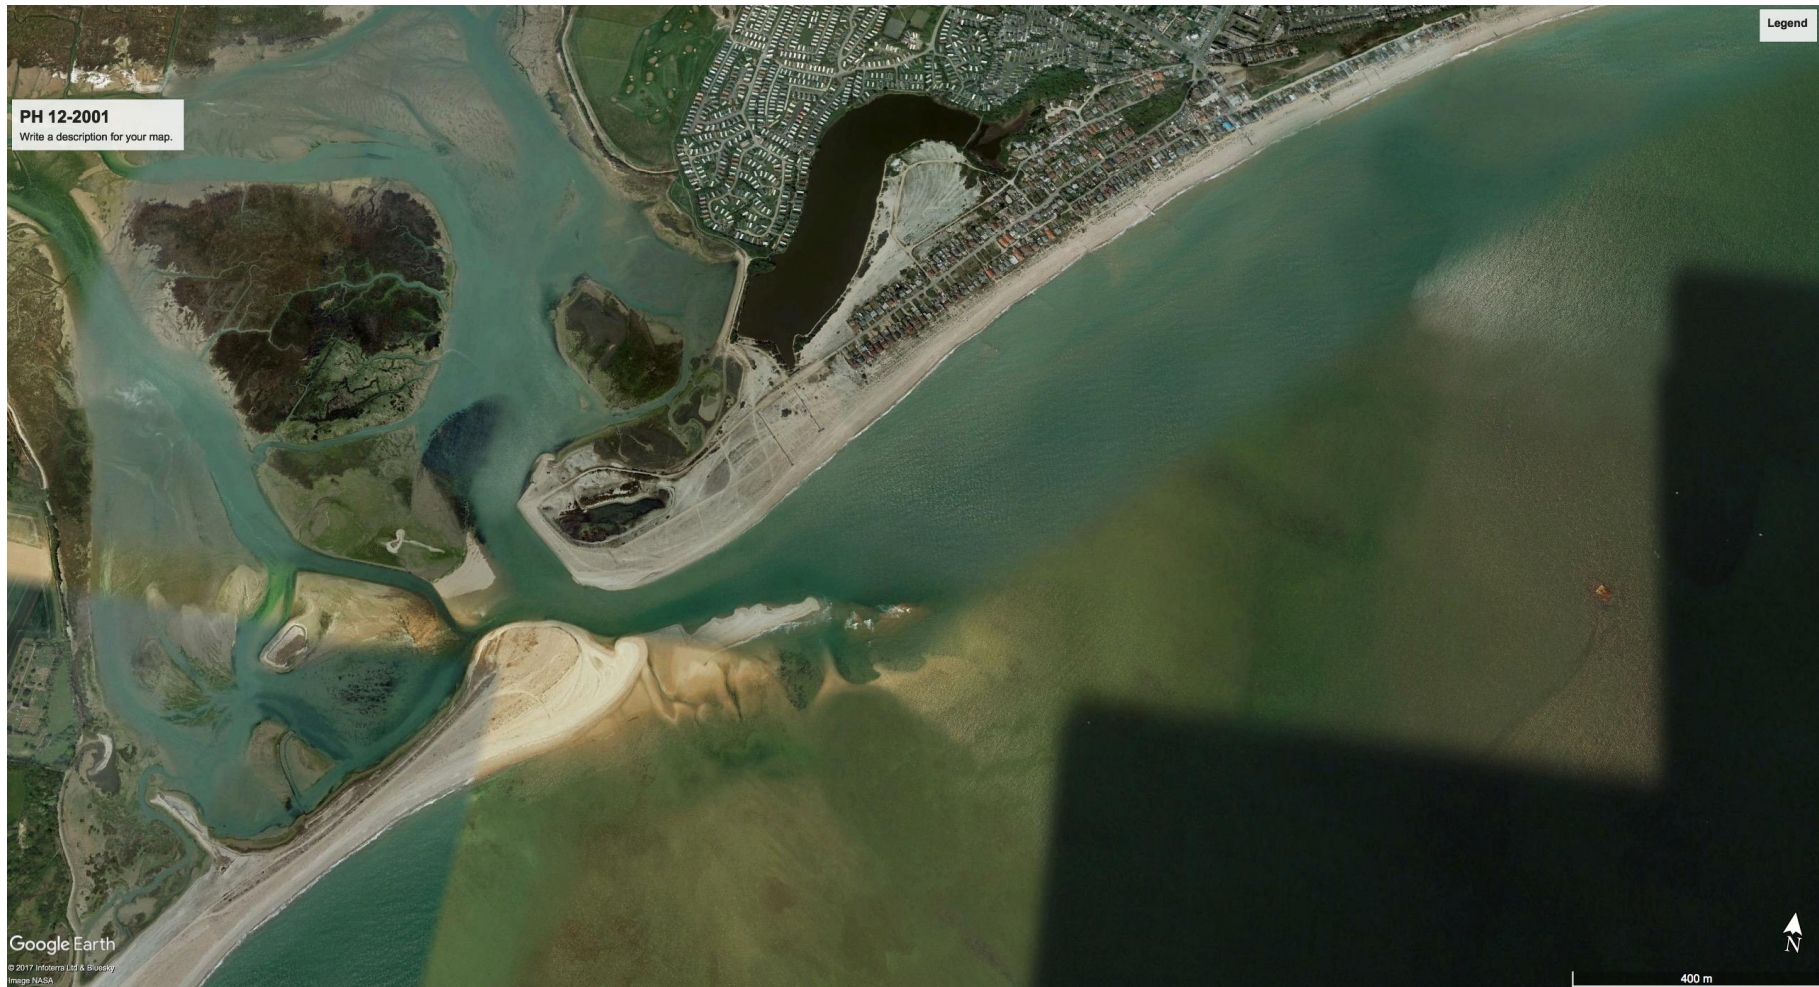
**Photograph 8** – taken May 2007

Further spit development in evidence since 2005

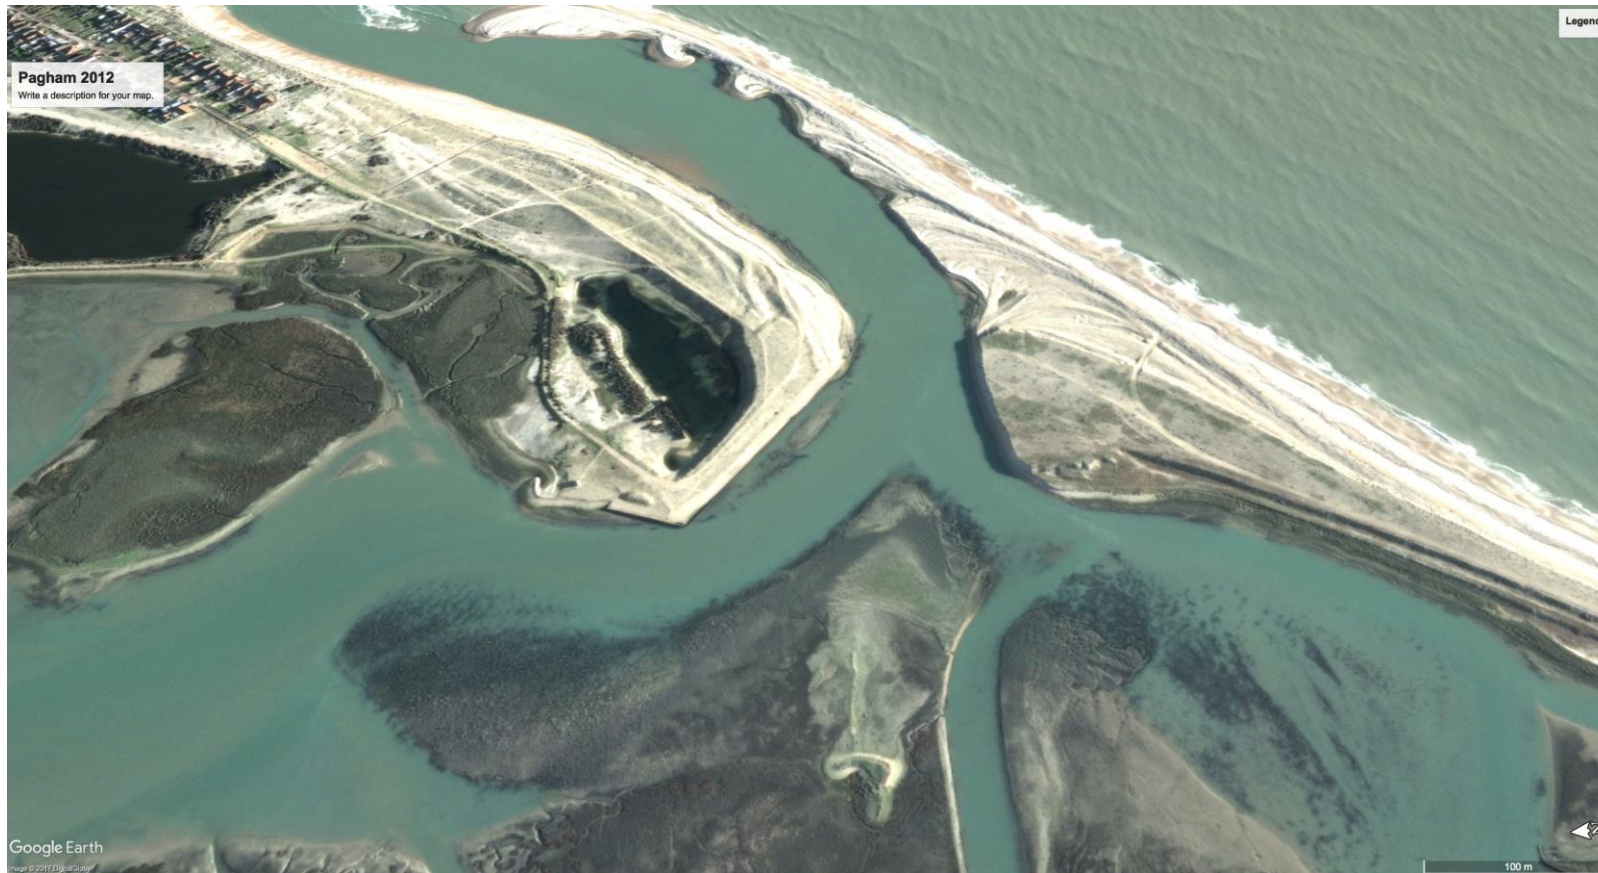
**Photograph 9** – taken January 2012

Further spit development since 2007 – note recurved remnants of spit historical development (9) and the altered behaviour (alignment) of the distal end of the spit in 2012. Upto this point of altered alignment the spit development had been generally linear and parallel to the Pagham Spit, (9, 10). The altered alignment is observed to occur around 2009 and is shown from different perspectives in (11, 12, 13, 14). Wave interaction with the shoreline (14, 15, 16) shows how the angle between the spit beach contours and the wave crests alters – the movement of shingle alongshore on the spit will alter with this angle alteration.

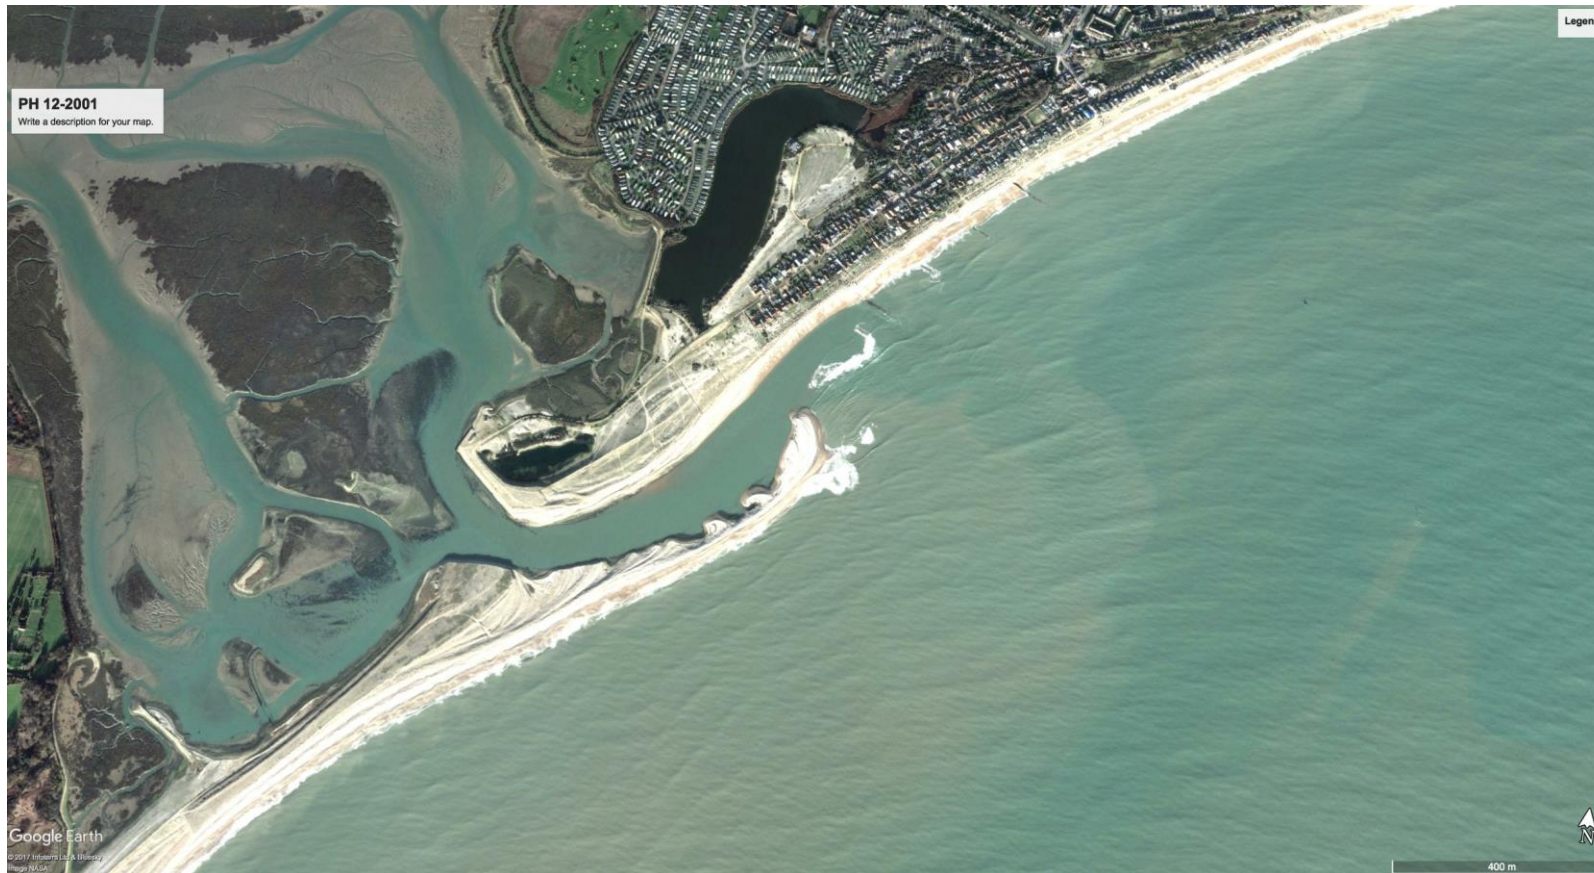
**Photograph 10** – taken January 2012

Further spit development since 2007 – note recurved remnants of spit historical development (9) and the altered behaviour (alignment) of the distal end of the spit in 2012. Upto this point of altered alignment the spit development had been generally linear and parallel to the Pagham Spit, (9, 10). The altered alignment is observed to occur around 2009 and is shown from different perspectives in (11, 12, 13, 14). Wave interaction with the shoreline (14, 15, 16) shows how the angle between the spit beach contours and the wave crests alters – the movement of shingle alongshore on the spit will alter with this angle alteration.

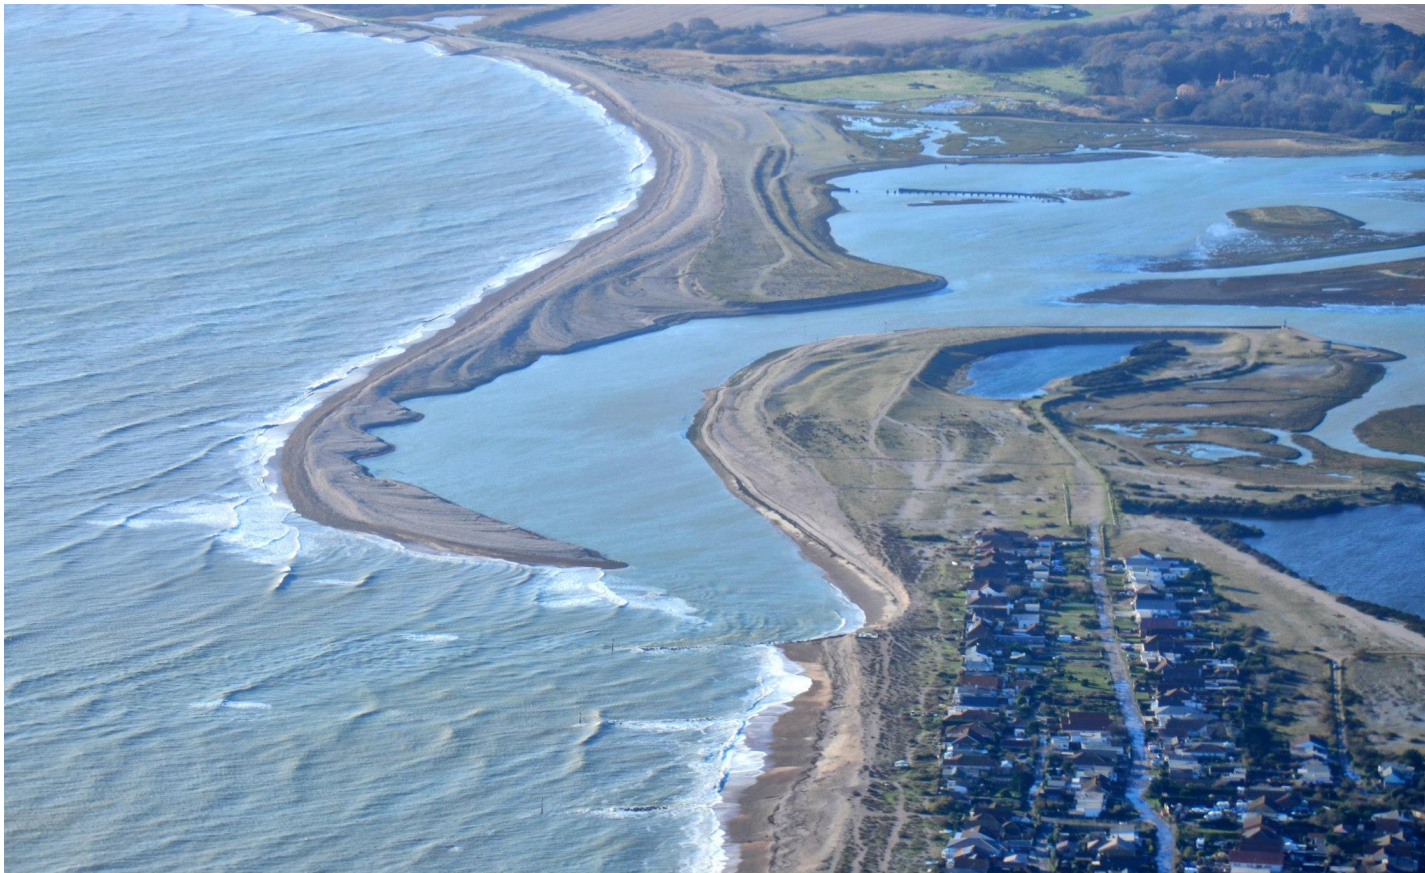
**Photograph 11** – taken 25.11.2012

Further spit development since 2007 – note recurved remnants of spit historical development (9) and the altered behaviour (alignment) of the distal end of the spit in 2012. Upto this point of altered alignment the spit development had been generally linear and parallel to the Pagham Spit, (9, 10). The altered alignment is observed to occur around 2009 and is shown from different perspectives in (11, 12, 13, 14). Wave interaction with the shoreline (14, 15, 16) shows how the angle between the spit beach contours and the wave crests alters – the movement of shingle alongshore on the spit will alter with this angle alteration.

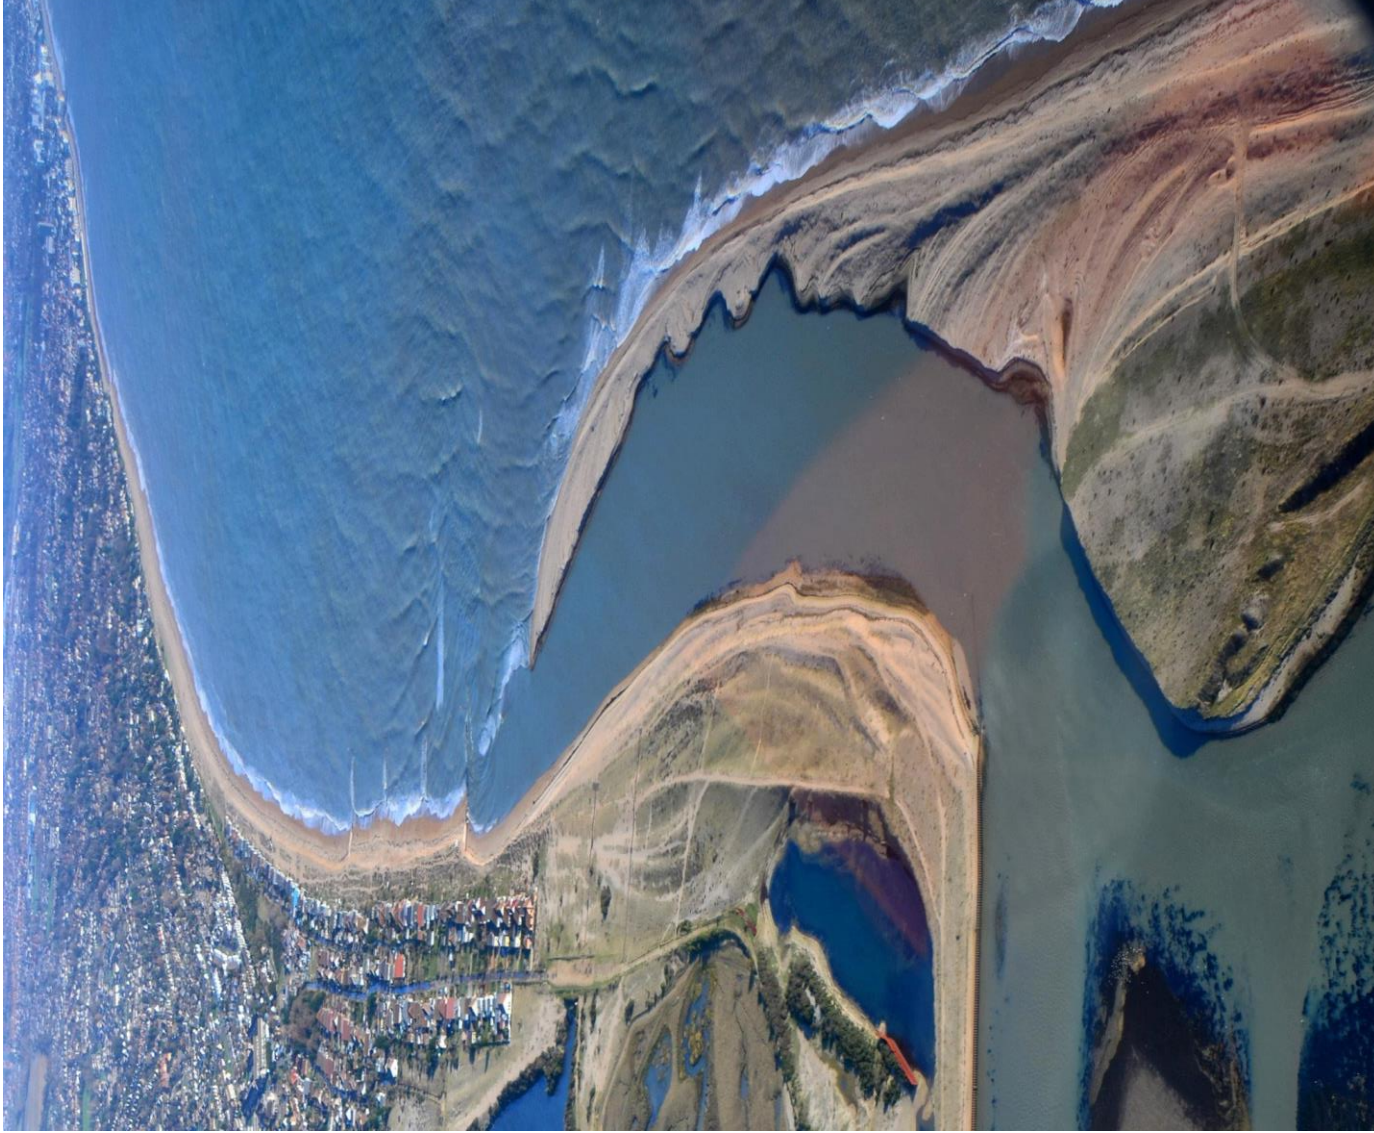
**Photograph 12** – taken 25.11.2012

Further spit development since 2007 – note recurved remnants of spit historical development (9) and the altered behaviour (alignment) of the distal end of the spit in 2012. Up to this point of altered alignment the spit development had been generally linear and parallel to the Pagham Spit, (9, 10). The altered alignment is observed to occur around 2009 and is shown from different perspectives in (11, 12, 13, 14). Wave interaction with the shoreline (14, 15, 16) shows how the angle between the spit beach contours and the wave crests alters – the movement of shingle alongshore on the spit will alter with this angle alteration.

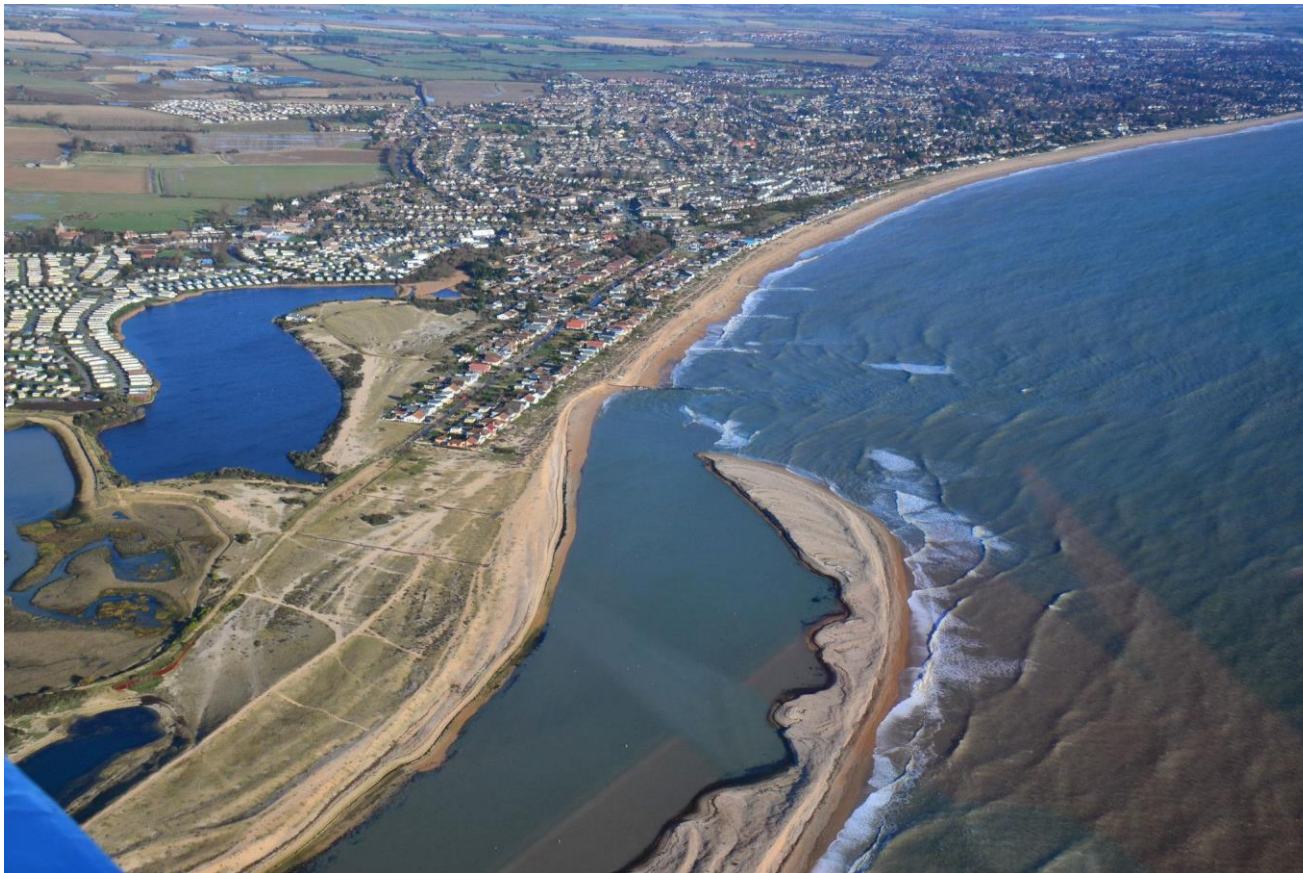
**Photograph 13** – taken 25.11.2012

Further spit development since 2007 – note recurved remnants of spit historical development (9) and the altered behaviour (alignment) of the distal end of the spit in 2012. Upto this point of altered alignment the spit development had been generally linear and parallel to the Pagham Spit, (9, 10). The altered alignment is observed to occur around 2009 and is shown from different perspectives in (11, 12, 13, 14). Wave interaction with the shoreline (14, 15, 16) shows how the angle between the spit beach contours and the wave crests alters – the movement of shingle alongshore on the spit will alter with this angle alteration.

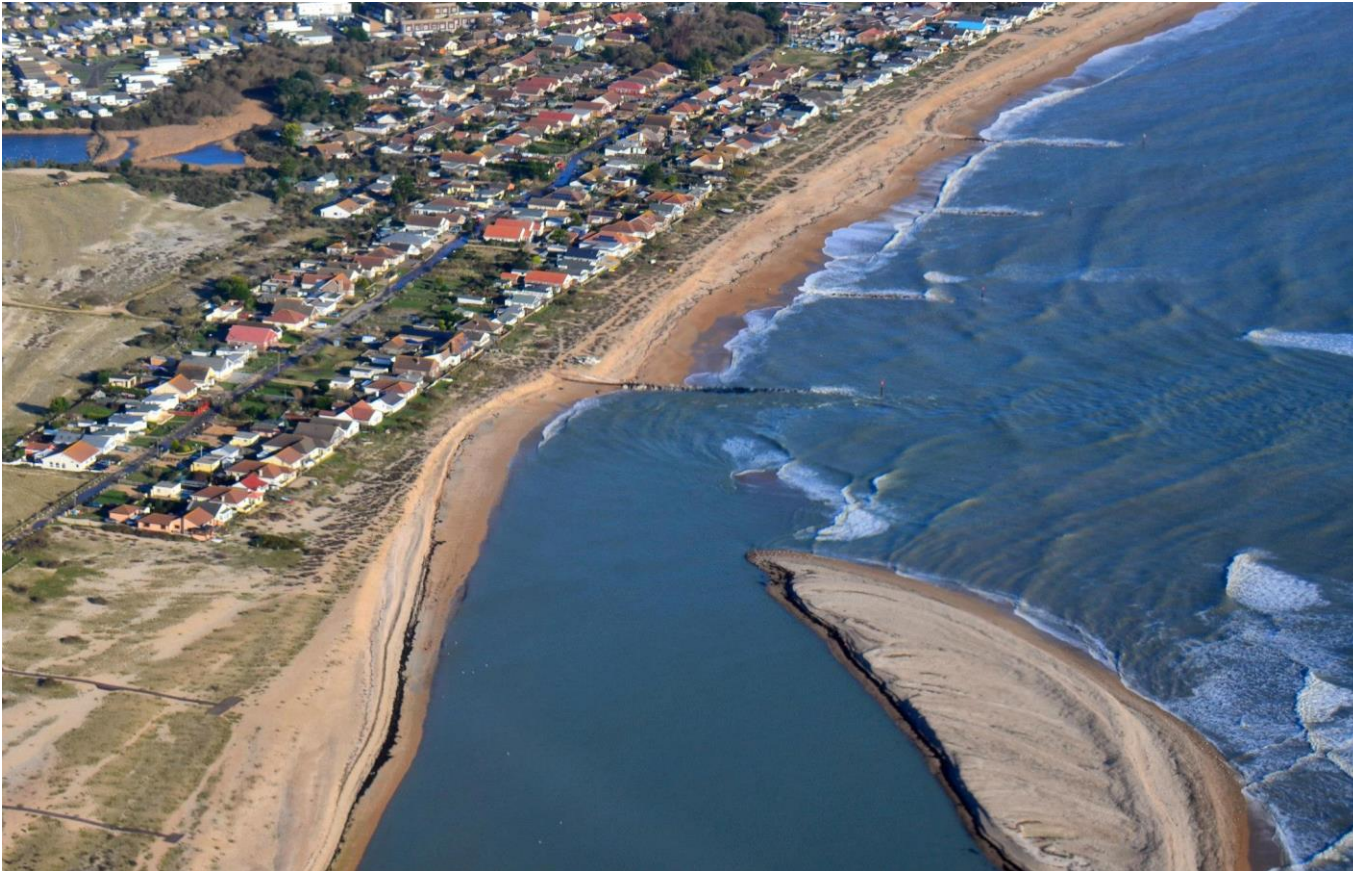
**Photograph 14** – taken 25.11.2012

Further spit development since 2007 – note recurved remnants of spit historical development (9) and the altered behaviour (alignment) of the distal end of the spit in 2012. Upto this point of altered alignment the spit development had been generally linear and parallel to the Pagham Spit, (9, 10). The altered alignment is observed to occur around 2009 and is shown from different perspectives in (11, 12, 13, 14). Wave interaction with the shoreline (14, 15, 16) shows how the angle between the spit beach contours and the wave crests alters – the movement of shingle alongshore on the spit will alter with this angle alteration.

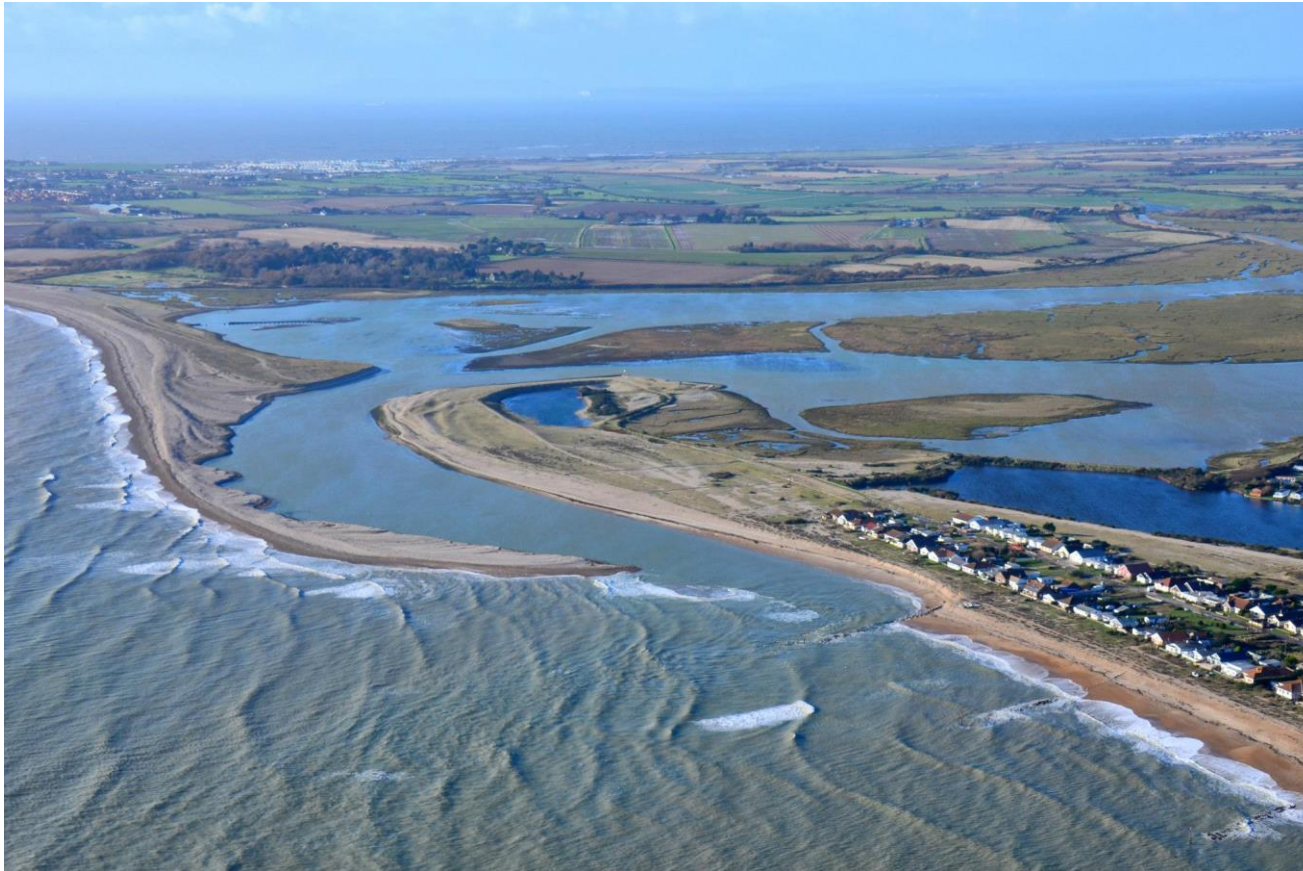
**Photograph 15** – taken 25.11.2012

Further spit development since 2007 – note recurved remnants of spit historical development (9) and the altered behaviour (alignment) of the distal end of the spit in 2012. Upto this point of altered alignment the spit development had been generally linear and parallel to the Pagham Spit, (9, 10). The altered alignment is observed to occur around 2009 and is shown from different perspectives in (11, 12, 13, 14). Wave interaction with the shoreline (14, 15, 16) shows how the angle between the spit beach contours and the wave crests alters – the movement of shingle alongshore on the spit will alter with this angle alteration.
